Construction Noise and Vibration Monthly Report – August 2023

North Warwickshire Borough Council

Non-Technical Summary

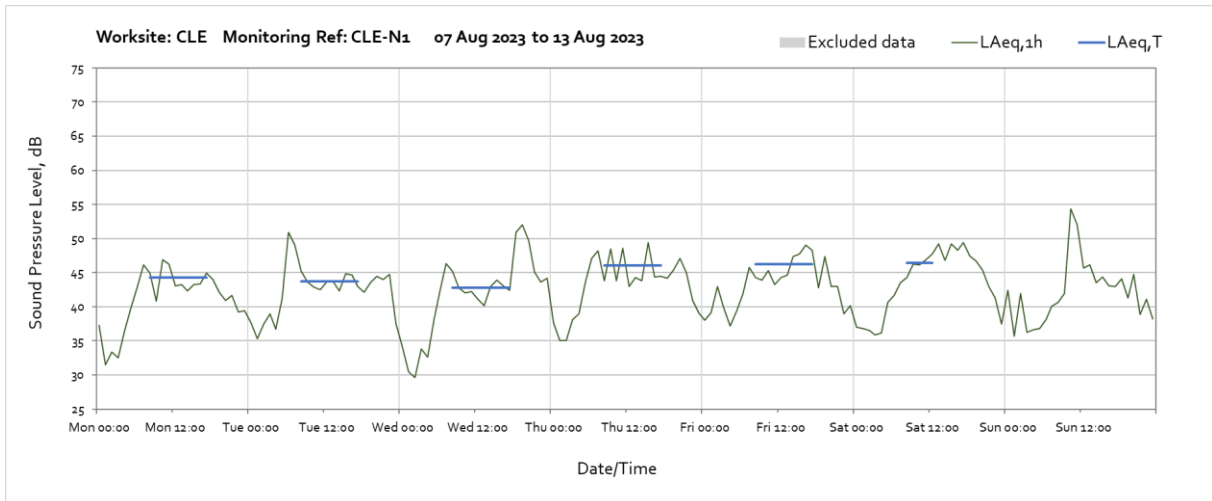
Worksite: CLE – Monitoring Ref: CLE-N1

The following graphs show the hourly measured ambient noise level $L_{Aeq,1h}$ and, where relevant, the averaged noise level $L_{Aeq,T}$ values, where the time period T is as specified in Table 1 of HS2 Information Paper E23. Periods with adversely weather affected noise levels are greyed out and have been excluded from the calculation of the $L_{Aeq,T}$ values in Table 3 of the main report.:

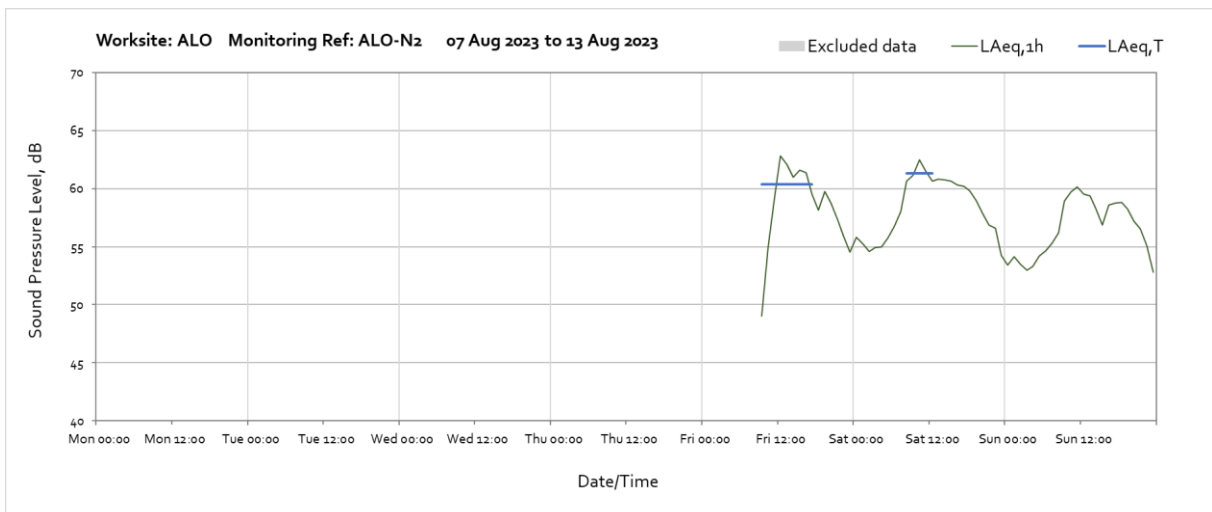
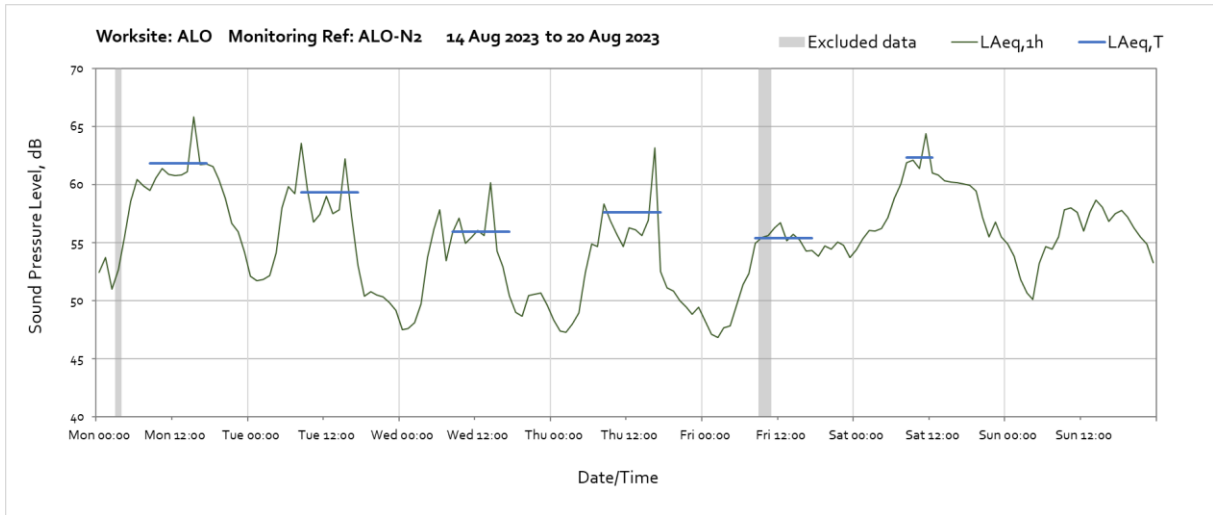
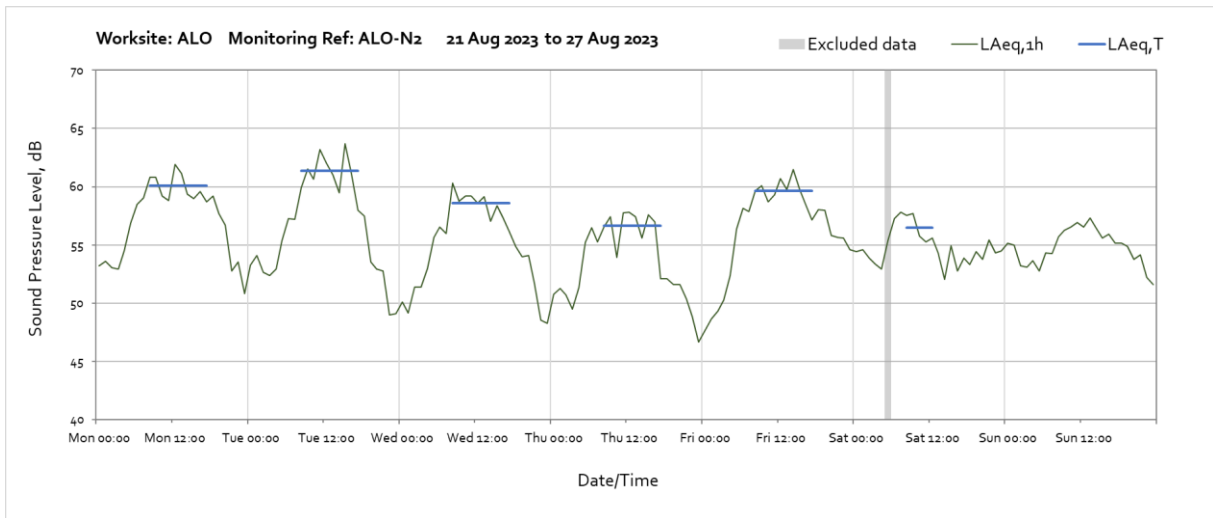
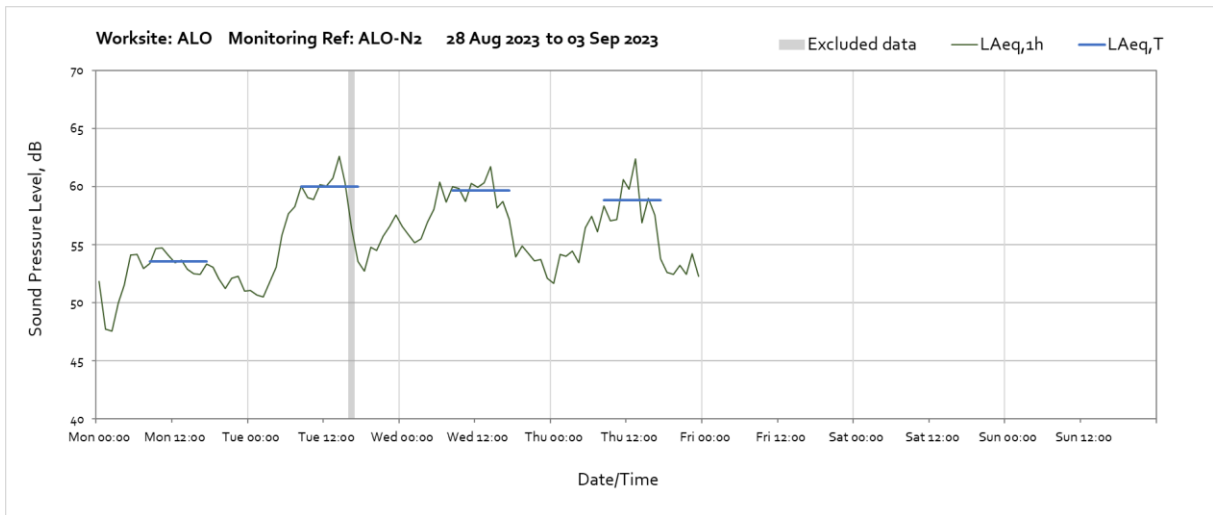
Worksite: ALO – Monitoring Ref: ALO-N2

Note: Monitor was installed 09:00 on Thursday 10th of August.

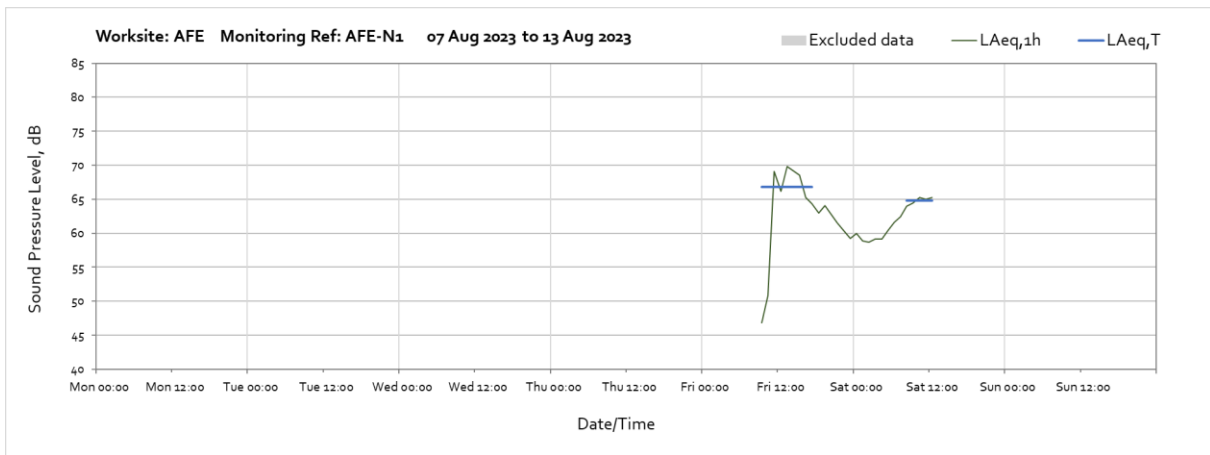
Worksite: AFE – Monitoring Ref: AFE-N1

Note: Monitor was installed 09:00 on Thursday 10th of August.

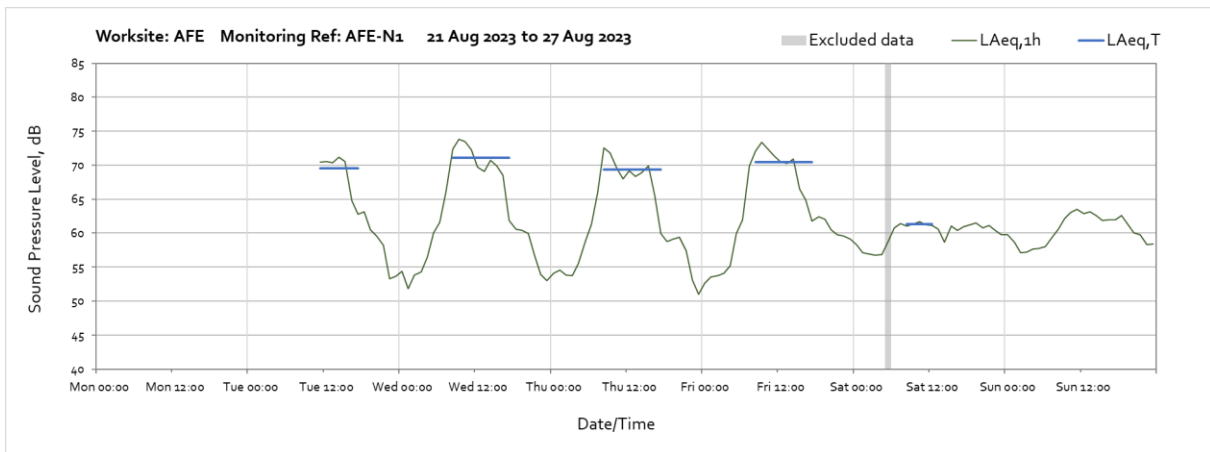
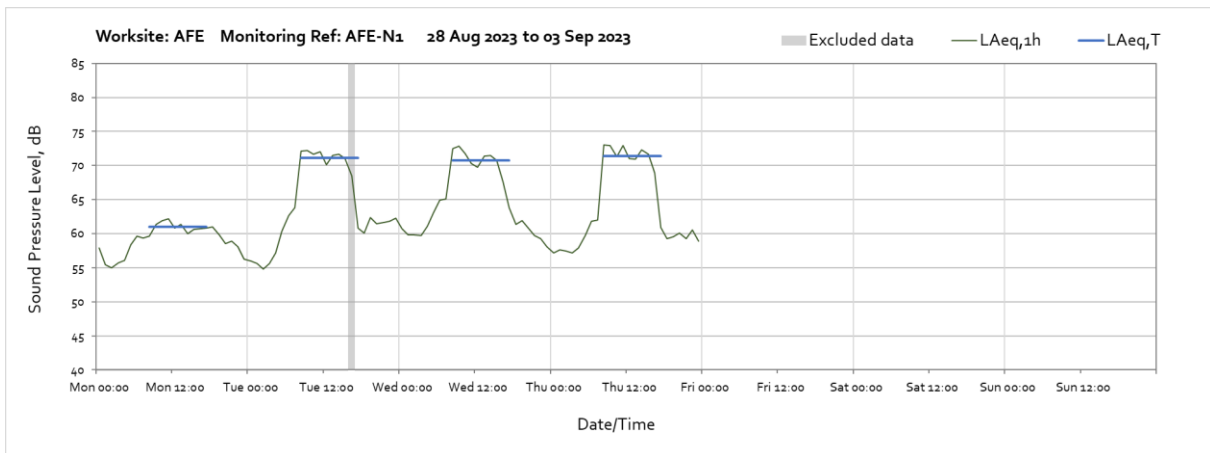
Note: Missing data from 12:00 on Saturday August 12th to 11:00 on Tuesday August 22nd was due to a solar panel issue at the monitoring station.

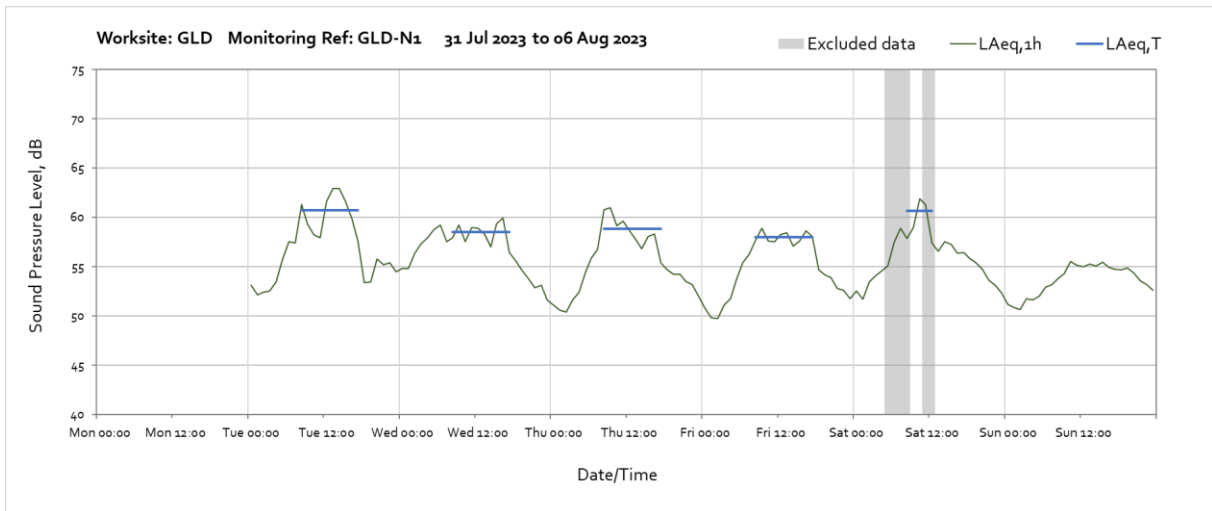
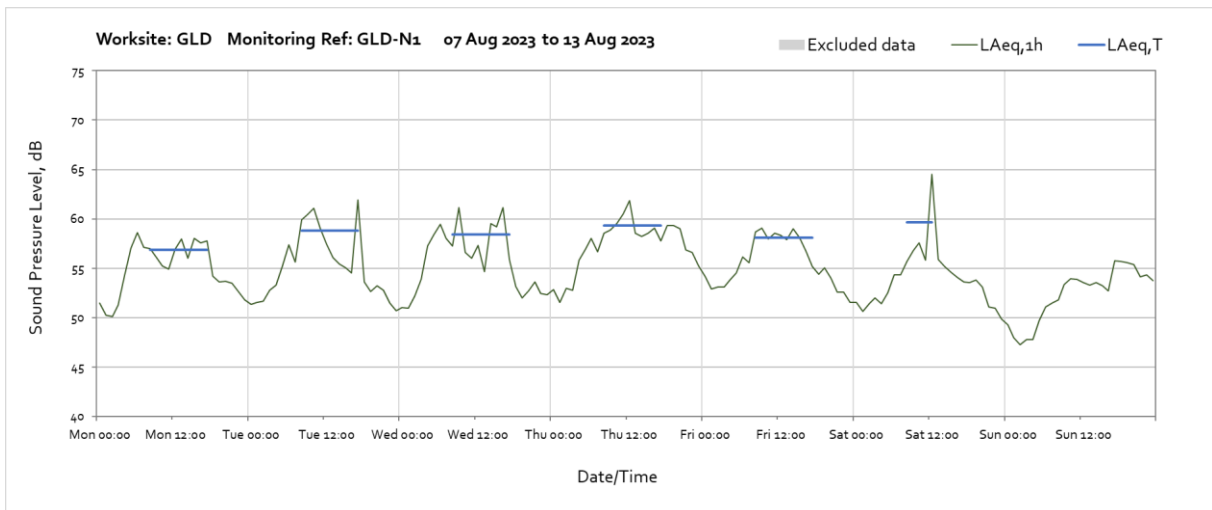
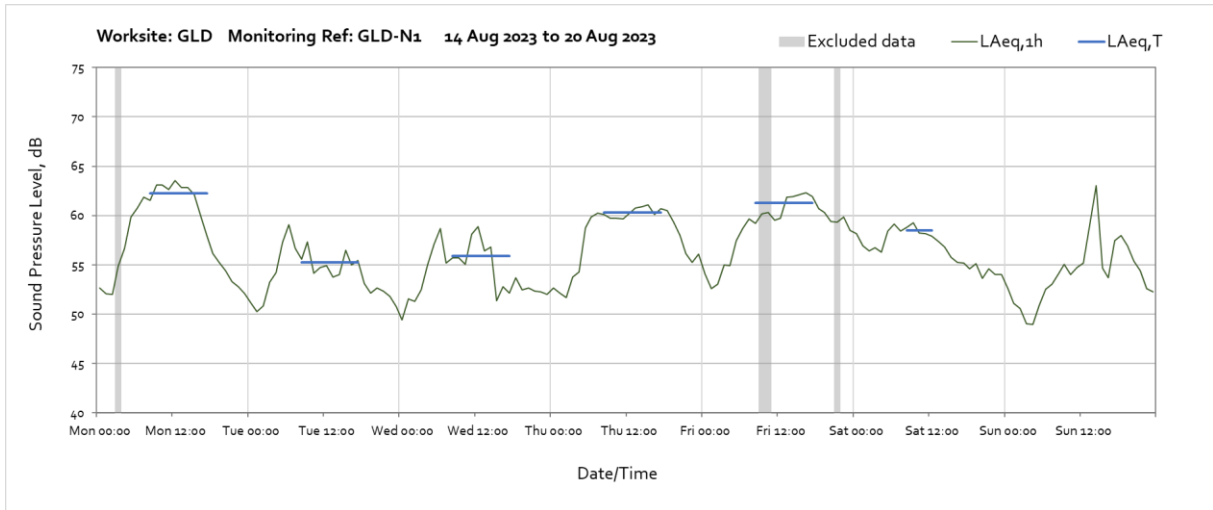
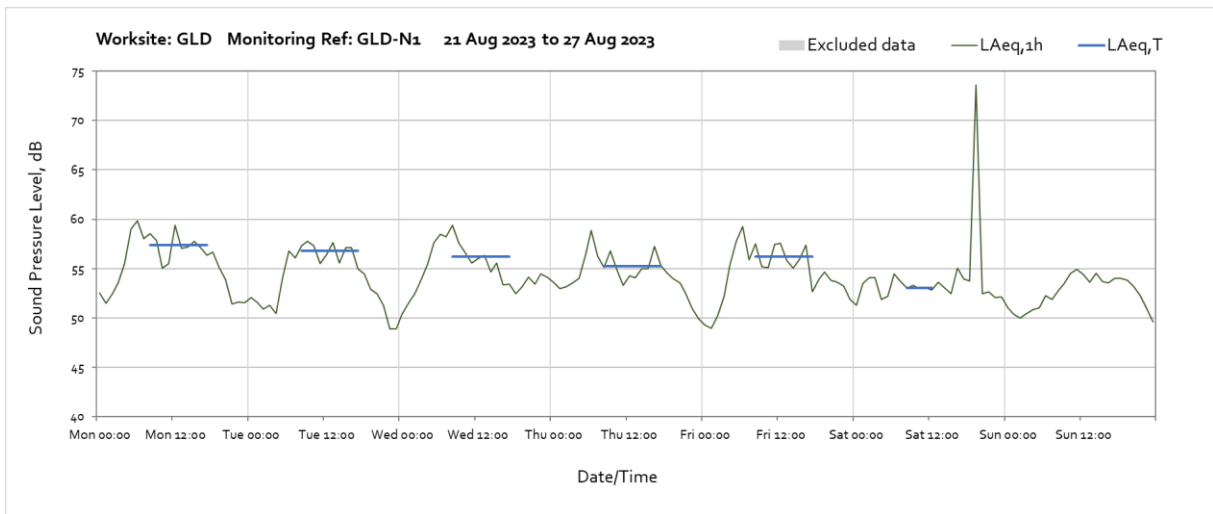
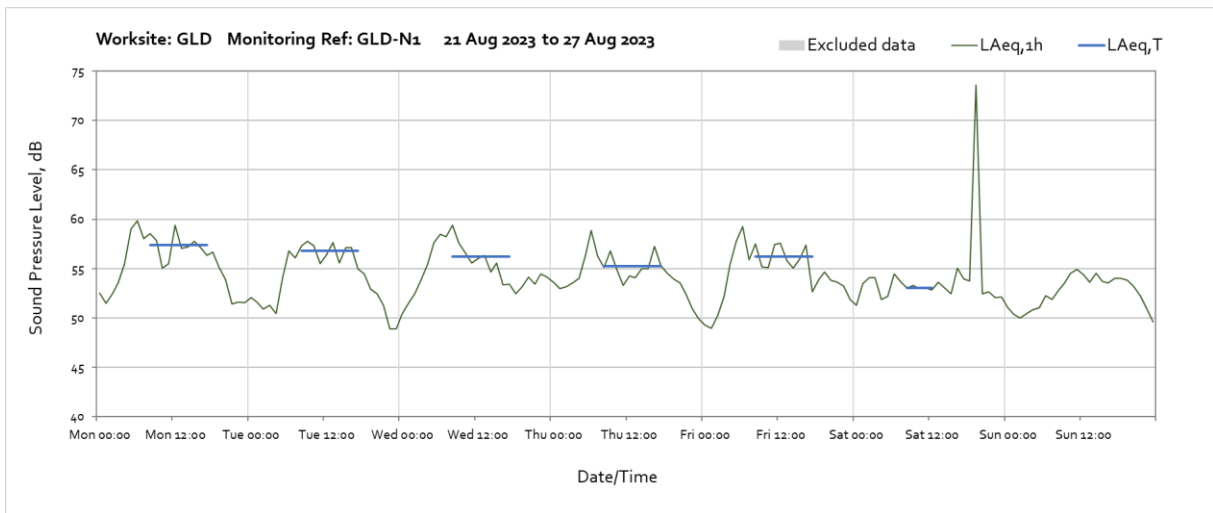
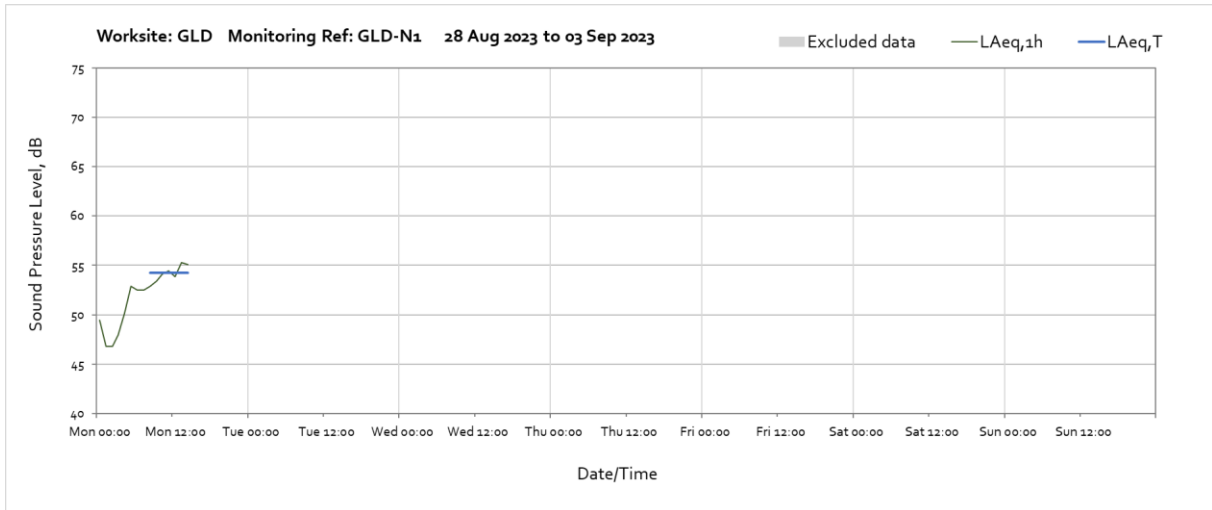
Worksite: GLD - Monitoring Ref: GLD-N1

Note: Missing data from 14:00 on Monday 28th August until the end of the month was due to a lost of power to the monitoring station.

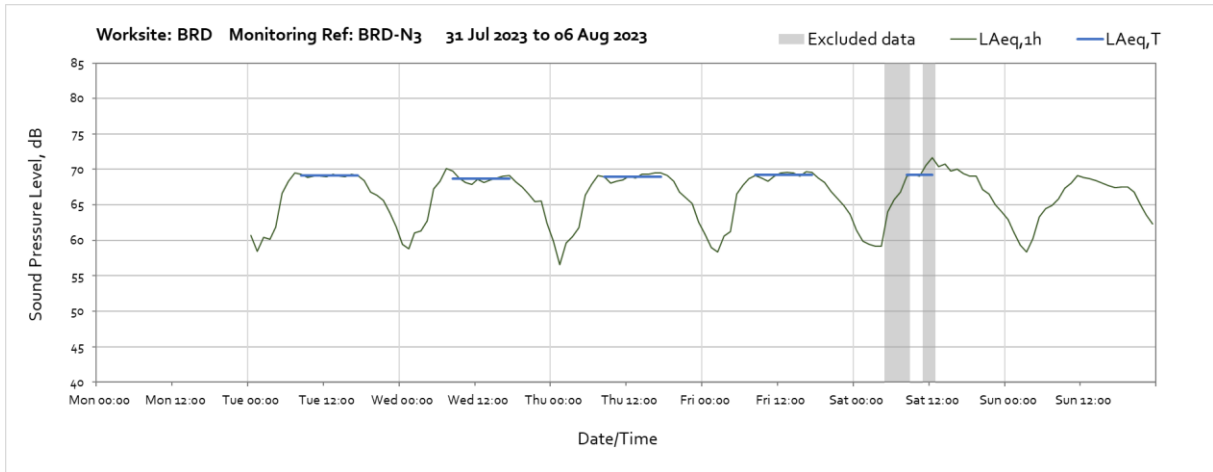
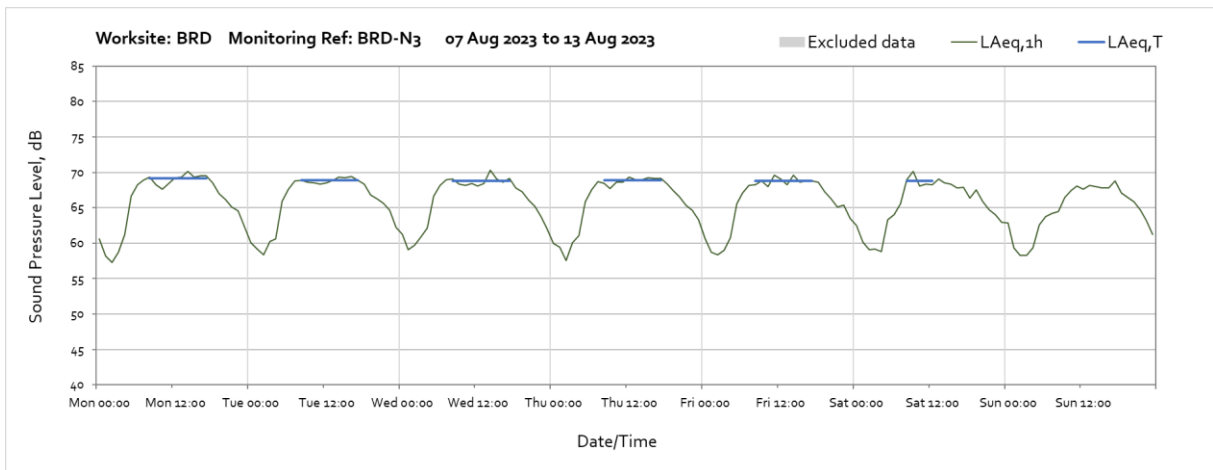
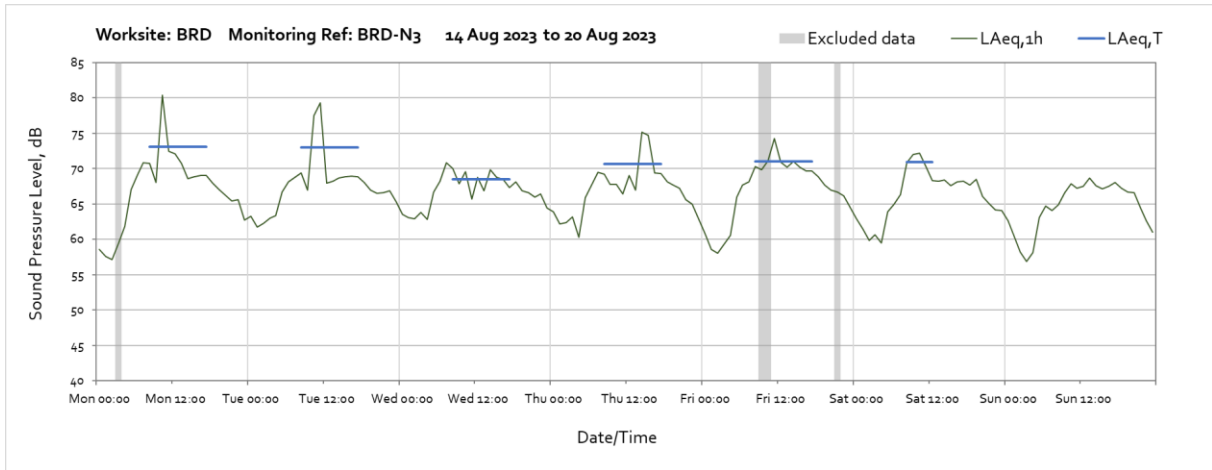
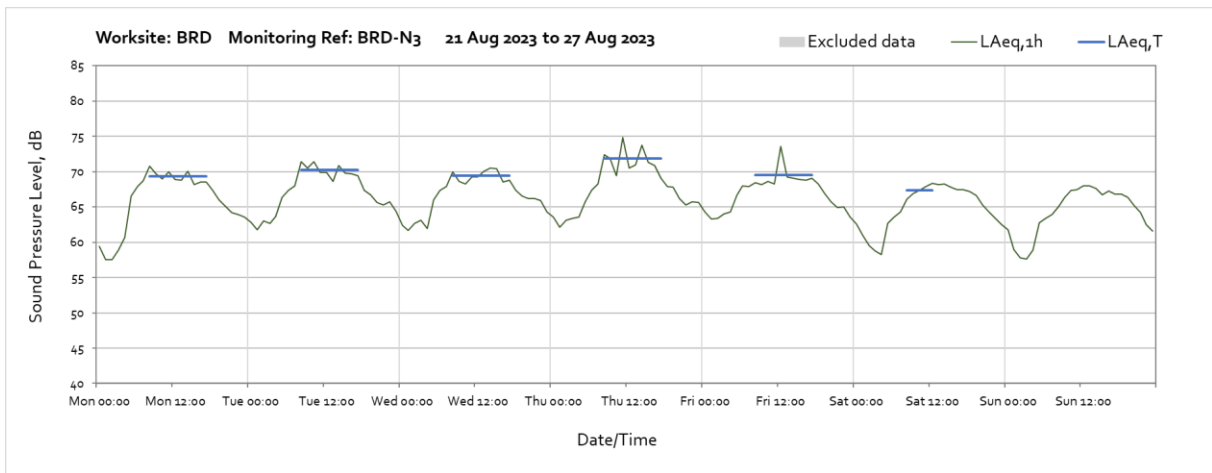
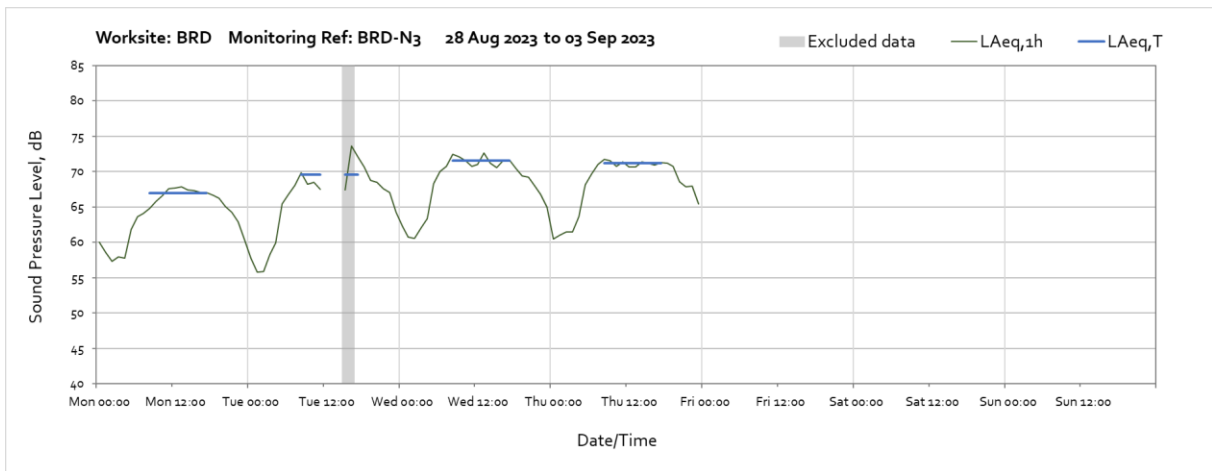
Worksite: BRD - Monitoring Ref: BRD-N3

Note: Missing data between 12:00 and 15:00 on Tuesday 29th August was due to the monitor position being adjusted.

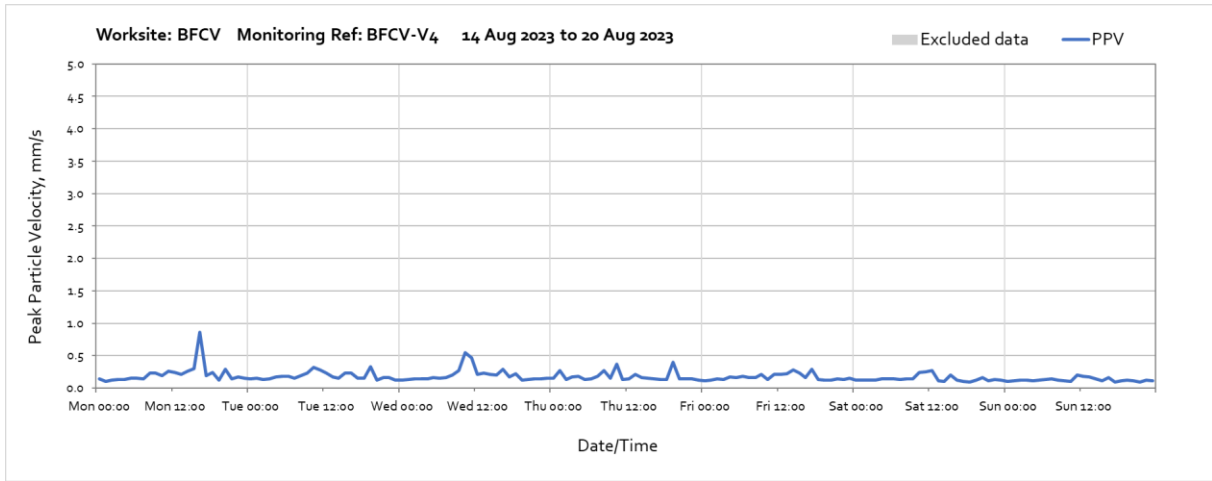
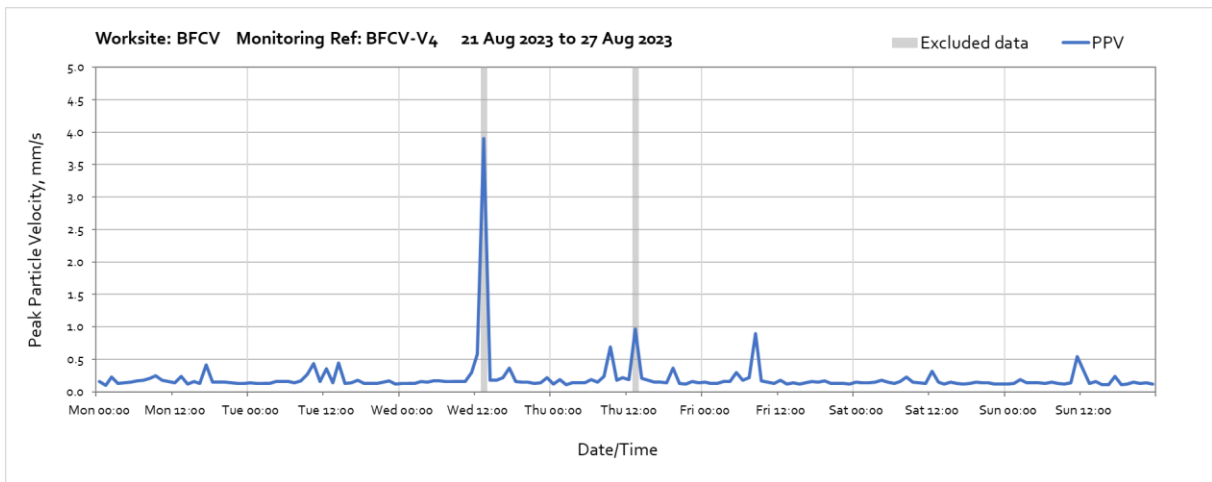
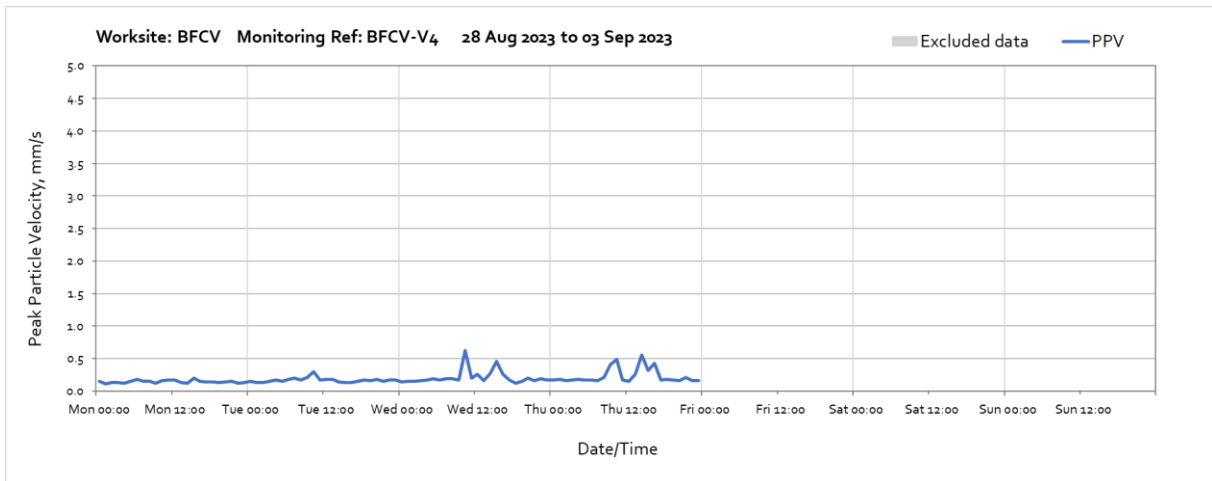
Worksite: BFCV - Monitoring Ref: BFCV-V4

The following graphs show the hourly measured peak particle velocity PPV recorded during the monitoring period. The graphs show the highest PPV of the three orthogonal axes x, y and z. Where high values of PPV were caused by local interference with the vibration monitor, which are not representative of HS2 construction works, these values have been greyed out in the following charts and have been excluded to calculate values in Table 4 of the main report.

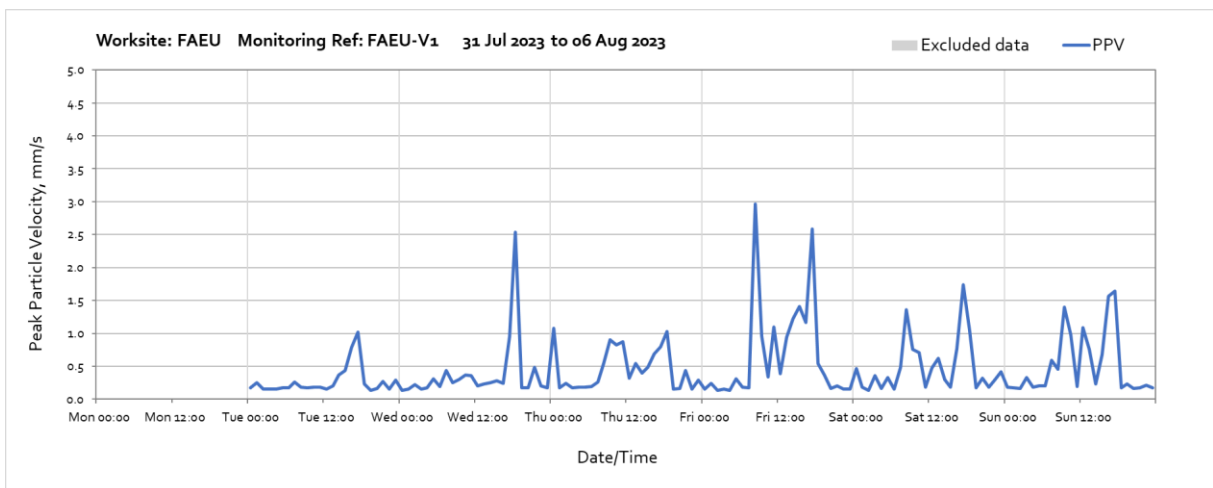
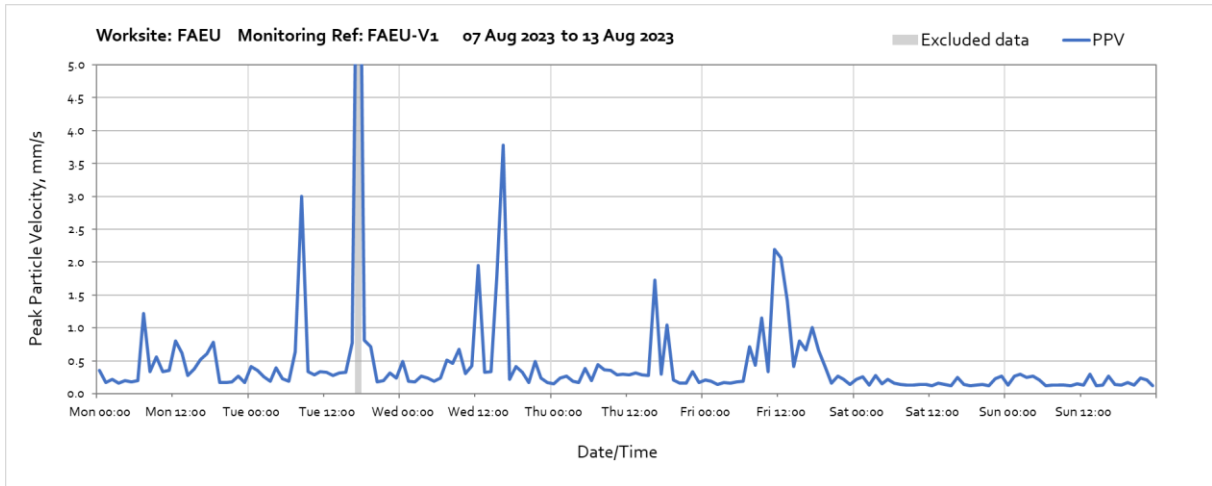
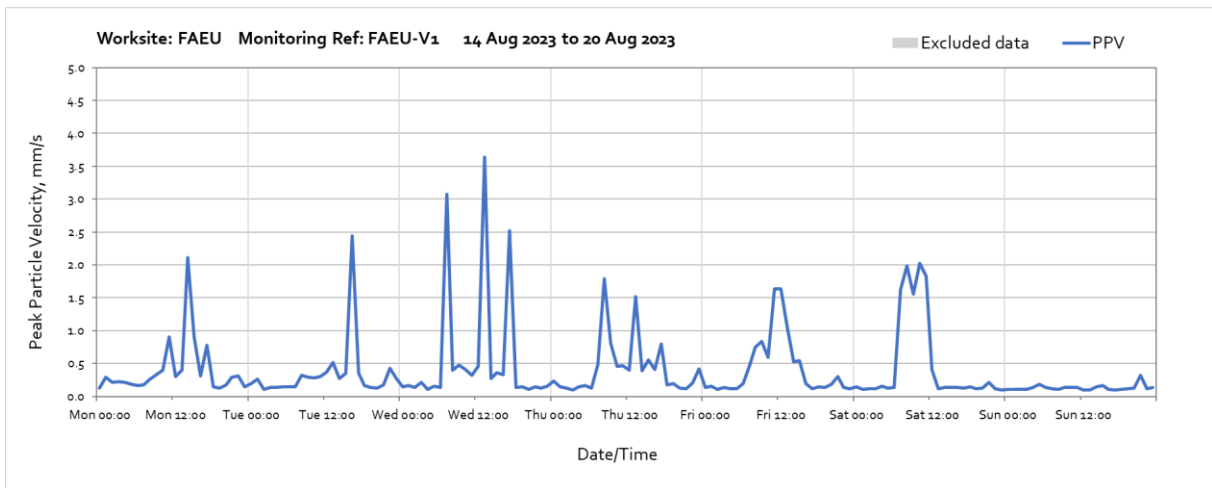
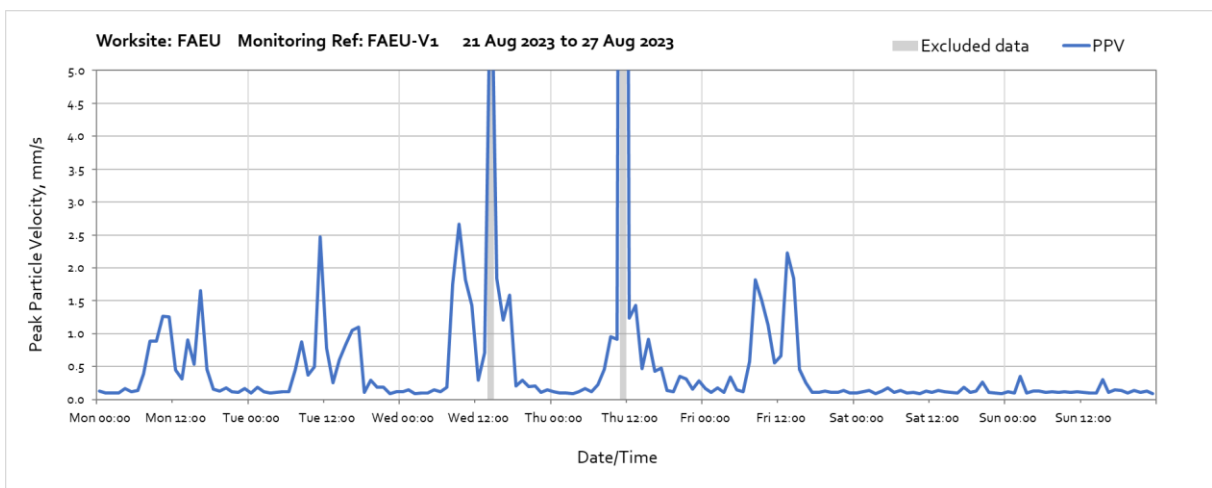
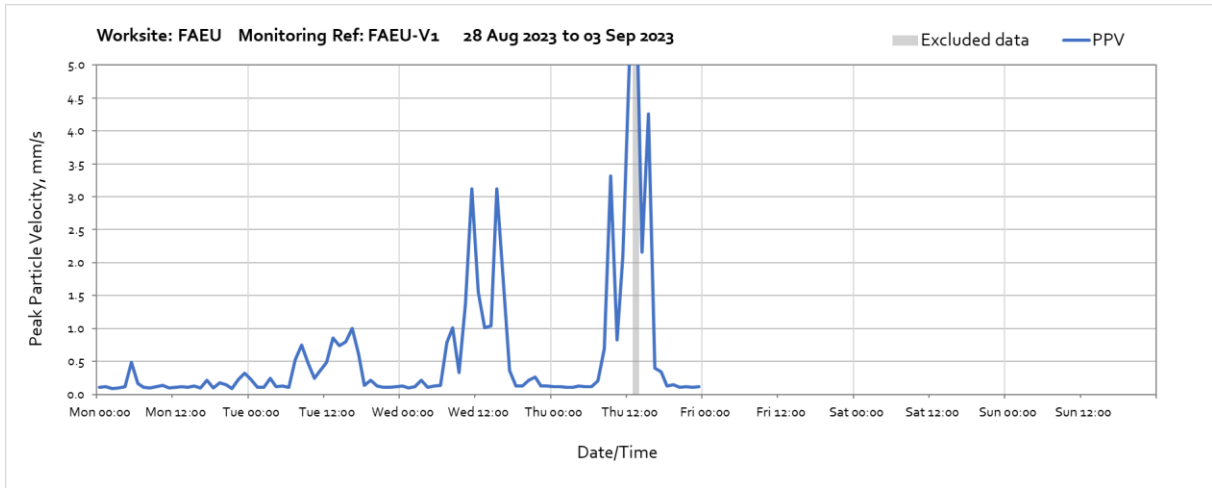
Worksite: FAEU – Monitoring Ref: FAEU-V1

Note: High vibration levels throughout the month were due to activities taking place in the workshop area close to the monitoring station.

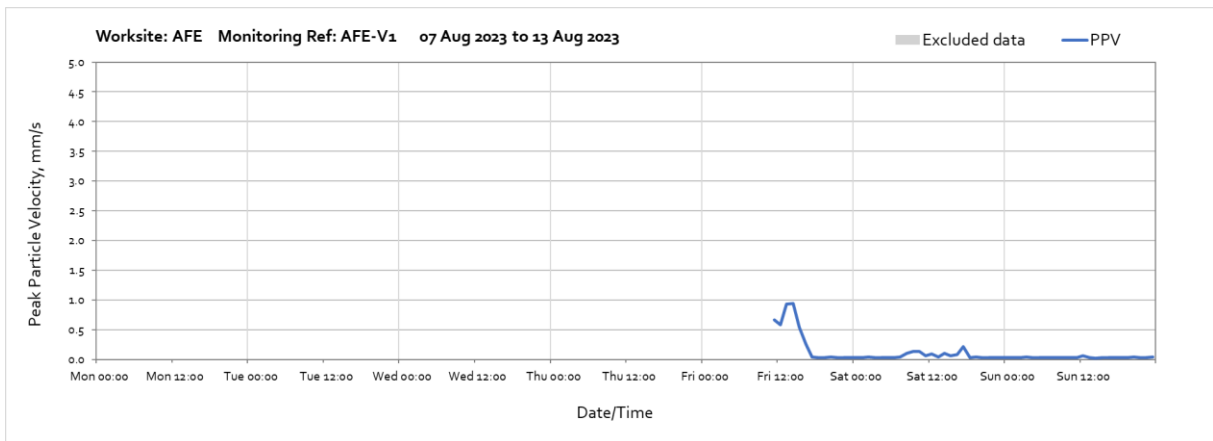
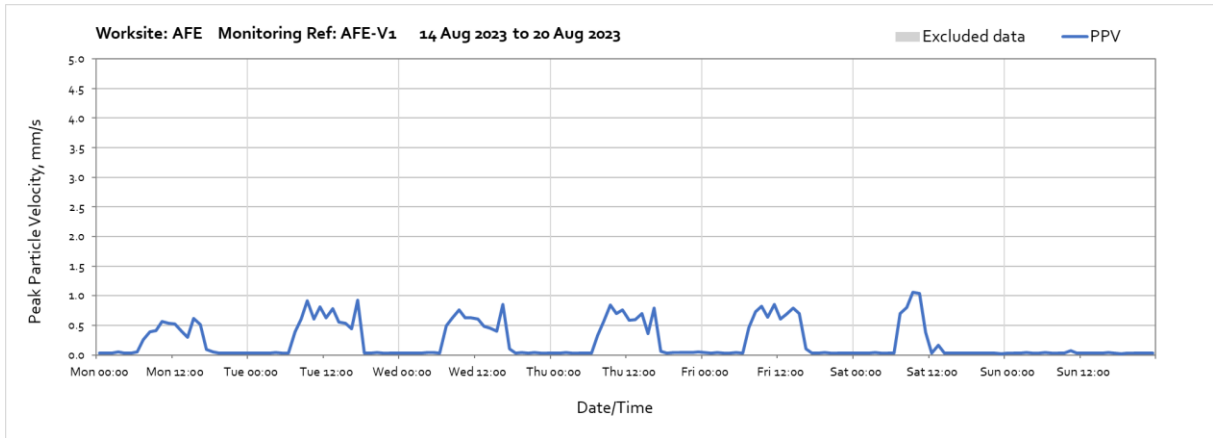
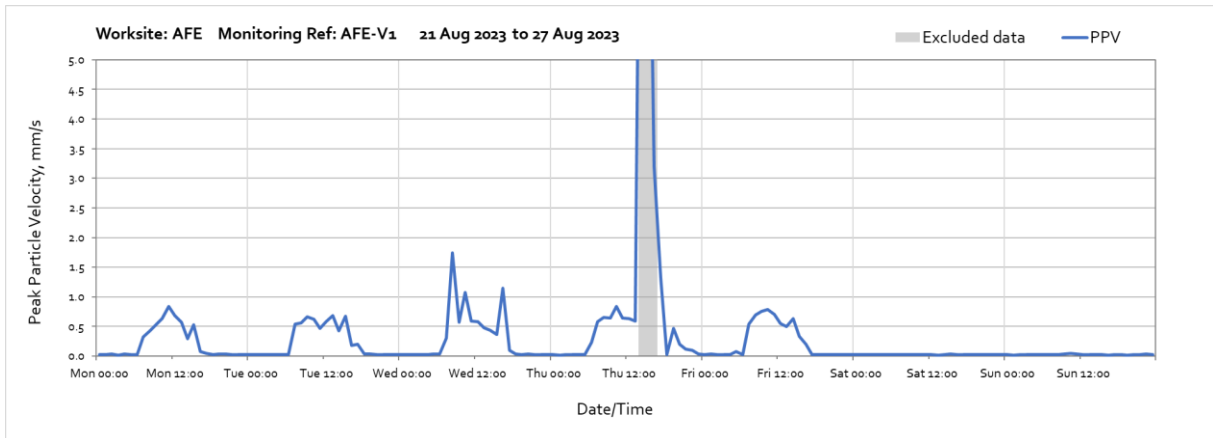
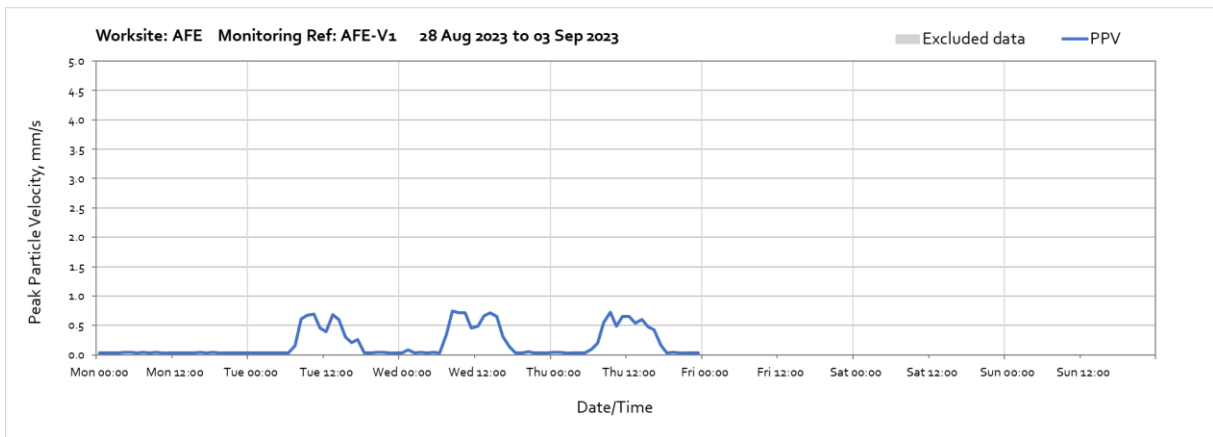
Worksite: AFE - Monitoring Ref: AFE-V1

Note: Monitor was installed 09:00 on Thursday 10th of August.

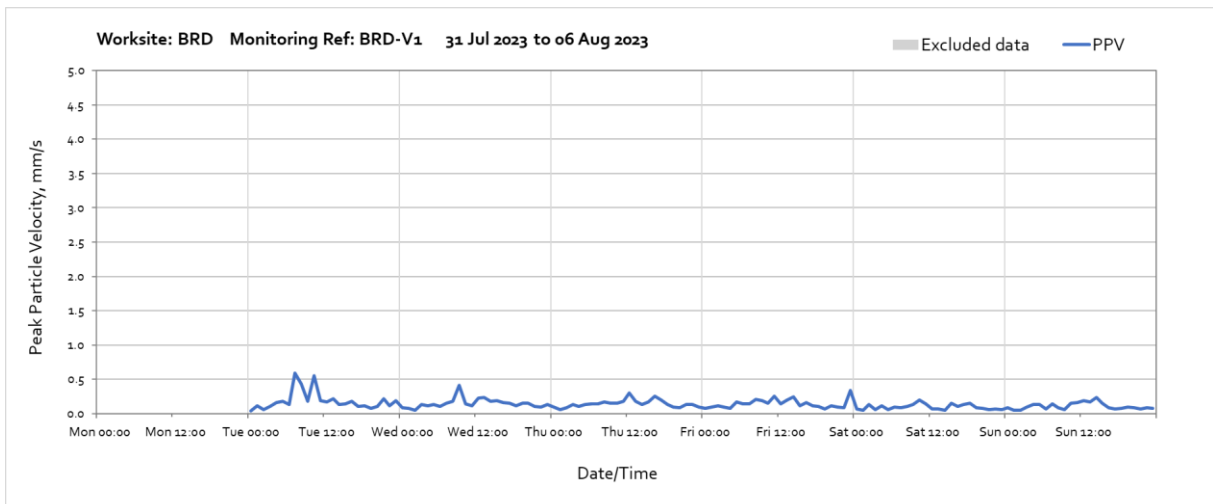
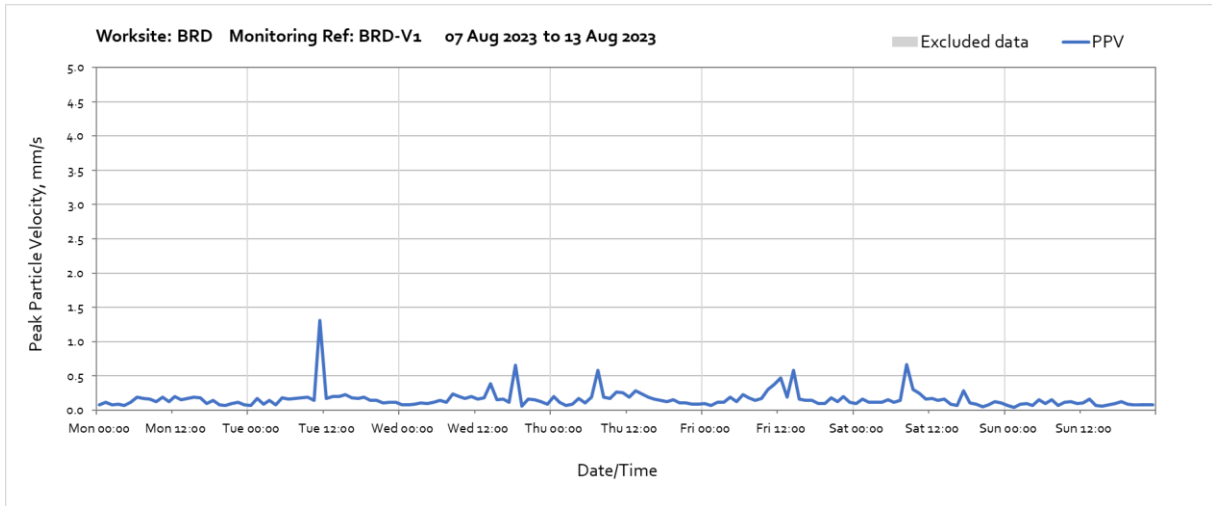
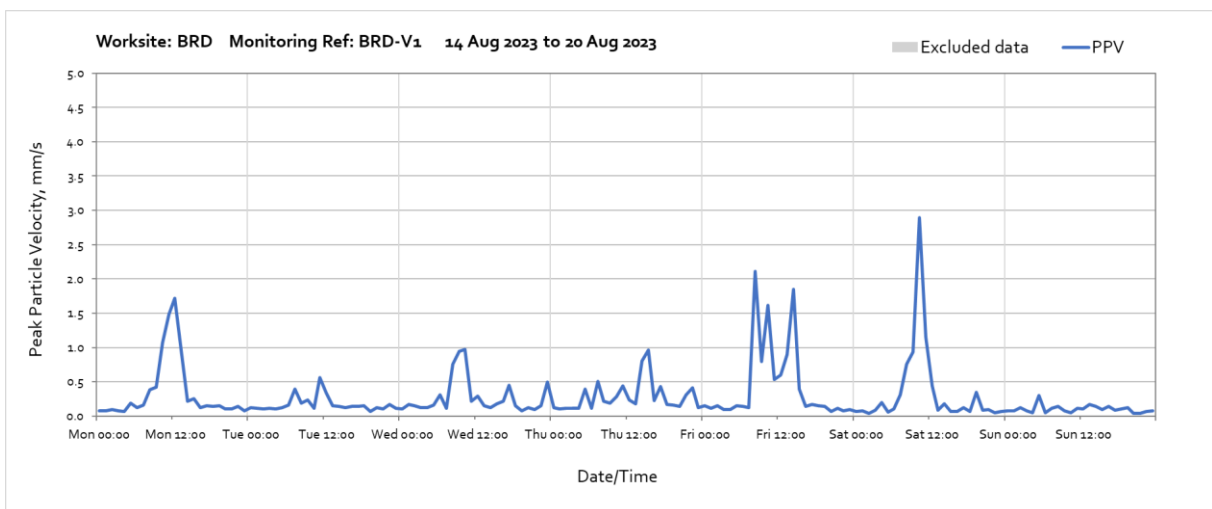
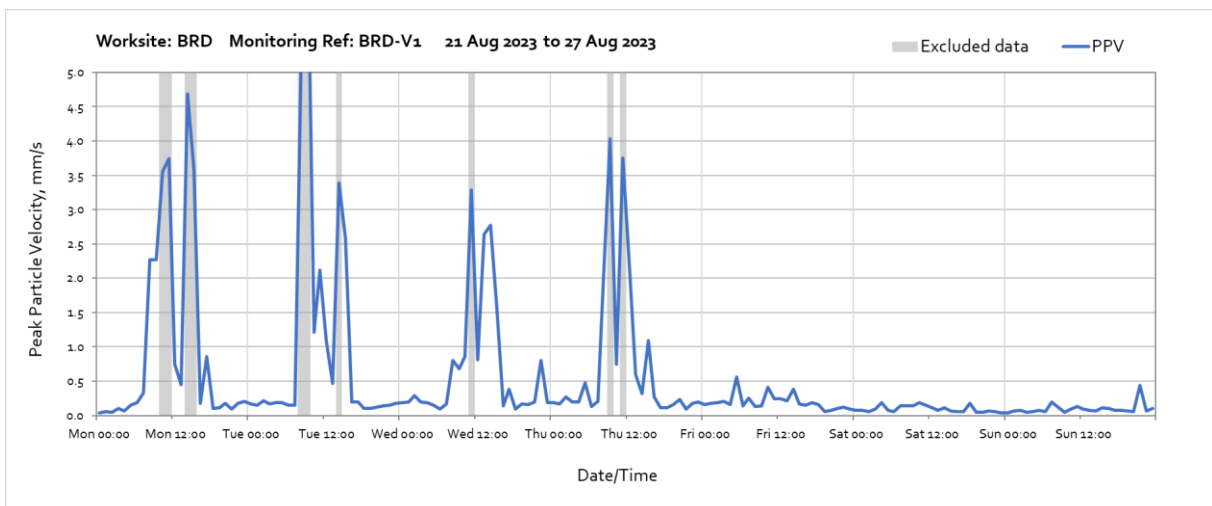
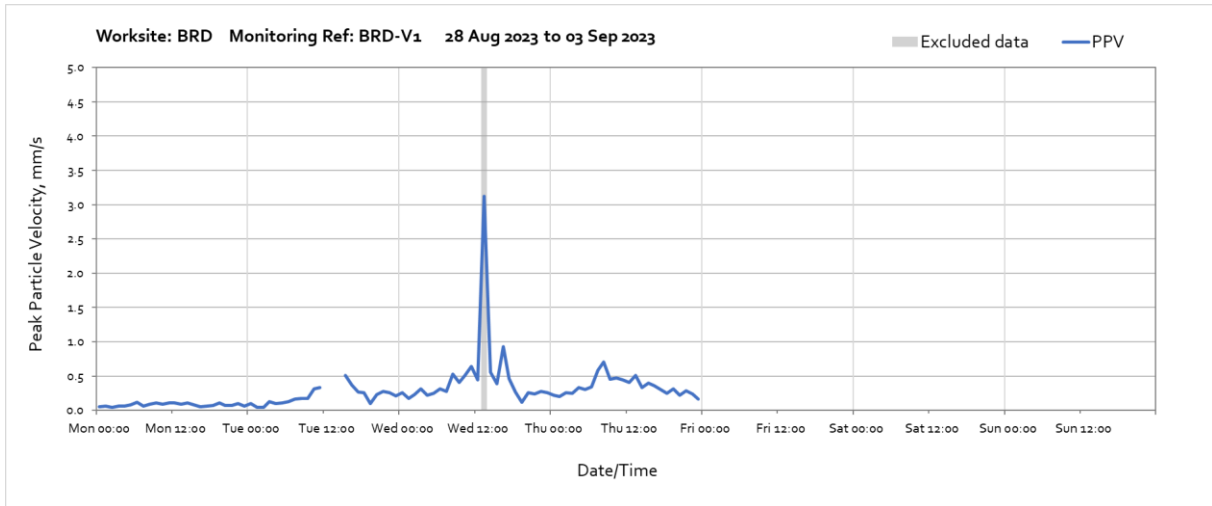
Worksite: BRD – Monitoring Ref: BRD-V1

Note: Missing data between 12:00 and 15:00 on Tuesday 29th August was due to the monitor position being adjusted.
