Construction Noise and Vibration Monthly Report – August 2023

Solihull Metropolitan Borough Council

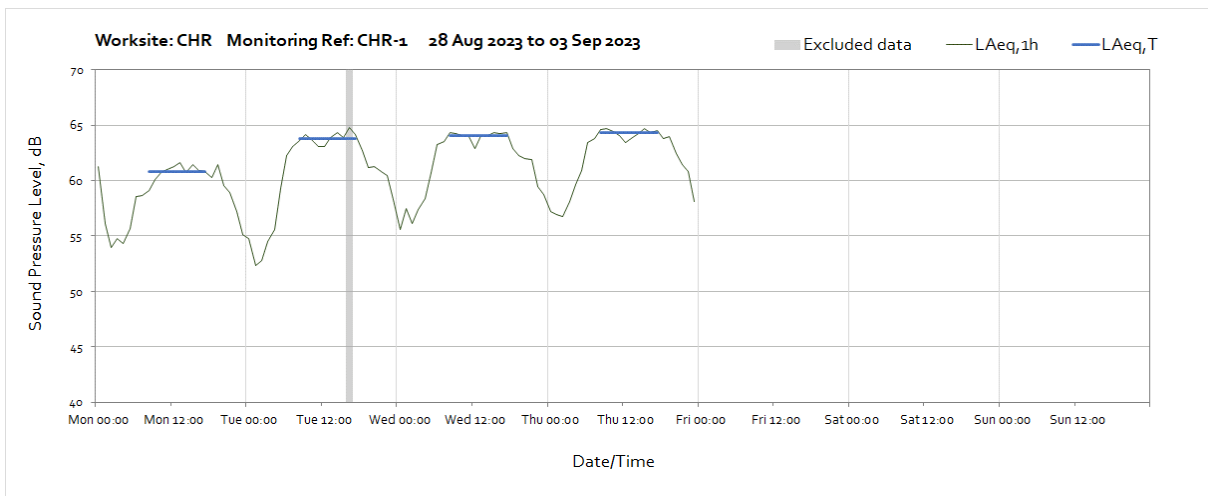
Worksite: CHR - Monitoring Ref: CHR-1

The following graphs show the hourly measured ambient noise level $L_{Aeq,1h}$ and, where relevant, the averaged noise level $L_{Aeq,T}$ values, where the time period T is as specified in Table 1 of HS2 Information Paper E23. Periods where noise levels are adversely affected by weather or only measured for part of the period, which are not representative of HS2 construction works, have been greyed out and excluded from the calculation of the $L_{Aeq,T}$ values in Table 3 of the main report.
