Construction Noise and Vibration Monthly Report – August 2023

Stratford-on-Avon District Council

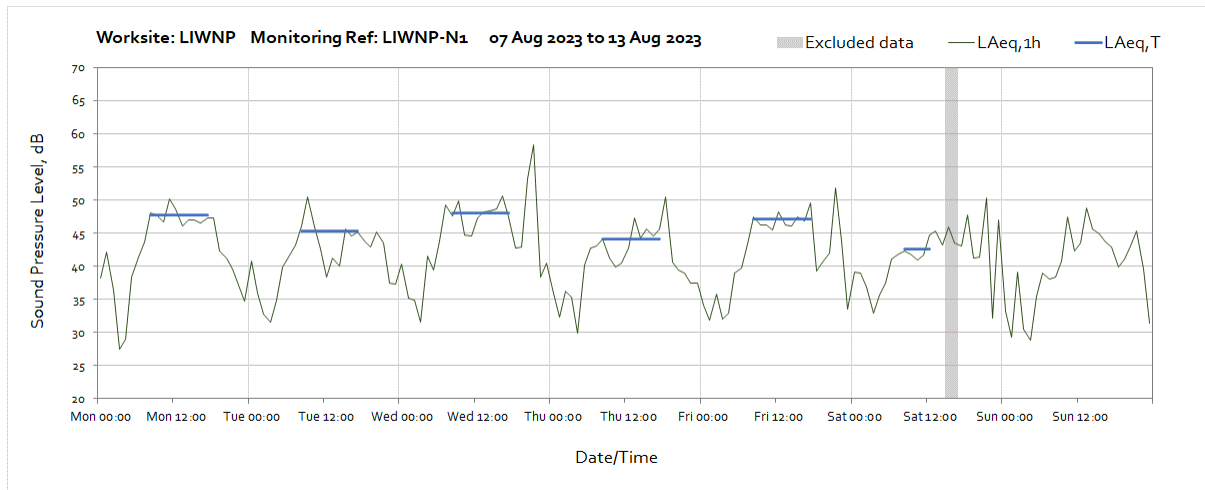
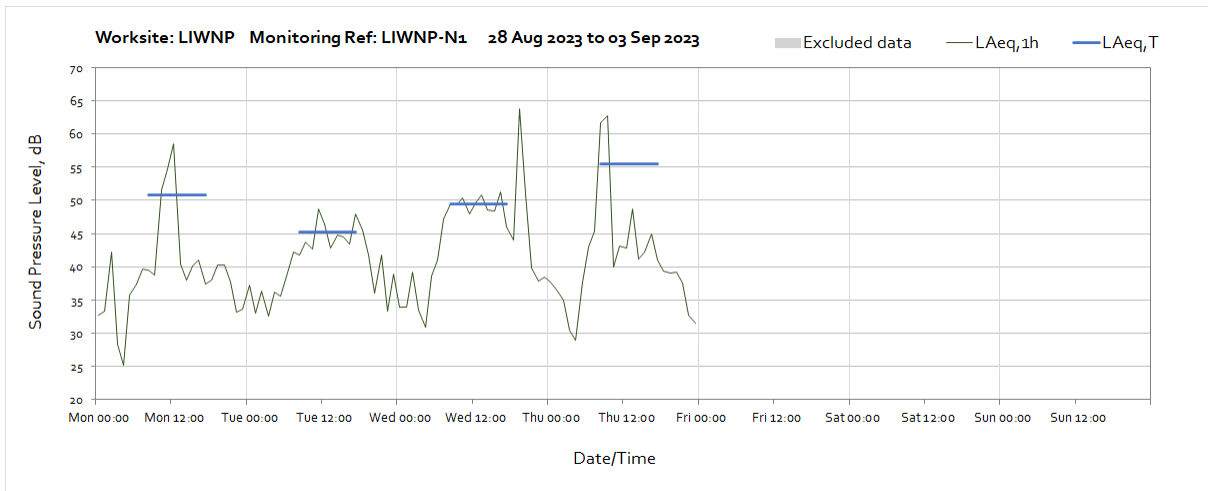
Worksite: LIWNP Monitoring Ref: LIWNP-N1

The following graphs show the hourly measured ambient noise level $L_{Aeq,1h}$ and, where relevant, the averaged noise level $L_{Aeq,T}$ values, where the time period T is as specified in Table 1 of HS2 Information Paper E23. Periods where noise levels are adversely affected by weather or only measured for part of the period, which are not representative of HS2 construction works, have been greyed out and excluded from the calculation of the $L_{Aeq,T}$ values in Table 3 of the main report.

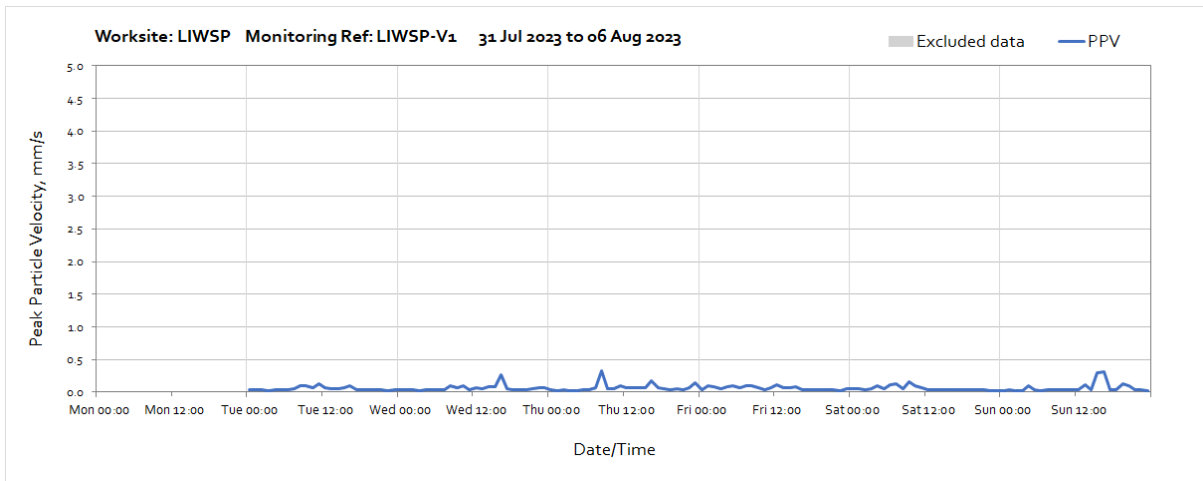
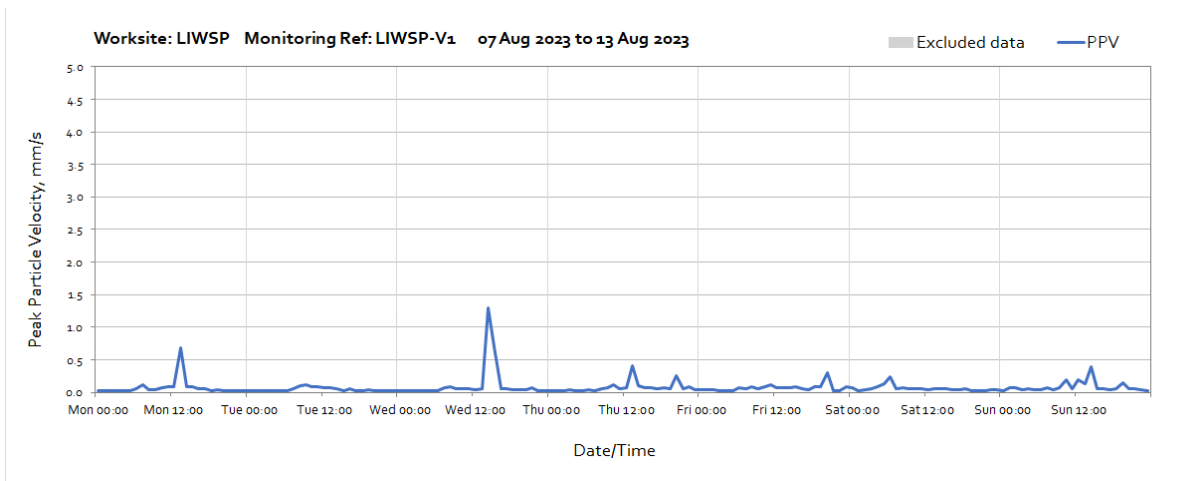
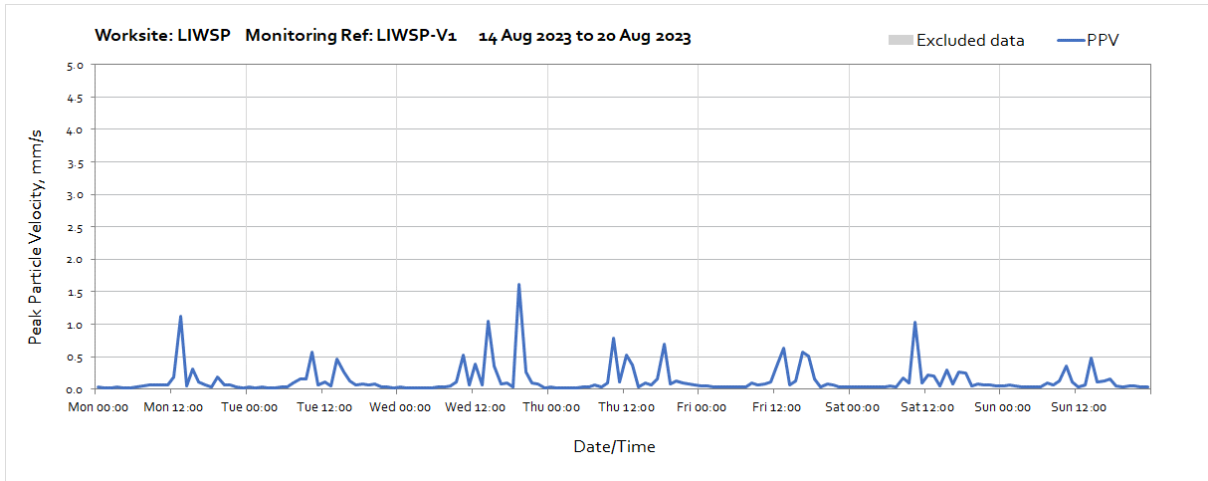
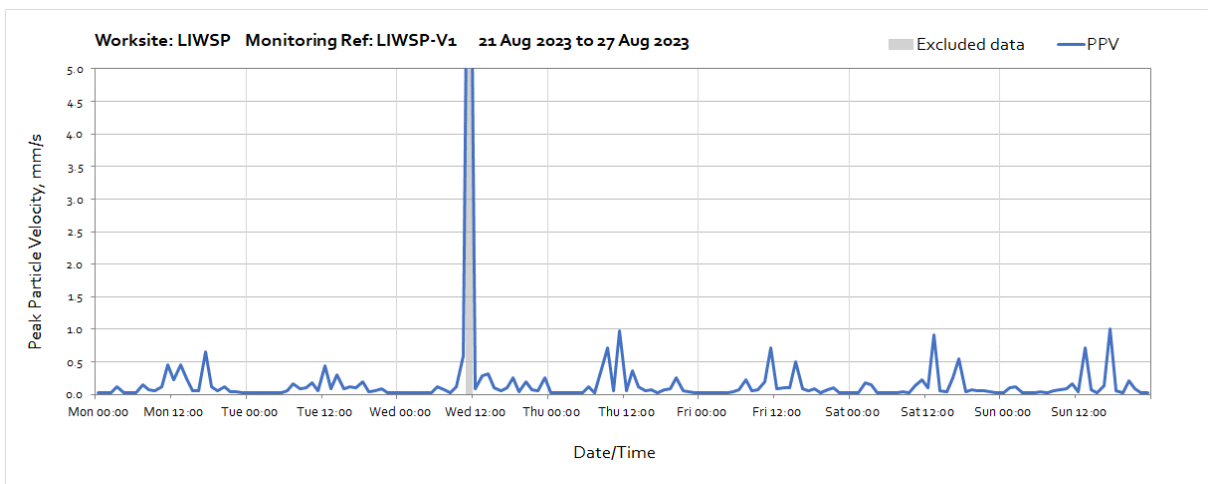
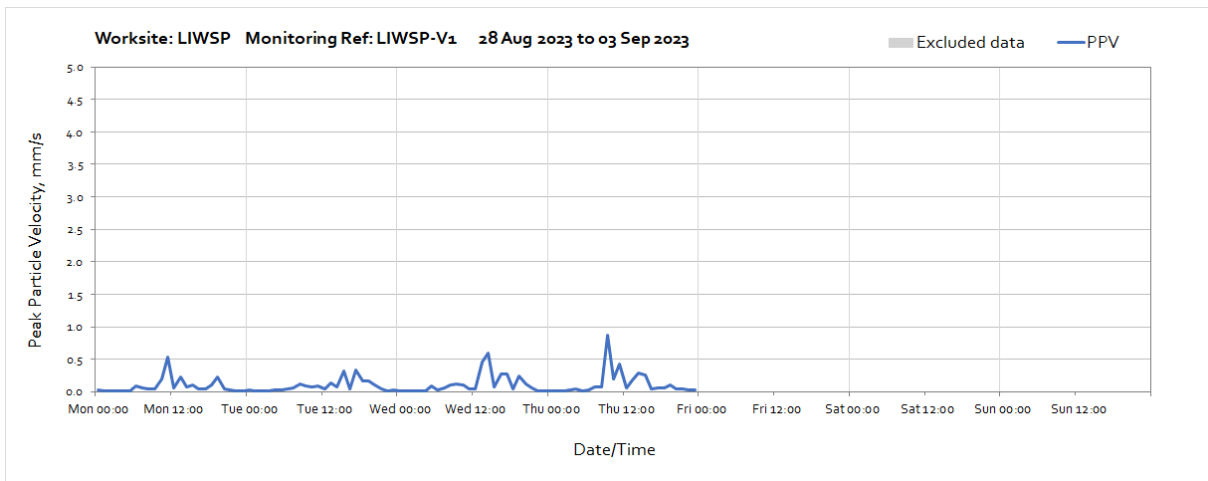
Worksite: LIWSP Monitoring Ref: LIWSP-V1

The following graphs show the hourly measured peak particle velocity PPV recorded during the monitoring period. The graphs show the highest PPV of the three orthogonal axes x, y and z. Periods where PPV values have been affected by local interference with the vibration monitor or only measured for part of the period, which are not representative of HS2 construction works, have been greyed out and excluded when calculating values in Table 4 of the main report.

Worksite Reference	Measurement Reference	Monitor Address	Highest PPV measured in any axis, mm/s
LIWSP - Long Itchington Wood South Portal	LIWSP-V1	Woodside House, Bascote Heath, Southam	2.00 (X-axis)
