Construction Noise and Vibration Monthly Report – August 2023

Warwick District Council

Non-Technical Summary

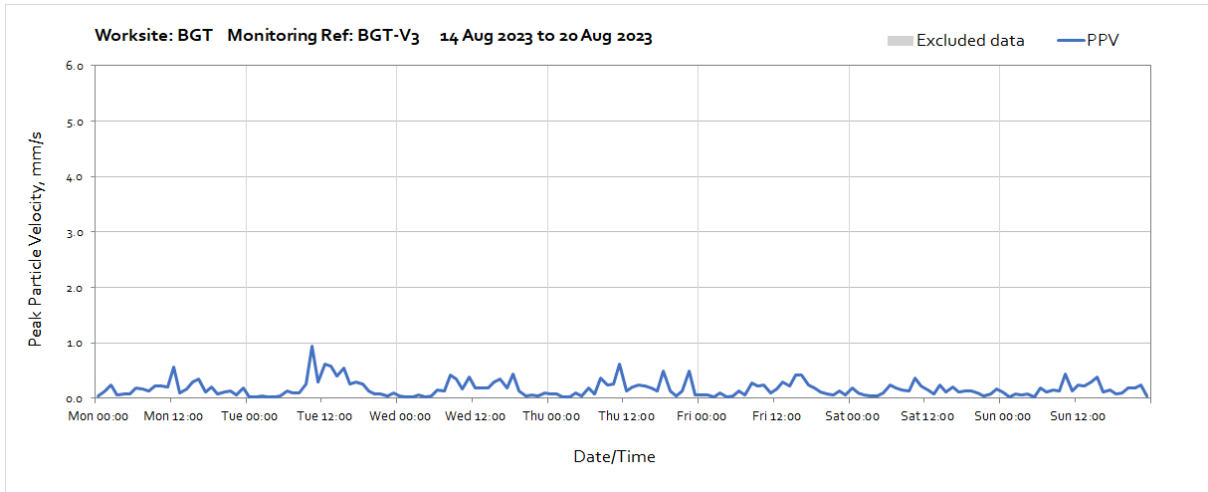
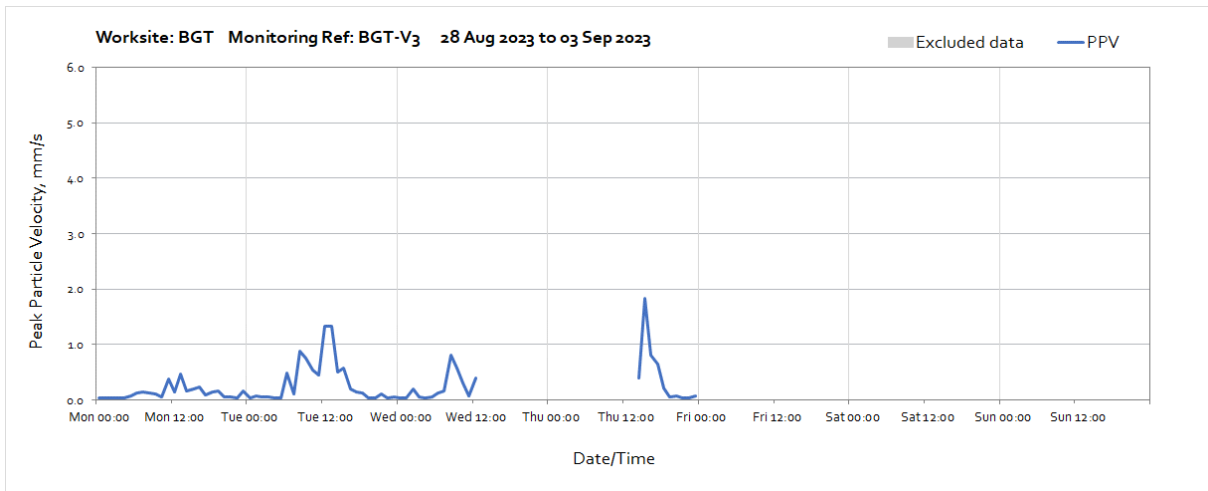
Worksite: BGT - Monitoring Ref: BGT-V3

Note: The high levels of vibration on Monday 7th August are due to excavation occurring within 20m of the monitor.

Note: Missing data from 13:00 on Wednesday 30th August to 14:00 on Thursday 31st August is due to an SD card error.
