## **Construction Noise and Vibration Monthly Report – August 2023**

**West Northamptonshire District Council**

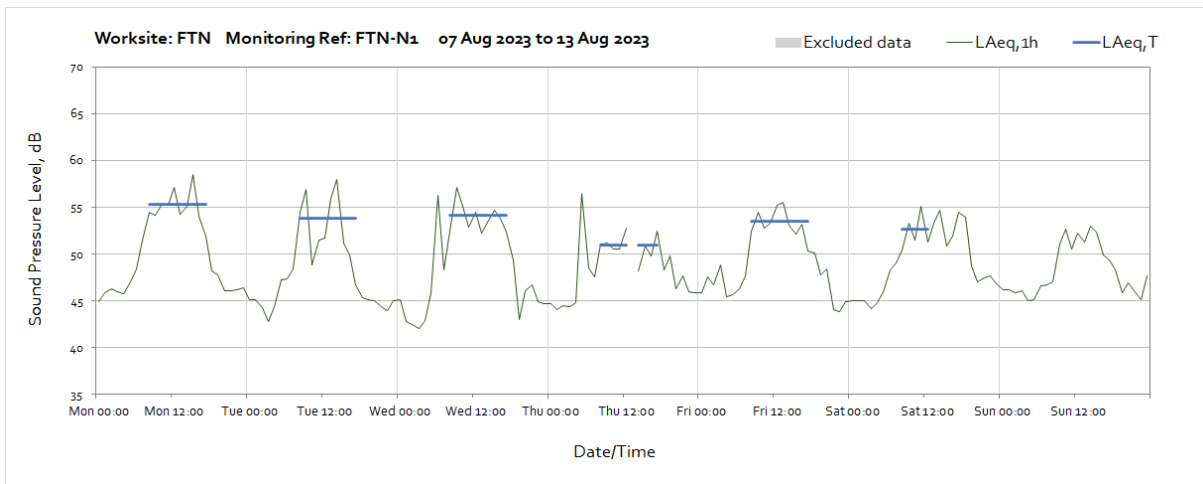
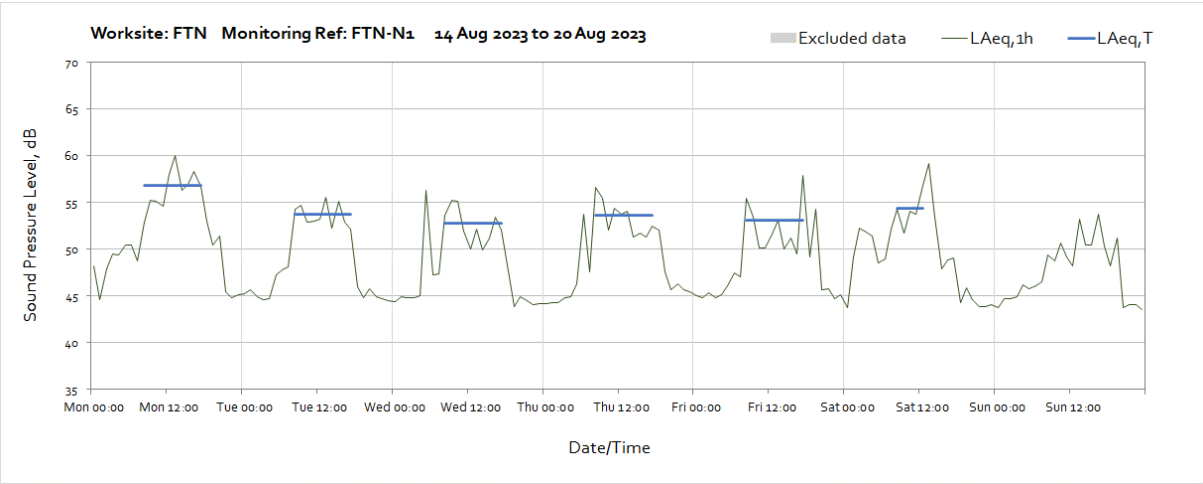
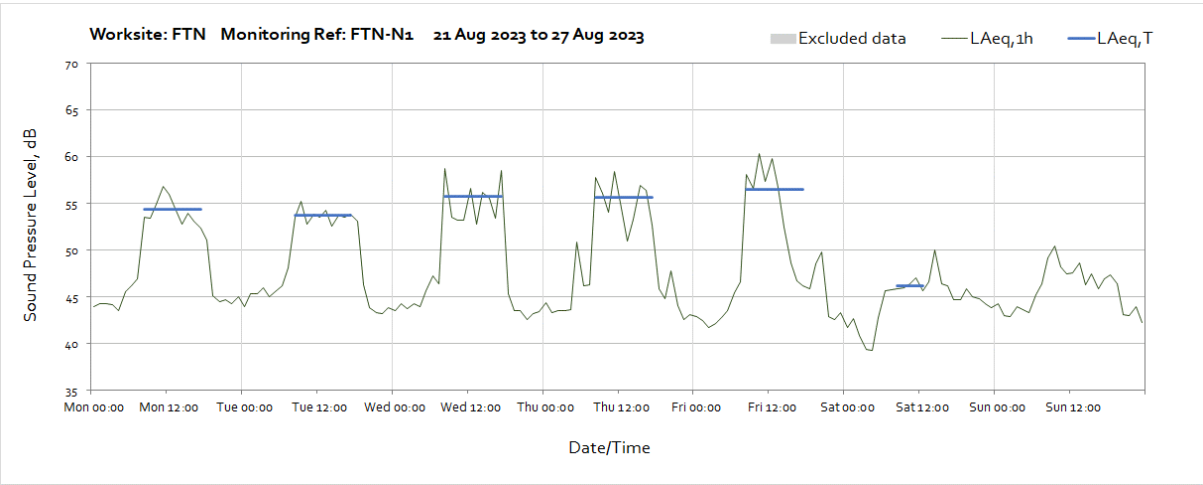
### Worksite: FTN – Monitoring Ref: FTN-N1

The following graphs show the hourly measured ambient noise level  $L_{Aeq,1h}$  and, where relevant, the averaged noise level  $L_{Aeq,T}$  values, where the time period T is as specified in Table 1 of HS2 Information Paper E23. Periods where noise levels are adversely affected by weather or only measured for part of the period, which are not representative of HS2 construction works, have been greyed out and excluded from the calculation of the  $L_{Aeq,T}$  values in in **Error! Reference source not found.** of the main report.

Note: Missing and erratic data from 09:00 on Wednesday 10<sup>th</sup> August and 08:00 on Thursday 11<sup>th</sup> August was attributed to suspected communications problems.

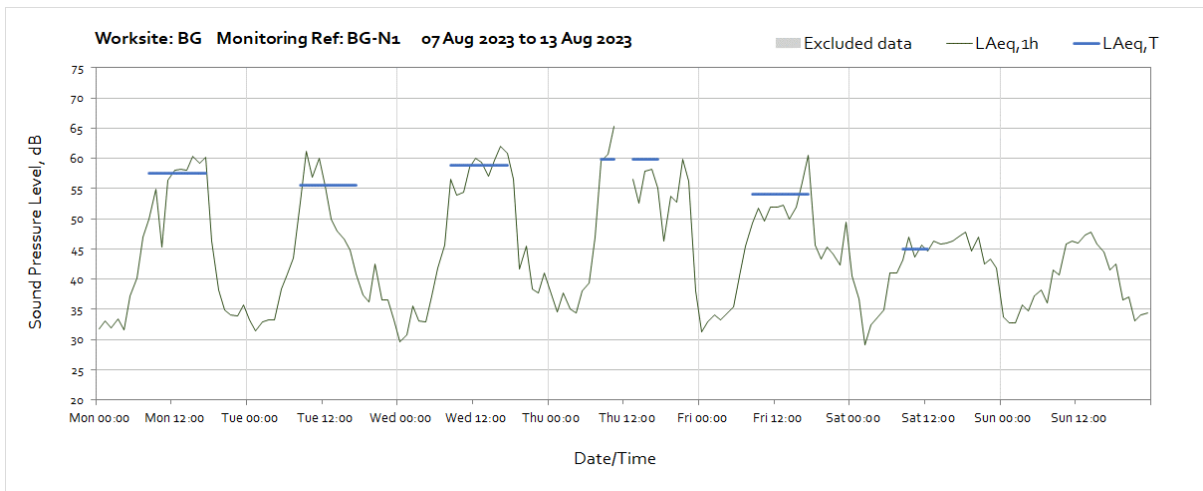
**Worksite: BG – Monitoring Ref: BG-N1**

Note: An explanation for the missing data from 11:00 to 13:00 on Thursday 10th August was due to an intermittent equipment problem and replacement items have been ordered.

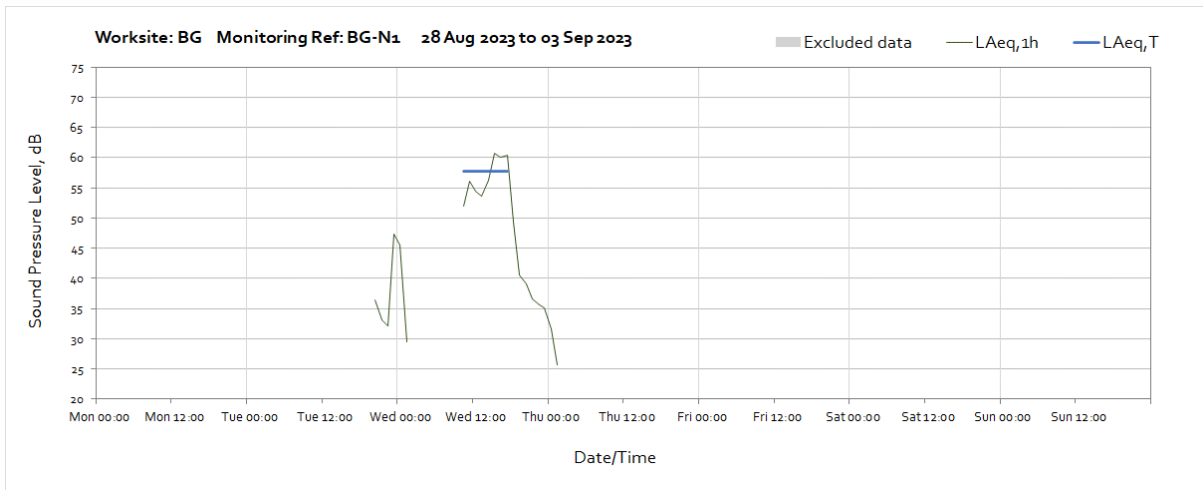
Note: Missing data throughout the week was due to an intermittent equipment problem and replacement items have been ordered.
