Construction Noise and Vibration Monthly Report – September 2023

Lichfield District Council

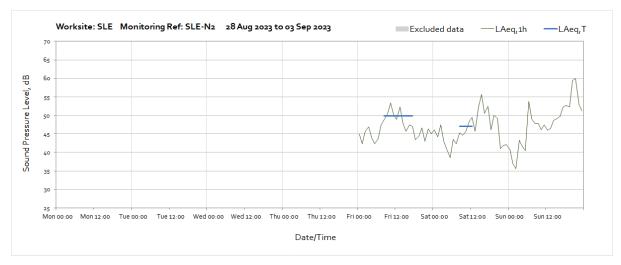
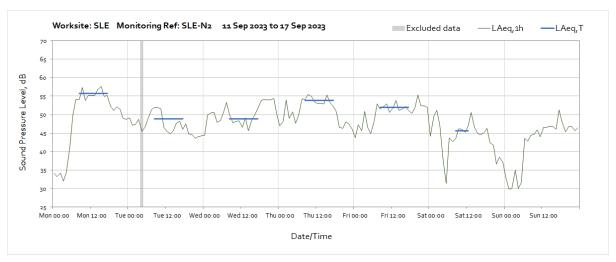
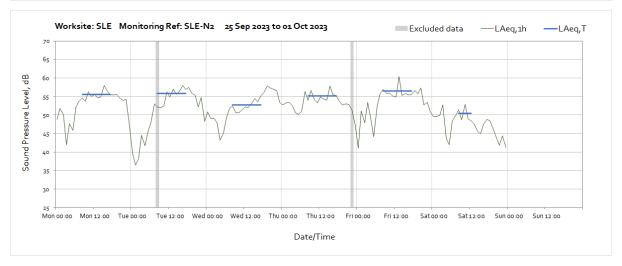
Worksite:SLE - Monitoring Ref: SLE-N2

The following graphs show the hourly measured ambient noise level LAeq,1h and, where relevant, the averaged noise level LAeq,T values, where the time period T is as specified in Table 1 of HS2 Information Paper E23. Periods where noise levels are adversely affected by weather or only measured for part of the period, which are not representative of HS2 construction works, have been greyed out and excluded from the calculation of the LAeq,T values in Table 3 of the main report.

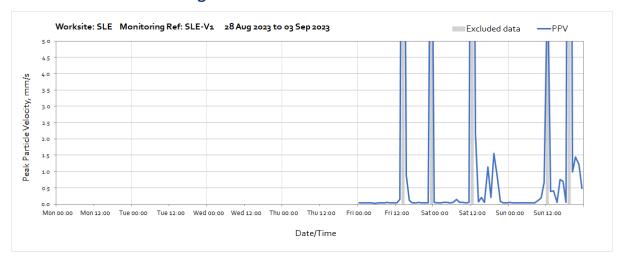
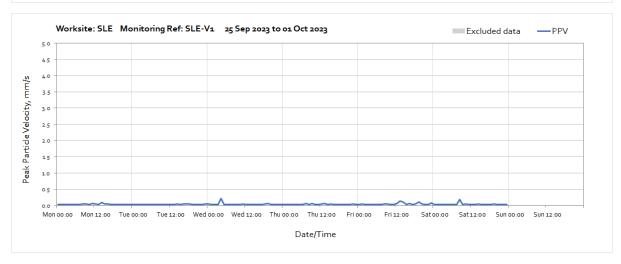
Worksite: SLE - Monitoring Ref: SLE-V1

The following graphs show the hourly measured peak particle velocity PPV recorded during the monitoring period. The graphs show the highest PPV of the three orthogonal axes x, y and z. Periods where PPV values have been affected by local interference with the vibration monitor or only measured for part of the period, which are not representative of HS2 construction works, have been greyed out and excluded when calculating values in Table 4 of the main report.
