HS2

Construction Noise and Vibration Monthly Report – September 2023

North Warwickshire Borough Council

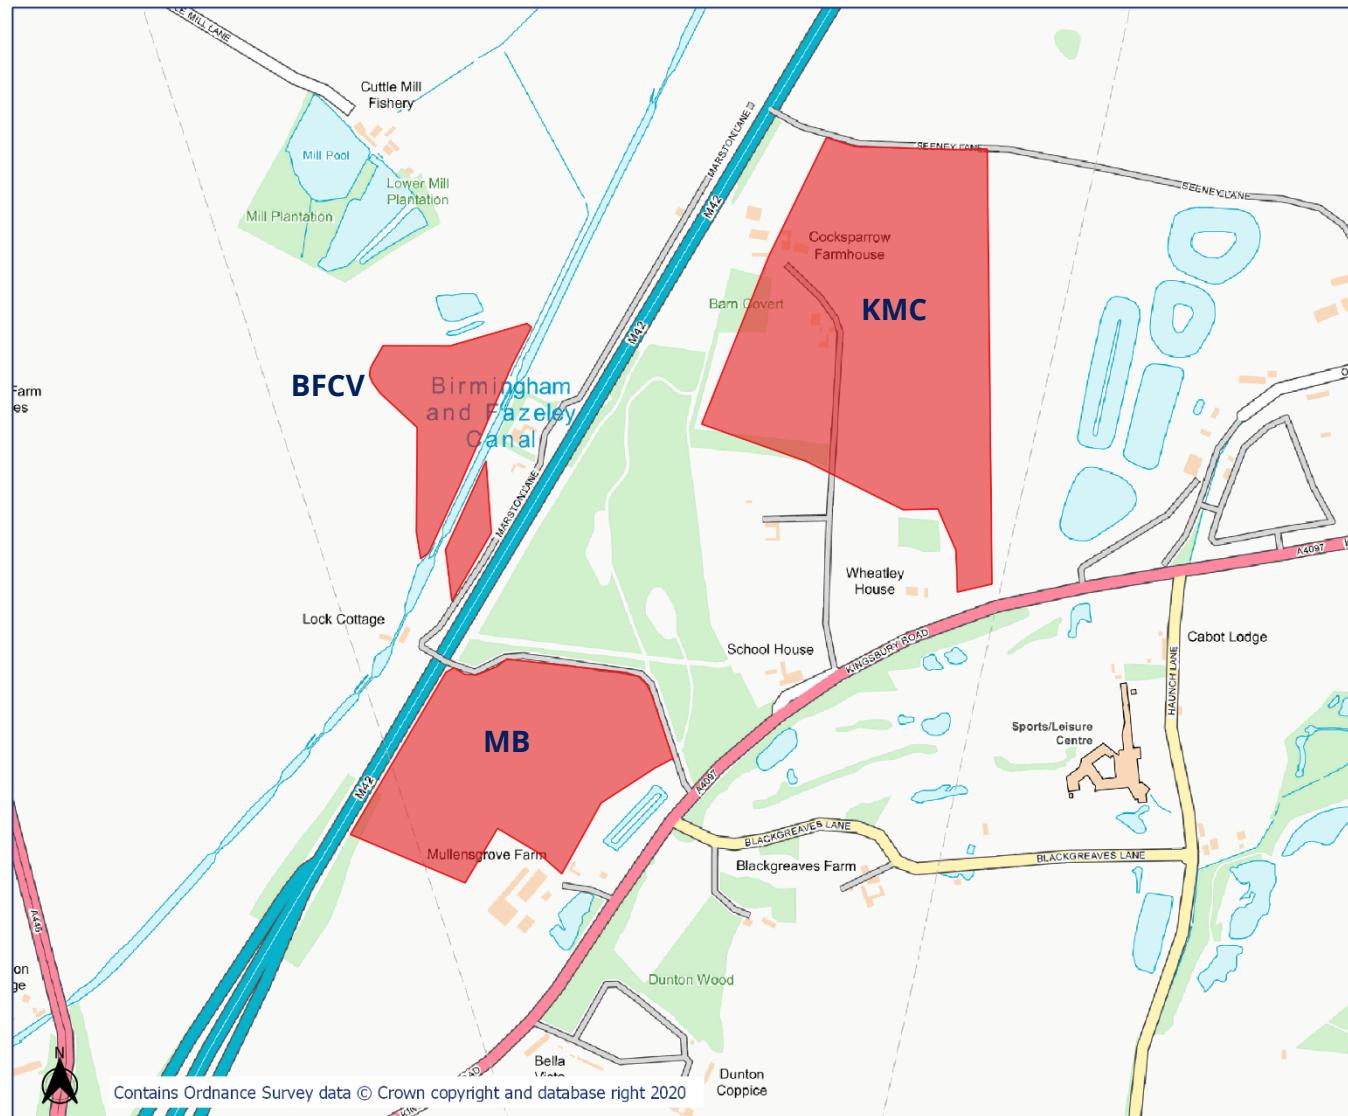
Worksite Identification Plan - 2

- De-vegetation, including strimming.
 - Material deliveries.
 - Compound operation.
 - Birmingham & Fazeley Canal Viaduct worksite, ref.: BFCV (see Plan 2 in Appendix A), where works activities included:

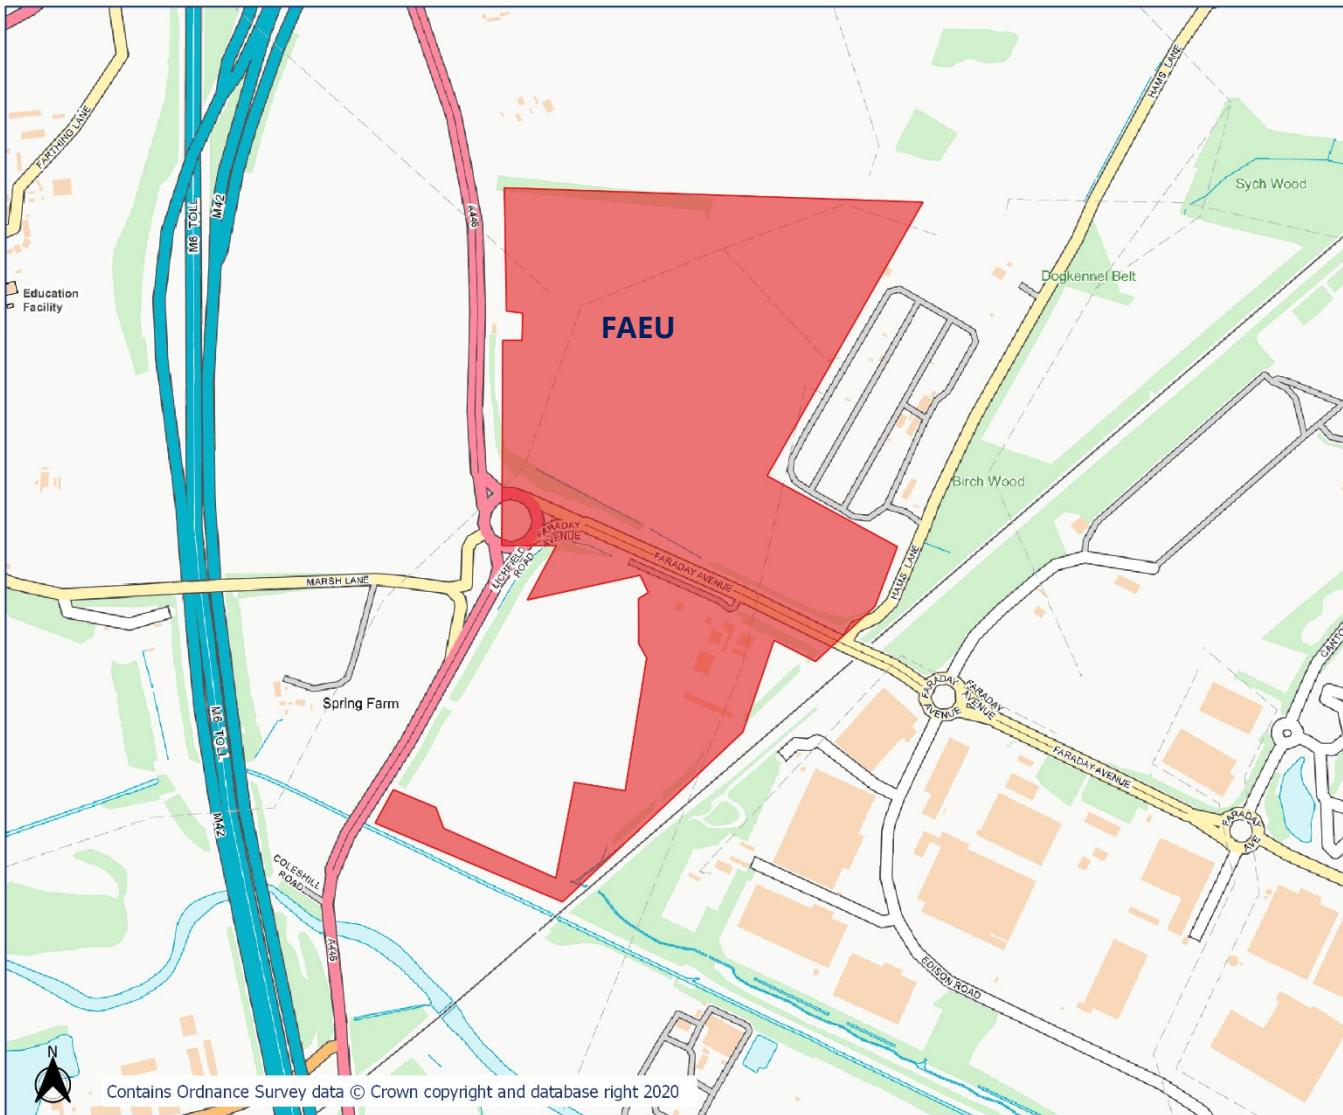
Worksite Identification Plan - 3

- Stockpiling.
 - Separation of rebar.
 - Material movements.
 - Concrete breaking out.
 - Piling platform construction.
- Faraday Avenue Embankment and Underbridge worksite, ref.: FAEU (see Plan 3 in Appendix A), work activities included:

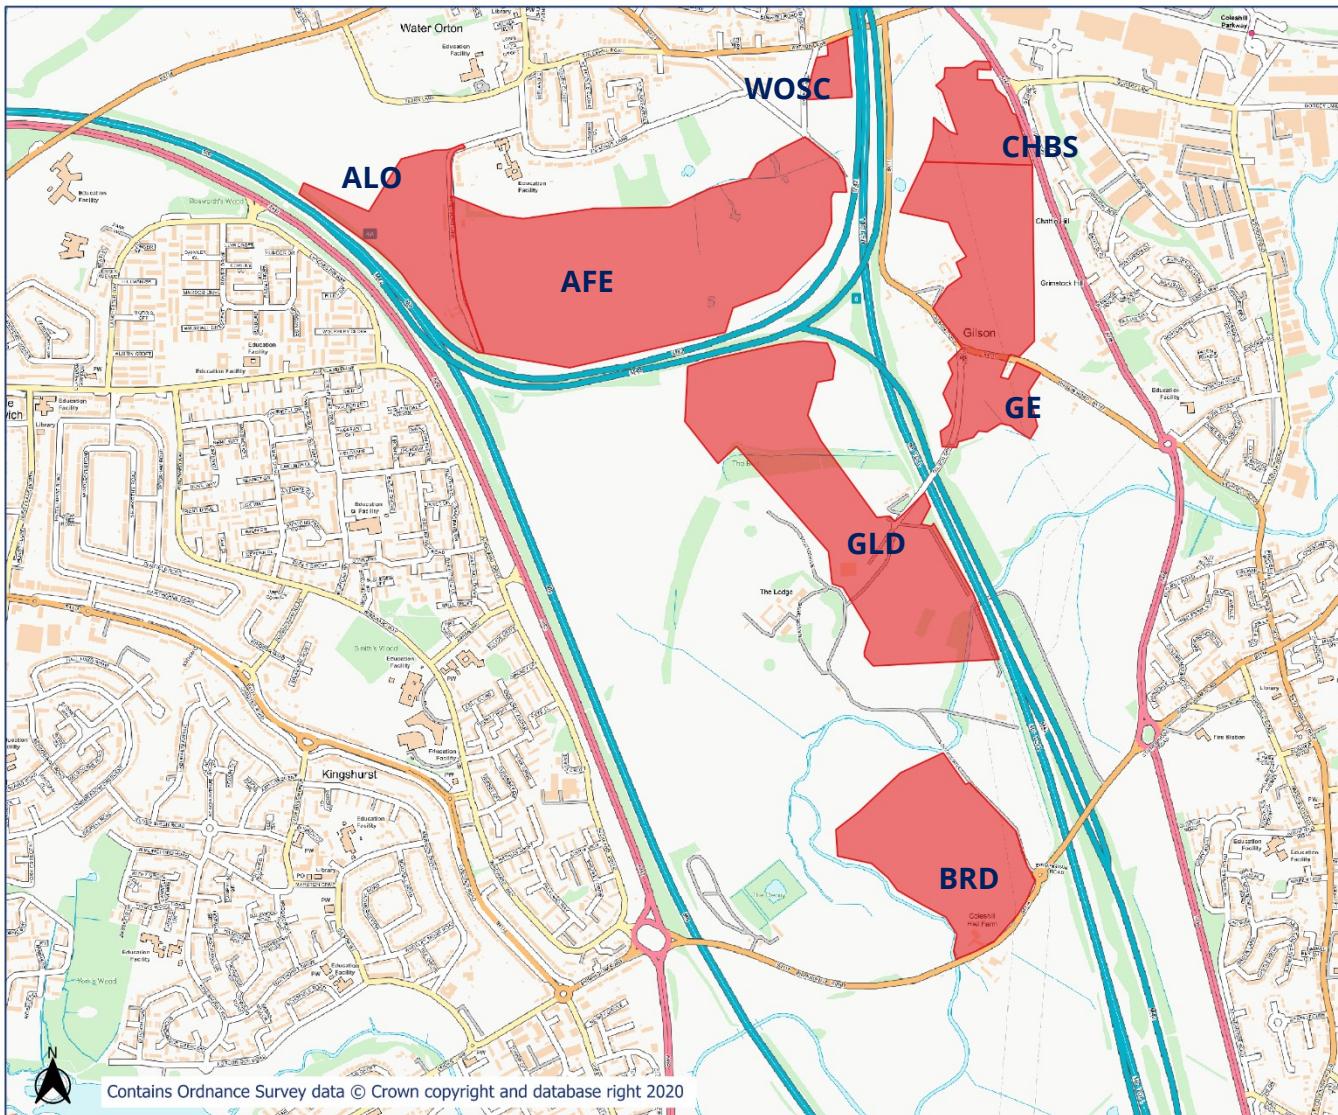
Worksite Identification Plan - 4

- Embankment construction.
- Water Orton South Compound worksite, ref.: WOSC (see Plan 4 in Appendix A), work activities included:
 - Installation of cofferdams.

- Chatte Hill Box Structure worksite, ref.: CHBS (see Plan 4 in Appendix A), where work activities included:
 - Pile cropping.
 - Concrete pours.
 - Material removal.

- Attleboro Lane Overbridge worksite, ref.: ALO (see Plan 4 in Appendix A), where work activities included:
 - Topsoil stripping.
 - Embankment filling.
- Gilson Embankment worksite, ref.: GE (see Plan 4 in Appendix A)

- Foundation works.
 - Technical backfill.
- Gilson Drive worksite, ref.: GLD (see Plan 4 in Appendix A), works activities included:
 - Temporary bridge installation.

- Vehicle movements.
- Culvert works including Excavation, dig and replace.
- Birmingham Road worksite, ref.: BRD (see Plan 4 in Appendix A), work activities included:
 - Installation of cofferdam.

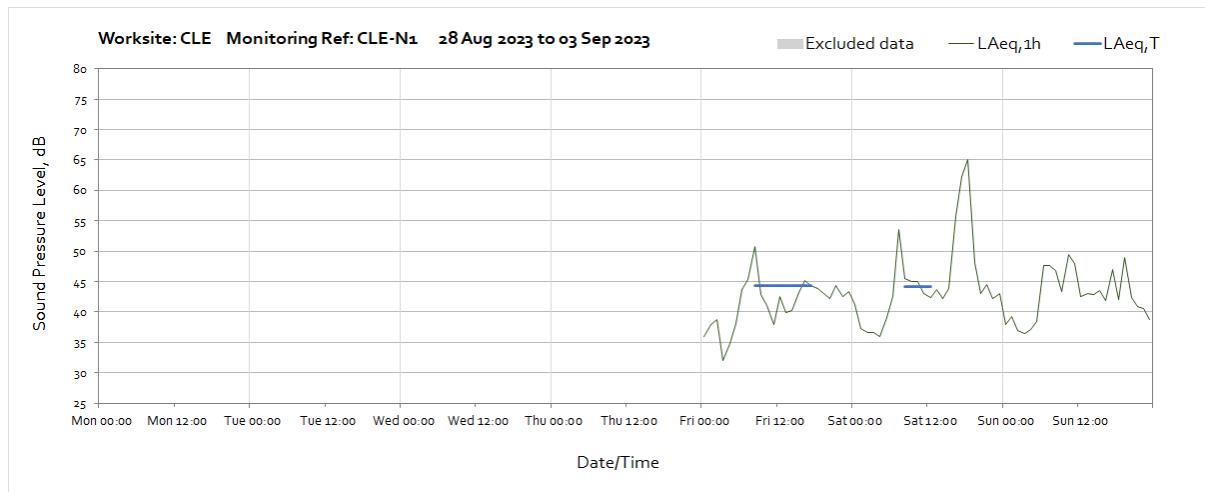
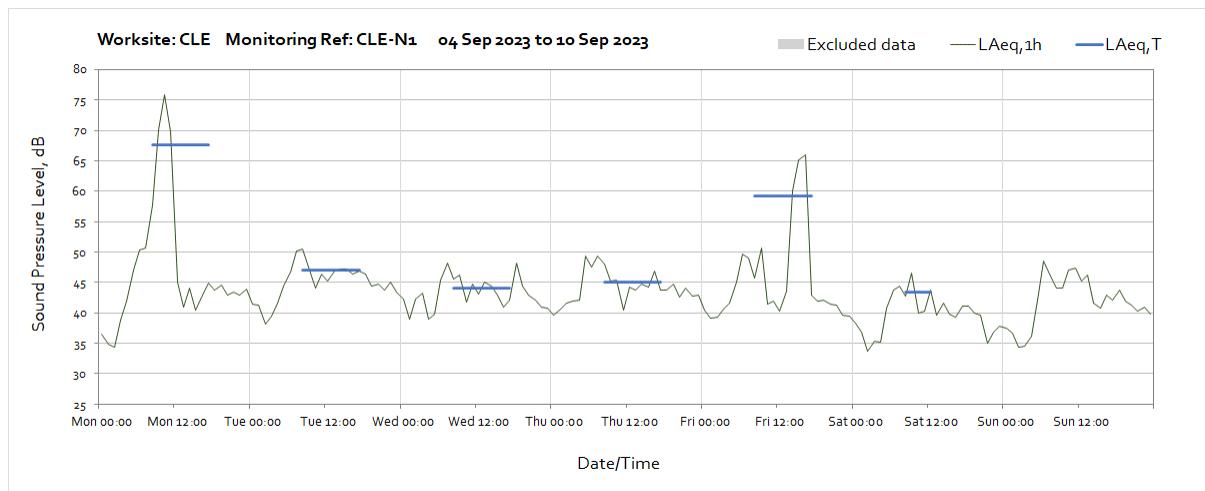
Worksite: CLE – Monitoring Ref: CLE-N1

The following graphs show the hourly measured ambient noise level $L_{Aeq,1h}$ and, where relevant, the averaged noise level $L_{Aeq,T}$ values, where the time period T is as specified in Table 1 of HS2 Information Paper E23. Periods with adversely weather affected noise levels are greyed out and have been excluded from the calculation of the $L_{Aeq,T}$ values in Table 3 of the main report.:.

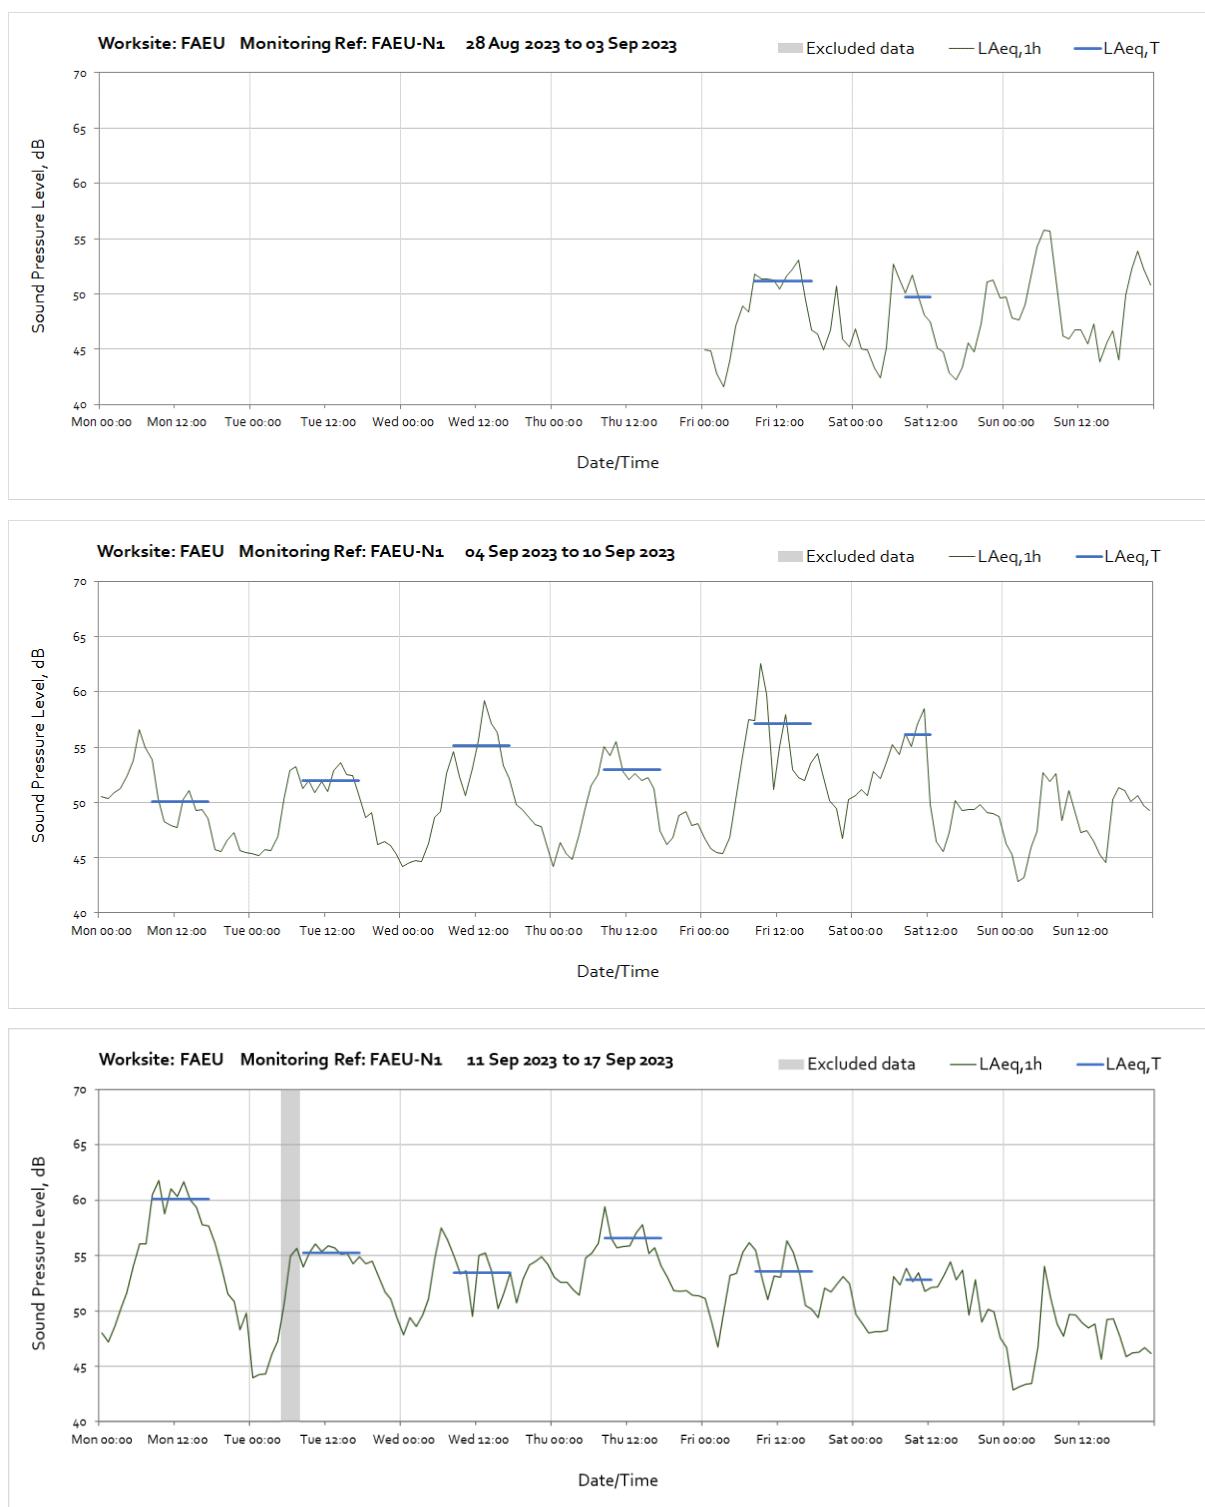
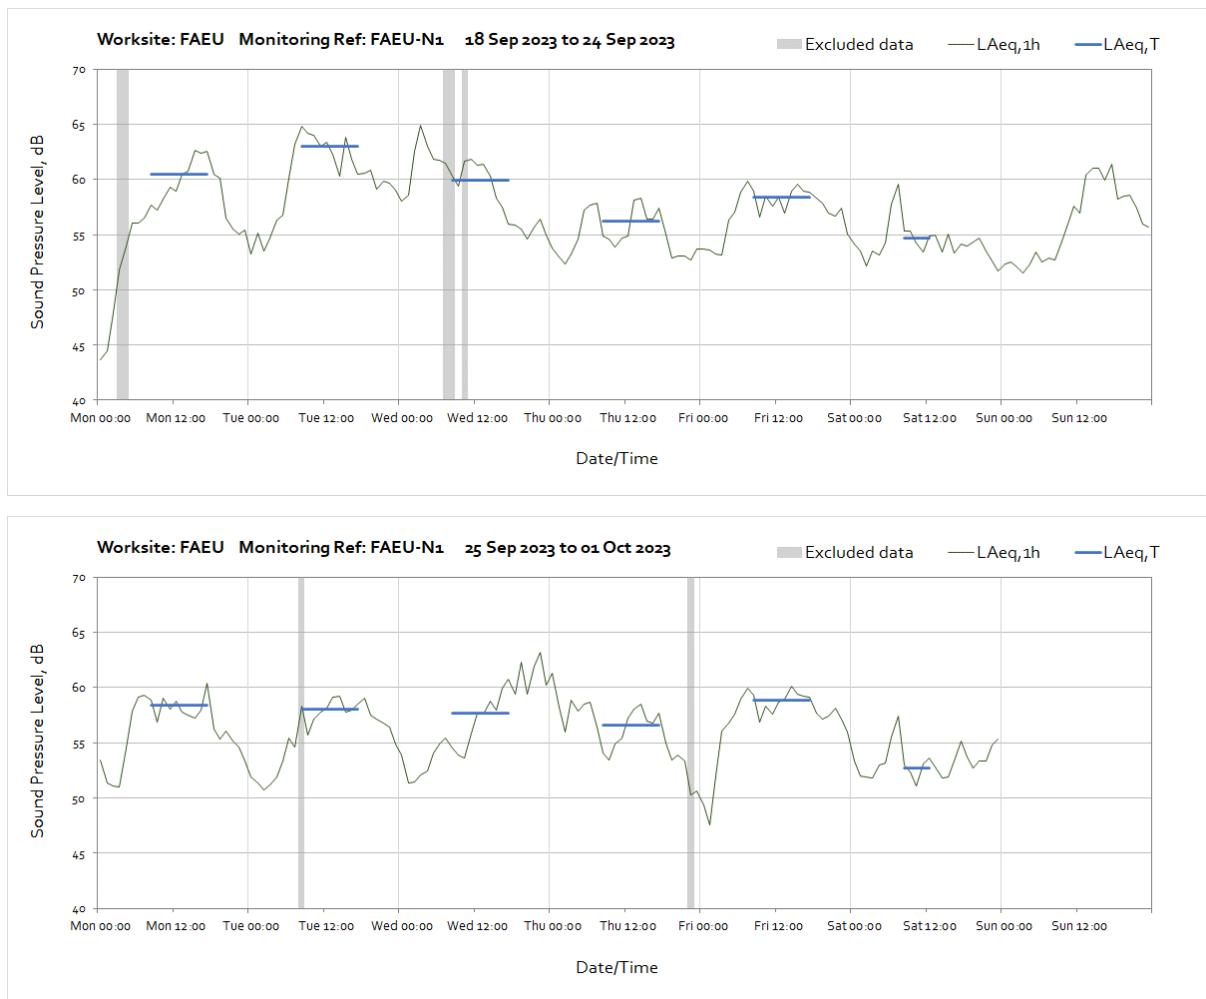
Worksite: FAEU – Monitoring Ref: FAEU-N1

- Noise monitoring was undertaken at the Faraday Avenue Embankment and Underbridge worksite (ref.: FAEU), where embankment construction works were underway.

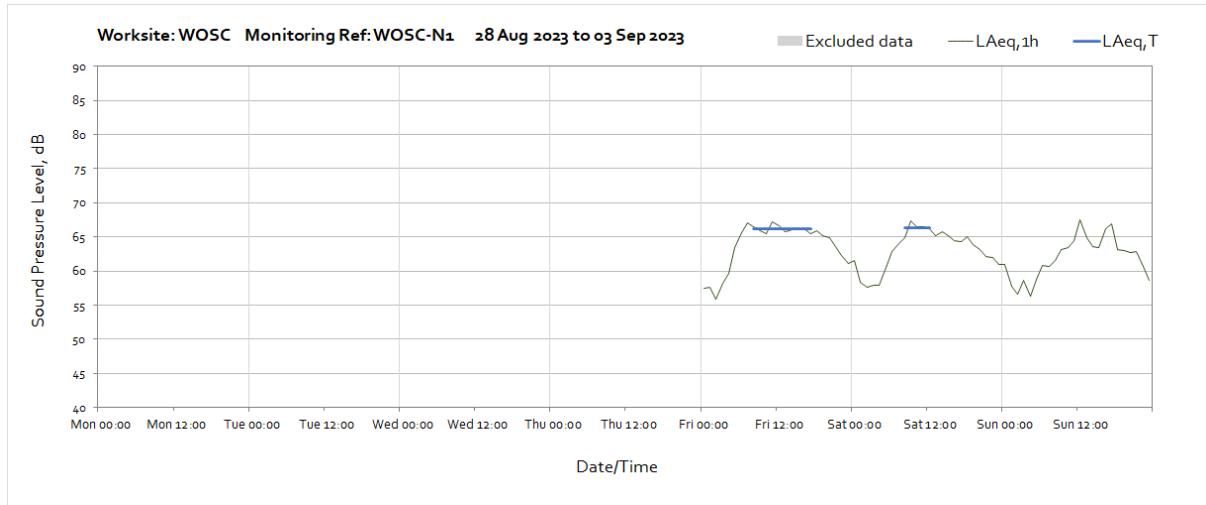
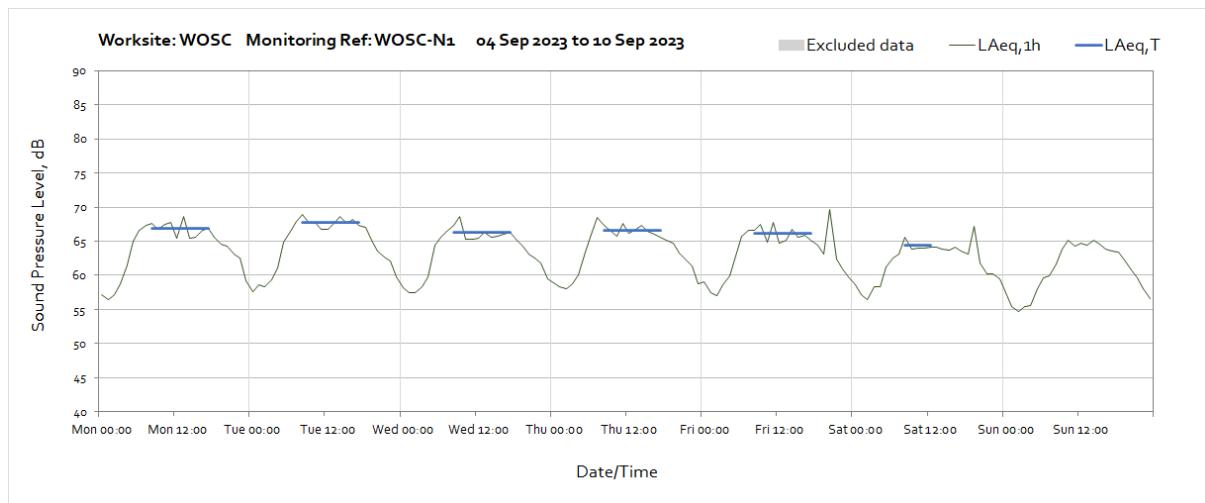
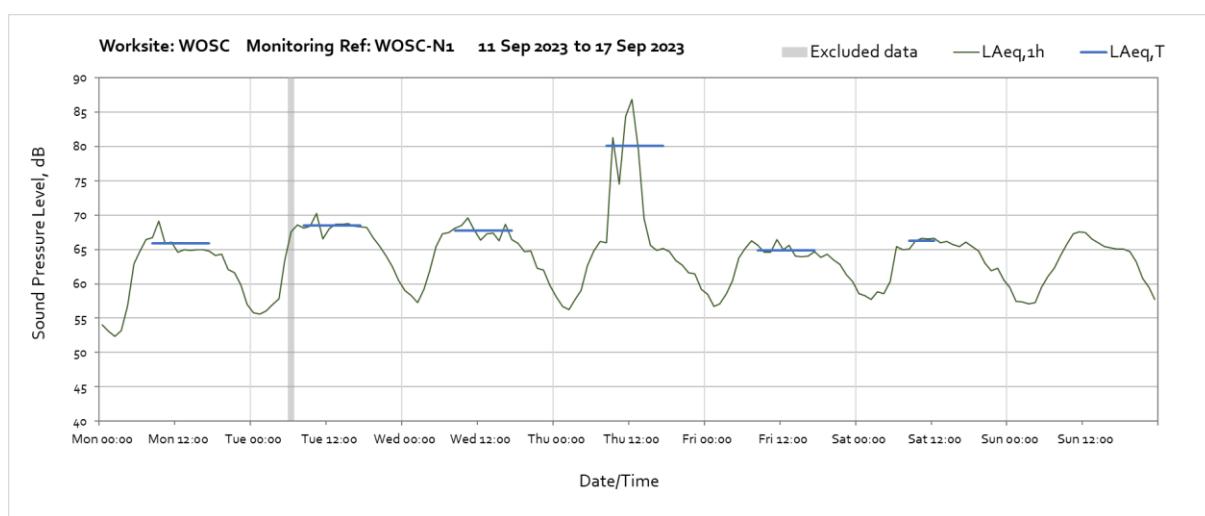
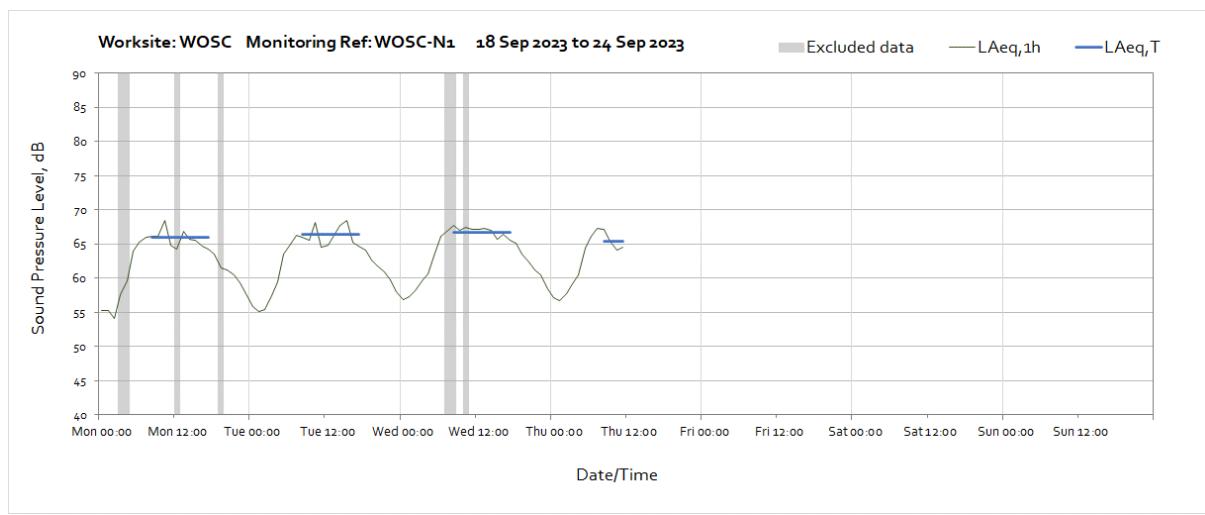
Worksite: WOSC – Monitoring Ref: WOSC-N1

- 2.2.8 One (1) 24-hour period that experienced an exceedance of the SOAEL was recorded due to HS2 construction works during September 2023. Exceedance occurred at noise monitor WOSC-N1 during weekday daytime period.

Note: Monitor was decommissioned at 12:00 on Thursday 21st September.

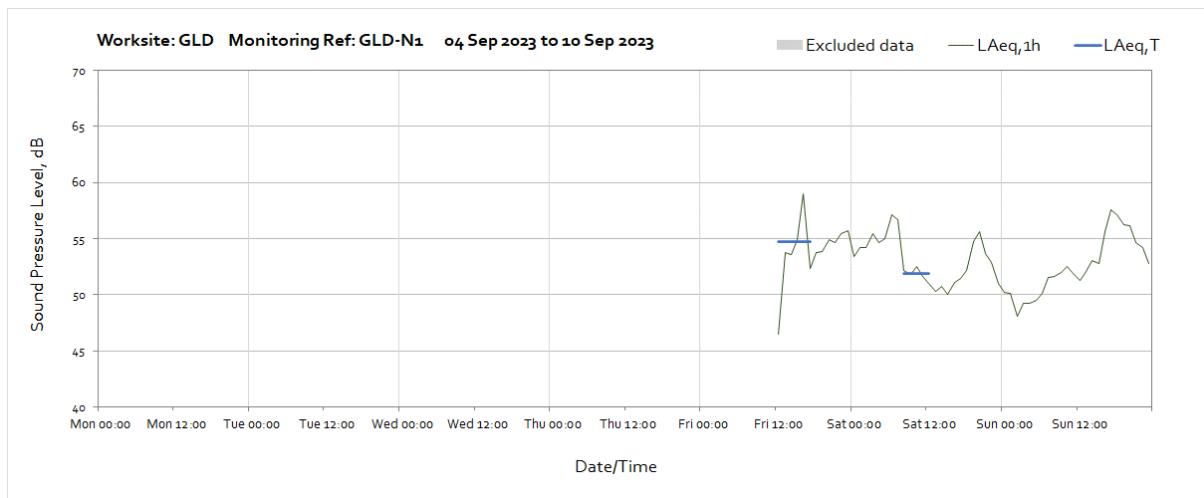
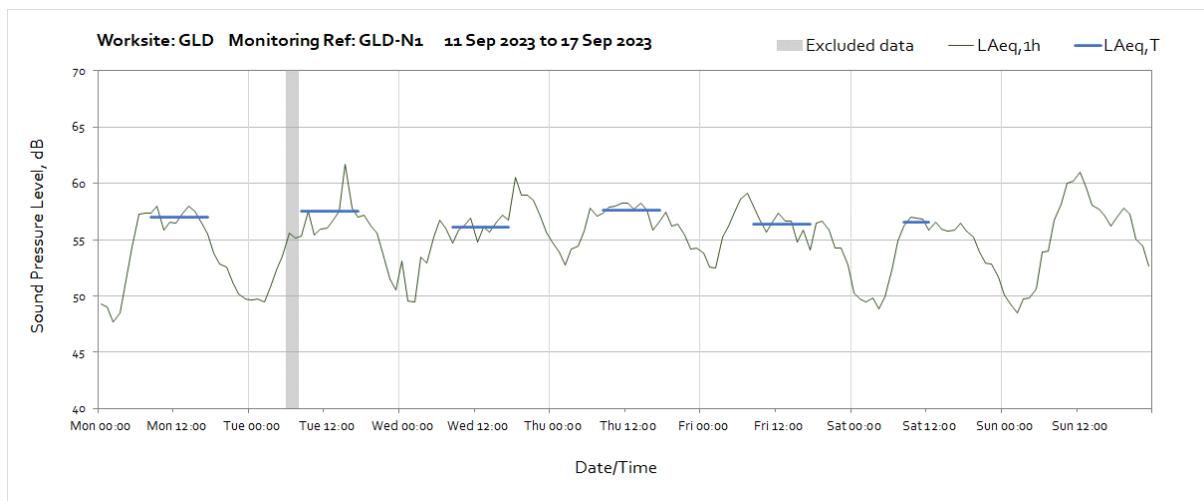
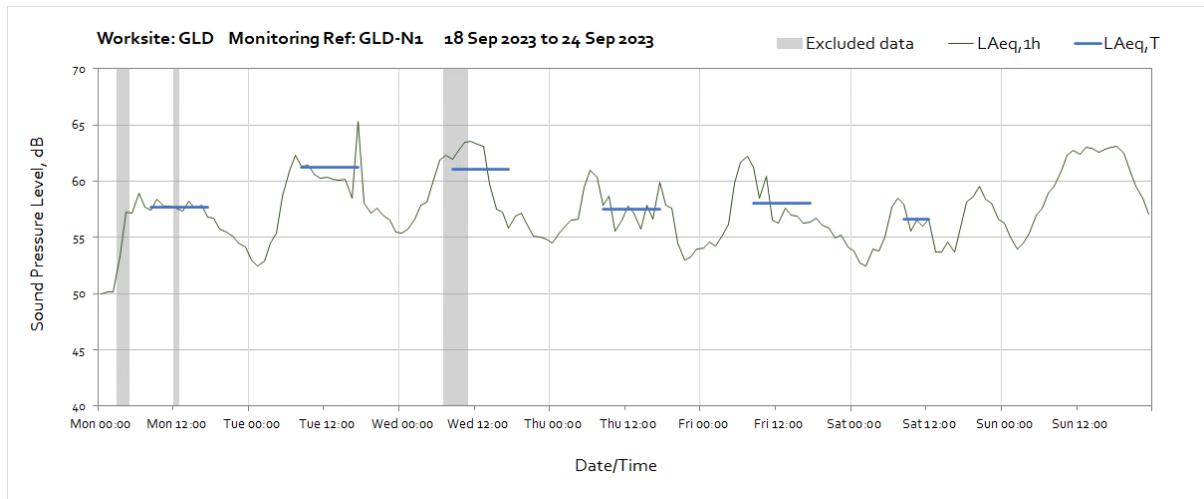
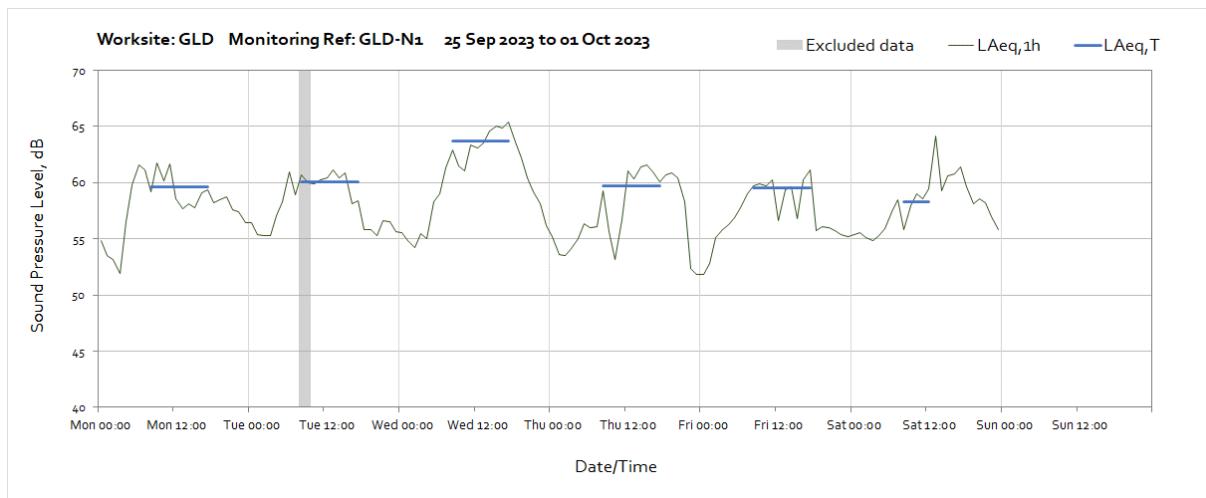
Worksite: GLD - Monitoring Ref: GLD-N1

Note: Missing data from the beginning of the month until 12:00 on Friday 8th of September was due to loss of power to the monitoring station.

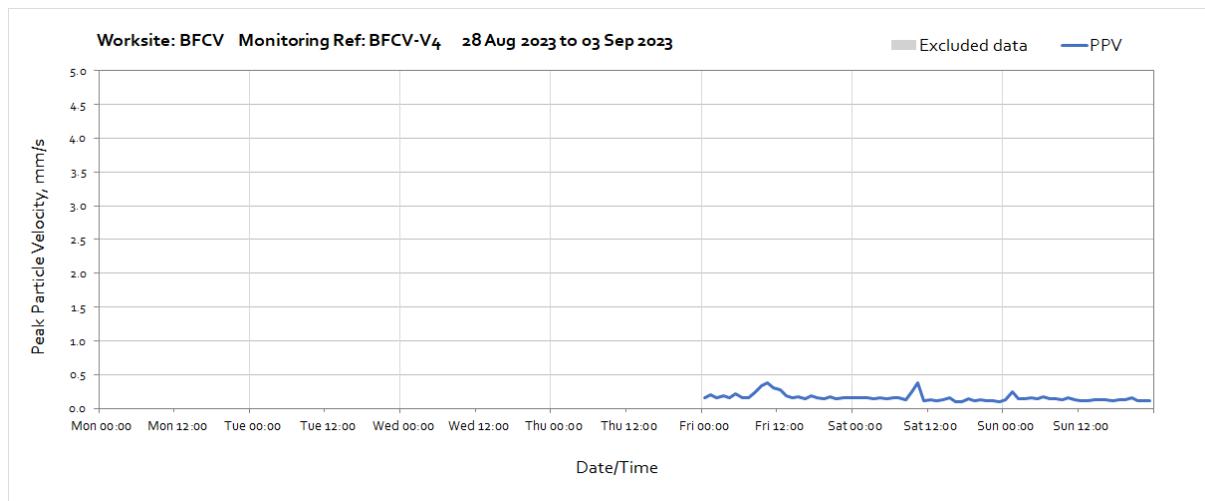
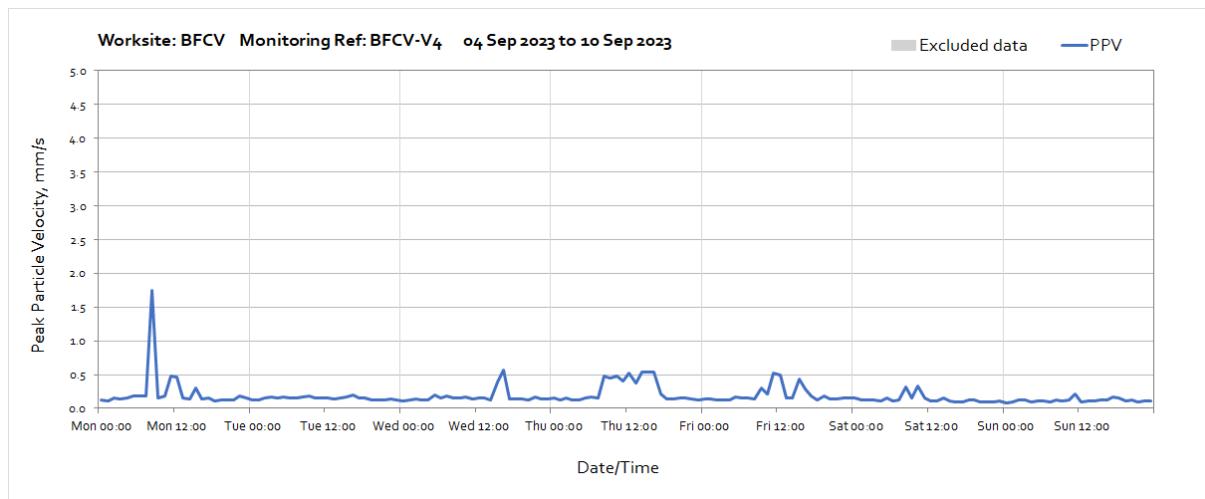
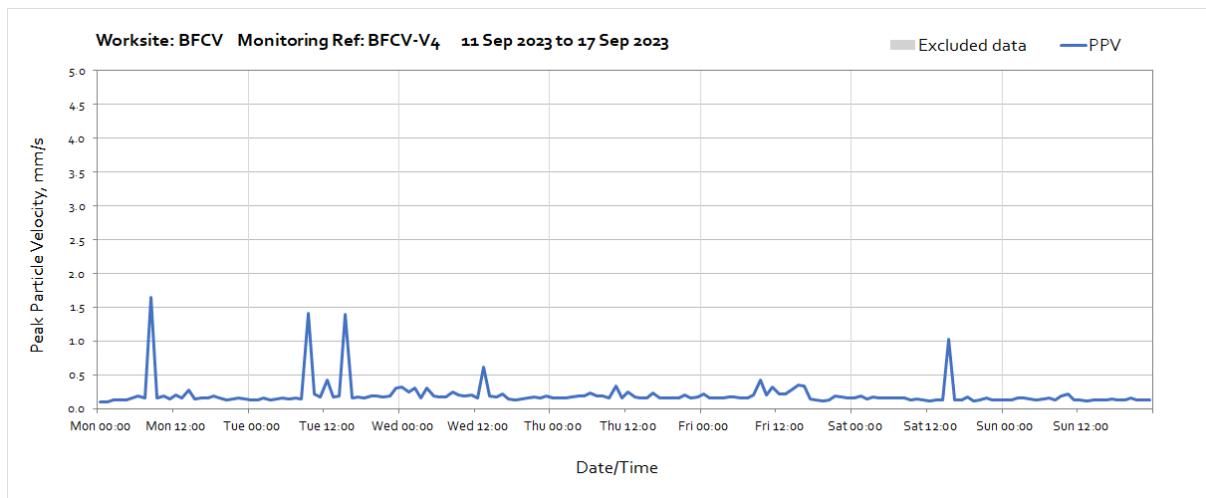
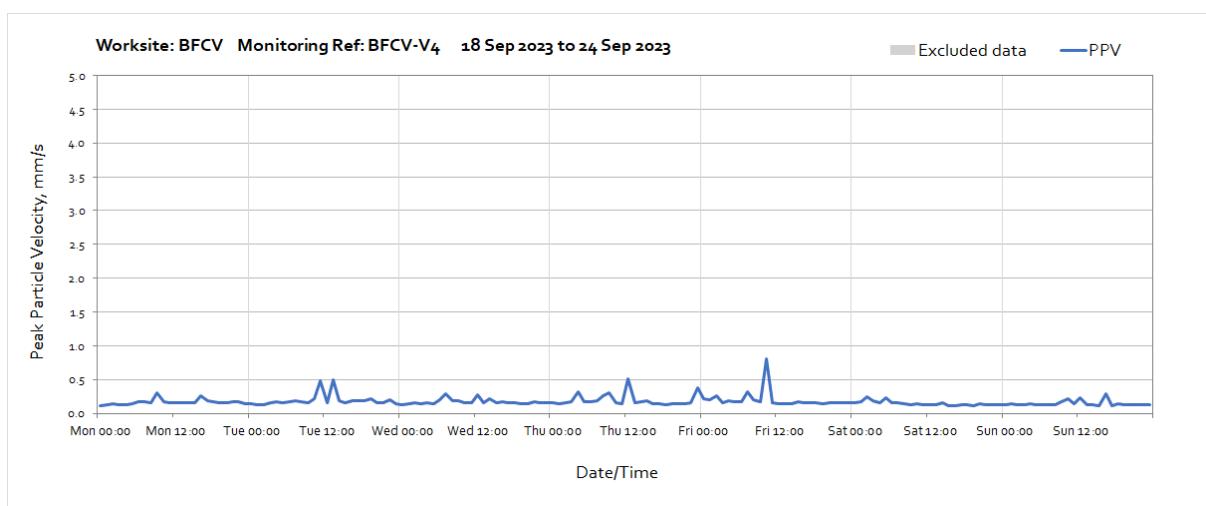
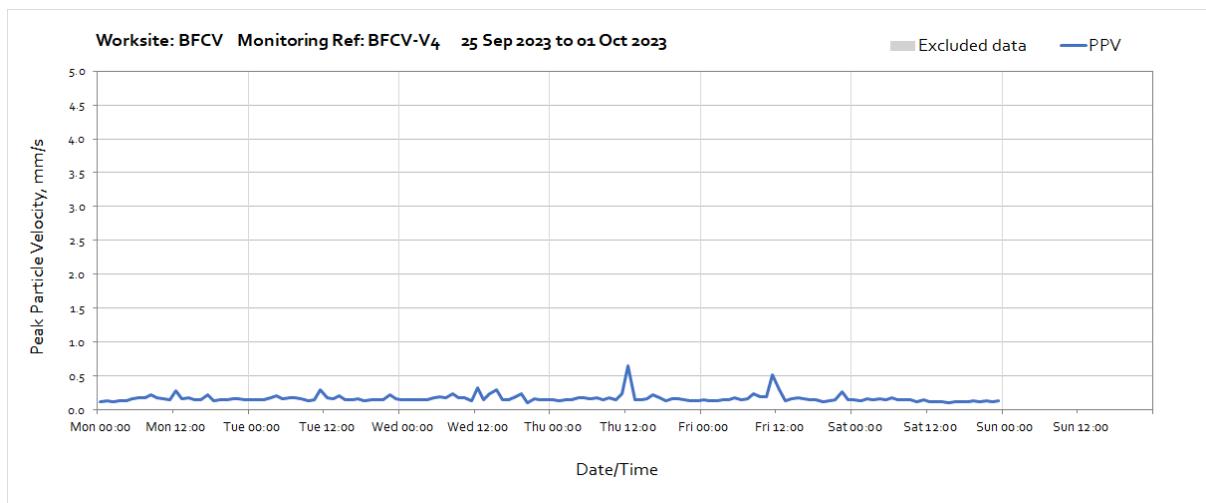
Worksite: BFCV – Monitoring Ref: BFCV-V4

The following graphs show the hourly measured peak particle velocity PPV recorded during the monitoring period. The graphs show the highest PPV of the three orthogonal axes x, y and z. Where high values of PPV were caused by local interference with the vibration monitor, which are not representative of HS2 construction works, these values have been greyed out in the following charts and have been excluded to calculate values in Table 4 of the main report.

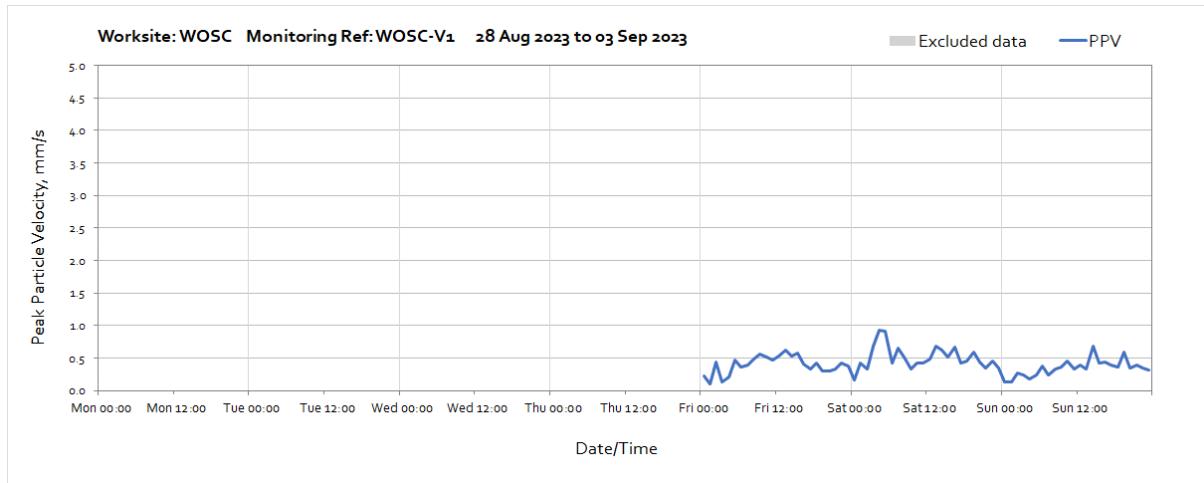
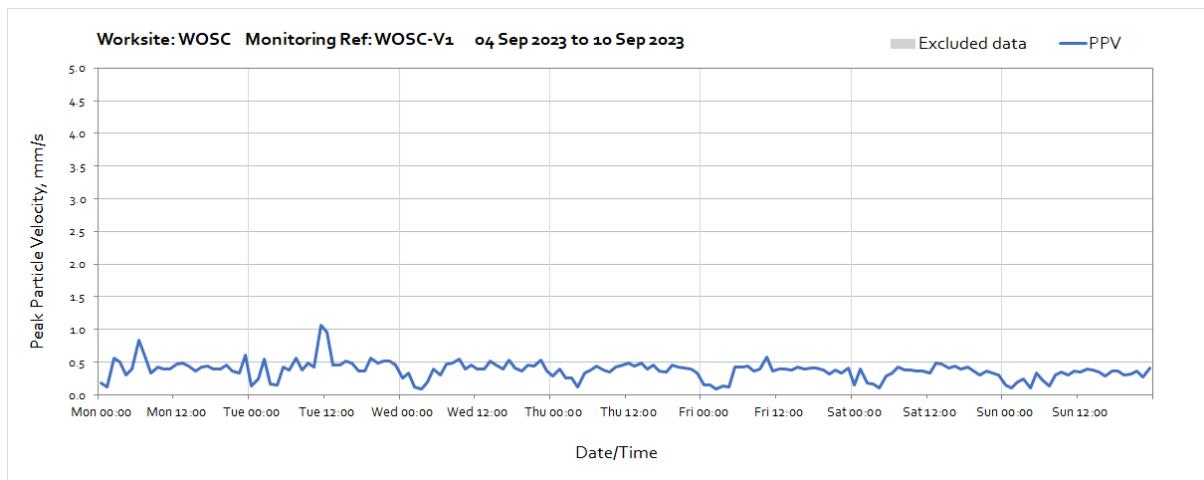
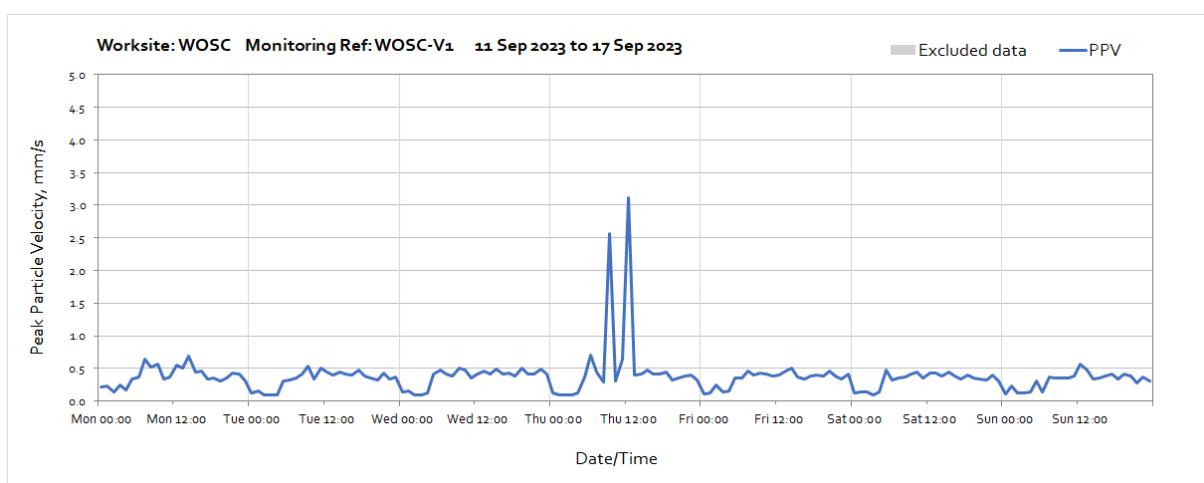
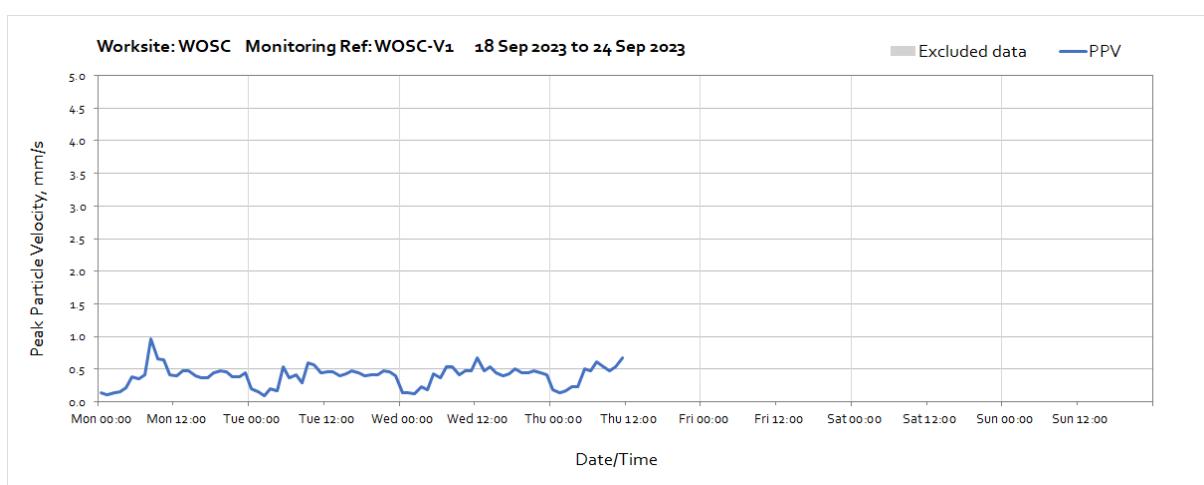
Worksite: WOSC – Monitoring Ref: WOSC-V1

Note: Monitor was decommissioned at 12:00 on Thursday 21st September.
