Construction Noise and Vibration Monthly Report – September 2023

Warwick District Council

Non-Technical Summary

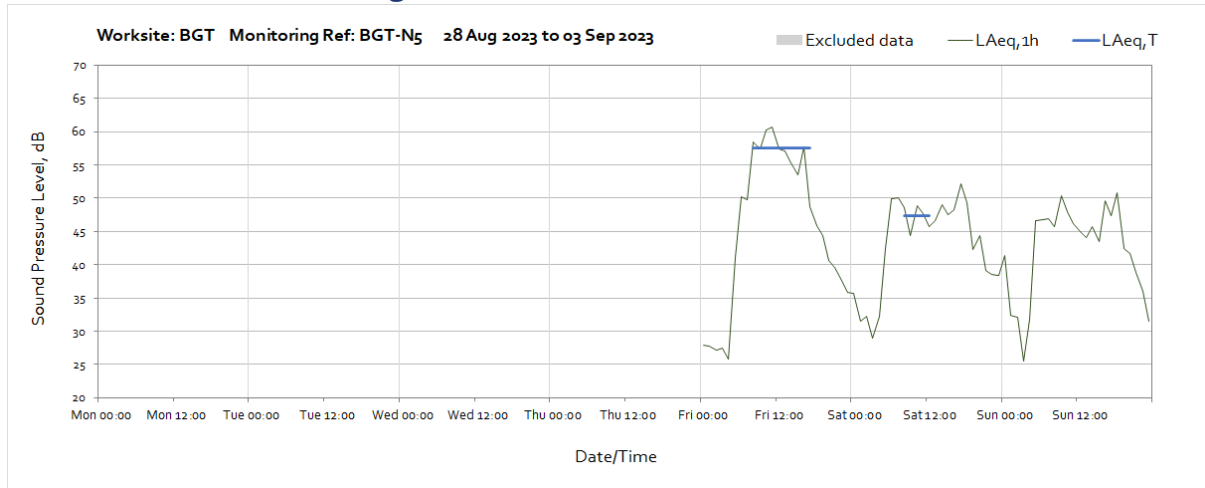
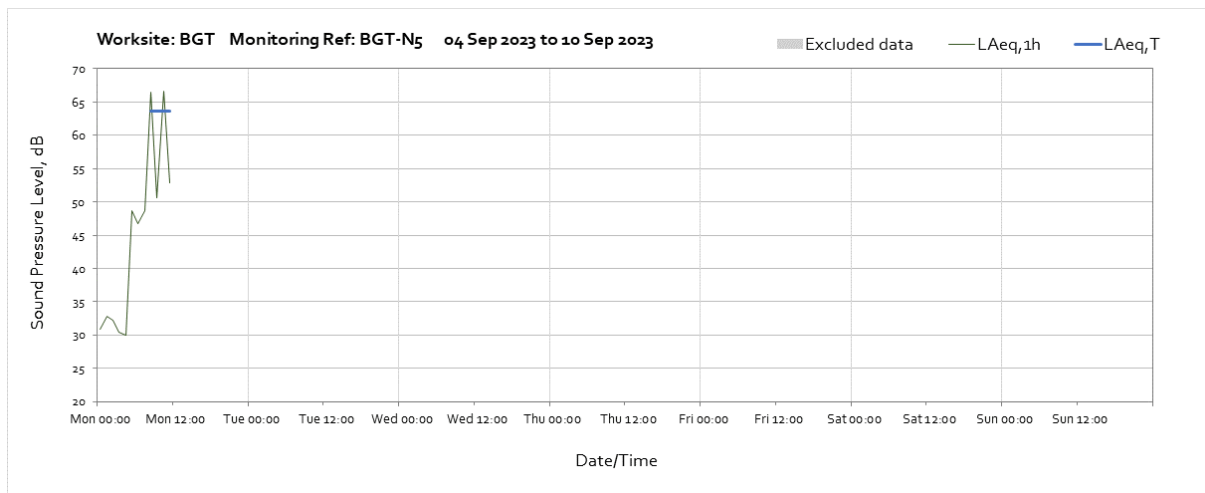
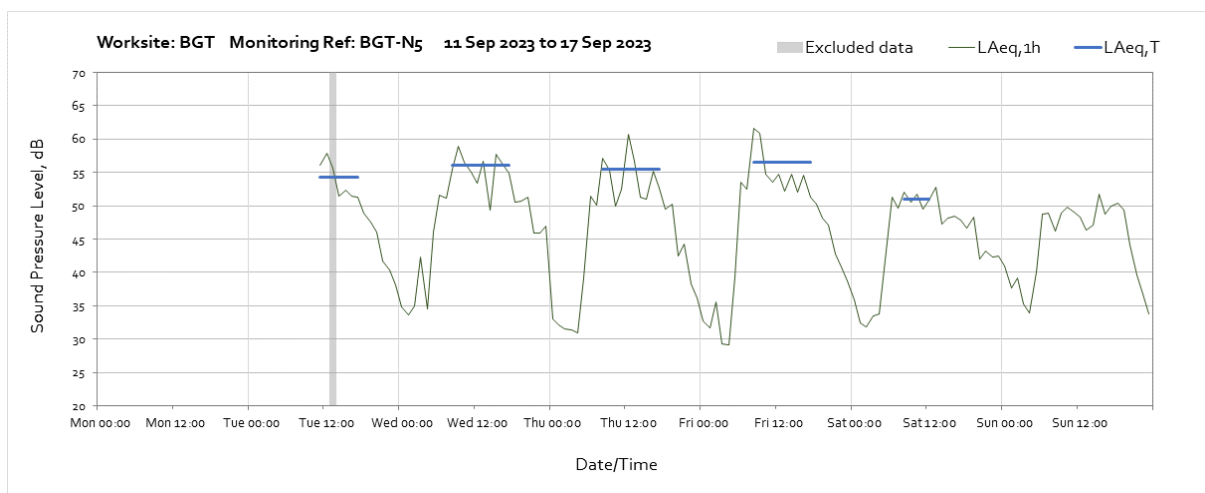
Worksite: BGT – Monitoring Ref: BGT-N5

Note: Missing data from 11:00 on Monday 4th September to 12:00 on Tuesday 12th September was due to a problem with the SD card.

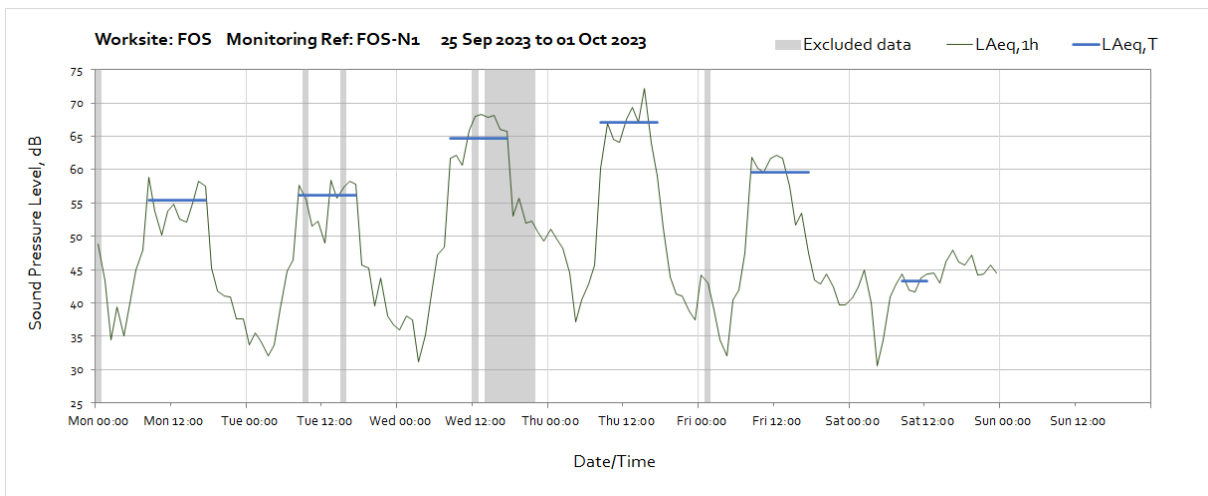
Worksite: OC - Monitoring Ref: FOS-N1

Note: The monitor was installed on Thursday 14th September.

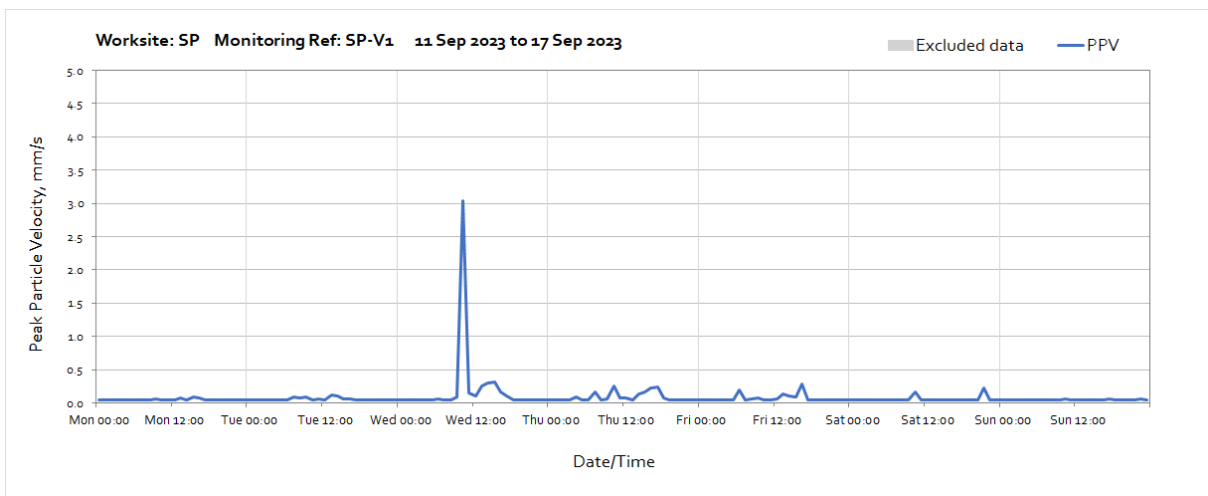
Worksite: SP – Monitoring Ref: SP-V1

Note: The high vibration level on the morning of 13 September is understood not to be due to HS2 site work.

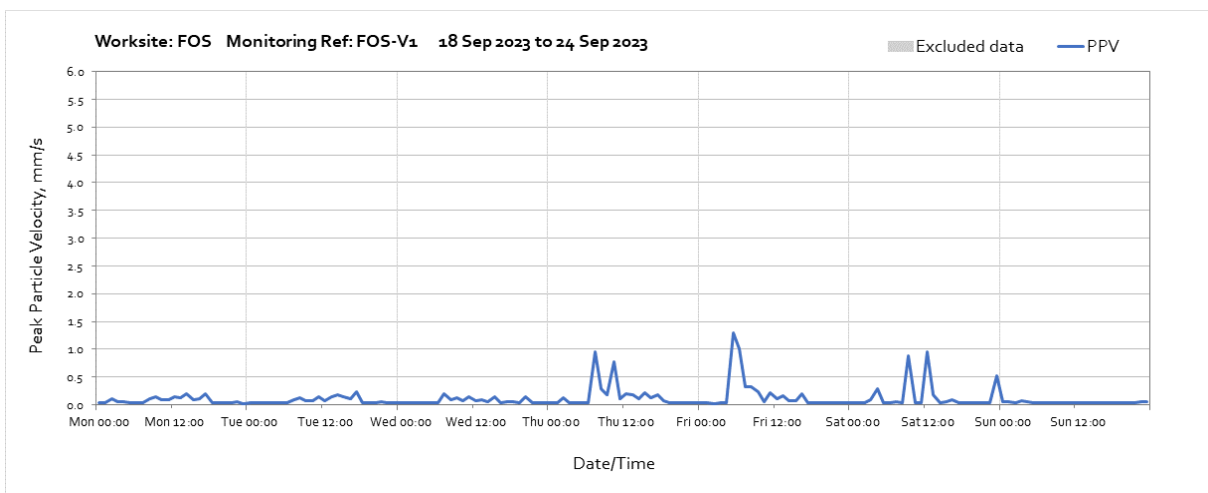
Worksite: OC – Monitoring Ref: FOS-V1

Note: The monitor was installed on Thursday 14th September.

Note: The high levels of vibration on Wednesday 27th September and Thursday 28th September were due to stockpile relocation within 15m of the monitor.
