Construction Noise and Vibration Monthly Report – October 2023

Lichfield District Council

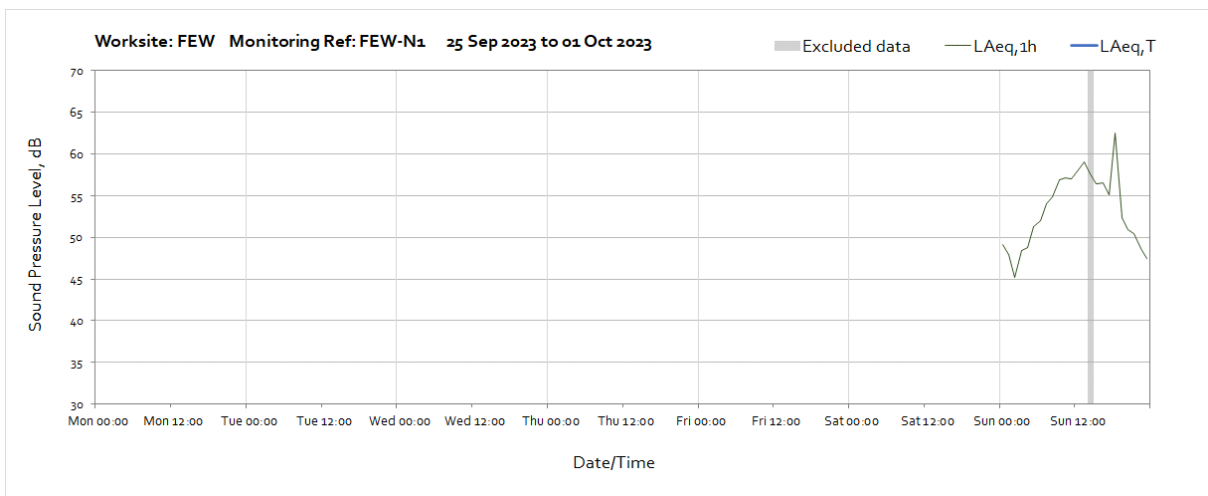
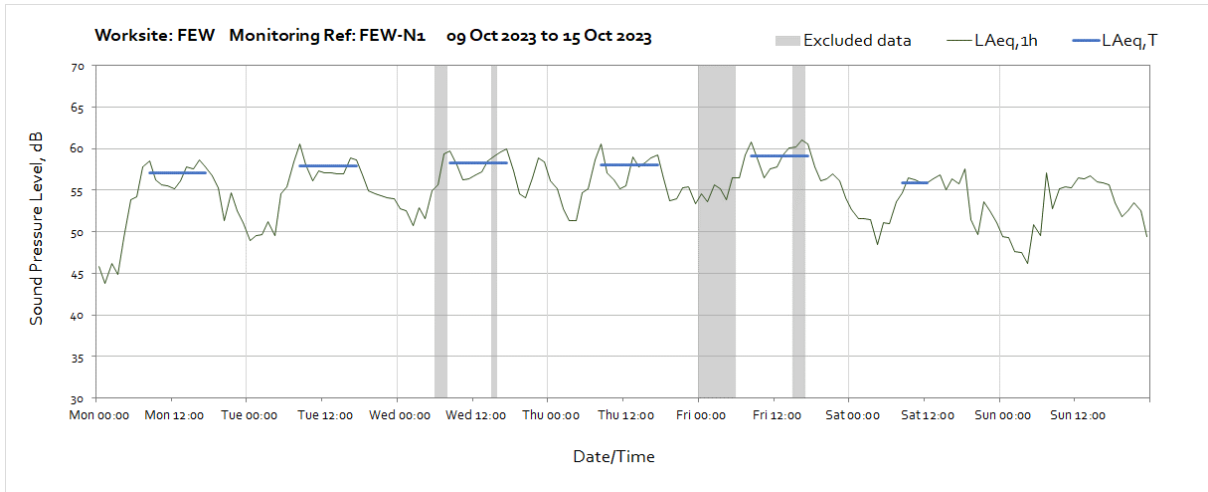
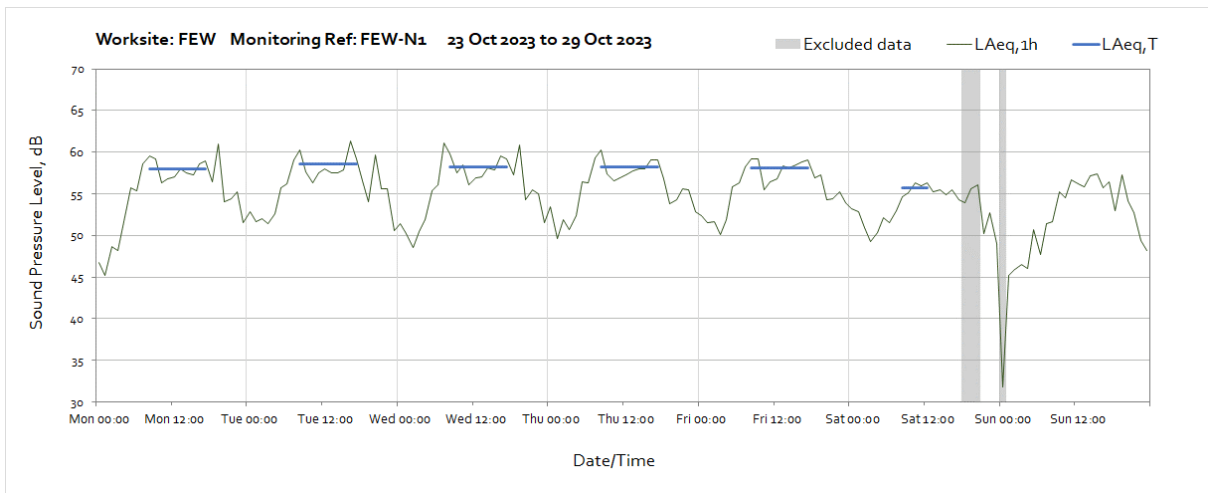
Worksite:FEW – Monitoring Ref: FEW-N1

The following graphs show the hourly measured ambient noise level LAeq,1h and, where relevant, the averaged noise level LAeq,T values, where the time period T is as specified in Table 1 of HS2 Information Paper E23. Periods where noise levels are adversely affected by weather or only measured for part of the period, which are not representative of HS2 construction works, have been greyed out and excluded from the calculation of the LAeq,T values in Table 3 of the main report.
