Construction Noise and Vibration Monthly Report – October 2023

North Warwickshire Borough Council

Non-Technical Summary

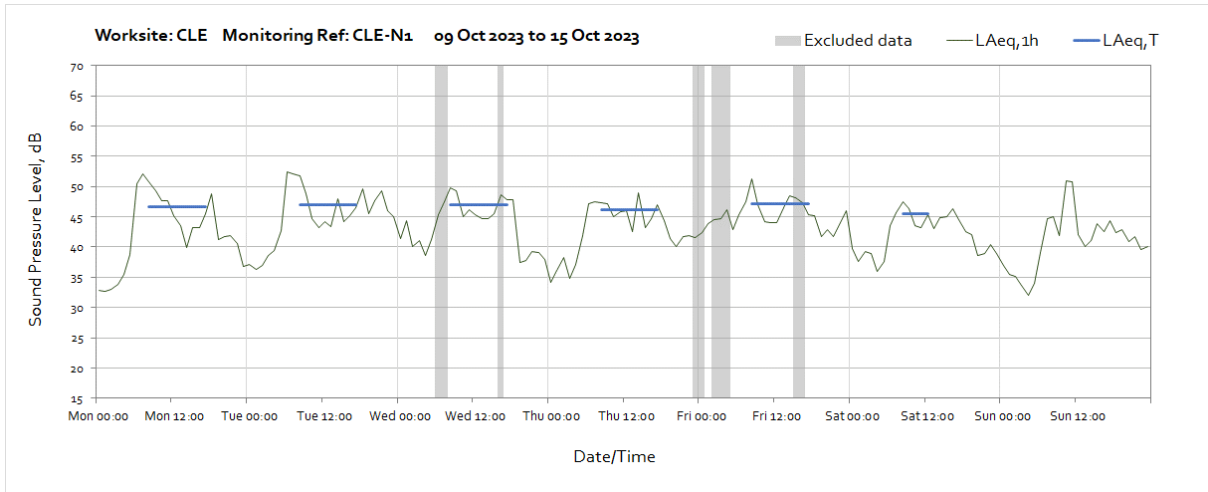
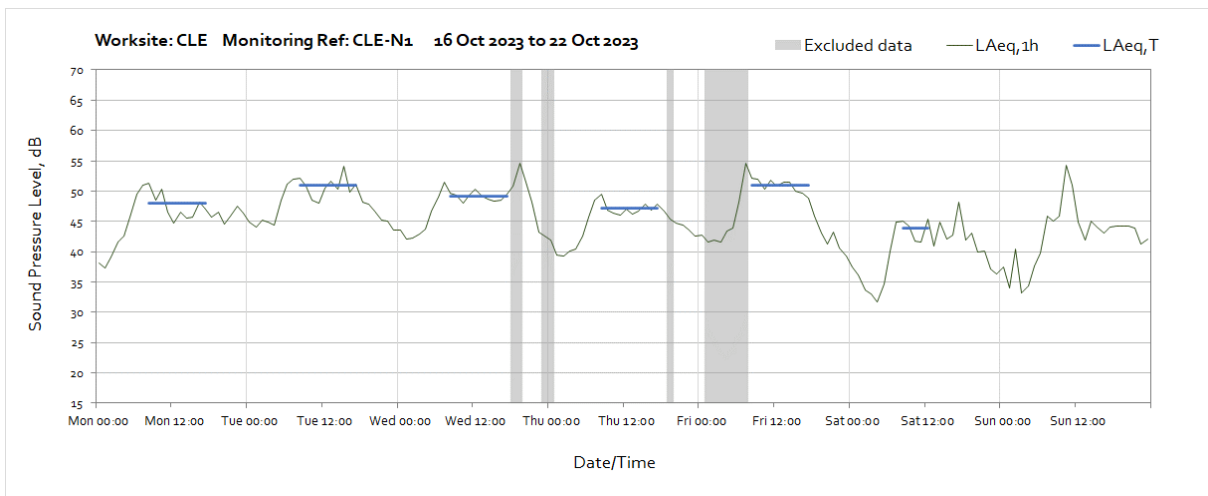
Worksite: CLE – Monitoring Ref: CLE-N1

The following graphs show the hourly measured ambient noise level $L_{Aeq,1h}$ and, where relevant, the averaged noise level $L_{Aeq,T}$ values, where the time period T is as specified in Table 1 of HS2 Information Paper E23. Periods with adversely weather affected noise levels are greyed out and have been excluded from the calculation of the $L_{Aeq,T}$ values in Table 3 of the main report.:

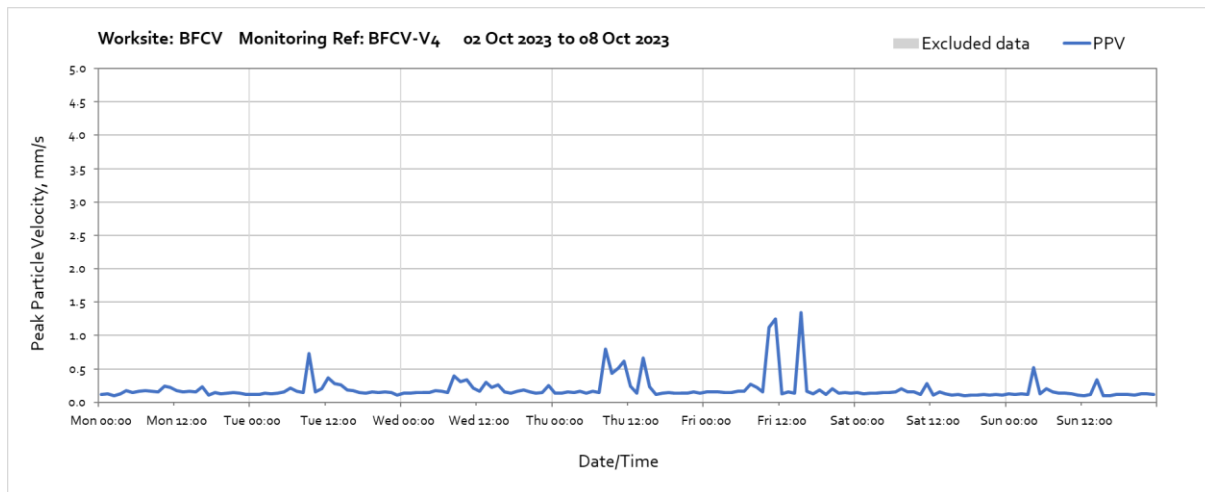
Worksite: BFCV - Monitoring Ref: BFCV-V4

The following graphs show the hourly measured peak particle velocity PPV recorded during the monitoring period. The graphs show the highest PPV of the three orthogonal axes x, y and z. Where high values of PPV were caused by local interference with the vibration monitor, which are not representative of HS2 construction works, these values have been greyed out in the following charts and have been excluded to calculate values in Table 4 of the main report.
