Construction Noise and Vibration Monthly Report – October 2023

Warwick District Council

Non-Technical Summary

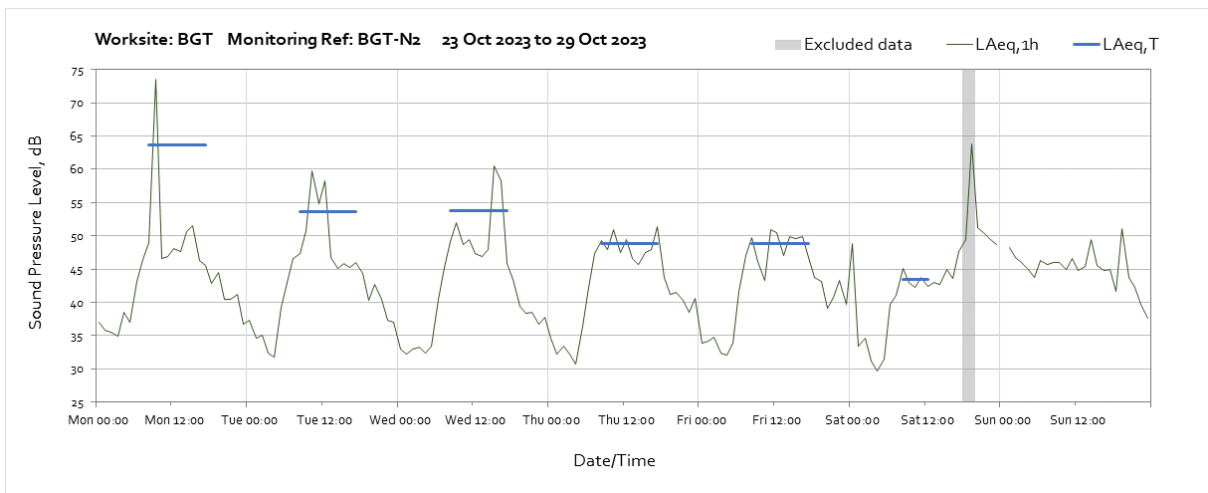
Worksite: BGT – Monitoring Ref: BGT-N2

Note: Missing data between 00:00 and 01:00 on Sunday 29th October was due to a monitor time adjustment at the end of British Summertime.

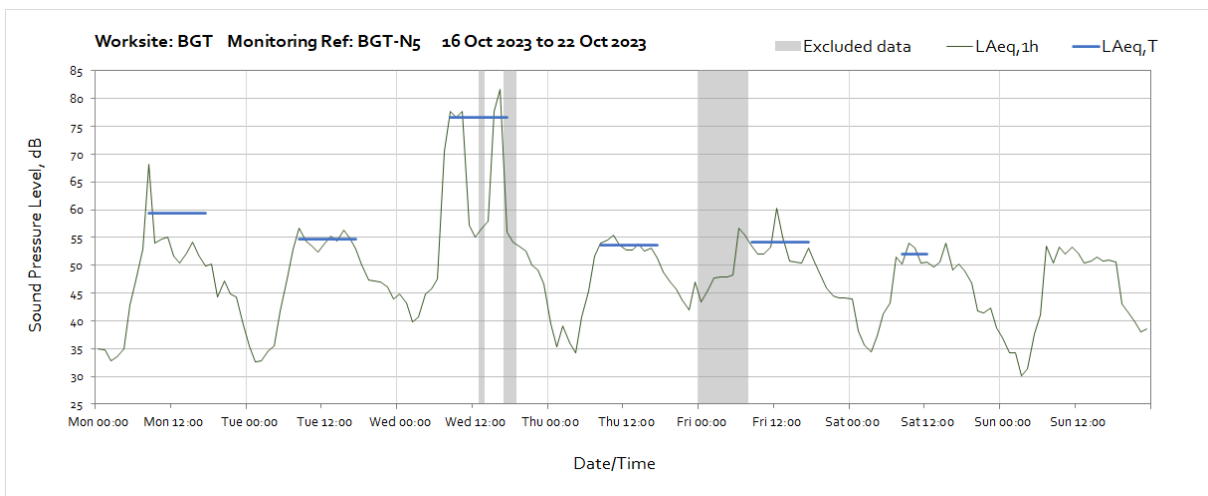
Worksite: BGT - Monitoring Ref: BGT-N5

Note: Missing data between 00:00 and 01:00 on Sunday 29th October was due to a monitor time adjustment at the end of British Summertime.

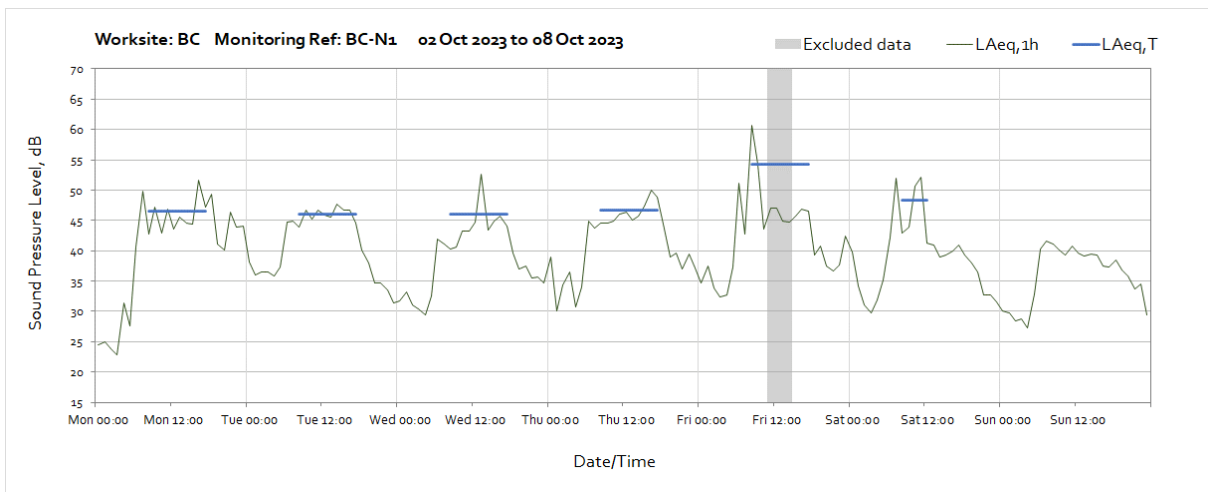
Worksite: BC – Monitoring Ref: BC-N1

Note: Note: Missing data throughout the week was due to vegetation obscuring solar panels leading to a loss of monitor power.
