## **ACCIDENT**

Aircraft Type and Registration: Robinson R22 BETA, G-BXOA

## **Synopsis**

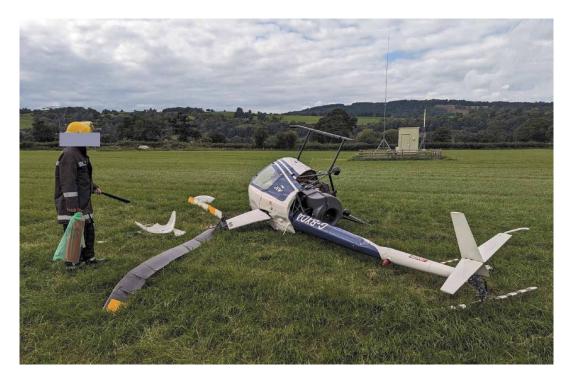
Figure 1
Accident site

Having brought the helicopter into a stable hover at a height of approximately 10 to 15 ft above the ground, control of the cyclic was passed to the passenger. Control of the yaw pedals and collective remained with the pilot. The pilot stated that the helicopter started to drift backwards, to which the passenger applied a "heavy" forward cyclic input. The helicopter then drifted left at which point the pilot advised the passenger that he was taking control before trying to apply right cyclic. However, the pilot stated that the passenger did not release his grasp and had applied left cyclic. The helicopter moved left whilst also dropping, which the pilot tried to counter with collective and cyclic inputs but was unable to prevent the front of the left skid of the helicopter from contacting the ground. The helicopter subsequently fell onto its left side due to dynamic rollover.

As the helicopter struck the ground, the windscreen broke and detached from the helicopter. The passenger, who was sitting in the right seat, was momentarily suspended in his seat by the multipoint harness before releasing himself. Both occupants then vacated the helicopter through the windscreen aperture and moved away from the helicopter. The pilot

The AAIB investigation was unable to resolve the differences between these two statements, but this accident highlights the importance of clear communication and setting out responsibilities as part of the pre-flight brief and, should it be deemed appropriate, the ability of the pilot to stop the flight at any time.
