## SERIOUS INCIDENT

<b>Aircraft Type and Registration:</b>	Rotorway Executive 162F Modified, G-ZHWH	
<b>No &amp; Type of Engines:</b>	1 Rotorway RI 600N piston engine	
<b>Year of Manufacture:</b>	2001 (Serial no: 6596)	
<b>Date &amp; Time (UTC):</b>	10 September 2023 at 1730 hrs	
<b>Location:</b>	In flight over Hampshire	
<b>Type of Flight:</b>	Private	
<b>Persons on Board:</b>	Crew - 1	Passengers - None
<b>Injuries:</b>	Crew - None	Passengers - N/A
<b>Nature of Damage:</b>	No damage reported	
<b>Commander's Licence:</b>	Private Pilot's Licence	
<b>Commander's Age:</b>	67 years	
<b>Commander's Flying Experience:</b>	580 hours (of which 39 were on type) Last 90 days - 17 hours Last 28 days - 4 hours	
<b>Information Source:</b>	Aircraft Accident Report Form submitted by the pilot and further enquiries by the AAIB

### Synopsis

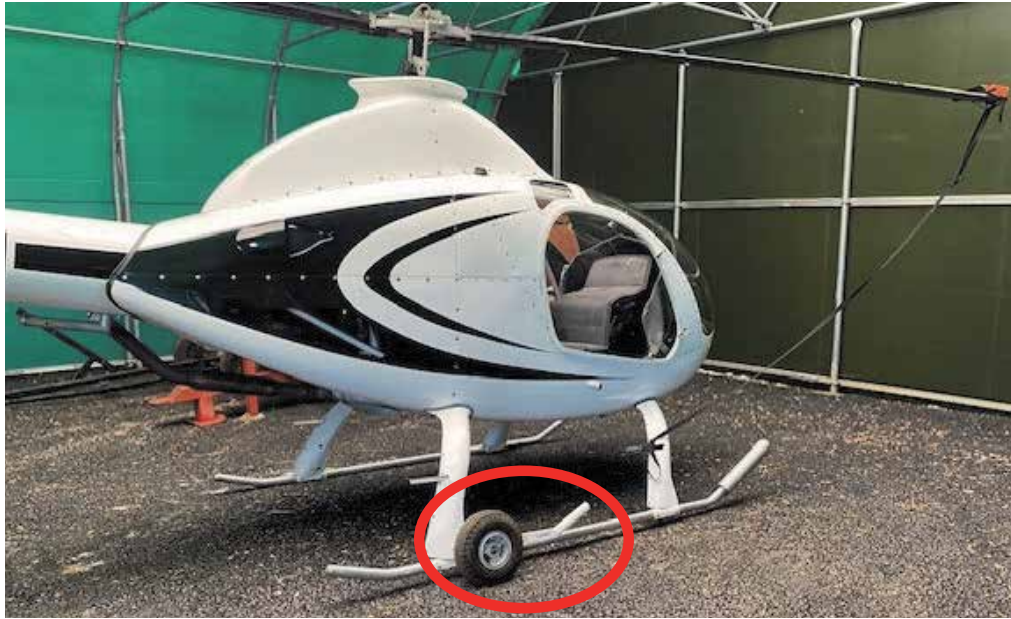
**Figure 1**

The pilot stated that he was on a local flight from a private site where the helicopter was kept. Prior to moving the helicopter out of its hangar, he completed the pre-flight inspection. He then self-manoeuvred it out of the hangar on its ground handling wheels. Each wheel weighs about 12 lb (5.4 kg). Figure 1 shows the helicopter with a wheel fitted. However, once the helicopter was in a position for startup and takeoff he became distracted by his dogs, which he had to take into his house. Upon returning to the helicopter the pilot forgot to remove the wheels and subsequently took off with them on. He only realised this after landing when he found one wheel attached and one missing. Realising the missing wheel had fallen off in flight, he immediately notified the local ATC unit and police but there had been no notification of any damage or injuries caused by the wheel falling off in flight.

G-ZHWH with ground handling wheel fitted

The ground handling wheels are attached to the rear of the helicopter's skids, with the handle to the rear. The handle is then pulled forward over centre which raises the rear of the helicopter onto the wheel and locks the wheel in position (Figure 1). The rear of the tail of the helicopter is then pulled down until the helicopter is on the wheels, and it can then be manoeuvred as required. The wheels are to be removed before flight.

As a result of this incident, and the inability of the design company to consider amending the POH, the UK maintenance organisation amended the helicopter's '*START UP, RUN UP AND TAKE OFF*' checklist by adding '*VERIFY THAT BOTH GROUND HANDLING WHEELS HAVE BEEN REMOVED BEFORE FLIGHT*'. The organisation planned to make this amendment to other helicopters' POH at their annual check. This would also be done on all the other variants maintained by the maintenance organisation. The CAA supported this safety action.

As a result of this incident the helicopter's maintenance organisation in the UK amended the '*START UP, RUN UP AND TAKE OFF*' checklist by adding '*VERIFY THAT BOTH GROUND HANDLING WHEELS HAVE BEEN REMOVED BEFORE FLIGHT*'. Other helicopters' POH would be amended when undergoing an annual check. This would also be done on all other variants maintained by the Maintenance organisation.
