Air Quality and Dust Monitoring Monthly Report – November 2023

London Borough of Hammersmith and Fulham

A report prepared by EWCs and MWCCs on behalf of HS2 Ltd.

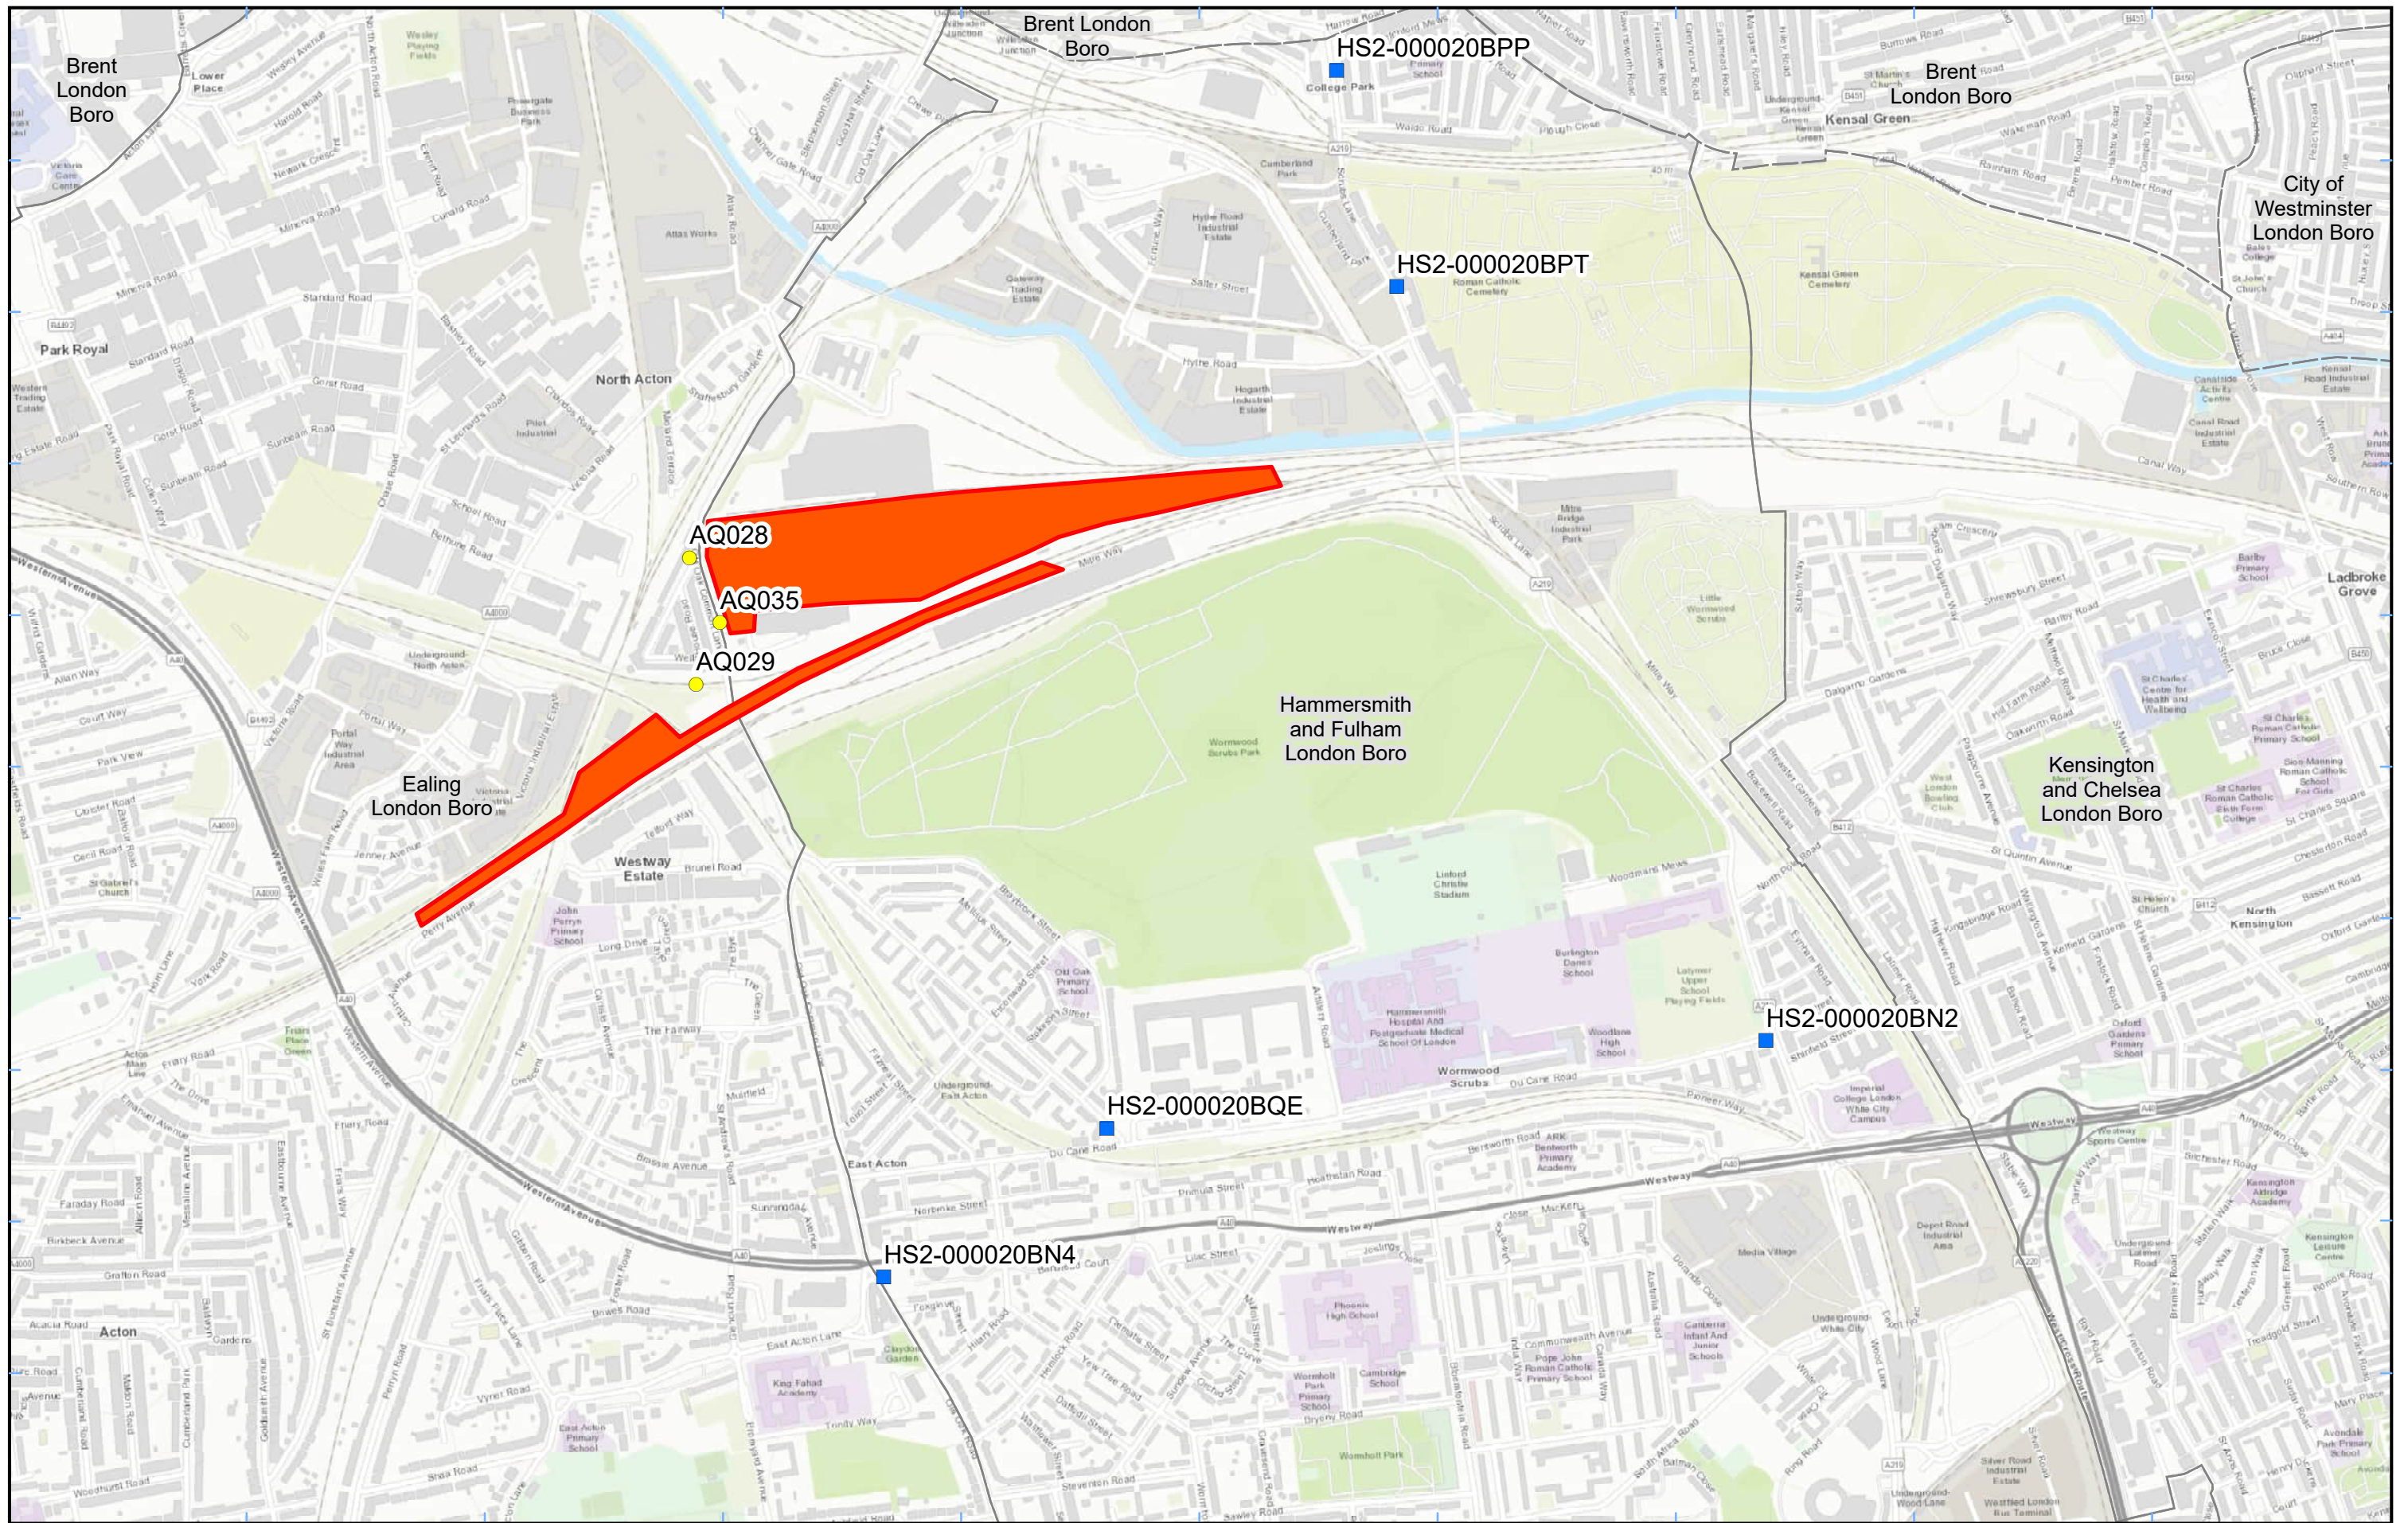
Figure 1 and 2: Worksites and monitoring locations within the LBHF

- 1.1.4 The current worksites, as presented in Appendix A, Figure 1 and Figure 2, include:
- Old Oak Common Depot**
- Mobilisation; and
 - New site set up for the station works.

- Scheme 6**
- Civil works; and
 - OLE works.
- 1.1.5 Three (3) dust monitors are installed around these worksites, where works are underway. These sites returned a medium to high dust risk rating.

Map Name
**Worksite and Monitoring Locations
 In LBHF (Sheet 1)**

- 1.1.2 Figure 1 and Figure 2 in Appendix A present the current worksites together with air quality and dust monitoring locations.
- 1.1.3 This summary should be read in conjunction with the overview monitoring report available from www.gov.uk/government/collections/monitoring-the-environmental-effects-of-hs2, which highlights: the applicable standards and guidance, as well as the air quality and dust monitoring methodologies to be implemented by nominated undertakers throughout construction.

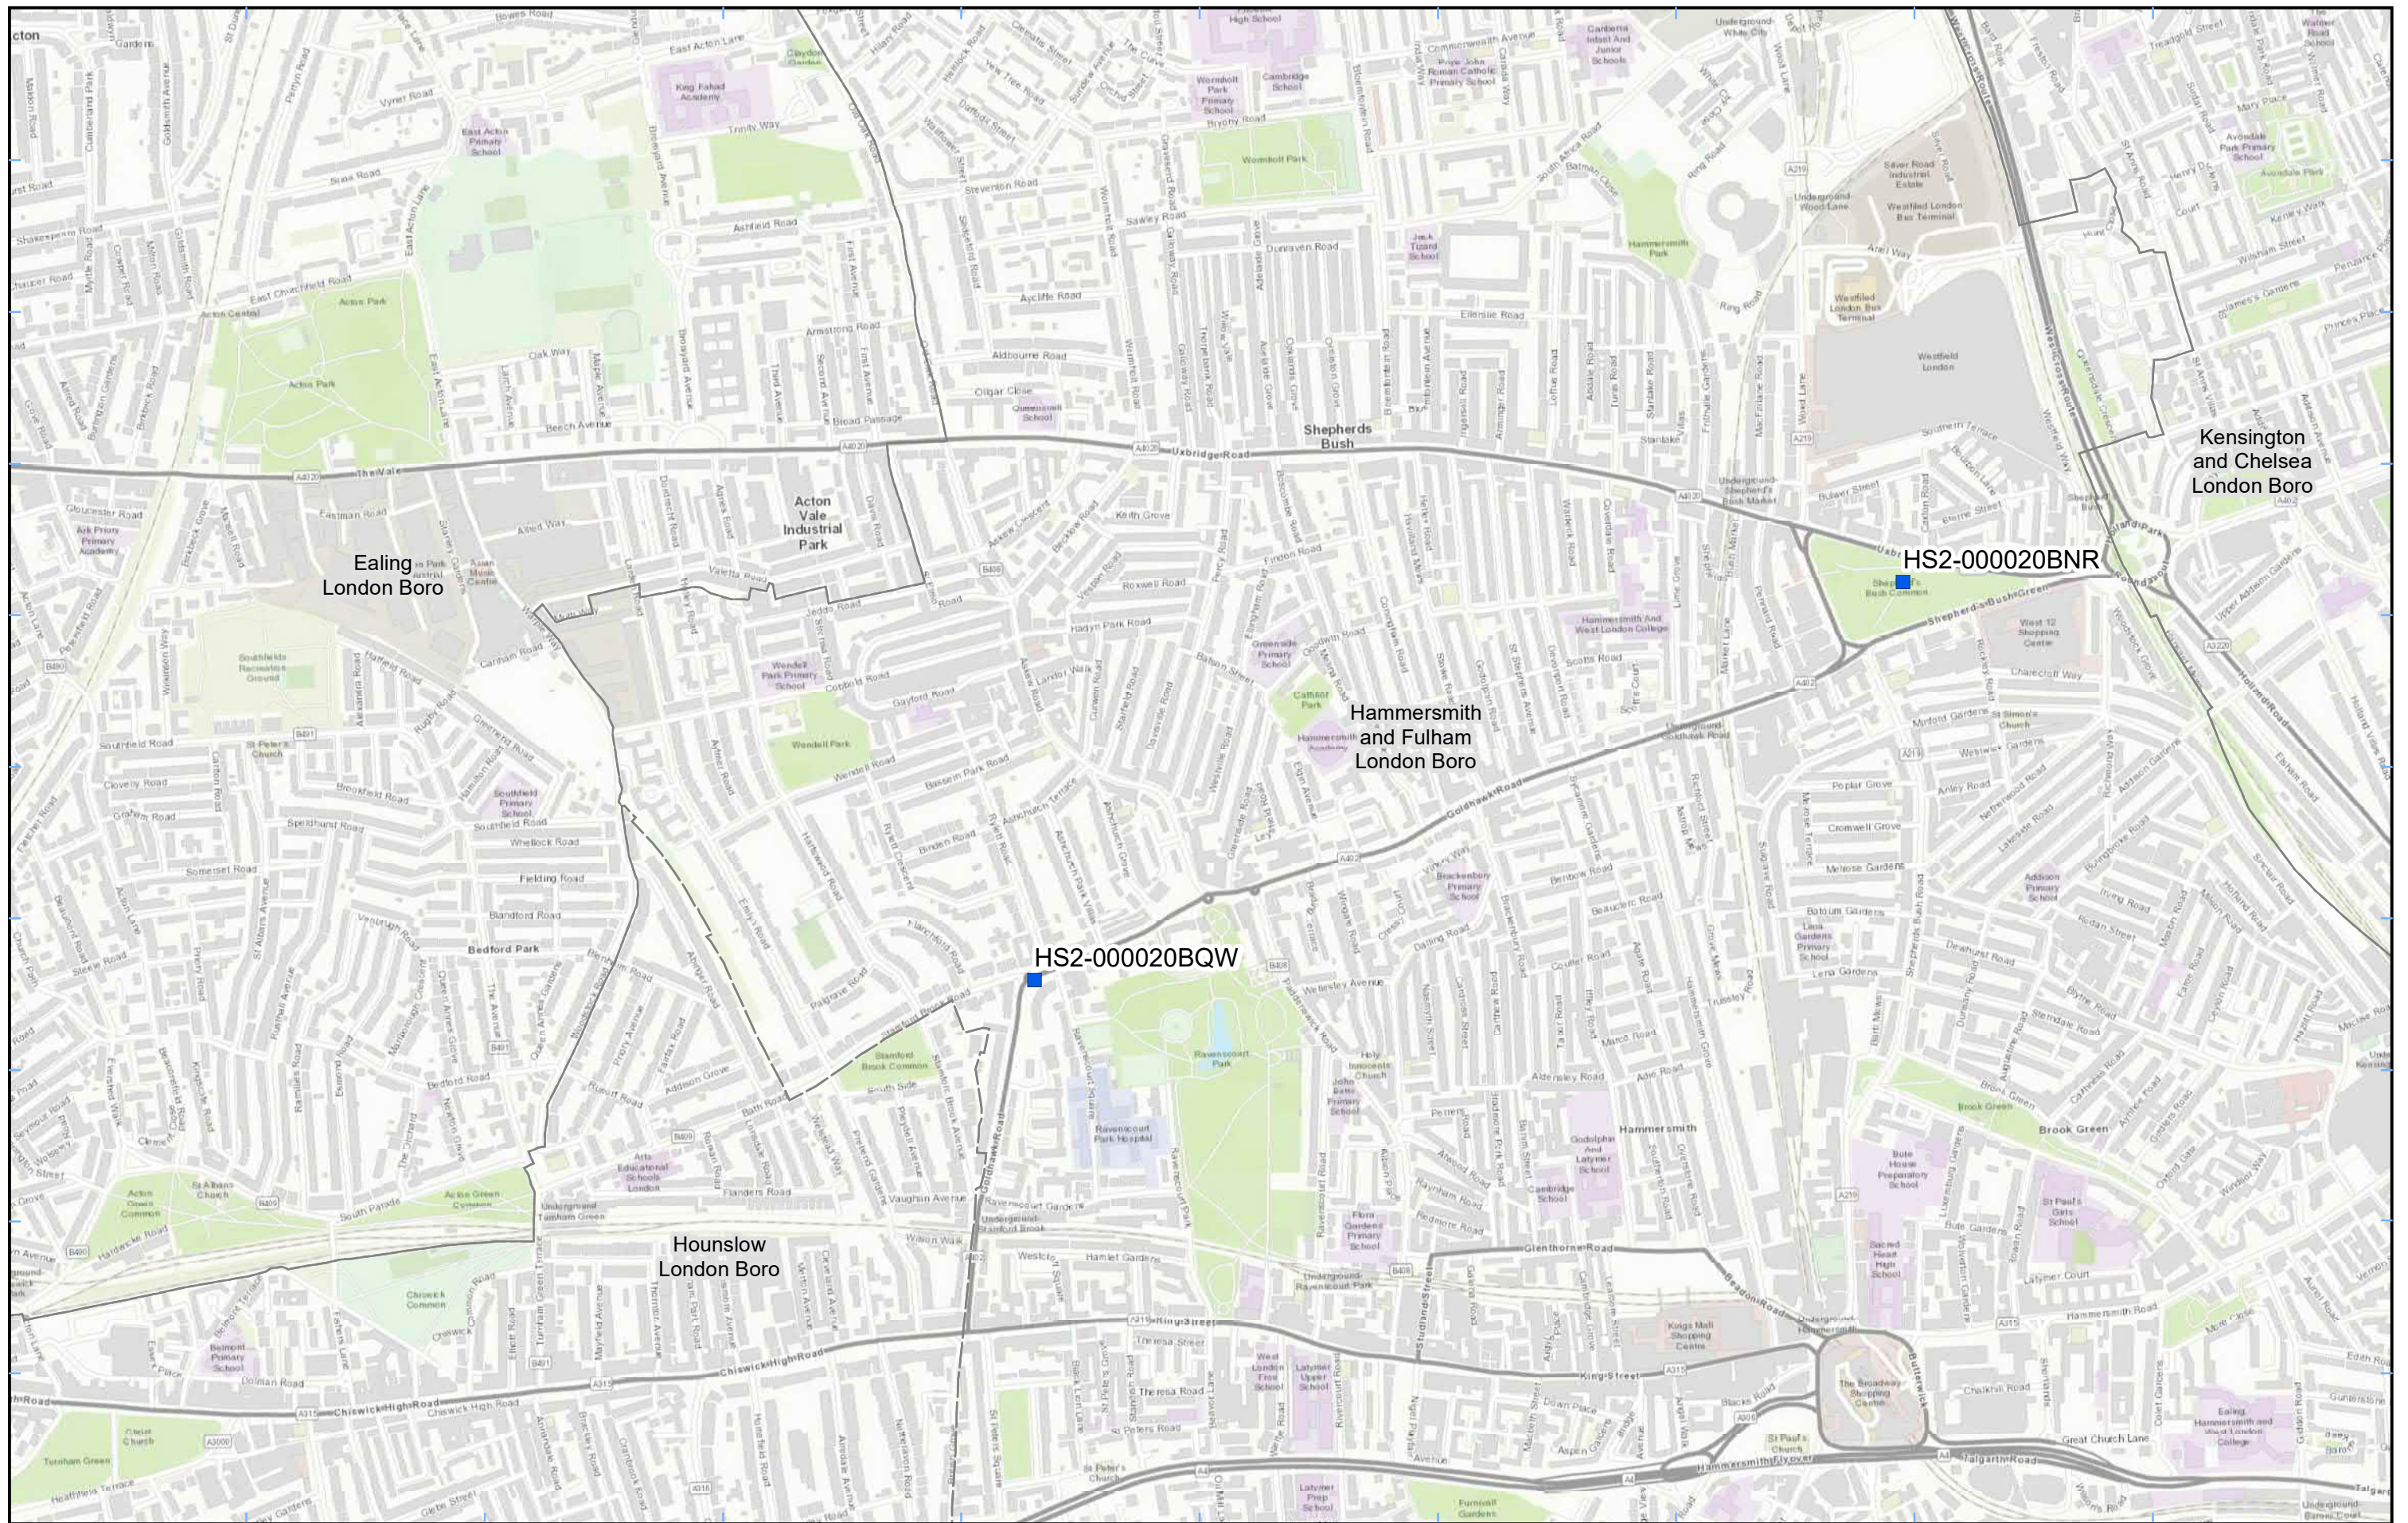
Map Number
 Map Name
**Monitoring Locations In LBHF
 (Sheet 2)**
 London Borough of Hammersmith
 and Fulham

- 1.1.9 Diffusion tube monitoring of Nitrogen Dioxide (NO₂) is undertaken at seven (7) locations around highways within the LBHF as part of the management of air quality where significant effects may occur as a result of the scheme.
- 1.1.10 Diffusion tube monitoring results are as provided from the laboratory analysis, and therefore still require various analysis and adjustments to be undertaken. Final corrected results will be presented and described in the annual report. However, based on the results to date, no unexpected values were recorded during the monitoring period.
- 1.1.11 NO₂ monitoring locations and results are presented in Appendix C, Table 2, together with the 2023 running mean.
- 1.1.12 There were no (0) complaints received during the reporting period (November 2023).

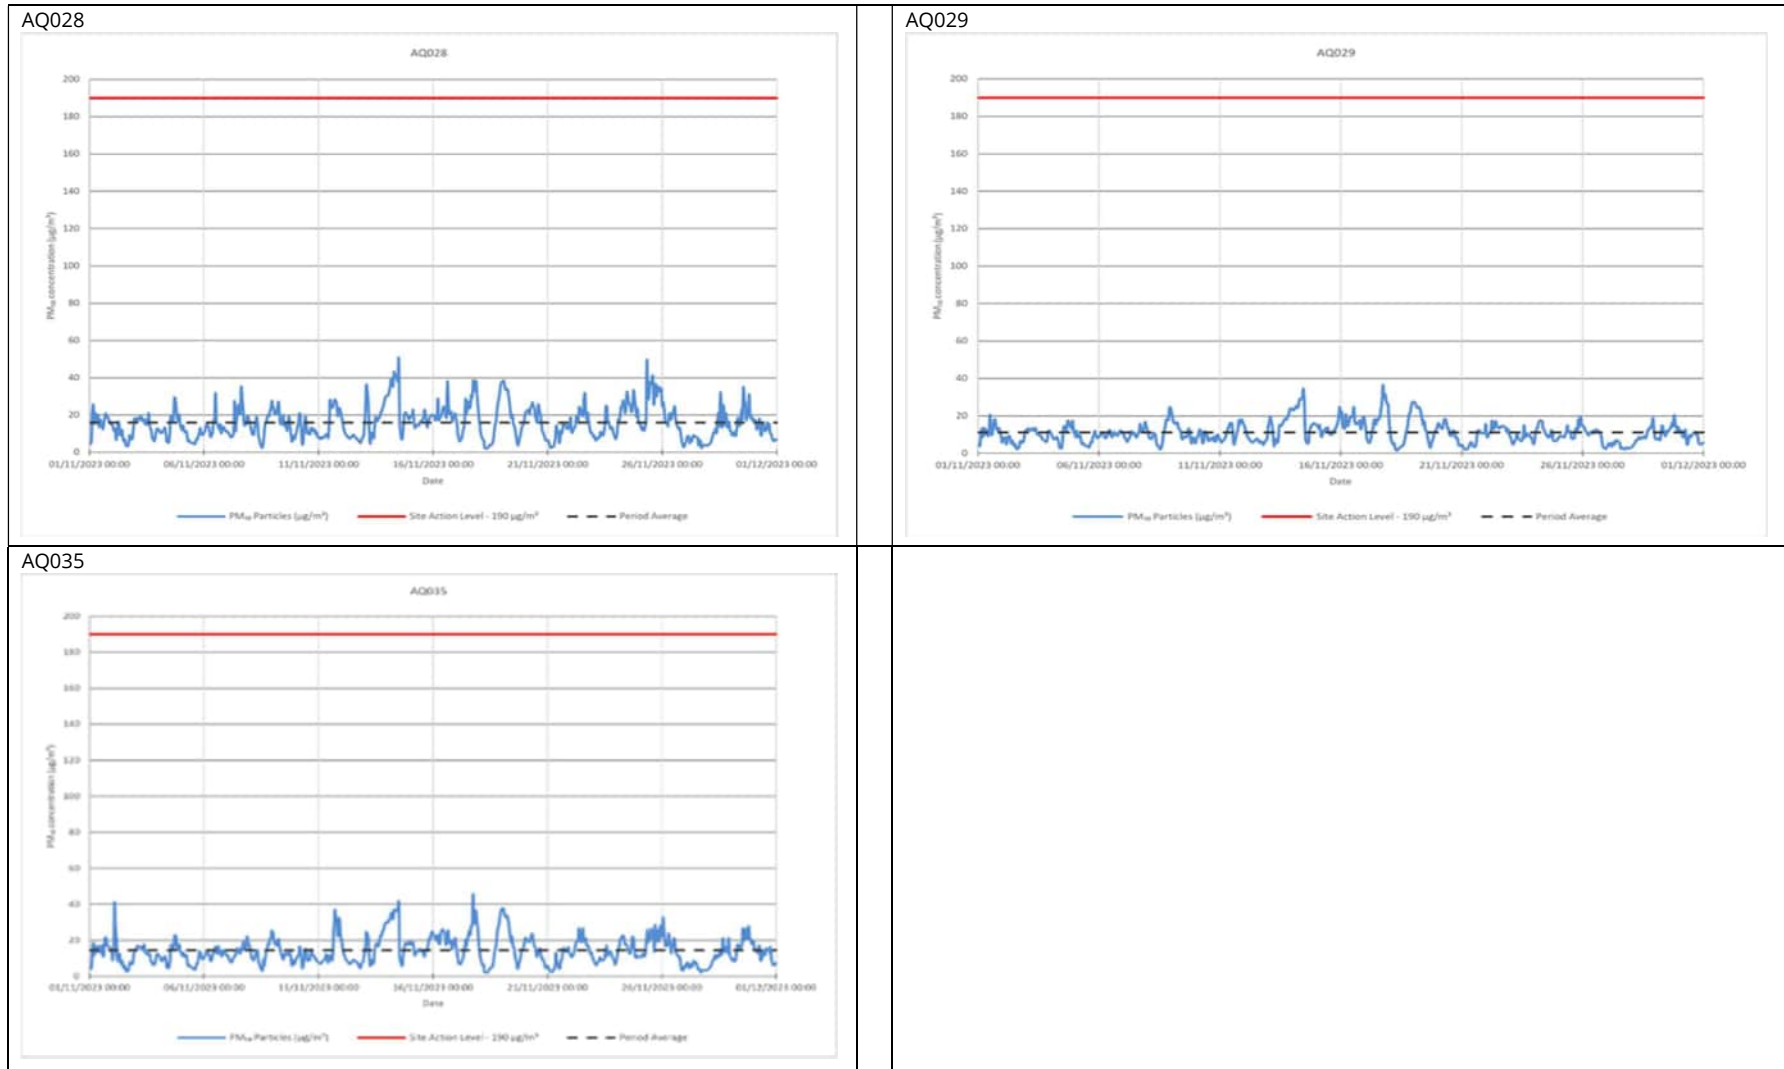
Figure 3: Construction dust 1-hour mean indicative PM₁₀ concentration for all dust monitors

- 1.1.6 Dust monitoring locations and results are presented in Appendix B, Table 1, together with line charts of monthly data from each dust monitor presented in Figure 3. All continuous dust monitoring is undertaken using indicative monitors. Despite being Environment Agency (MCERTS) certified, indicative monitors carry a higher level of uncertainty than reference monitors, and therefore cannot be strictly compared with Air Quality Standards for human health and the environment. The purpose of the monitoring undertaken is to ensure the effectiveness of the on-site mitigation.

- 1.1.7 The trigger level for PM₁₀ concentrations of 190 µg/m³, over a 1-hour period, in accordance with the updated guidance document '*Guidance on Monitoring in the Vicinity of Demolition and Construction Sites – (October 2018)*' has been applied.

- 1.1.8 No (0) dust trigger alerts were recorded during the monitoring period (November 2023).
