Construction Noise and Vibration Monthly Report – November 2023

Lichfield District Council

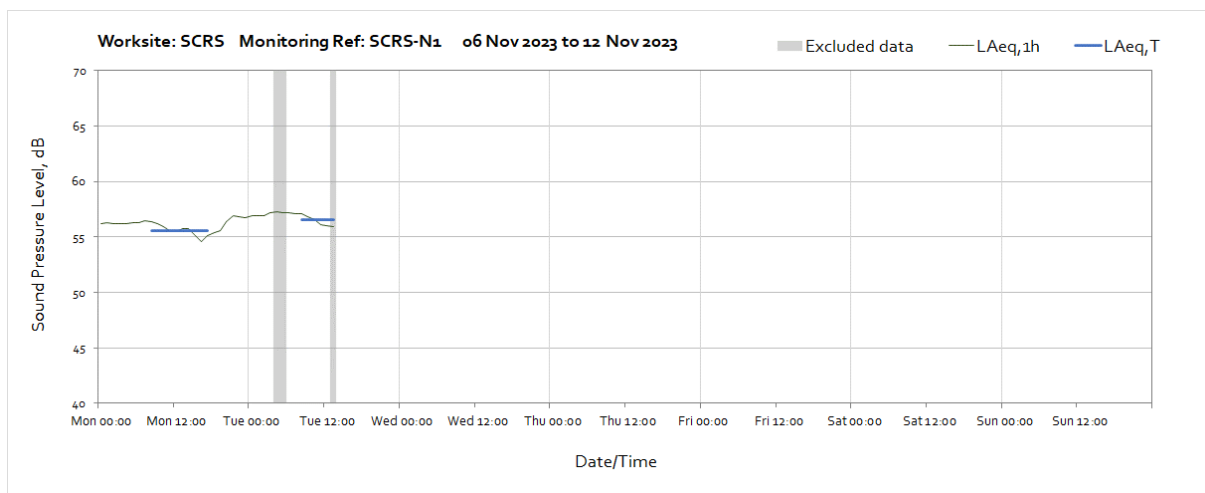
Worksite:SCRS – Monitoring Ref: SCRS-N1

Note: Missing data from 7th of November at 14:00 until 20th of November at 23:00 was due to loss of power at monitoring station.

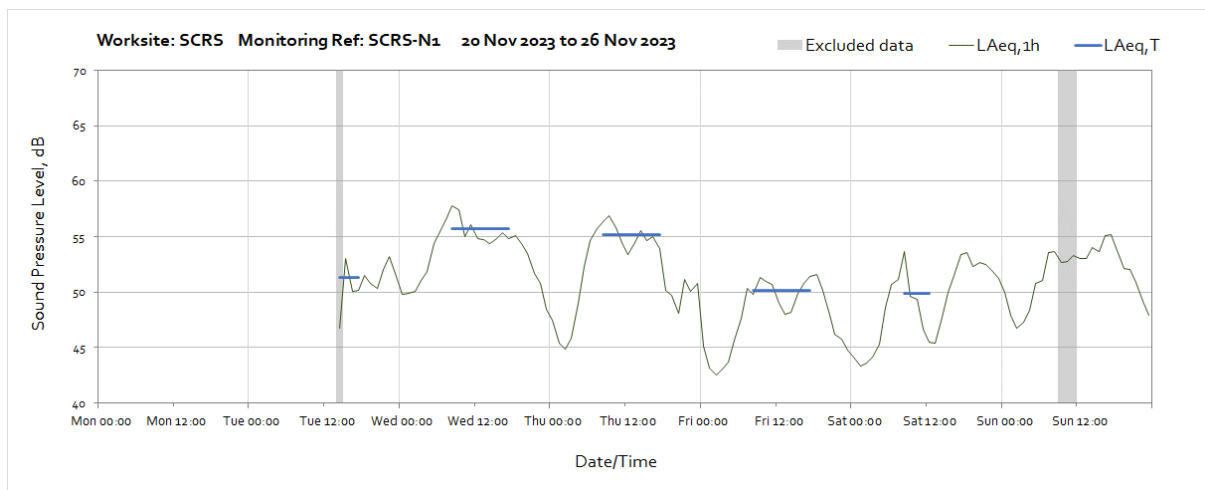
Note: Missing data from 20th of November at 00:00 until 21st of November at 13:00 was due to loss of power at monitoring station
