## **Construction Noise and Vibration Monthly Report – November 2023**

**Stratford-on-Avon District Council**

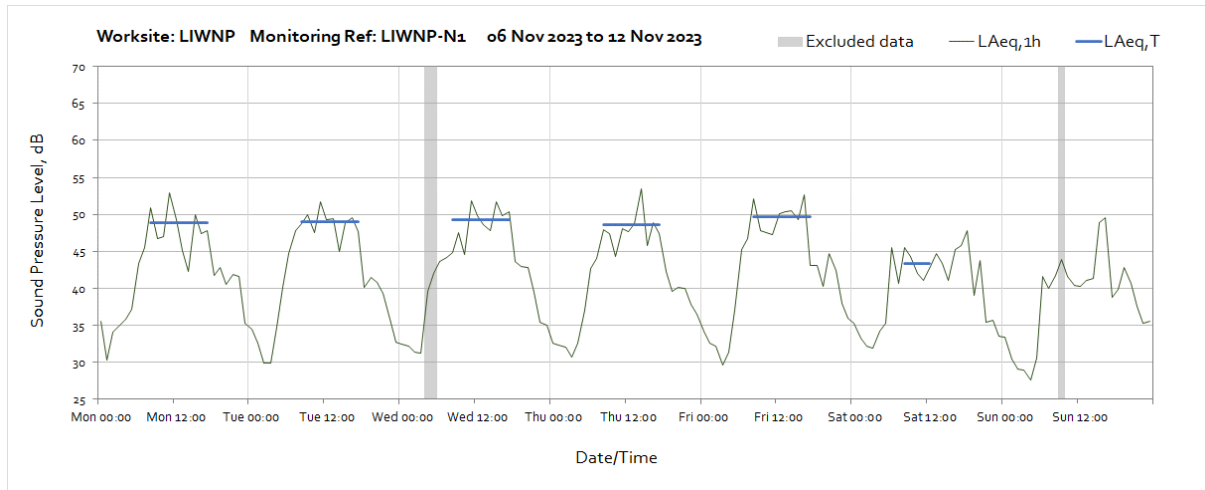
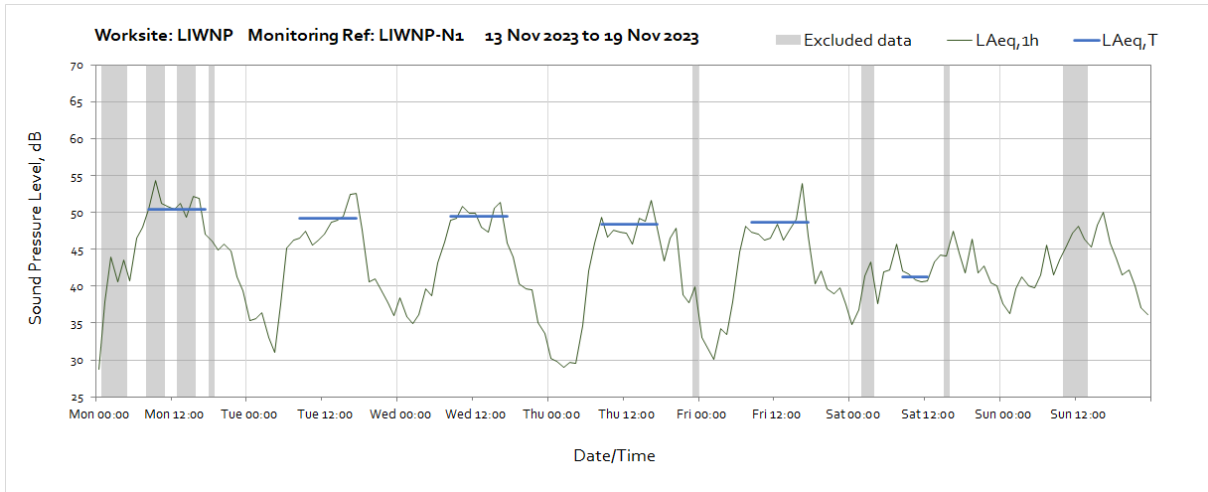
### Worksite: LIWNP Monitoring Ref: LIWNP-N1

The following graphs show the hourly measured ambient noise level  $L_{Aeq,1h}$  and, where relevant, the averaged noise level  $L_{Aeq,T}$  values, where the time period T is as specified in Table 1 of HS2 Information Paper E23. Periods where noise levels are adversely affected by weather or only measured for part of the period, which are not representative of HS2 construction works, have been greyed out and excluded from the calculation of the  $L_{Aeq,T}$  values in Table 3 of the main report.

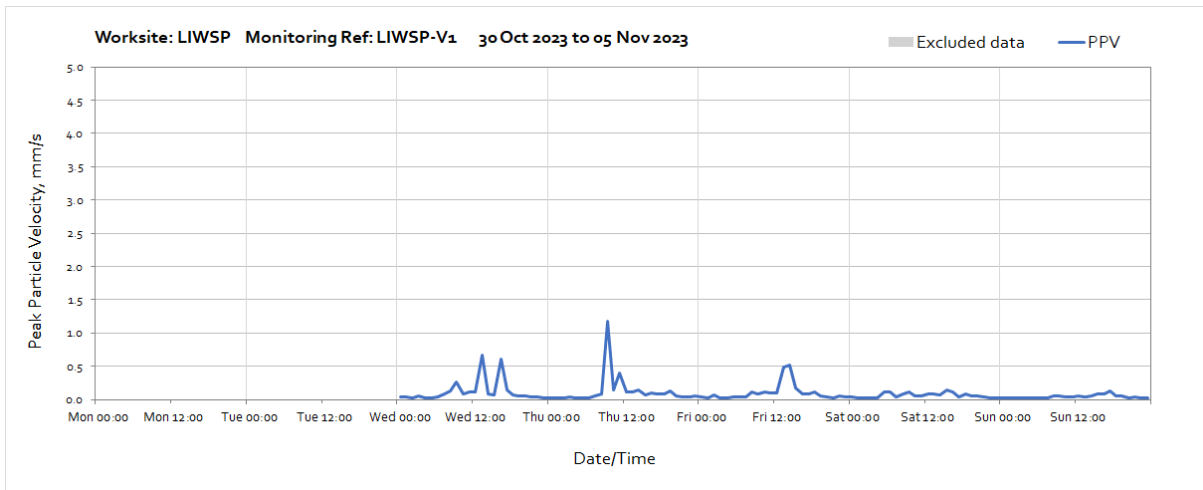
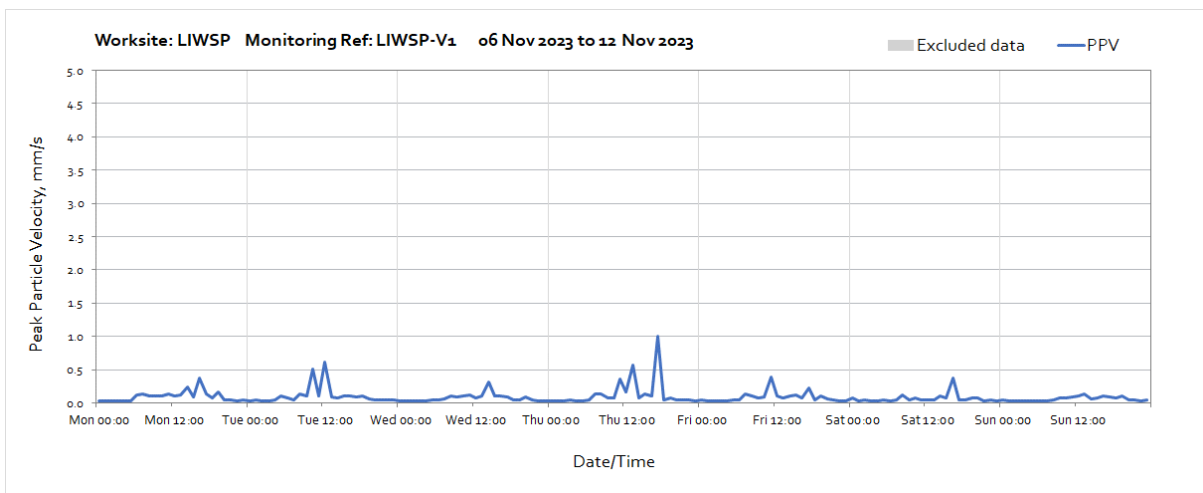
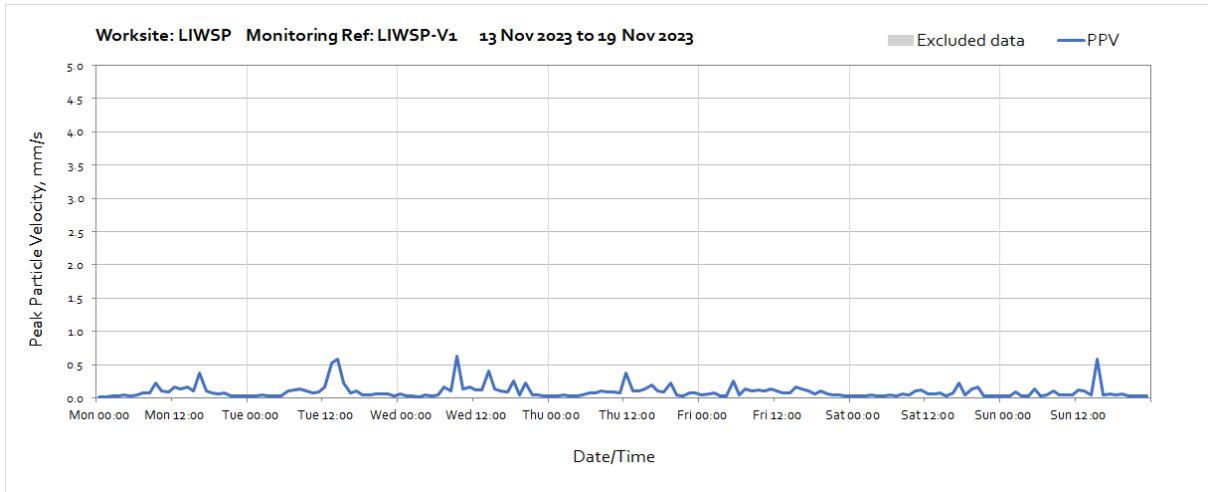
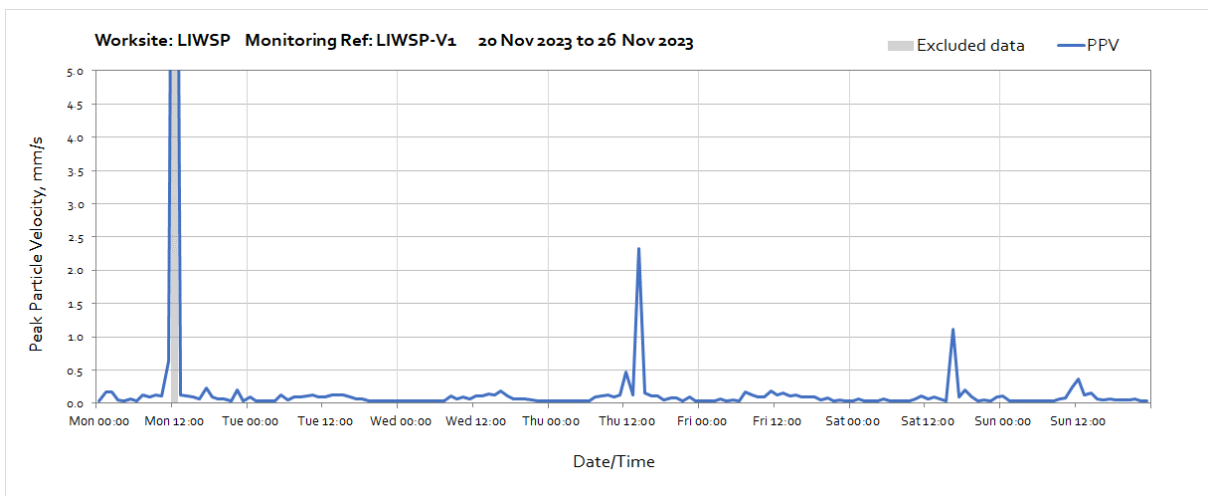
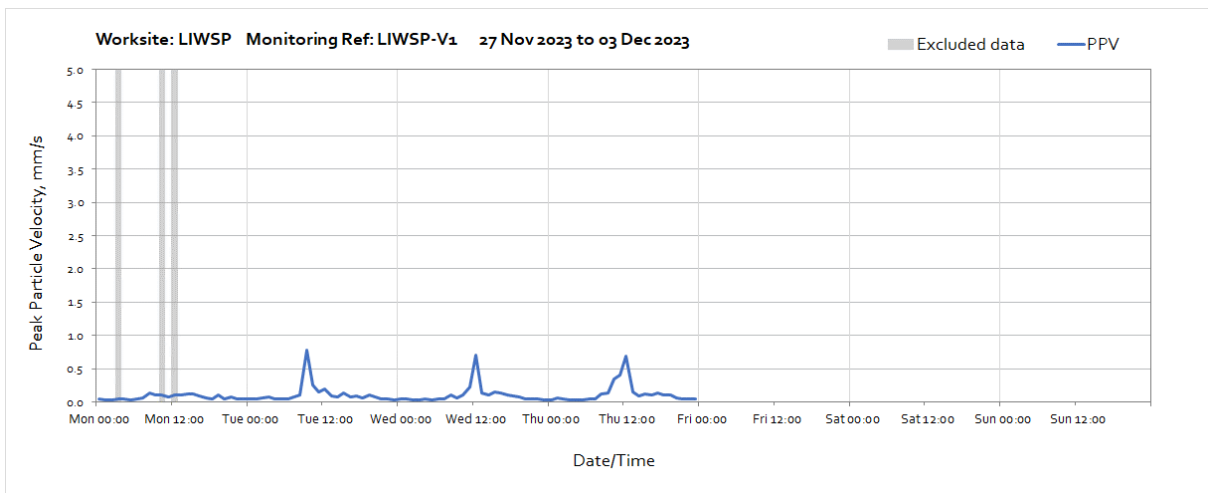
### Worksite: LIWSP Monitoring Ref: LIWSP-V1

The following graphs show the hourly measured peak particle velocity PPV recorded during the monitoring period. The graphs show the highest PPV of the three orthogonal axes x, y and z. Periods where PPV values have been affected by local interference with the vibration monitor or only measured for part of the period, which are not representative of HS2 construction works, have been greyed out and excluded when calculating values in Table 4 of the main report.

Worksite Reference	Measurement Reference	Monitor Address	Highest PPV measured in any axis, mm/s
LIWSP	LIWSP-V1	Woodside House, Bascote Heath, Southam	1.67 (Z-axis)
