Construction Noise and Vibration Monthly Report – November 2023

Warwick District Council

Non-Technical Summary

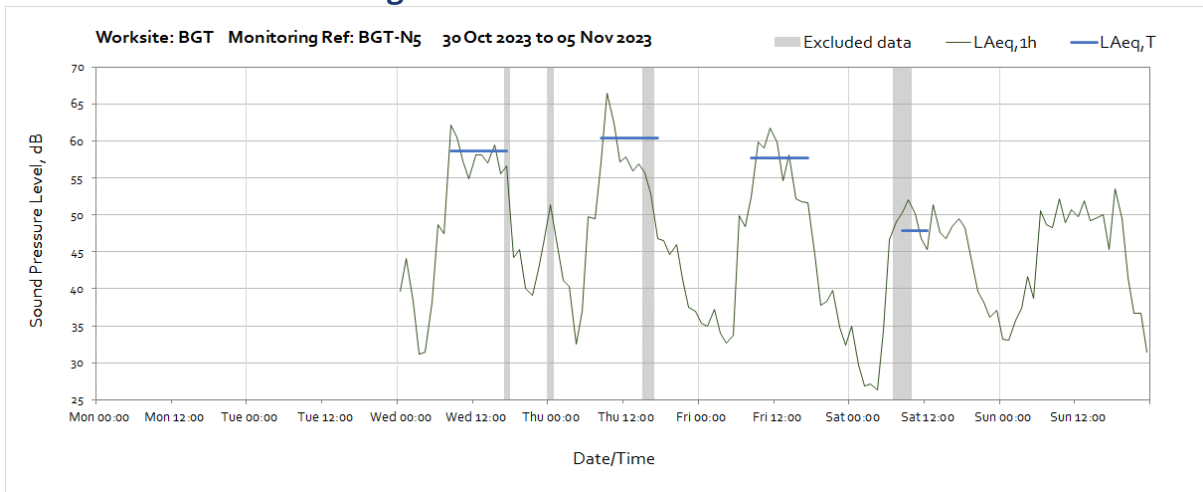
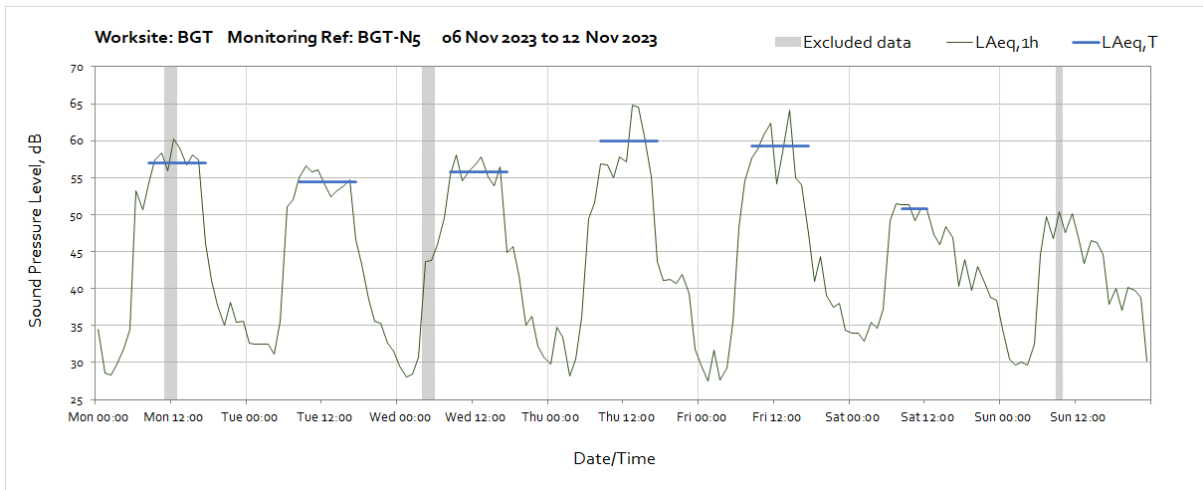
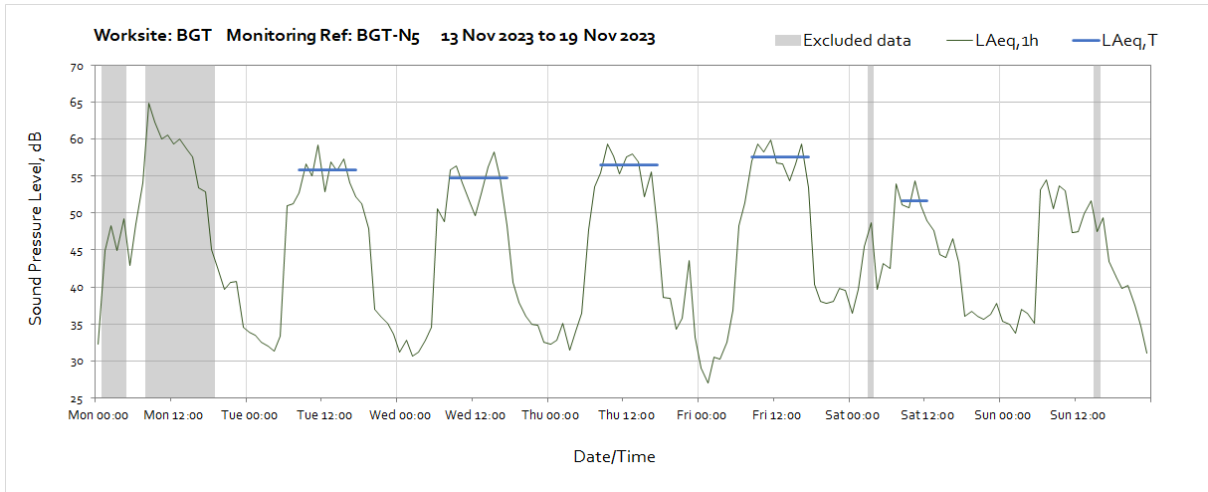
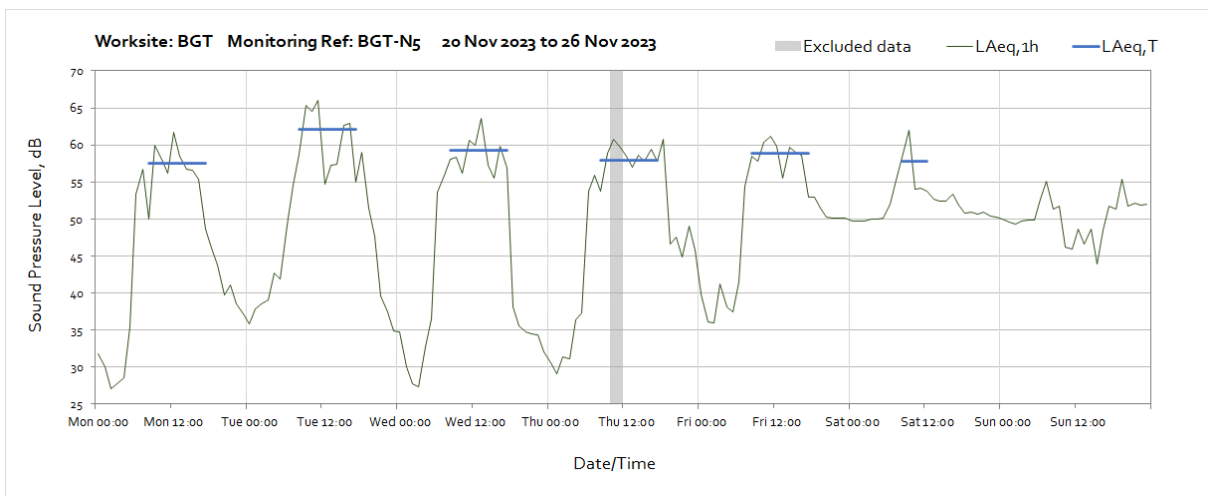
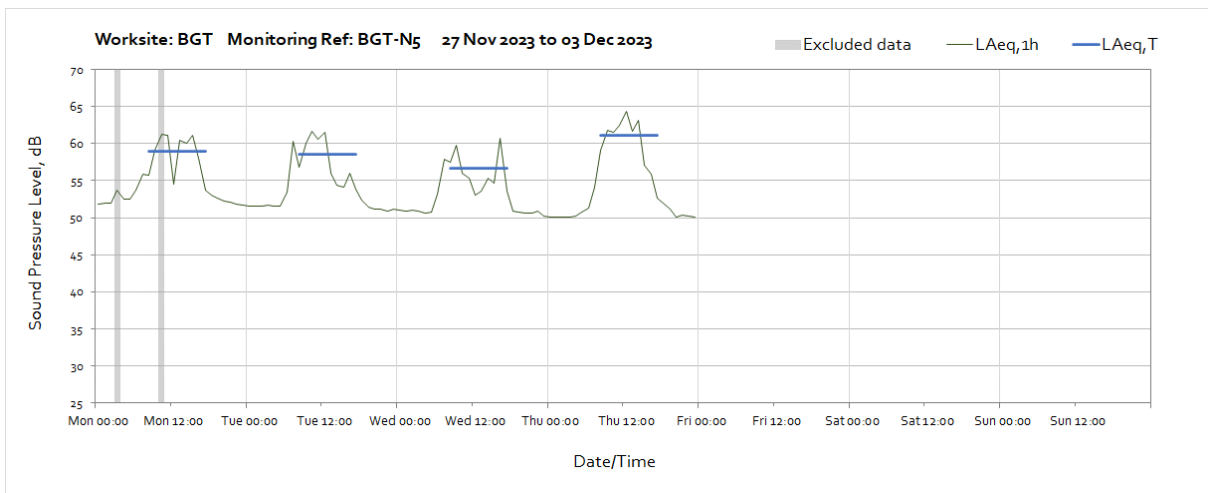
Worksite: BGT – Monitoring Ref: BGT-N5

The following graphs show the hourly measured ambient noise level $L_{Aeq,1h}$ and, where relevant, the averaged noise level $L_{Aeq,T}$ values, where the time period T is as specified in Table 1 of HS2 Information Paper E23. Periods where noise levels are adversely affected by weather or only measured for part of the period, which are not representative of HS2 construction works, have been greyed out and excluded from the calculation of the $L_{Aeq,T}$ values in in **Error! Reference source not found.** of the main report.

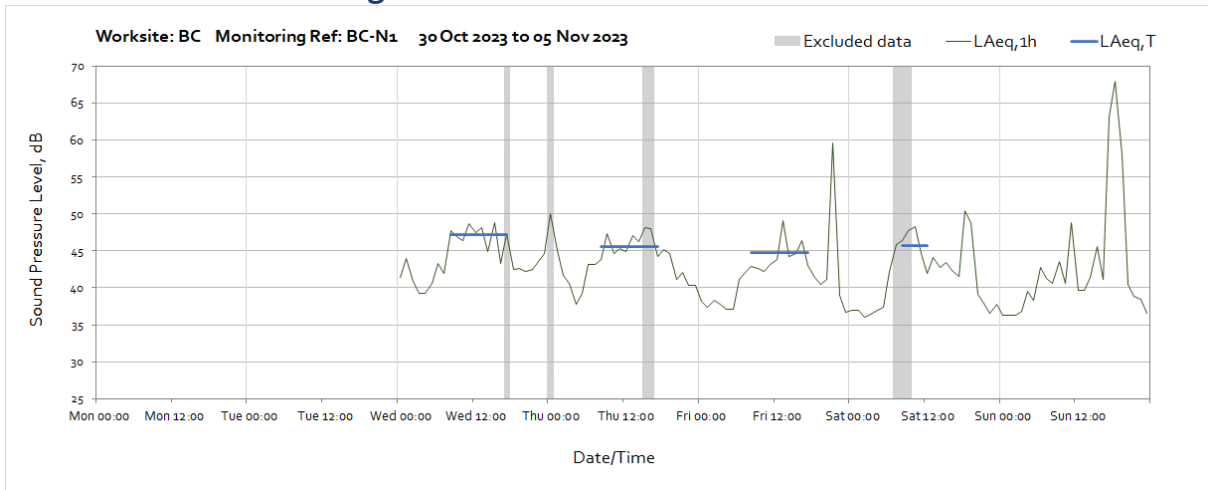
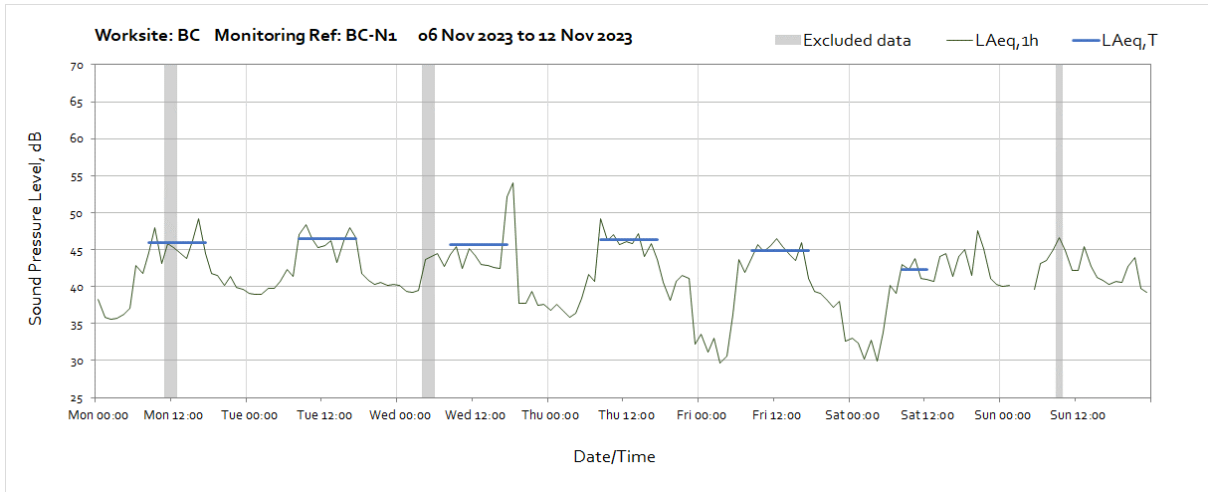
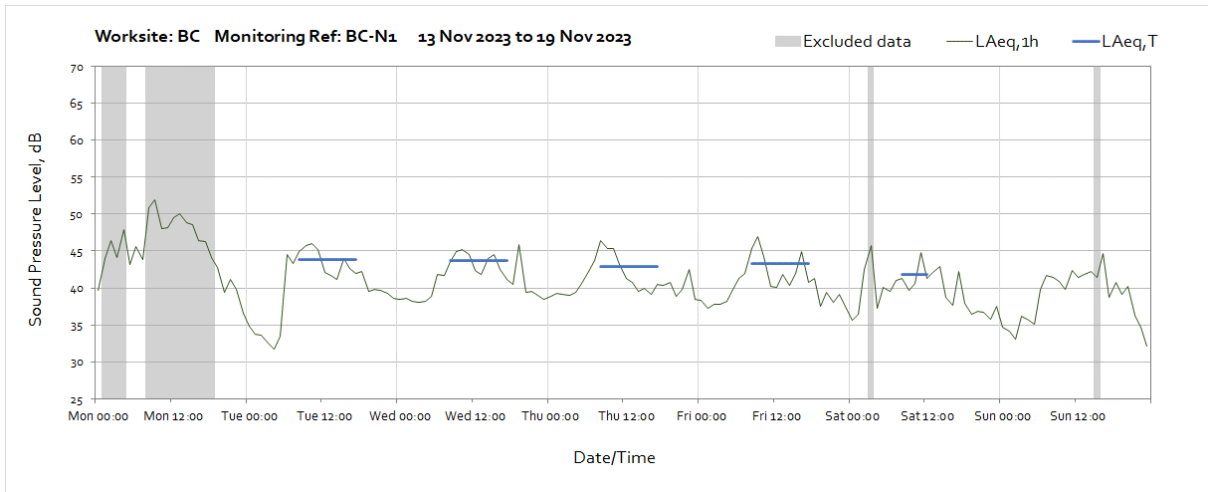
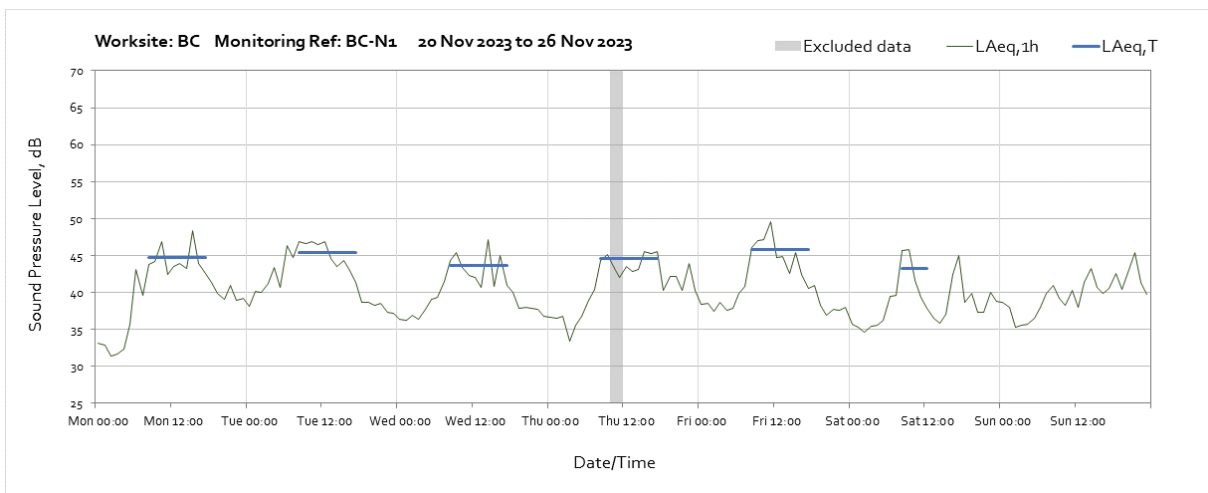
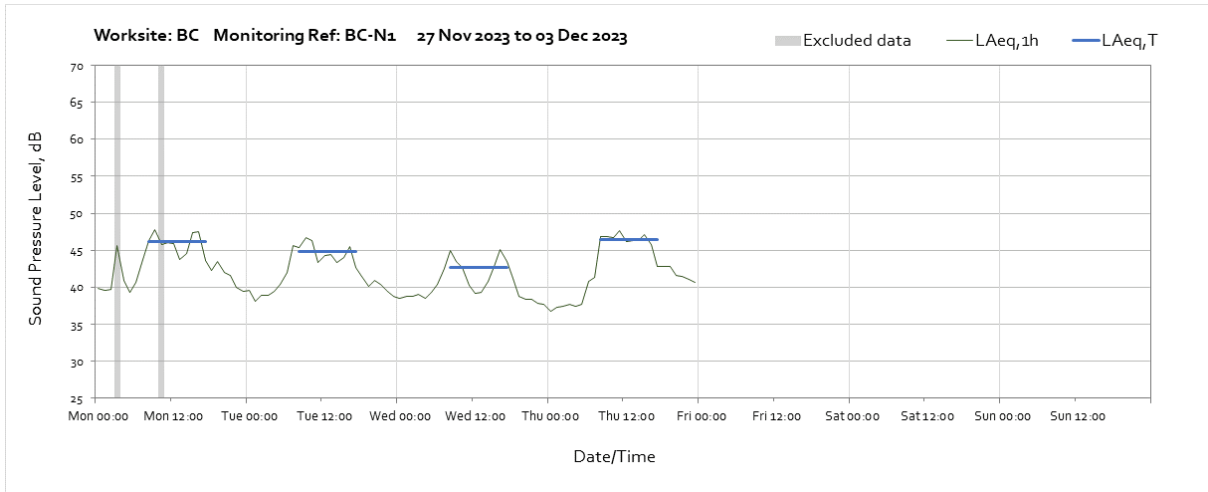
Worksite: BC - Monitoring Ref: BC-N1

Note: Missing data between 02:00 and 05:00 on Sunday 12th November was due to a clock alignment process.

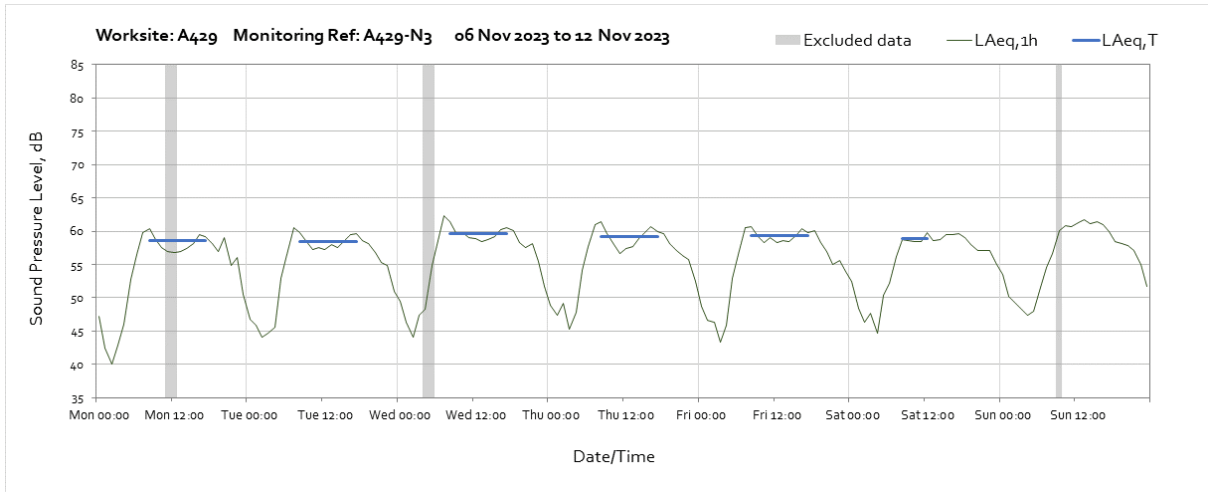
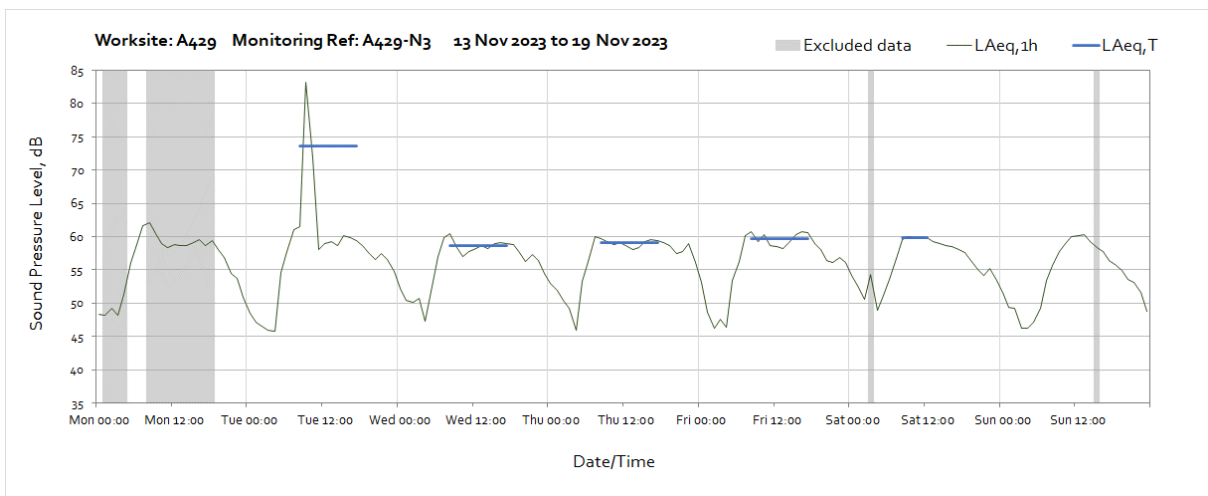
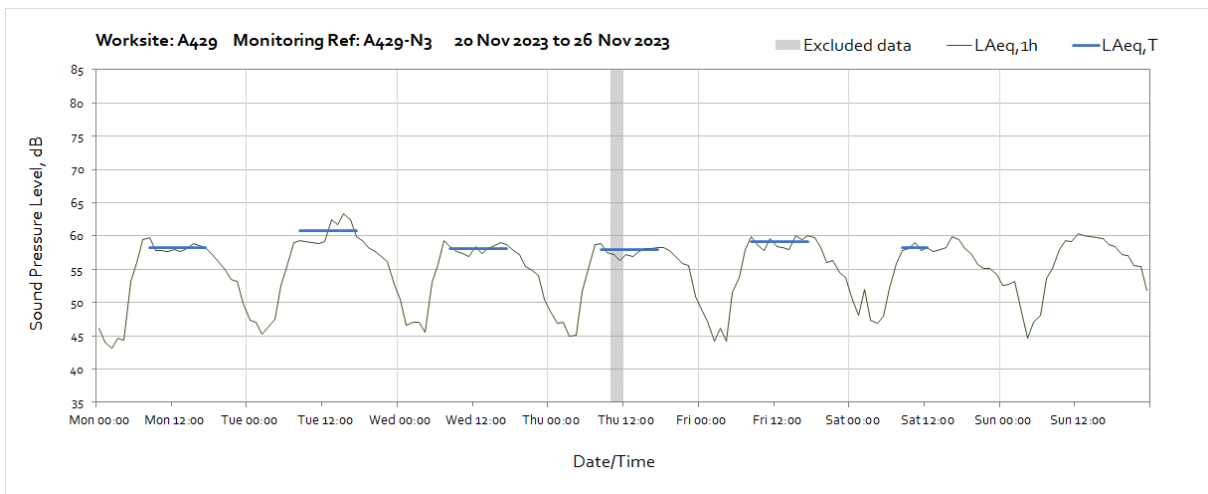
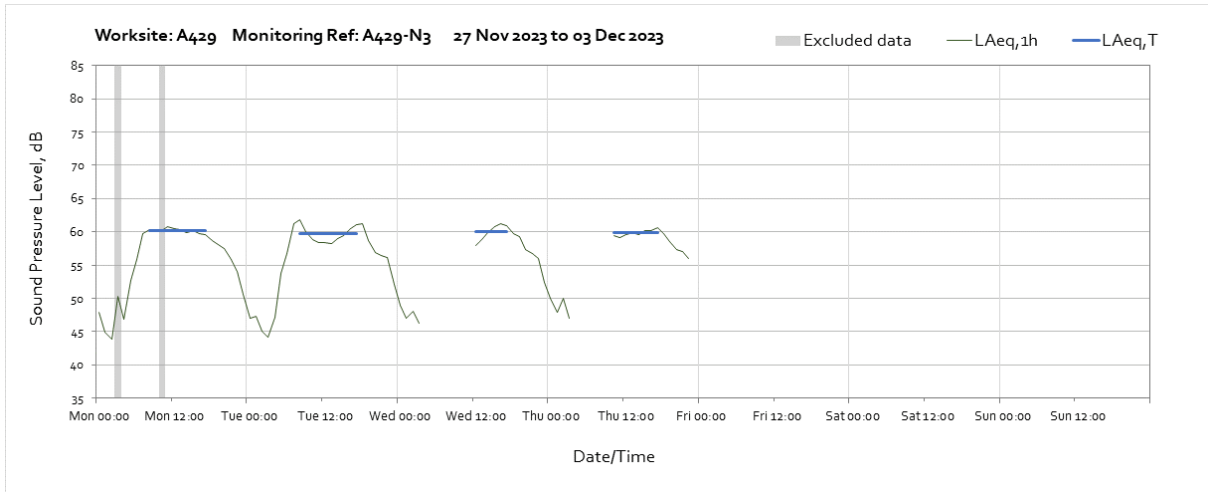
Worksite: A429 - Monitoring Ref: A429-N3

Note: Missing data on Tuesday 29th and Wednesday 30th November was due to power supply issues.

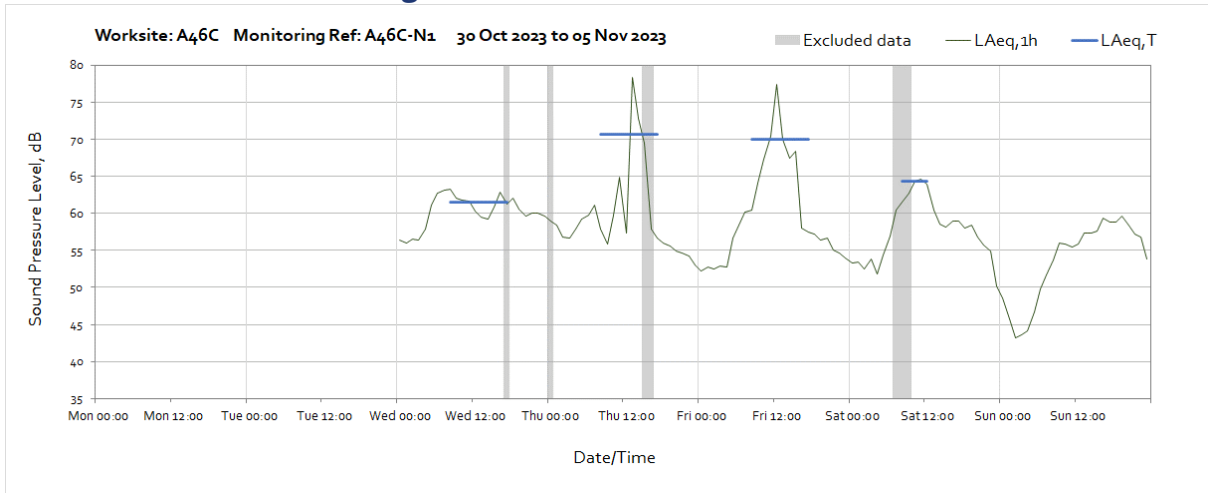
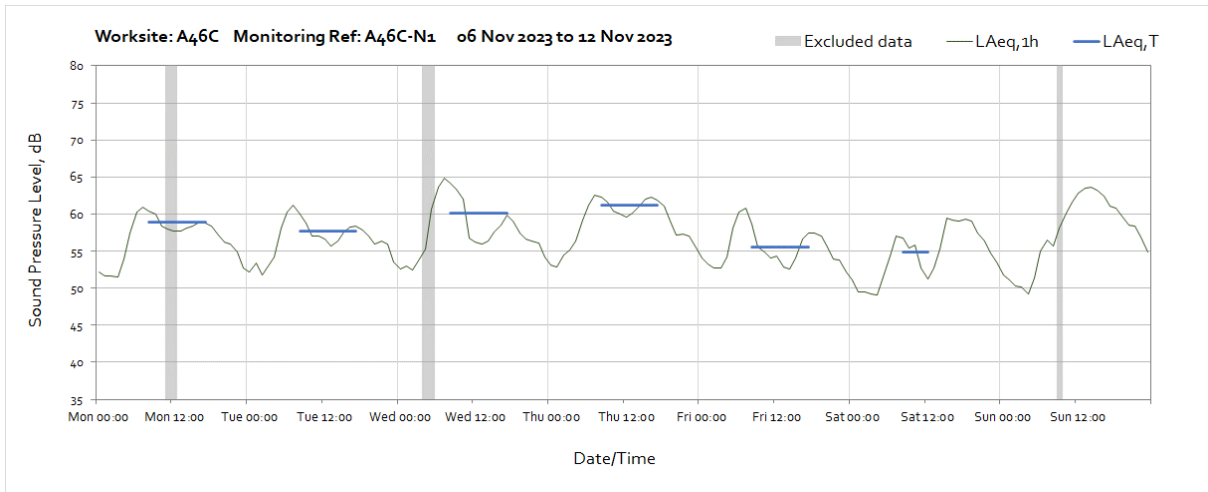
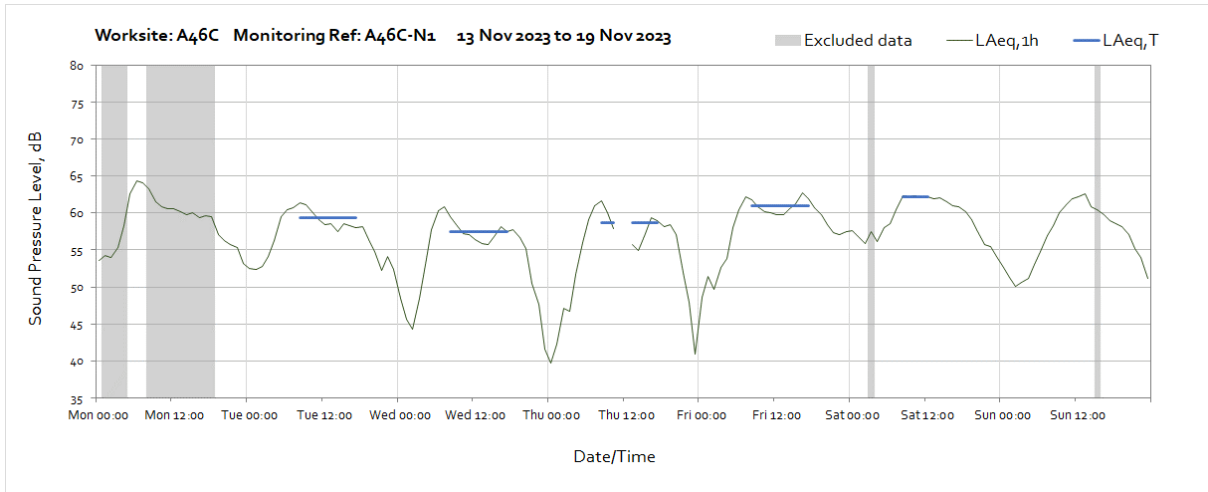
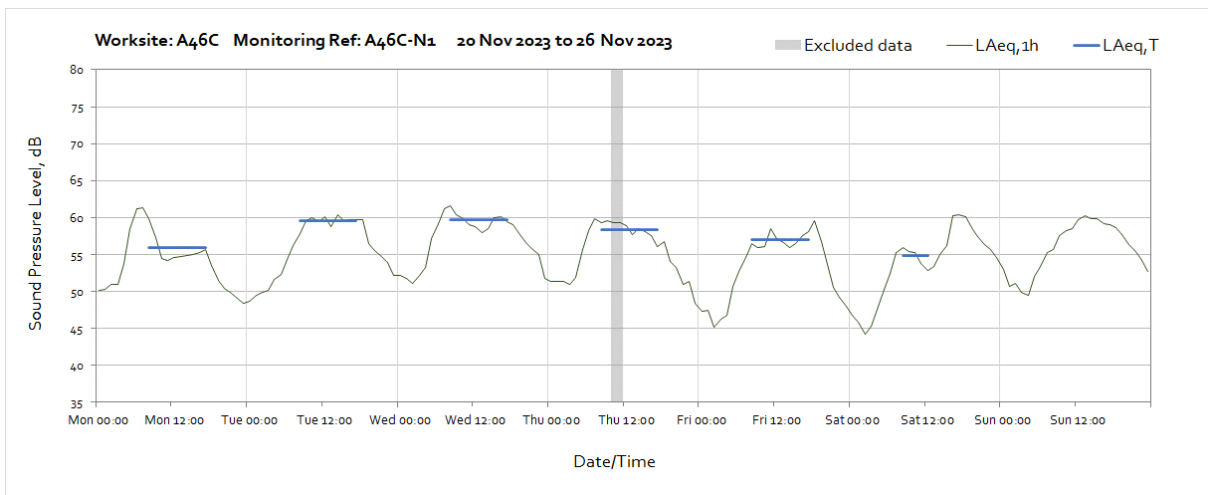
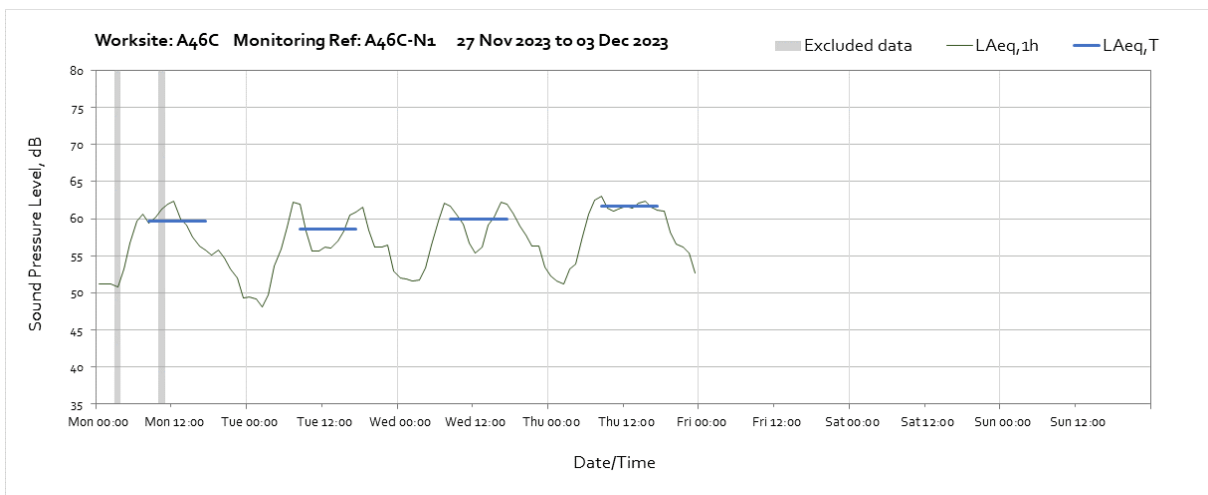
Worksite: A46C - Monitoring Ref: A46C-N1

Note: Missing data between 11:00 and 13:00 on Thursday 16th November was due to an equipment swap.

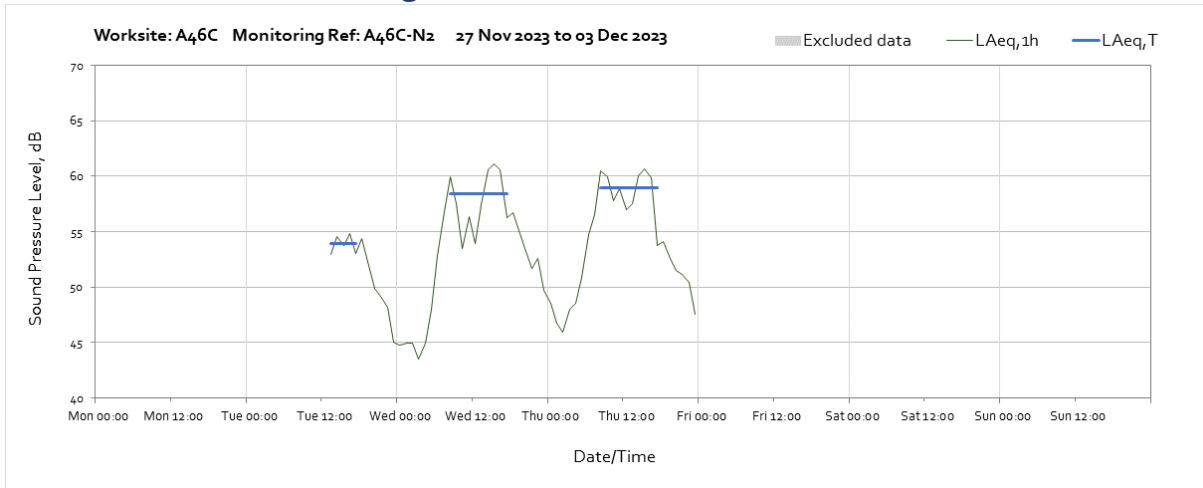
Worksite: A46C – Monitoring Ref: A46C-N2

Note: The monitoring equipment was installed on Tuesday 28th November and data was logged from 13:00 on that day.

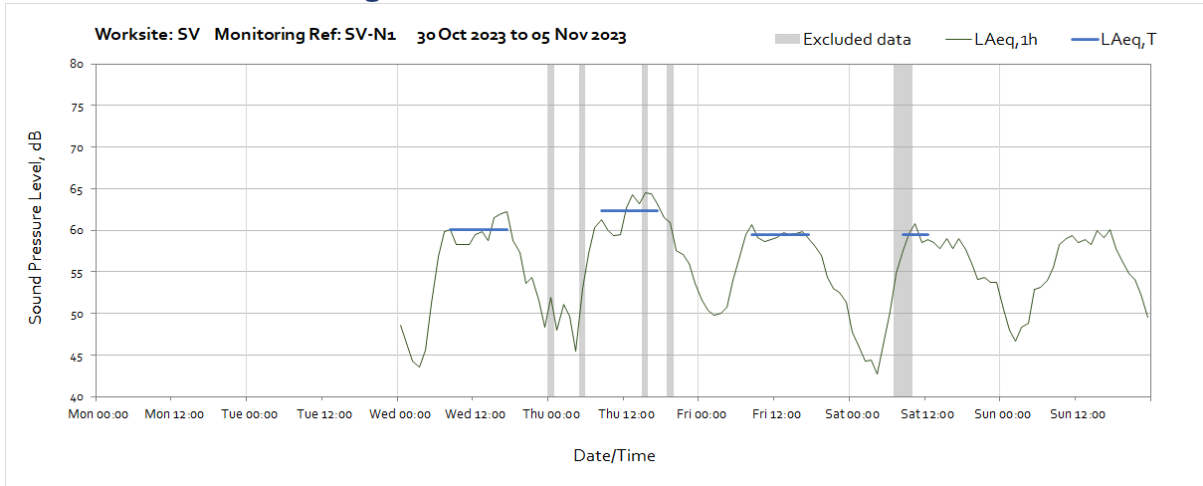
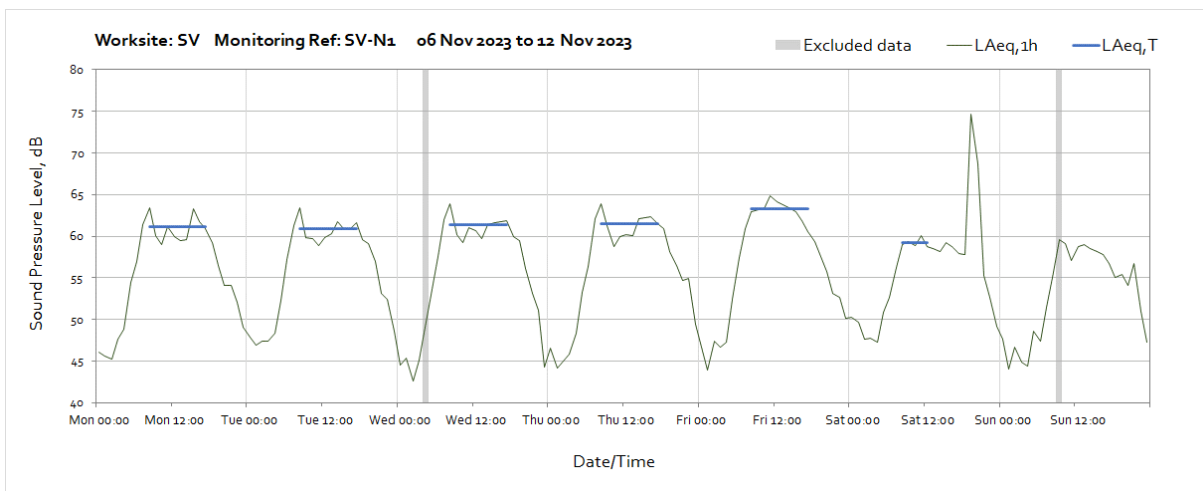
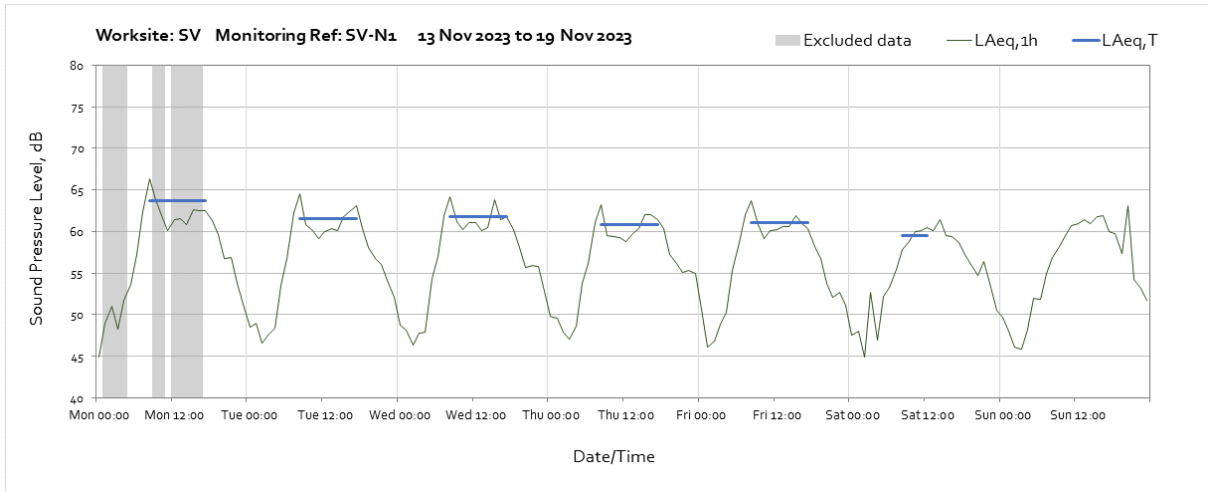
Worksite: SV – Monitoring Ref: SV-N1

Note: The monitoring equipment was decommissioned at 10:00 on Wednesday 22nd November.

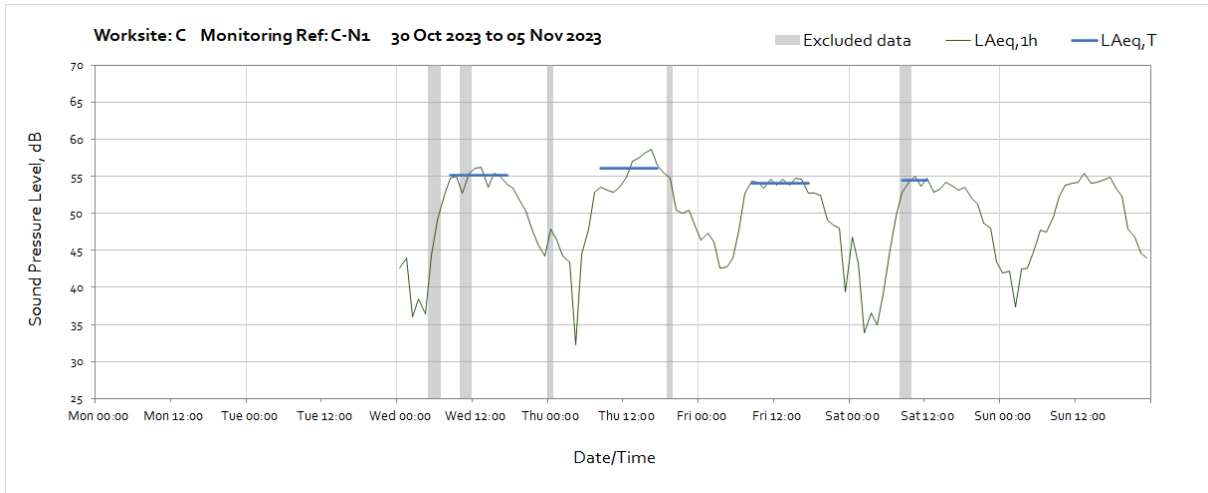
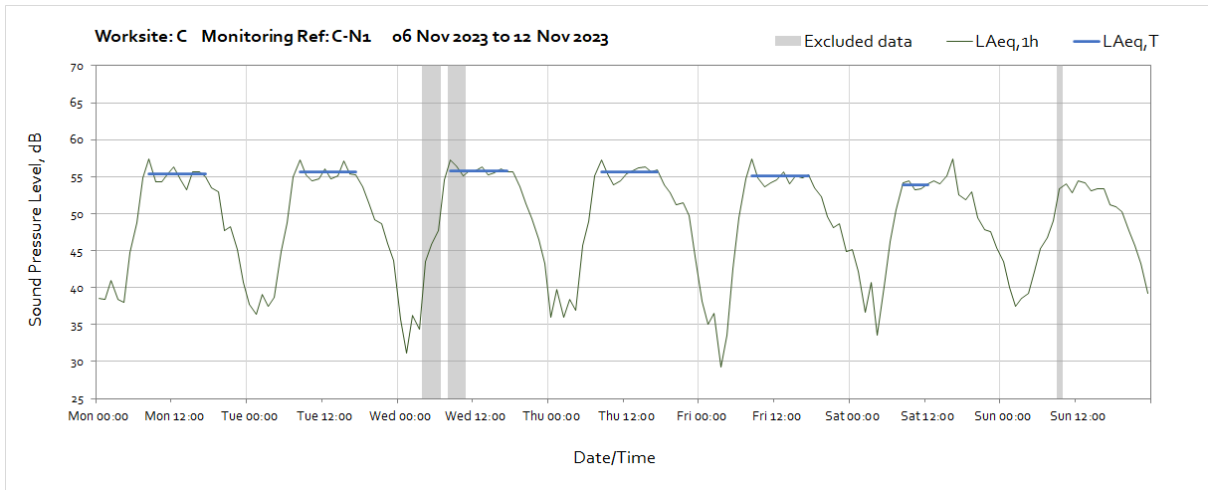
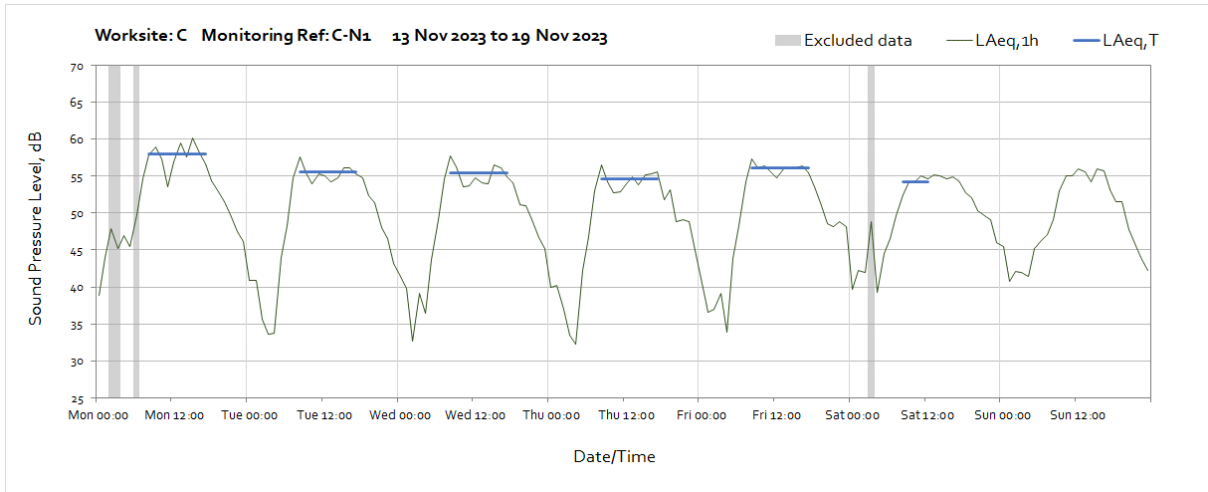
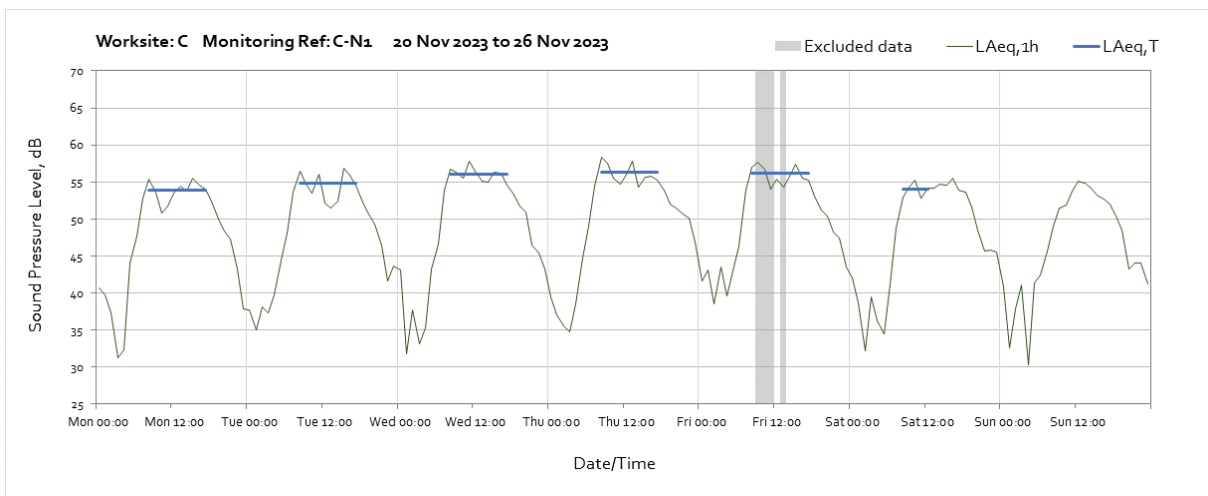
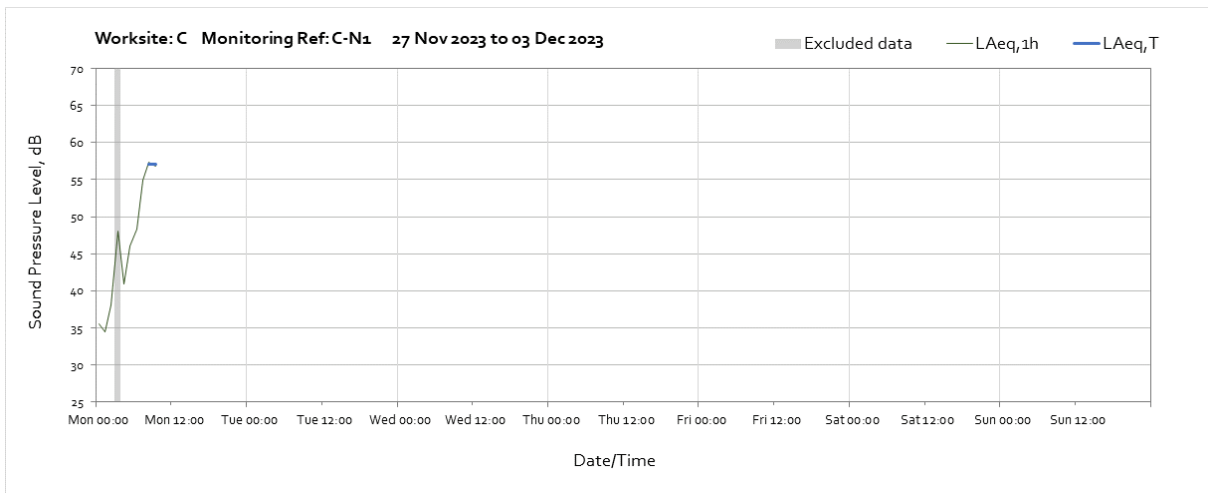
Worksite: C - Monitoring Ref: C-N1

Note: Data is missing from 10:00 on Monday 27th November to the end of the month because, during a field calibration, the monitoring equipment was found to be infested with ants and was thus temporarily removed.

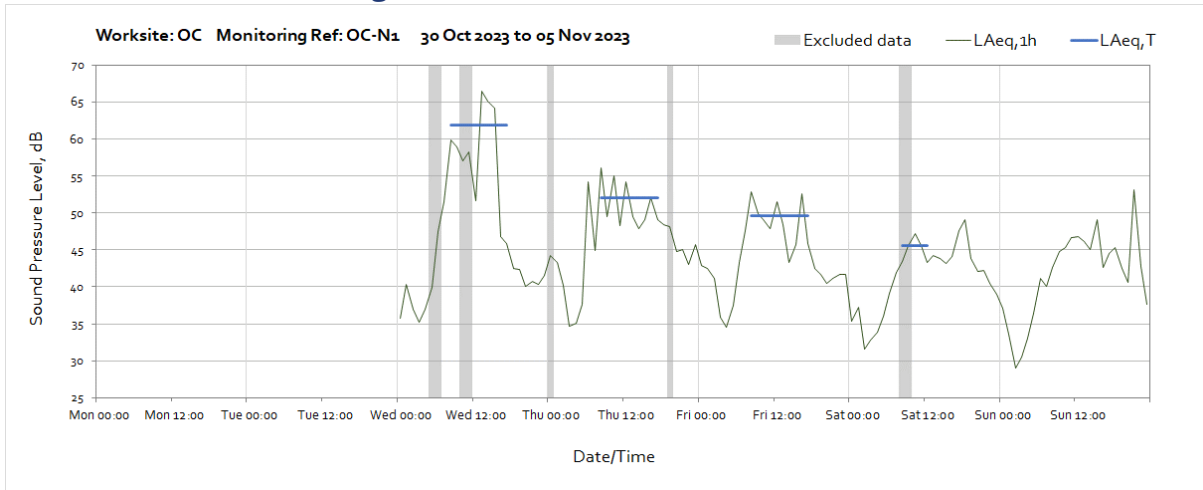
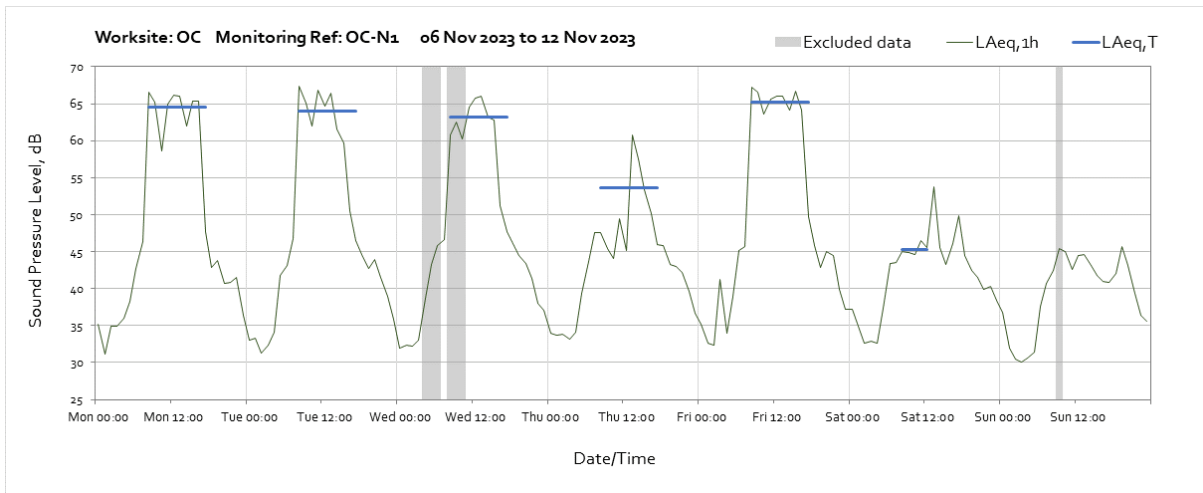
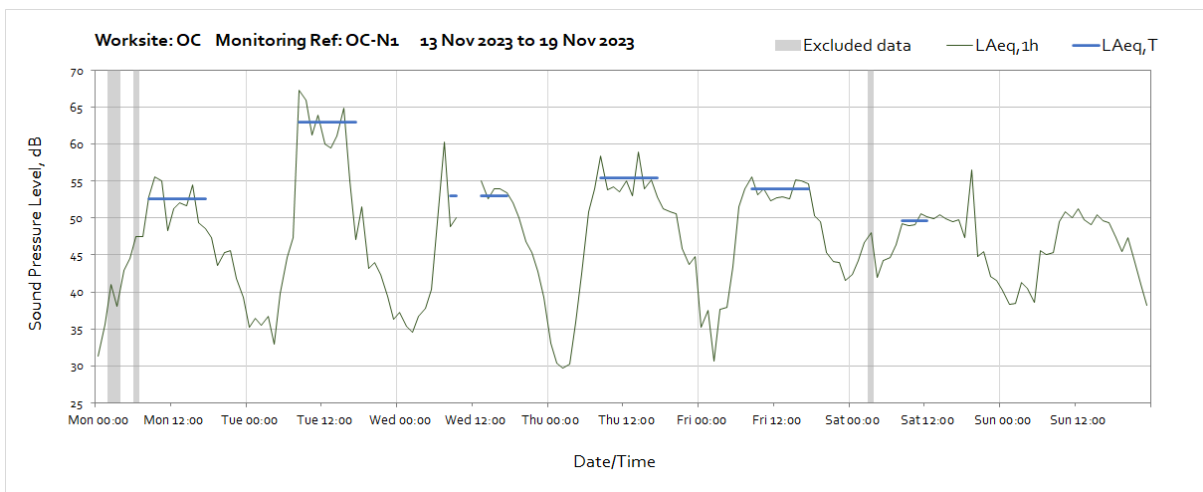
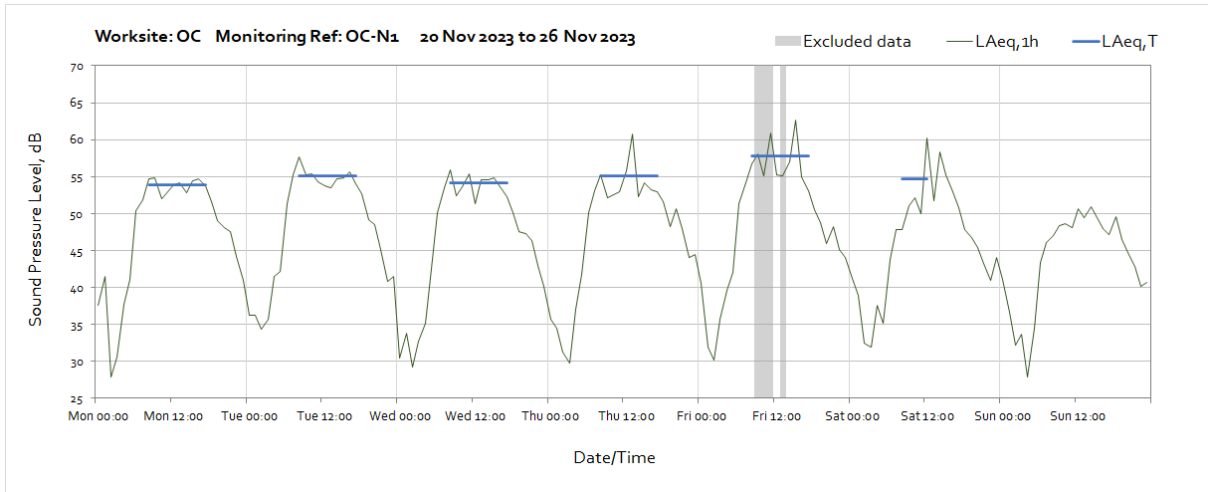
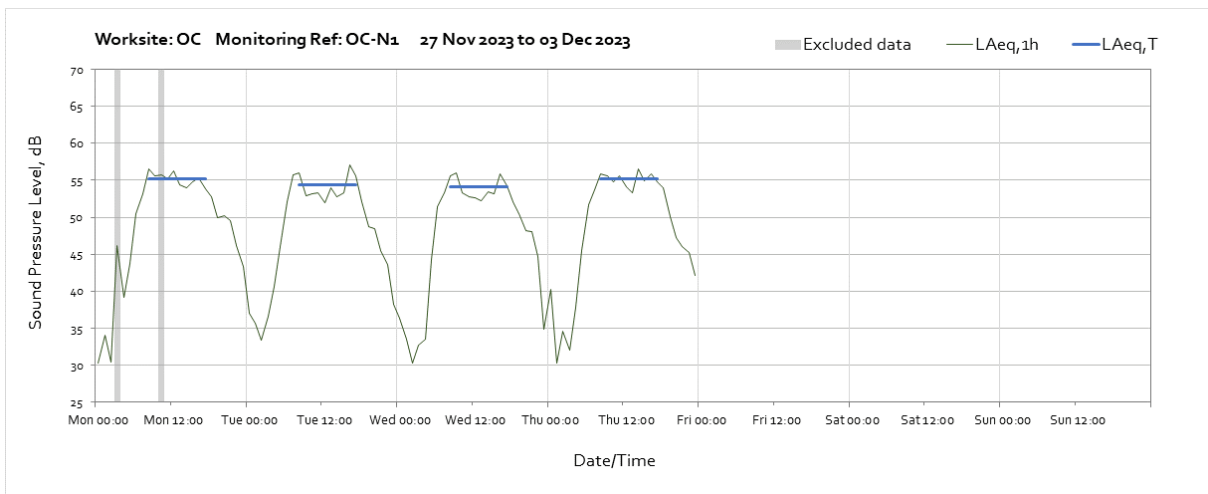
Worksite: OC – Monitoring Ref: OC-N1

Note: Data is missing from 10:00 to 13:00 on Wednesday 15th November because the monitor was moved due to haul road changes.

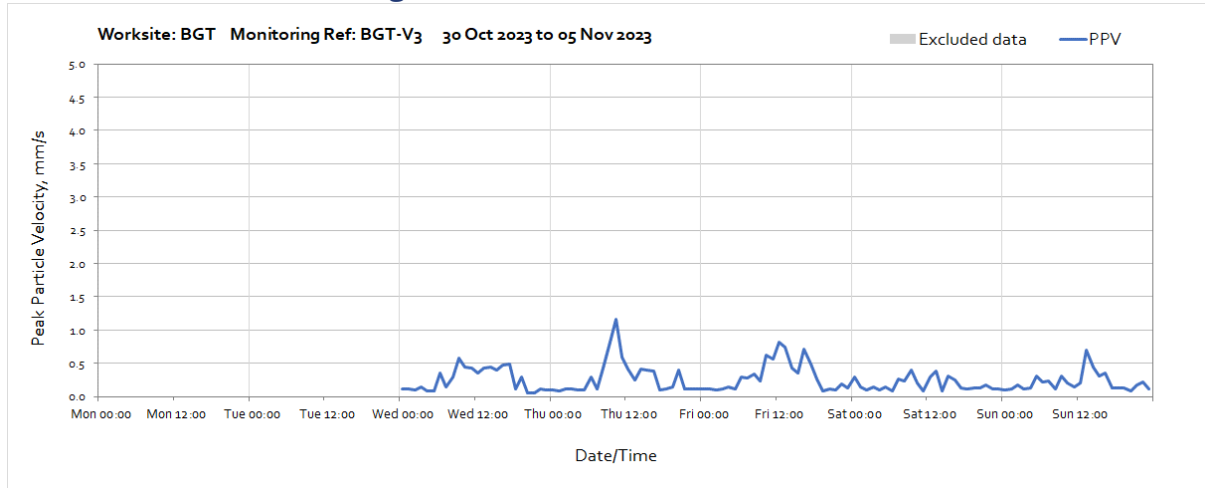
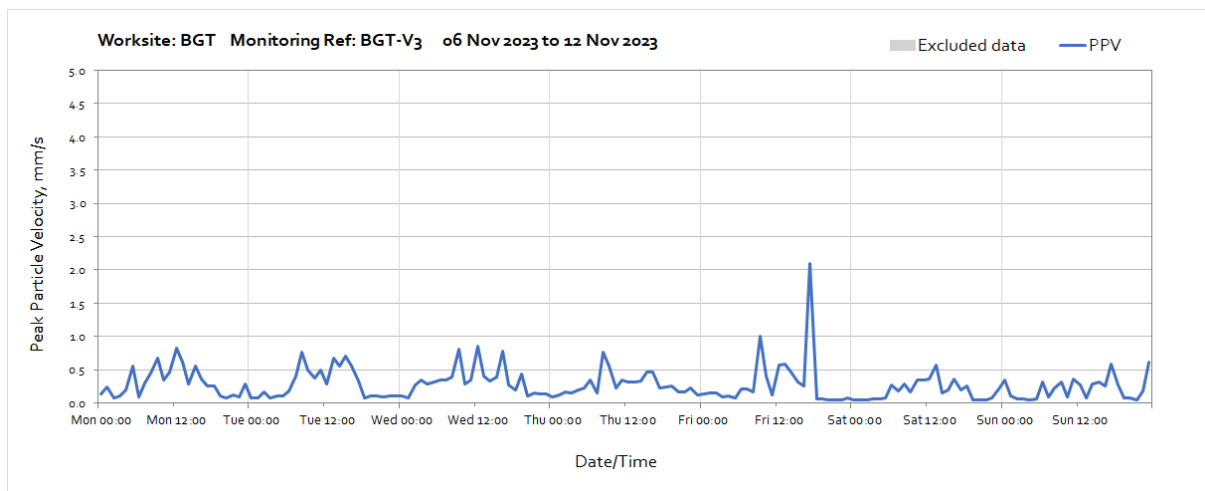
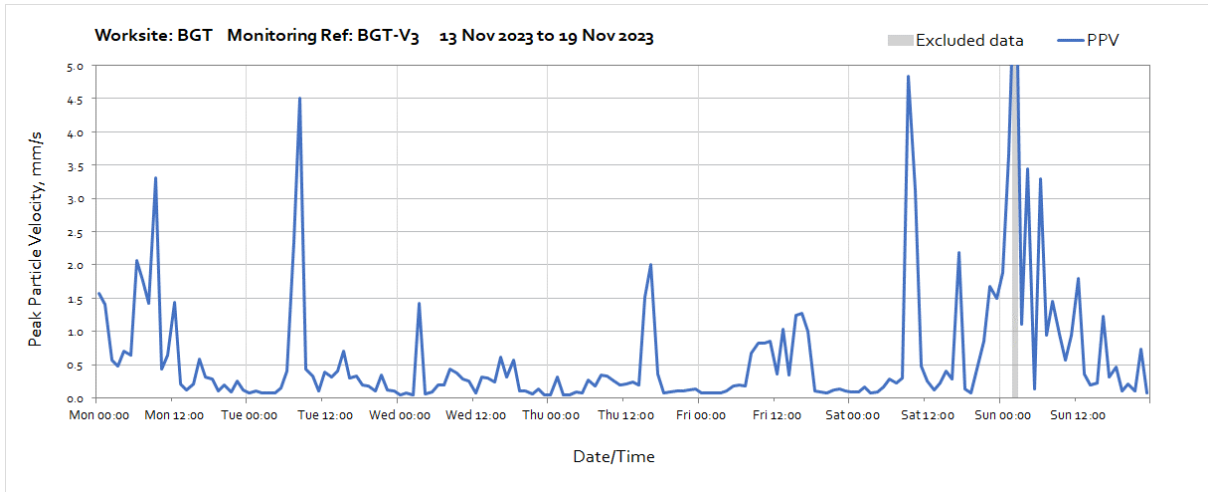
Worksite: BGT - Monitoring Ref: BGT-V3

The following graphs show the hourly measured peak particle velocity PPV recorded during the monitoring period. The graphs show the highest PPV of the three orthogonal axes x, y and z . Periods where PPV values have been affected by local interference with the vibration monitor or only measured for part of the period, which are not representative of HS2 construction works , have been greyed out and excluded when calculating values in Table 4 of the main report.
