Construction Noise and Vibration Monthly Report – November 2023

Warwick District Council

Non-Technical Summary

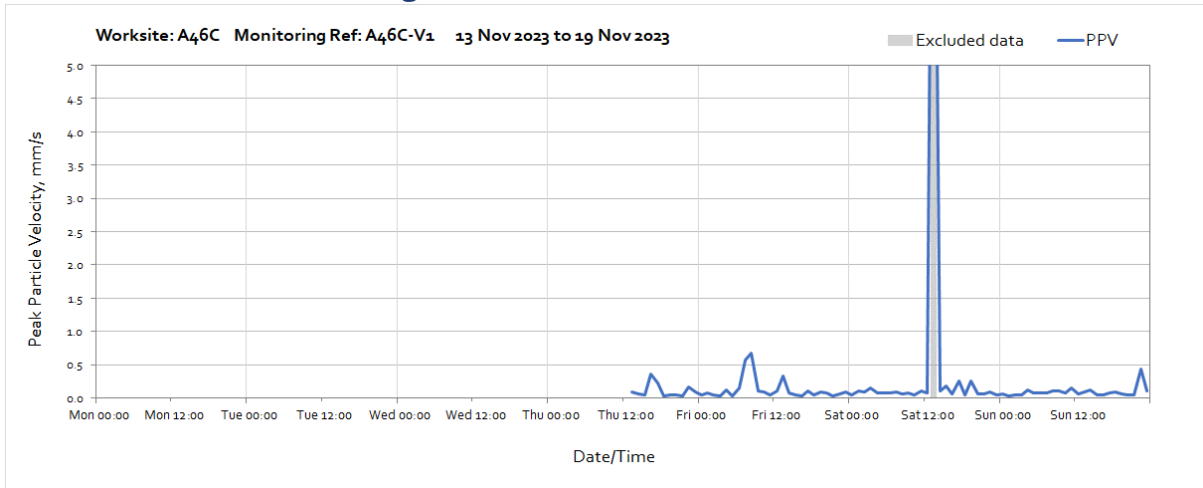
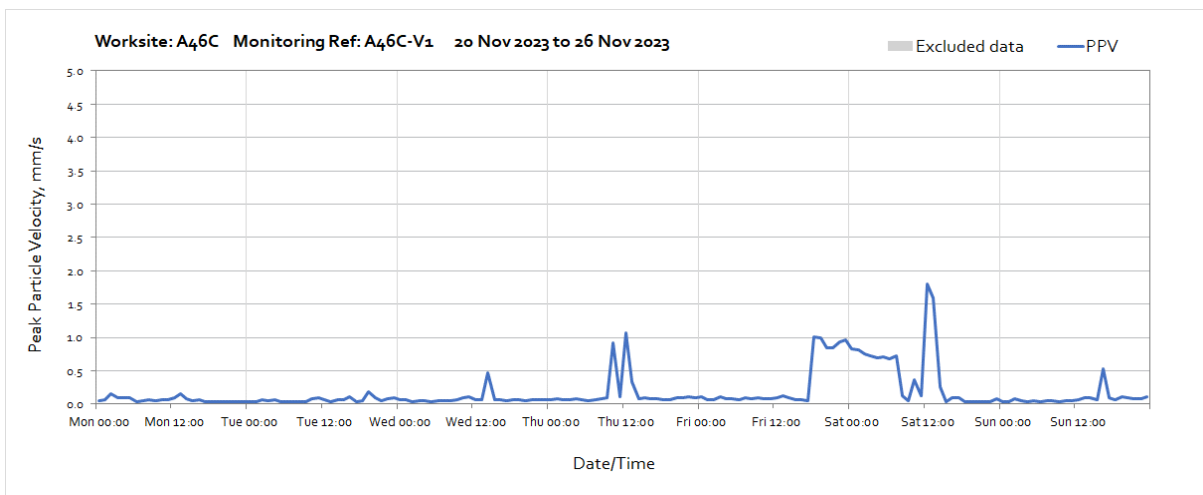
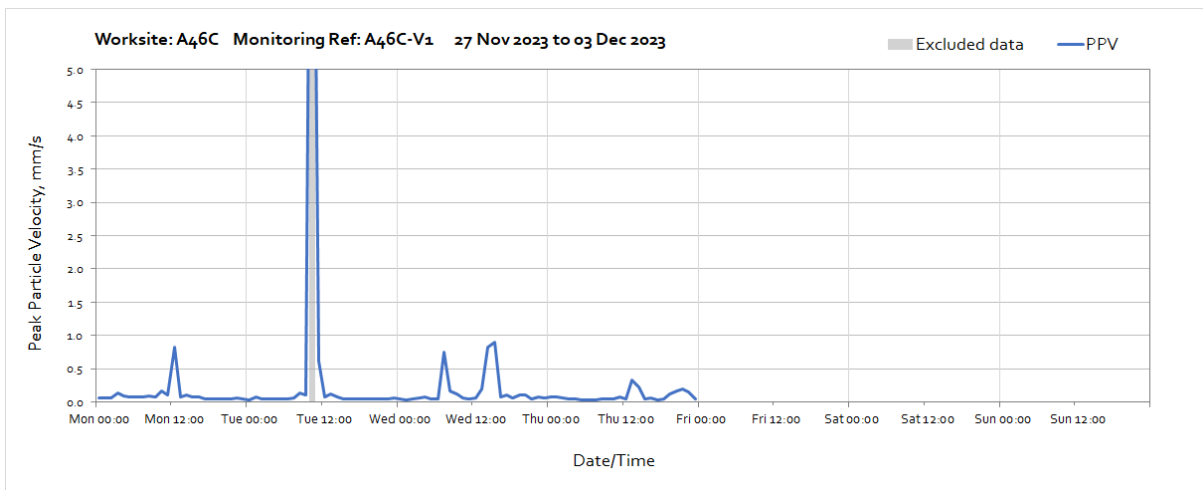
Worksite: A46C – Monitoring Ref: A46C-V1

The following graphs show the hourly measured peak particle velocity PPV recorded during the monitoring period. The graphs show the highest PPV of the three orthogonal axes x, y and z . Periods where PPV values have been affected by local interference with the vibration monitor or only measured for part of the period, which are not representative of HS2 construction works , have been greyed out and excluded when calculating values in Table 4 of the main report.

Note: The monitor started logging at 13:00 on Thursday 16th November 2023.

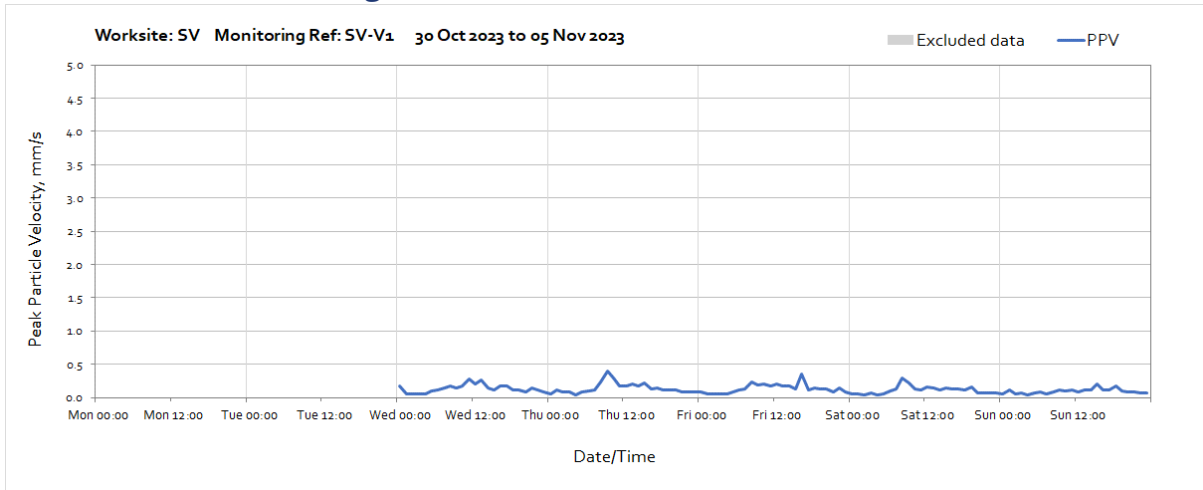
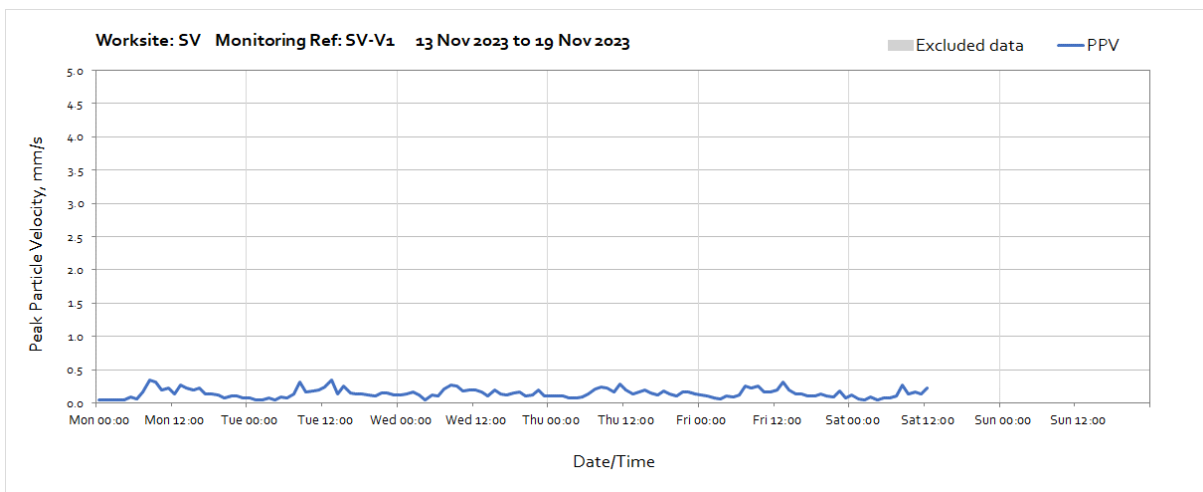
Worksite: SV – Monitoring Ref: SV-V1

Note: The monitor was decommissioned at 13:00 on Saturday 18 November 2023.

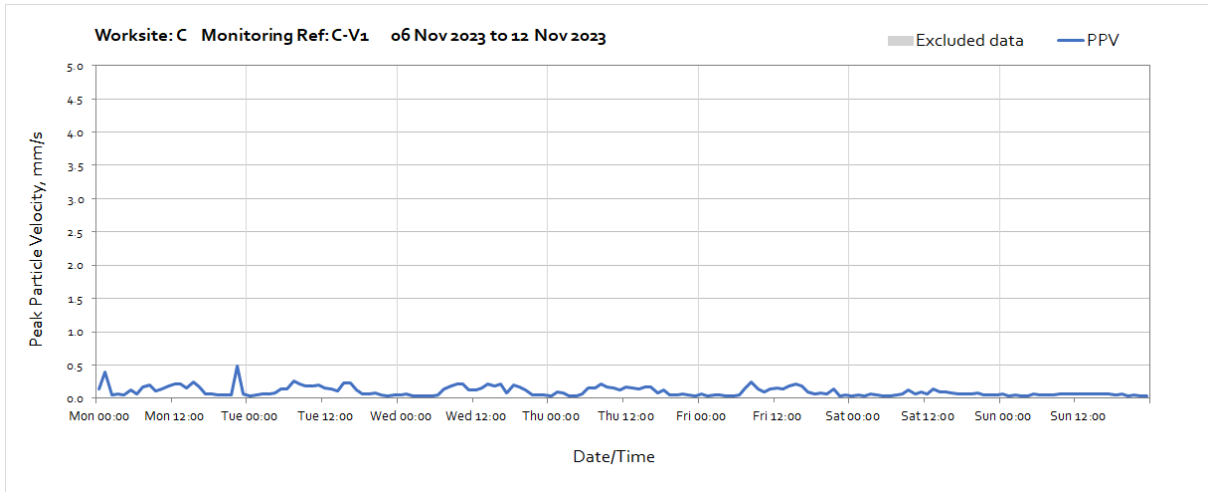
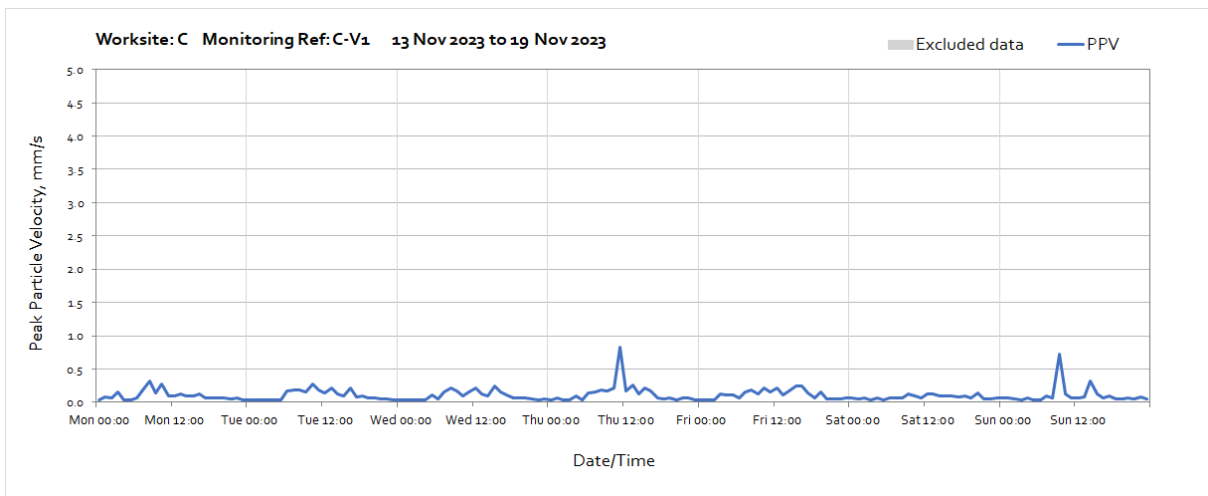
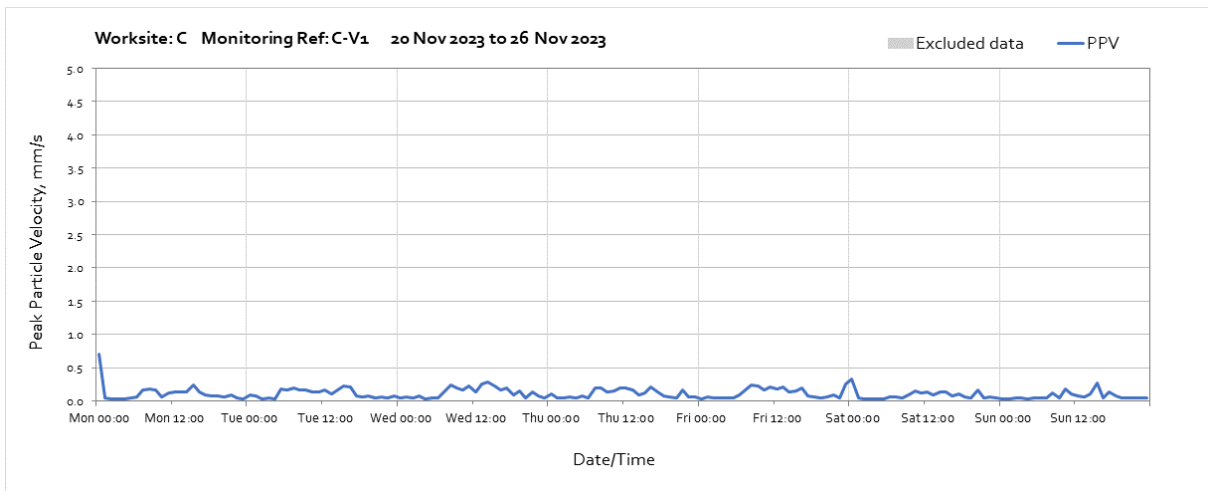
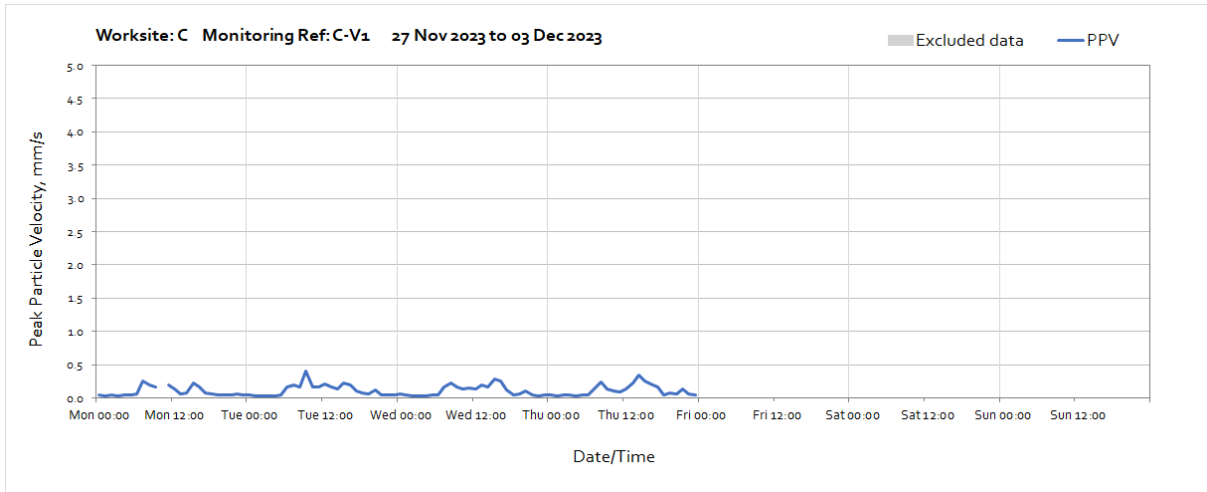
Worksite: C – Monitoring Ref: C-V1

Note: Data for the period 10:00 to 11:00 on Monday 27th November is missing due to field calibration.
