Maw Green Landfill Soils Treatment Facility

Environmental Setting and Installation Design - Addendum 2022

Environmental Permit Variation Application

Document Reference: 5193-CAU-XX-XX-RP-V-0309.A0.C1

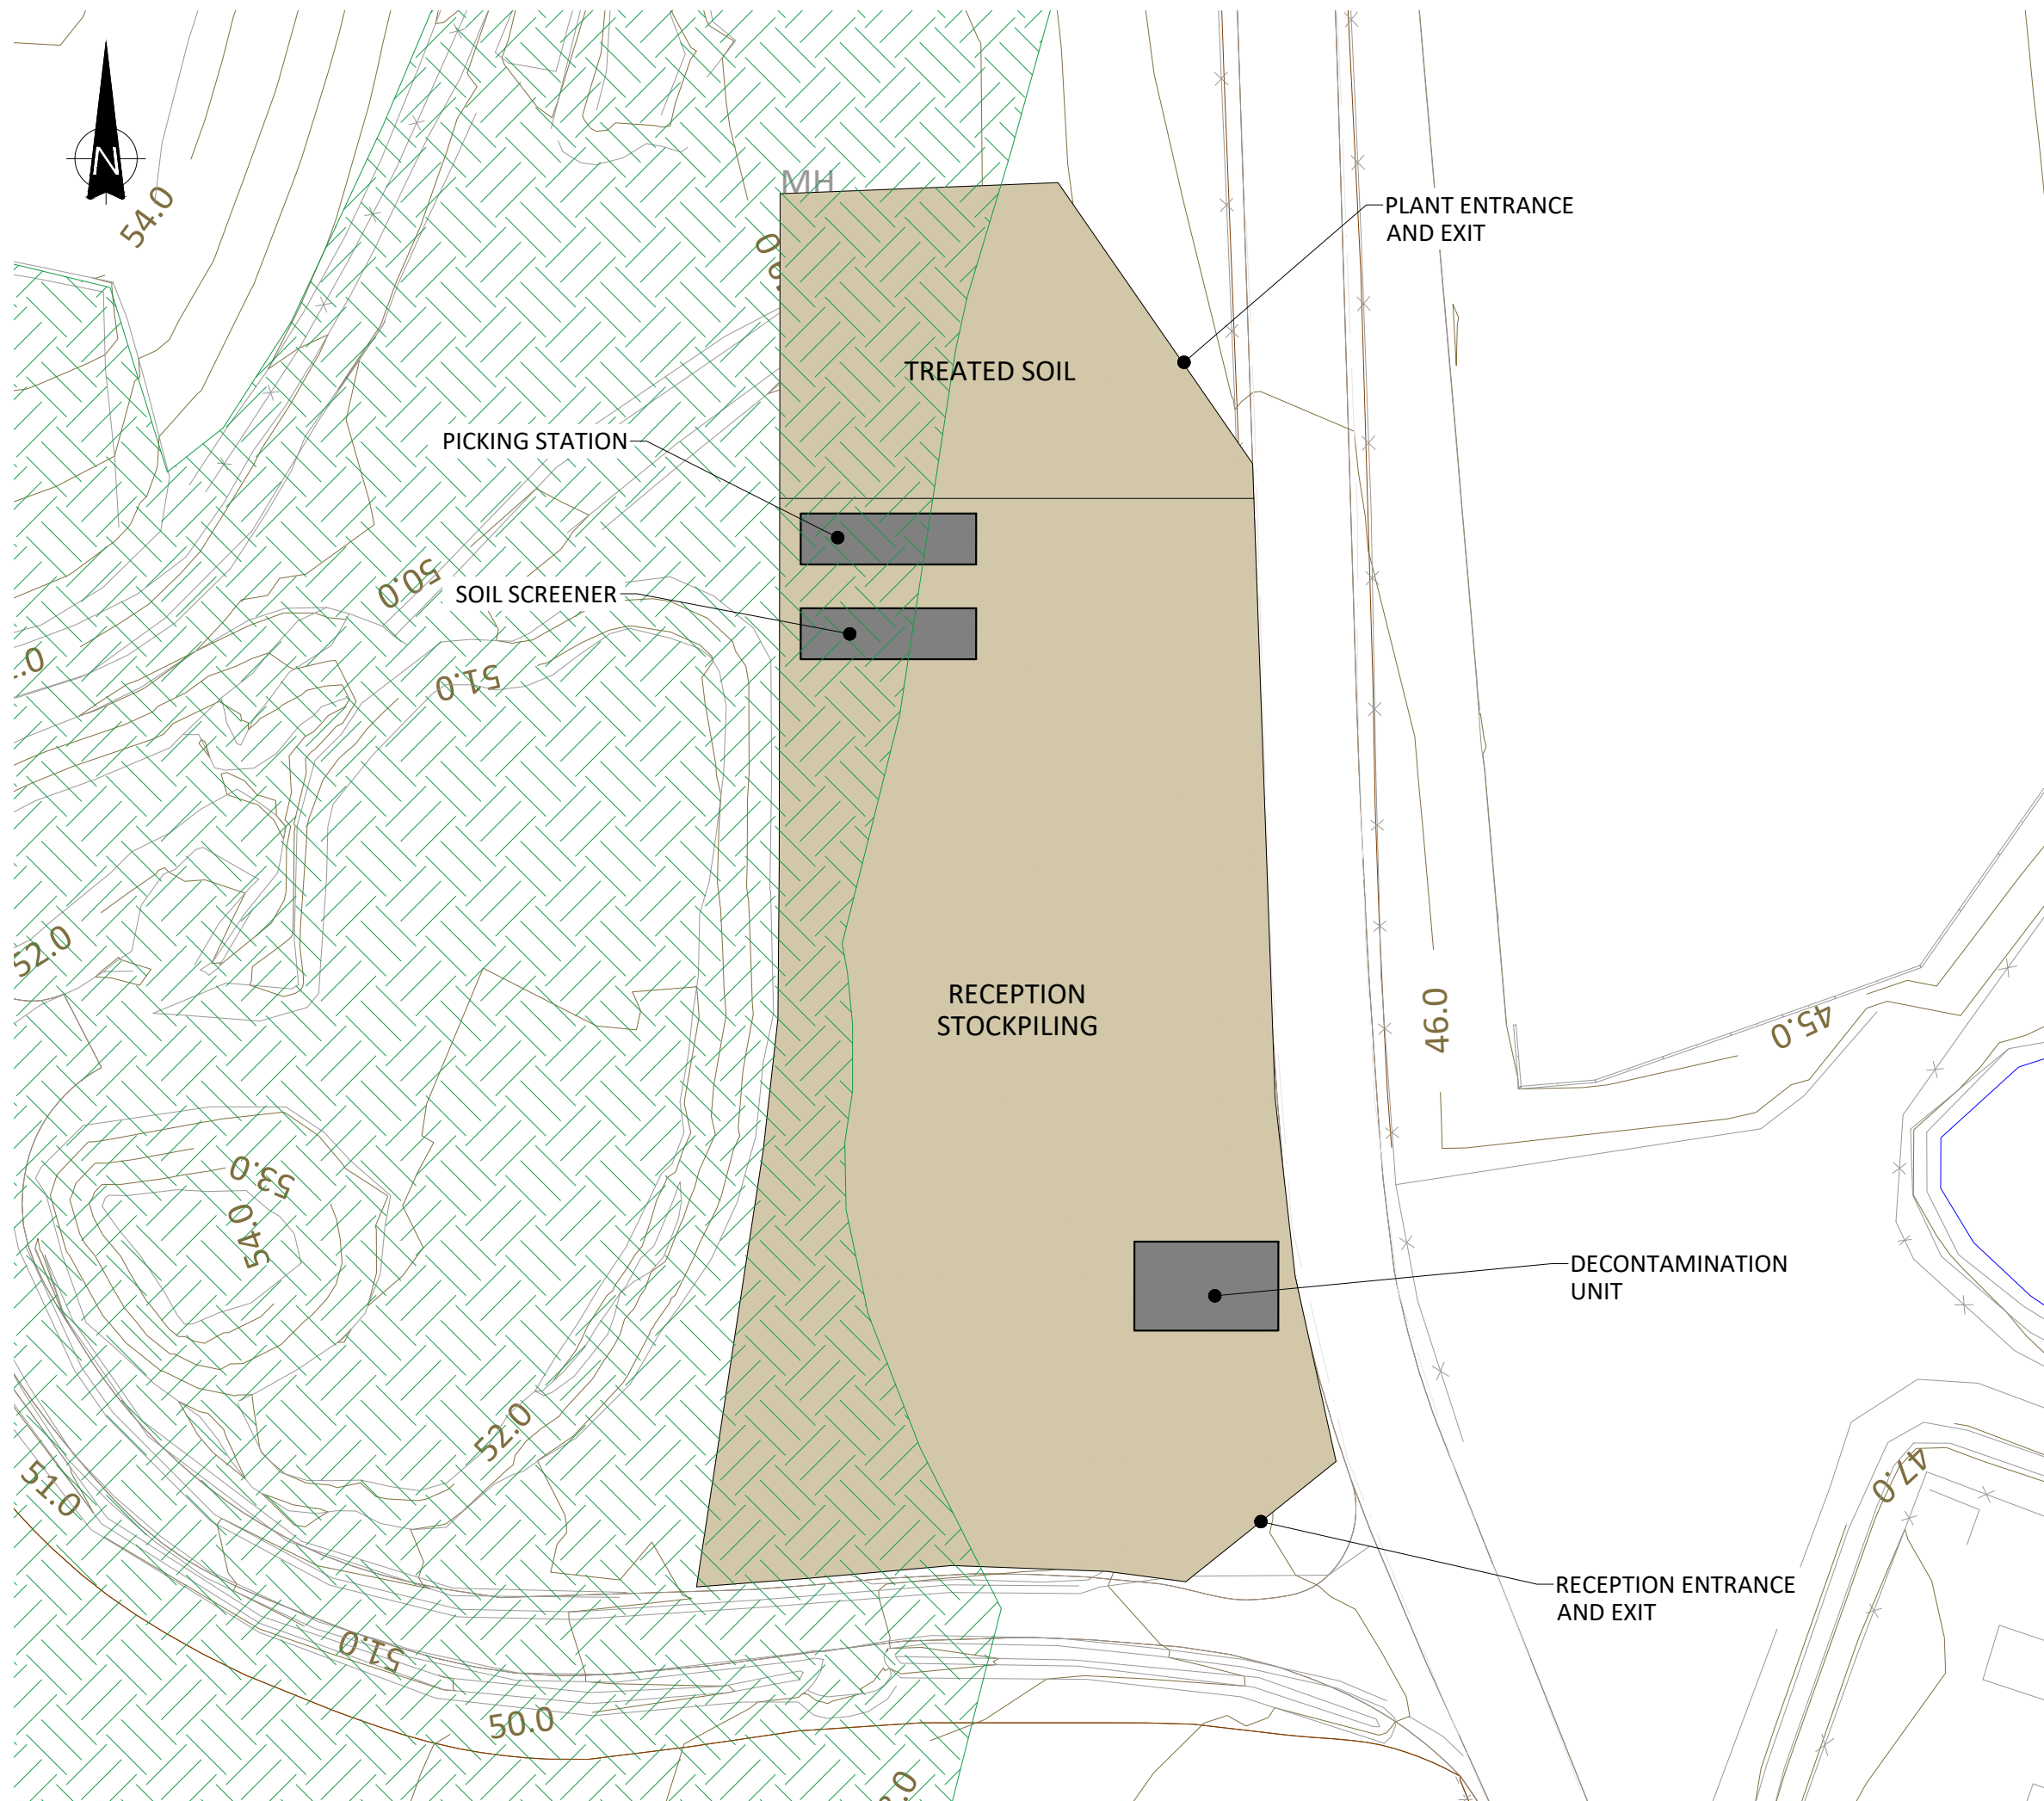
- CRUSHED CONCRETE SITE SURFACING WITH GEO-COMPOSITE CLAY LINER (GCL)
- PERMANENTLY CAPPED LANDFILL

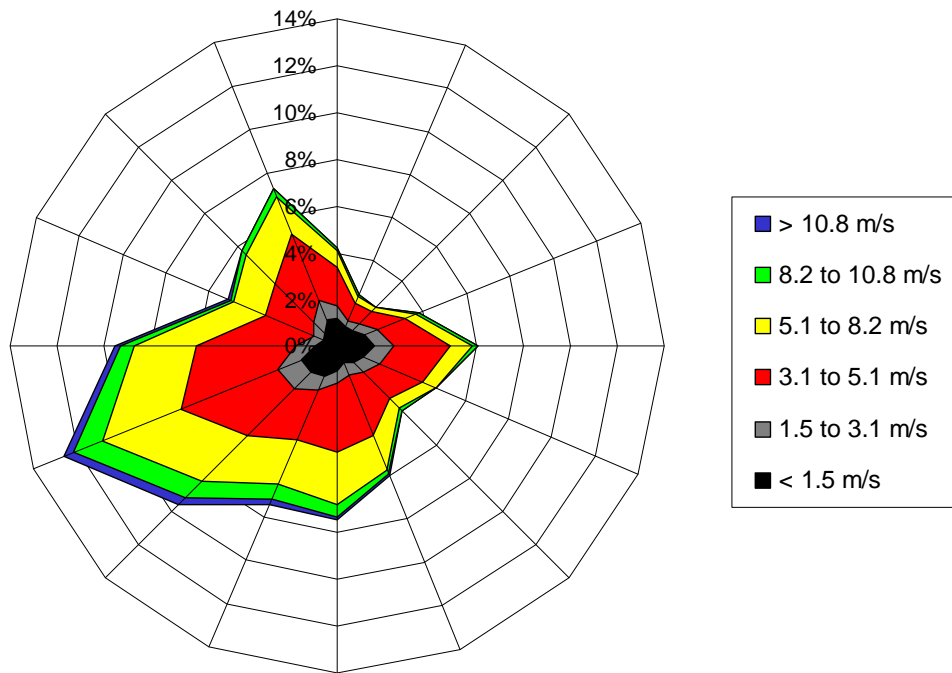
Wind direction and strength information is given within the wind rose below which related to Shawbury weather station which is approximately 37 km south east of the application site.

The wind rose indicates that the predominant wind direction is southerly with approximately 12% of wind coming from this direction. Wind strengths are almost entirely below 10.8m/s.

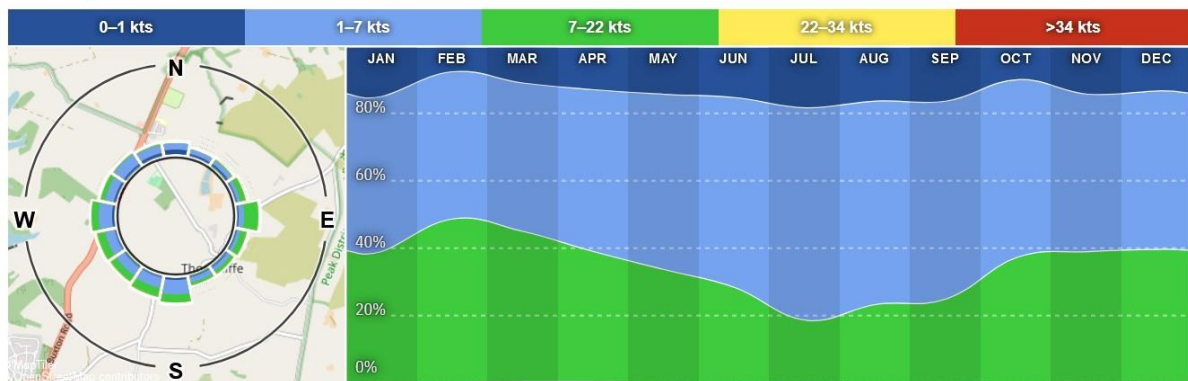
Figure 2 – Leek Thorncliffe – average annual wind direction & strength 2010-2022

3.5.2 A review of the data recorded daily between April 2010 and September 2022 on the Windfinder.com website indicates that the most dominant wind direction is from the south-southwest towards the north-northeast.
