Construction Noise and Vibration Monthly Report – December 2023

London Borough of Ealing

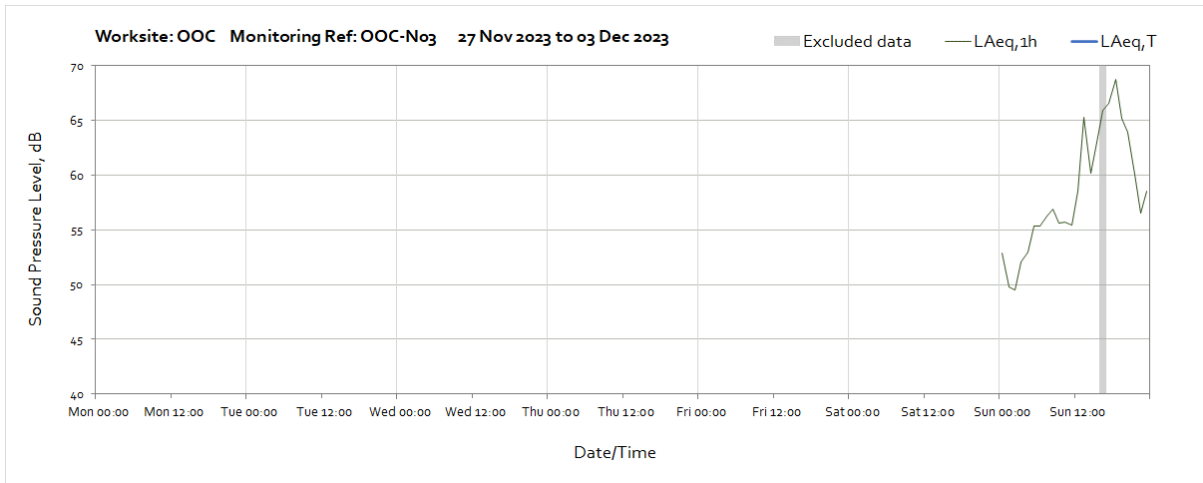
Worksite: OOC – Monitoring Ref: OOC-N03

Note: Missing data between 00:00 on Friday 1st December and 00:00 on Sunday 3rd December were due to a logging error at the monitoring station.
