## Construction Noise and Vibration Monthly Report – December 2023

North Warwickshire Borough Council

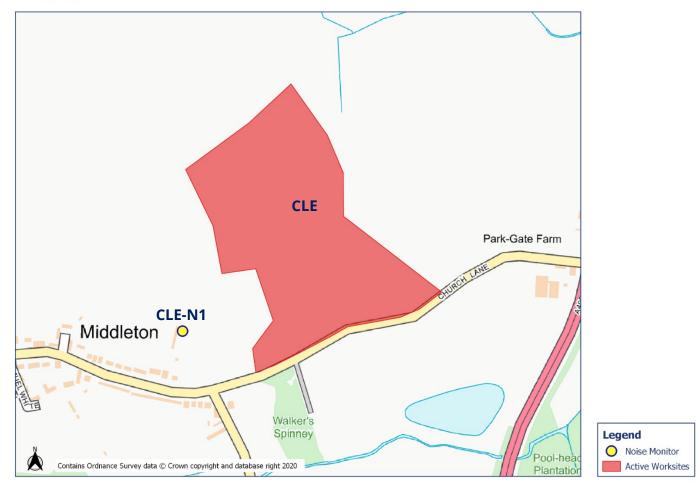
### **HS2** Noise and Vibration Monitoring Plan - 1

- 1.2.1 Sixteen (16) noise monitoring installations and nine (9) vibration monitoring installations were active in December in the NWBC area. Table 2 summarises the position of noise and vibration monitoring installations within the NWBC area in December 2023.
- 1.2.2 Maps showing the position of noise and vibration monitoring installations are presented in Appendix B.

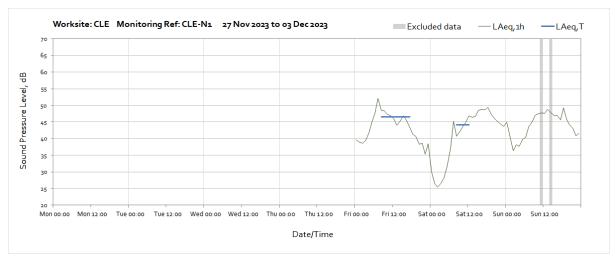
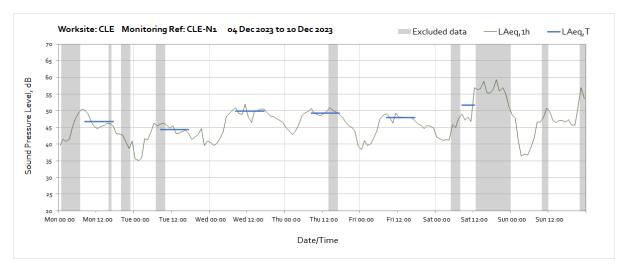
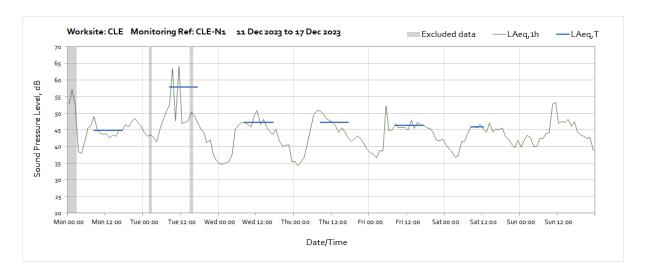
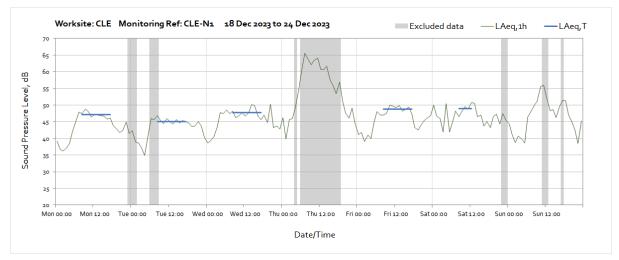
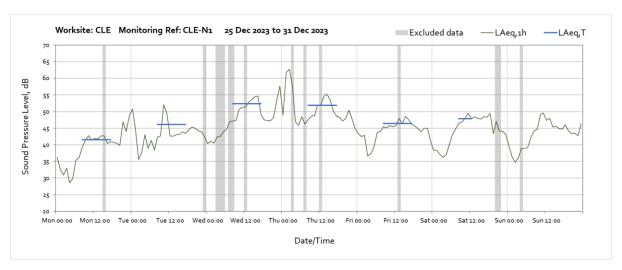
#### Worksite: CLE - Monitoring Ref: CLE-N1

The following graphs show the hourly measured ambient noise level  $L_{Aeq,1h}$  and, where relevant, the averaged noise level  $L_{Aeq,T}$  values, where the time period T is as specified in Table 1 of HS2 Information Paper E23. Periods with adversely weather affected noise levels are greyed out and have been excluded from the calculation of the  $L_{Aeq,T}$  values in Table 3 of the main report.:

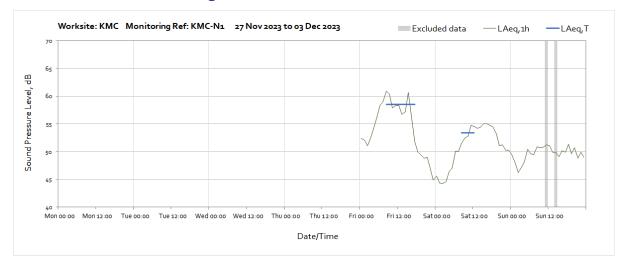
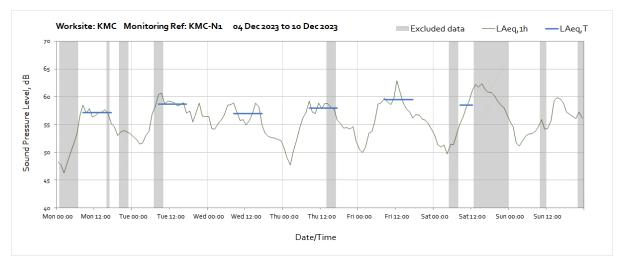
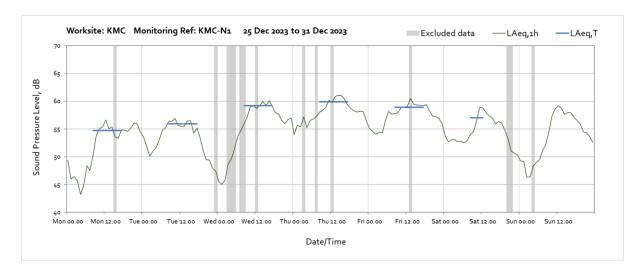
#### Worksite: KMC - Monitoring Ref: KMC-N1

Note: Missing data from 21:00 on Friday 15<sup>th</sup> of December until 11:00 on Wednesday 20<sup>th</sup> of December was due to poor weather conditions effecting the solar power source at the monitoring station.

Note: Missing data throughout the week was due to poor weather conditions effecting the solar power source at the monitoring station.

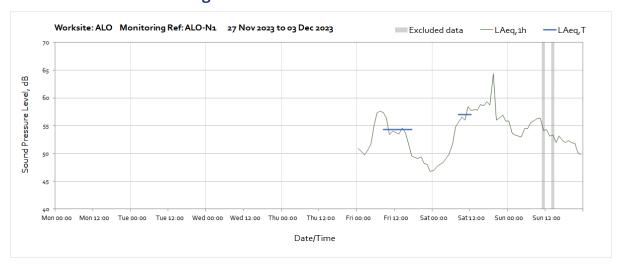
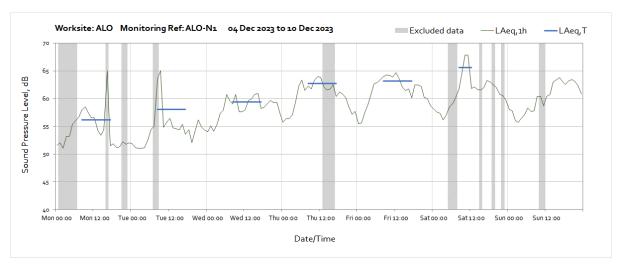
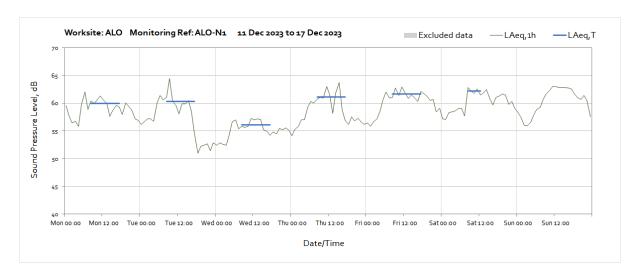
# **Worksite: ALO - Monitoring Ref: ALO-N1**

Note: Missing data from 07:00 on Wednesday 27<sup>th</sup> of December until the end of the month was due to poor weather conditions effecting the solar power source at the monitoring station.

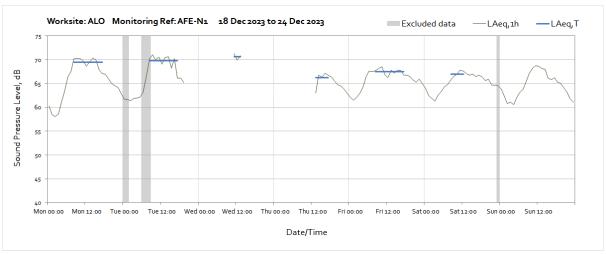
Note: Missing data throughout the week was due to poor weather conditions effecting the solar power source at the monitoring station.

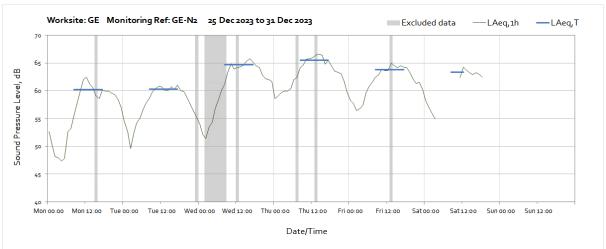
Note: Missing data between 04:00 and 11:00 on Saturday 30<sup>th</sup> of December and from 12:00 on Saturday 30<sup>th</sup> of December until the end of the month was due to poor weather conditions effecting the solar power source at the monitoring station.

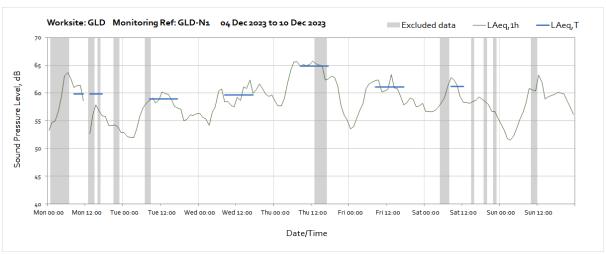
Note: Missing data between 12:00 and 13:00 on Monday  $4^{th}$  of December was due to a local power outage meaning a loss of power at the monitoring station.

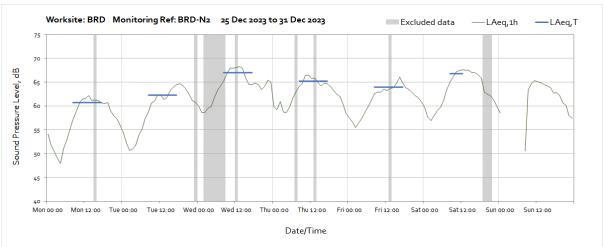
Note: Missing data between 01:00 and 08:00 on Sunday the 31<sup>st</sup> of December was due to poor weather conditions effecting the solar power source at the monitoring station.

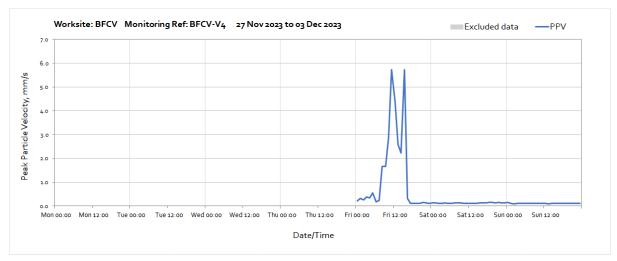
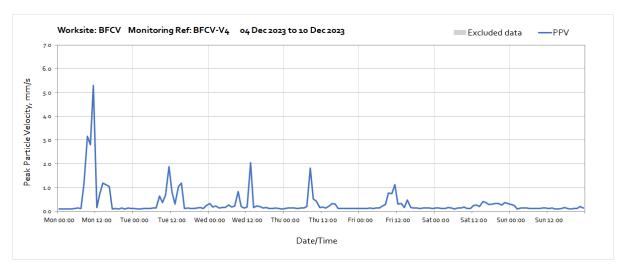
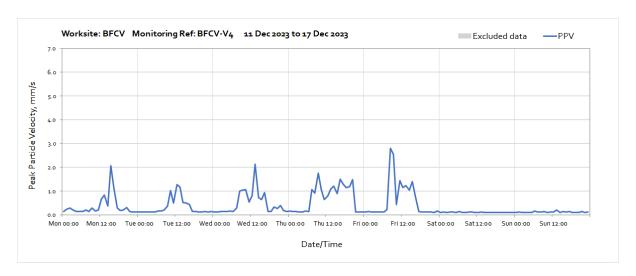
## **Worksite: BFCV - Monitoring Ref: BFCV-V4**

The following graphs show the hourly measured peak particle velocity PPV recorded during the monitoring period. The graphs show the highest PPV of the three orthogonal axes x, y and z. Where high values of PPV were caused by local interference with the vibration monitor, which are not representative of HS2 construction works, these values have been greyed out in the following charts and have been excluded to calculate values in Table 4 of the main report.

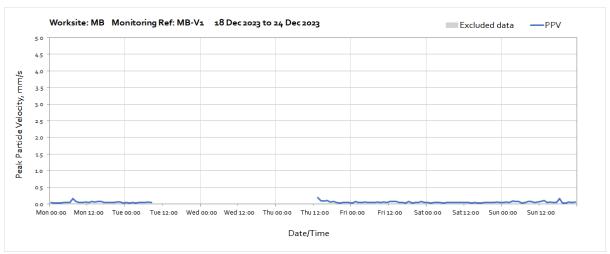
Note: Missing data between 09:00 on Tuesday 19<sup>th</sup> of December and 13:00 on Thursday 21<sup>st</sup> of December was due to poor weather conditions effecting the solar power source at the monitoring station.

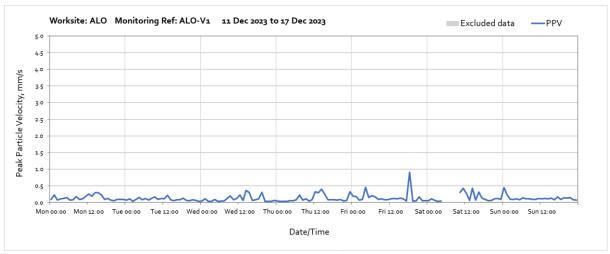
Note: Missing data between 05:00 and 10:00 on Saturday 16<sup>th</sup> of December was due to poor weather conditions effecting the solar power source at the monitoring station.

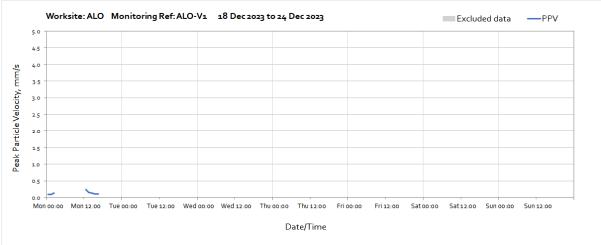
Note: Missing data between 03:00 and 11:00 on Monday 18<sup>th</sup> of December and from 17:00 on Monday 18<sup>th</sup> of December until the end of the month was due to poor weather conditions effecting the solar power source at the monitoring station.

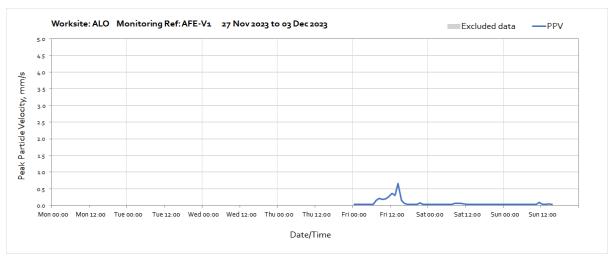
Note: Missing data between 16:00 on Sunday 3<sup>rd</sup> of December and 11:00 on Tuesday 5th of December was due to poor weather conditions effecting the solar power source at the monitoring station.

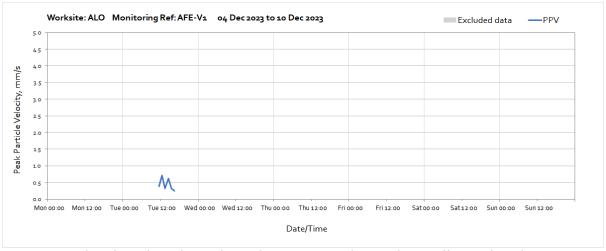
Note: Missing data throughout the week was due to poor weather conditions effecting the solar power source at the monitoring station.

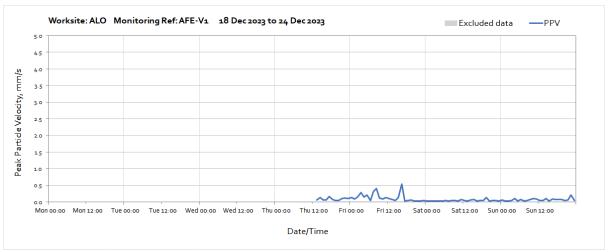
Note: Missing data between 17:00 on Tuesday 5<sup>th</sup> of December and 13:00 on Thursday 21<sup>st</sup> of December was due to poor weather conditions effecting the solar power source at the monitoring station.
