Daneshill Soils Treatment Facility

Environmental Setting and Installation Design Site Report Addendum

Environmental Permit Variation Application

Document Reference: 3982-CAU-XX-XX-RP-V-0304-A0.C1

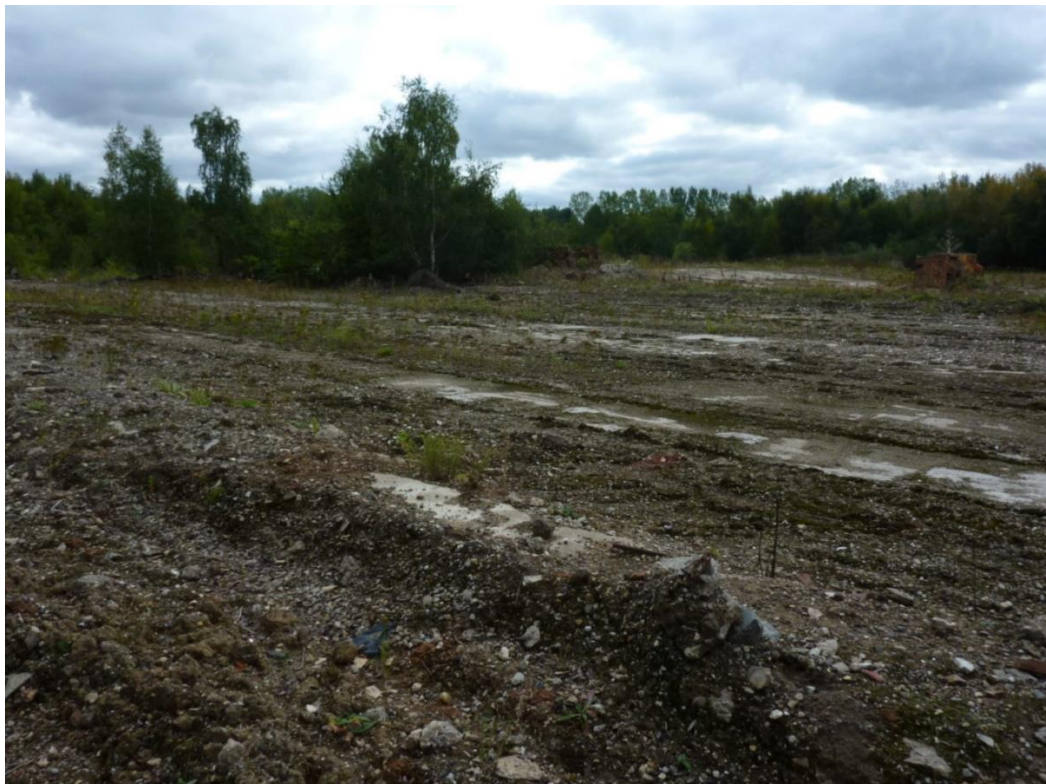
Figure 2 area of concrete pad looking to the north west

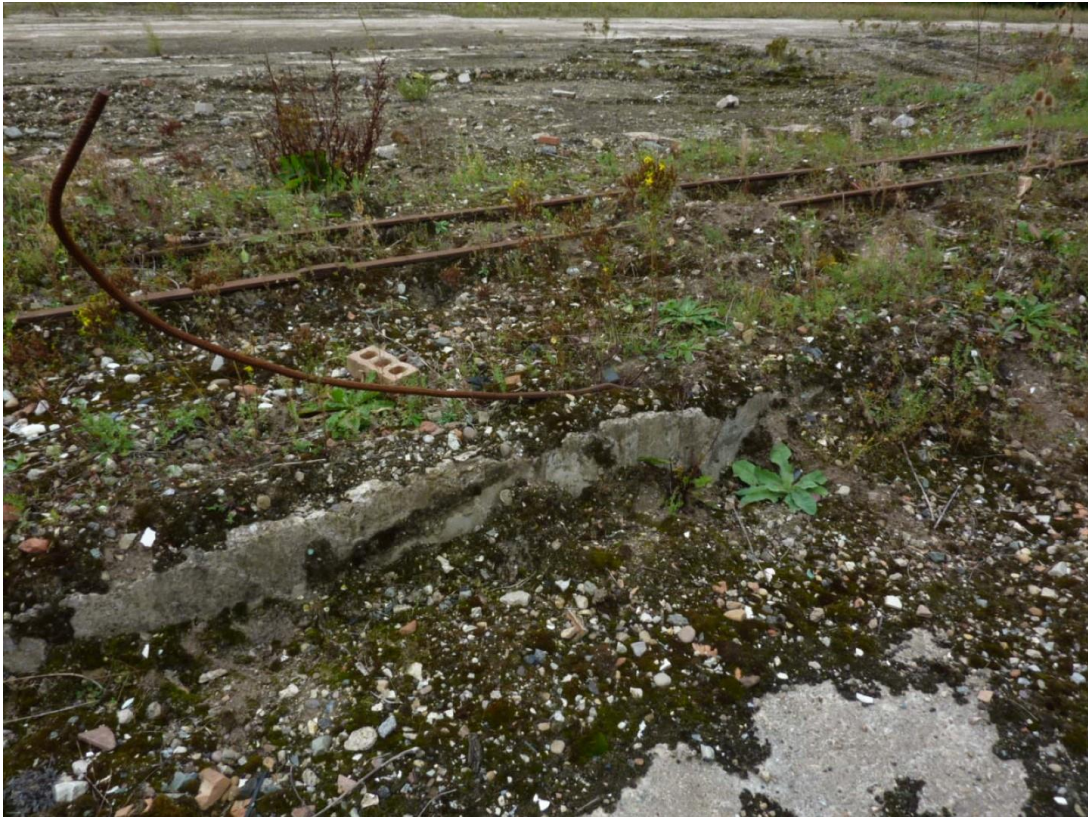
- The site was previously used as a Royal Ordnance ammunitions factory, evidence of a small rail/tram line still exists (as shown in the site photos) as well as foundations from previous structures. The site area was reported to have more recently been used as storage for WEEE, inert soils processing, composting of green waste.

Figure 3 closer inspection of concrete pad with disused rail line

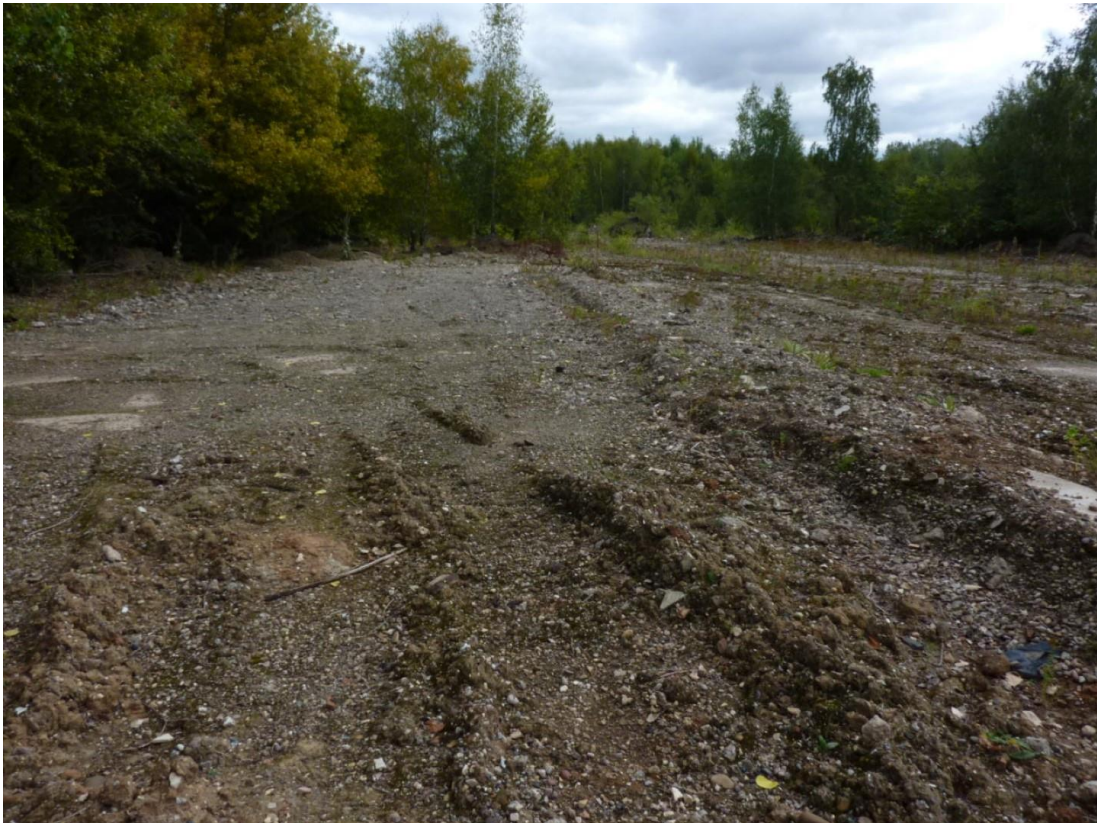
- 1.1.3 A summary of the observations are presented below:
- The condition and permeability of the existing concrete surfacing could not be determined due to the quantity of soils covering concrete surface. However, there was evidence of cracking/breakage across the surface. Evidence from the photographs detailed below shows a mixture of soils and stones across the majority of the surface.

Figure 4 Existing site surface at proposed STF area
