## Daneshill Soils Treatment Facility

## Environmental Setting and Installation Design Site Report Addendum

### Environmental Permit Variation Application

**Document Reference:** 3982-CAU-XX-XX-RP-V-0304-A0.C1

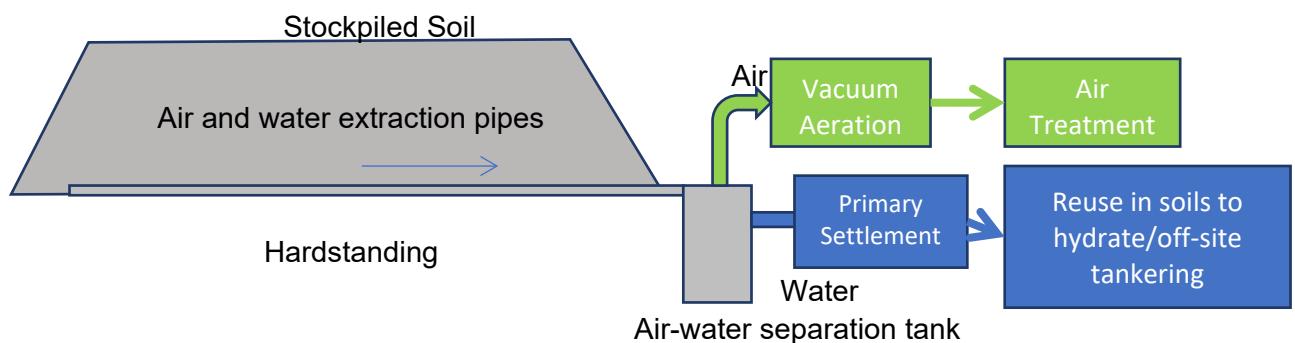
**Figure 1: Bioremediation process proposed at Daneshill Soils Treatment Facility**

- 4.2.2 The proposed bioremediation process will utilise industry standard biopile technology and will operate through means of use of biopiles and moisture control, addition of suitable amendments to the soil, forced air extraction to encourage micro-organism growth and breakdown of hydrocarbons into by products such as carbon dioxide and water vapour. The process is detailed in Figure 1 below.

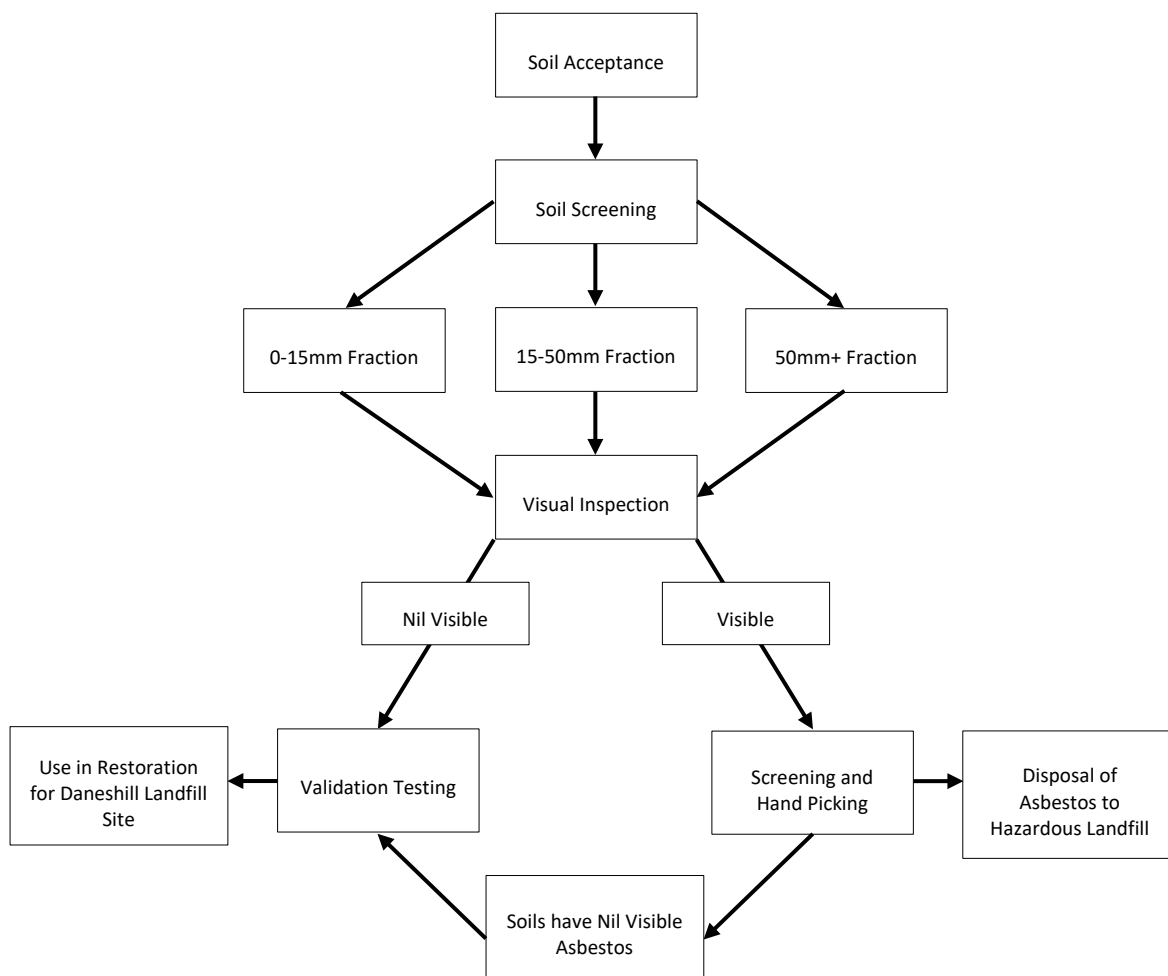
**Figure 2: Overall Soil Treatment process at Daneshill Landfill Site**

4.2.8 The approach is to accept hazardous asbestos impacted soils which can be treated and recovered to soils of a non-hazardous classification. Asbestos containing soils will undergo a number of pre-acceptance conditions, the overall soil treatment approach is detailed in Figure 2 below.

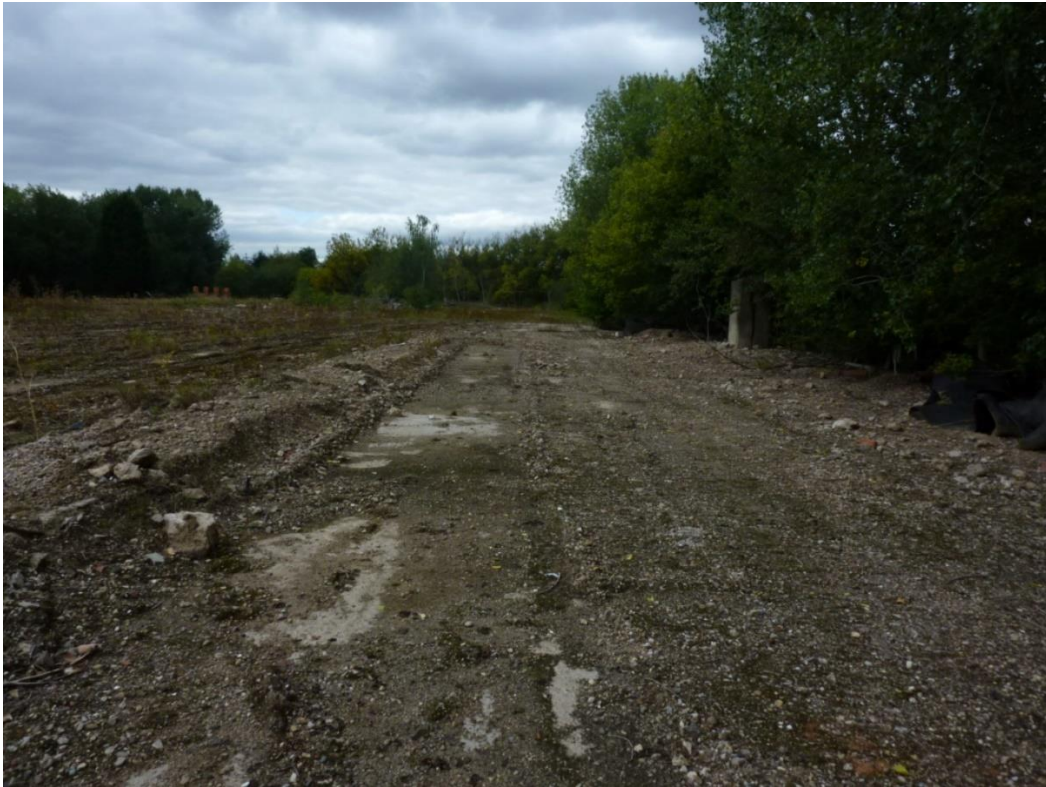
**Figure 1 area of proposed STF operations existing concrete conditions**

- 1.1.3 A summary of the observations are presented below:
- The condition and permeability of the existing concrete surfacing could not be determined due to the quantity of soils covering concrete surface. However, there was evidence of cracking/breakage across the surface. Evidence from the photographs detailed below shows a mixture of soils and stones across the majority of the surface.

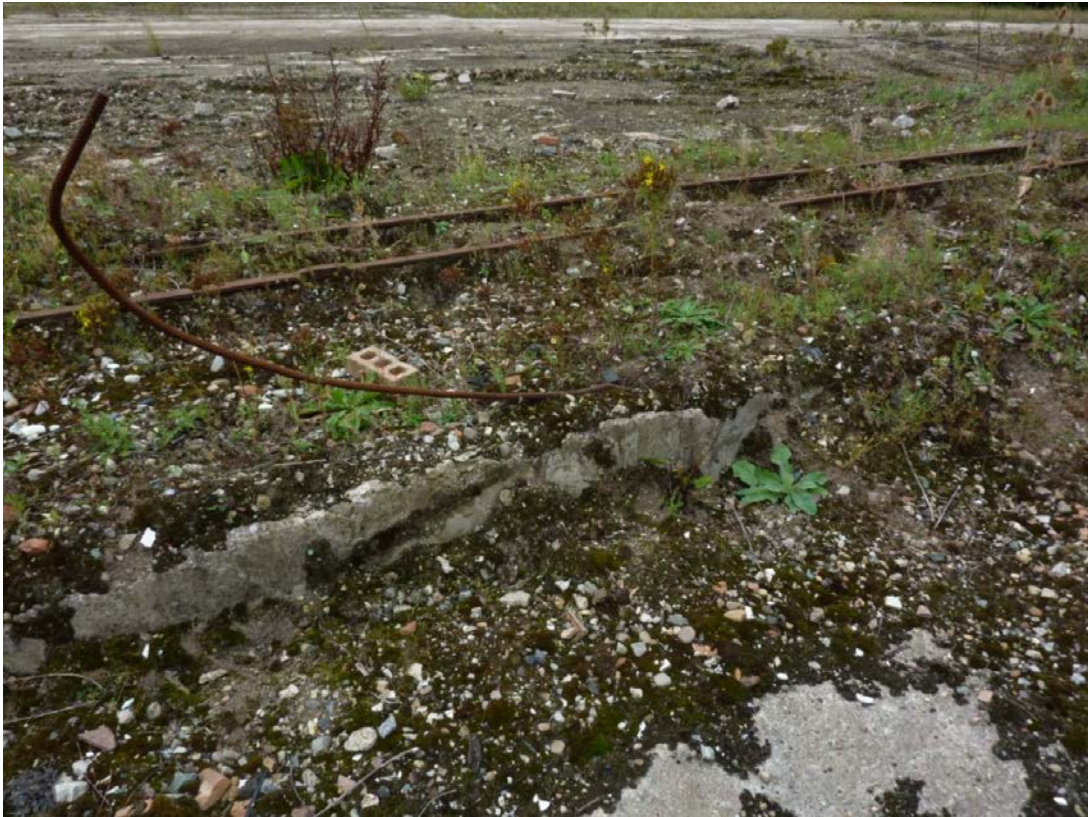
**Figure 3 closer inspection of concrete pad with disused rail line**

- The site was previously used as a Royal Ordnance ammunitions factory, evidence of a small rail/tram line still exists (as shown in the site photos) as well as foundations from previous structures. The site area was reported to have more recently been used as storage for WEEE, inert soils processing, composting of green waste.

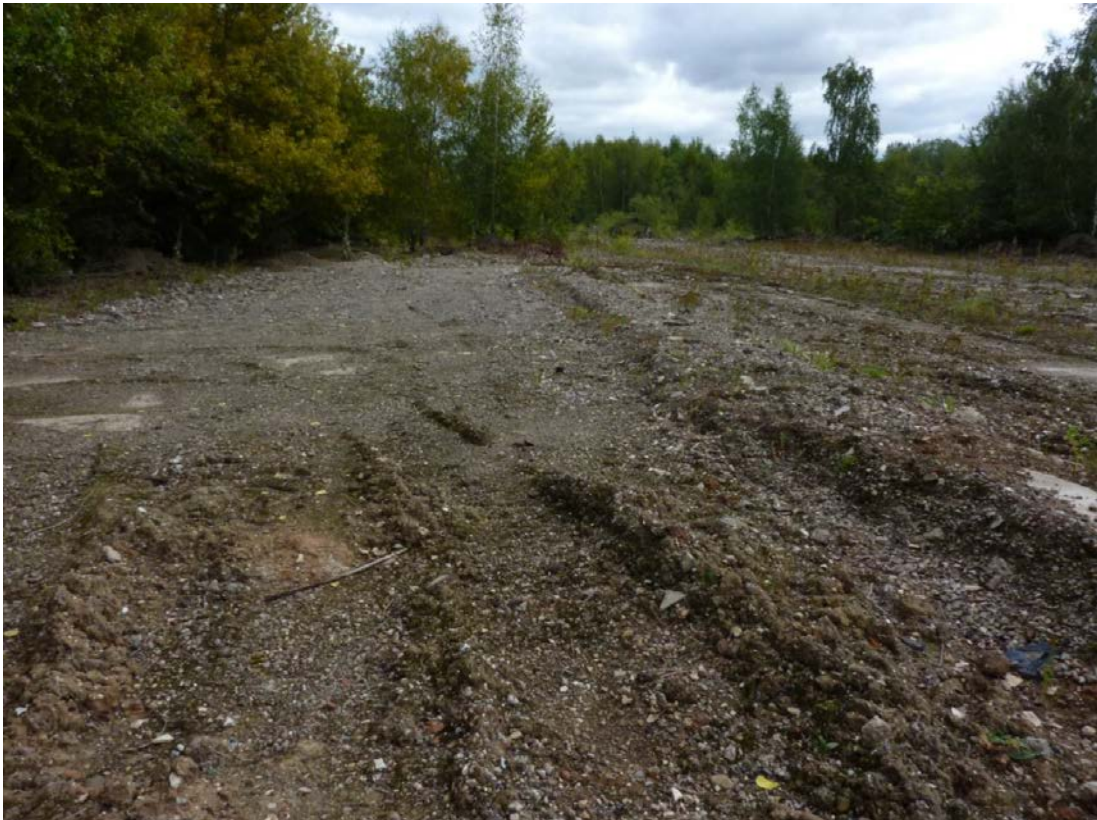
**Figure 4 Existing site surface at proposed STF area**

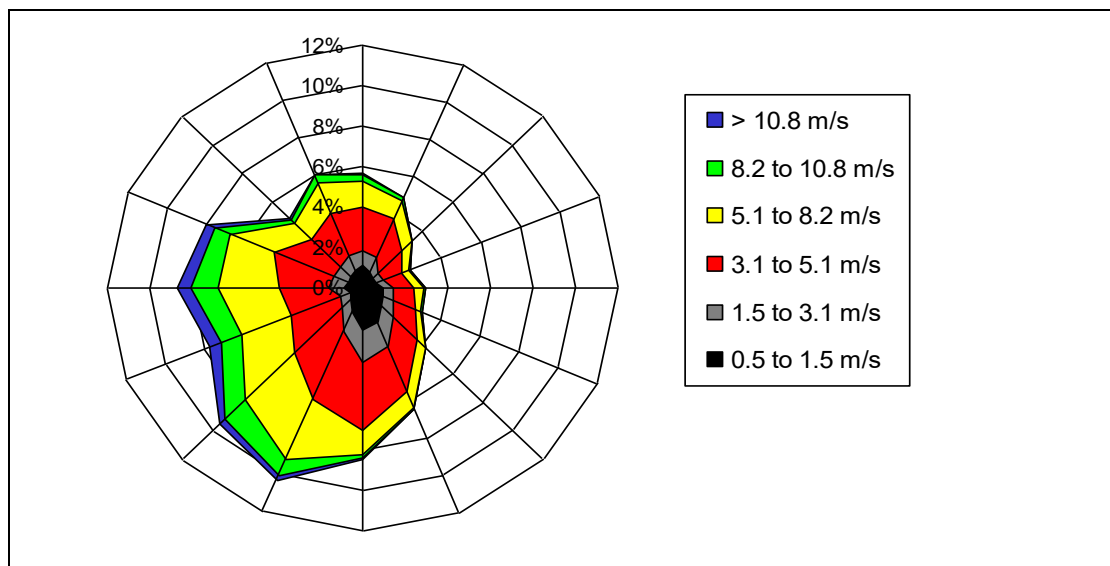
With regards to local wind speed and direction, data has been obtained from the observing station at Finningley, for the period 1990 to 1994 inclusive. The wind speed and direction data recorded at this observing station are appropriate for characterising the wind climate at Daneshill Landfill. Wind speed and direction data for the observing station are presented as a wind rose below.

The predominant wind direction is from the west-north-west and west-south-west, winds from between these two directions occurring for 59.9% of the time. The south-west direction alone accounts for 14.8% of the wind, the single largest sector. Winds from the north-north-west also occur relatively frequently at 7.6% of the time. Wind directions from the north-east and south-east sectors occur relatively infrequently. Calm conditions (i.e. wind speeds of less than 2.1m/s) occur for approximately 2.4% of the time.
