Daneshill Soils Treatment Facility

Emissions Management Plan

Document Reference: 3982-CAU-XX-XX-RP-V-0307.A0-C3

Project Title: Environmental Permit Variation

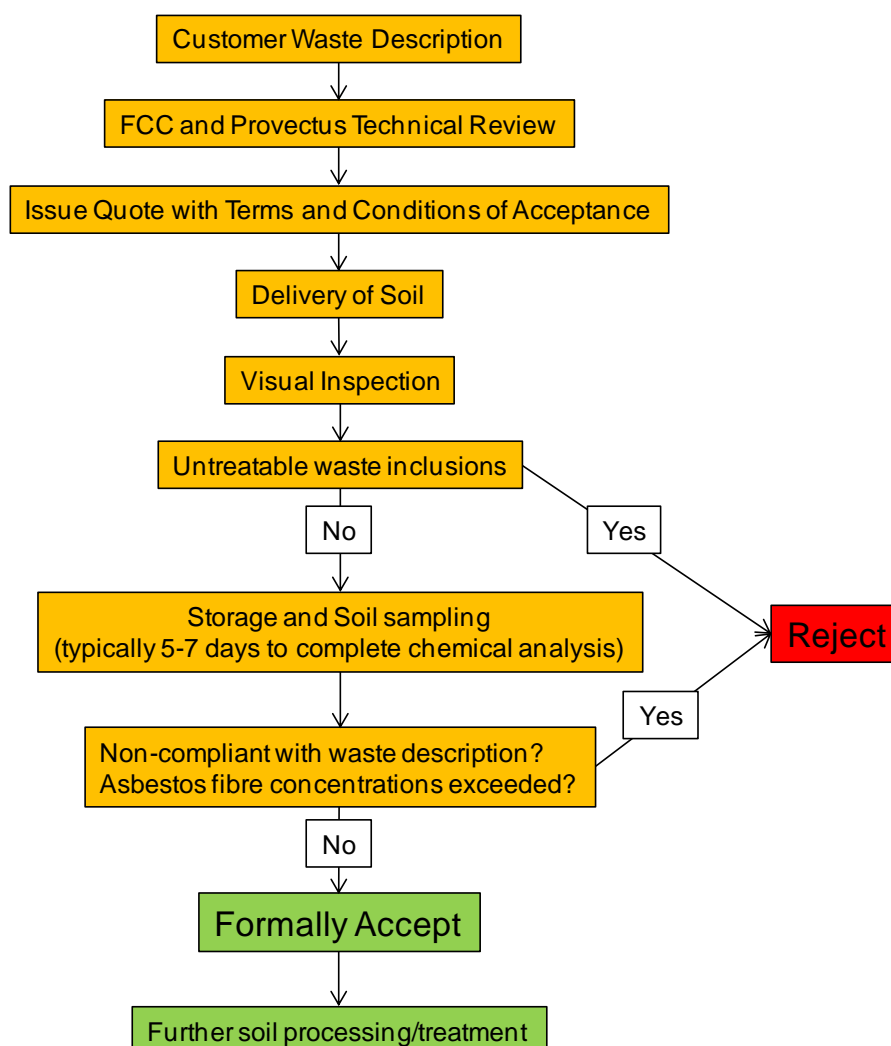
Figure 1: Summary of Waste Acceptance Procedures – Asbestos containing wastes

- 7.1.8 Soil with asbestos will be consigned by contractors and haulier as 17 05 03* ‘soils and stones containing hazardous substances’ or 17 06 05* ‘other construction materials containing asbestos’. All asbestos containing wastes will undergo visual inspection and chemical analysis to ensure that any soils that are formally accepted are suitable for further soil processing/treatment without the potential for any asbestos fibre emissions above the detection limit. A summary of waste acceptance is shown in Figure 1 below.

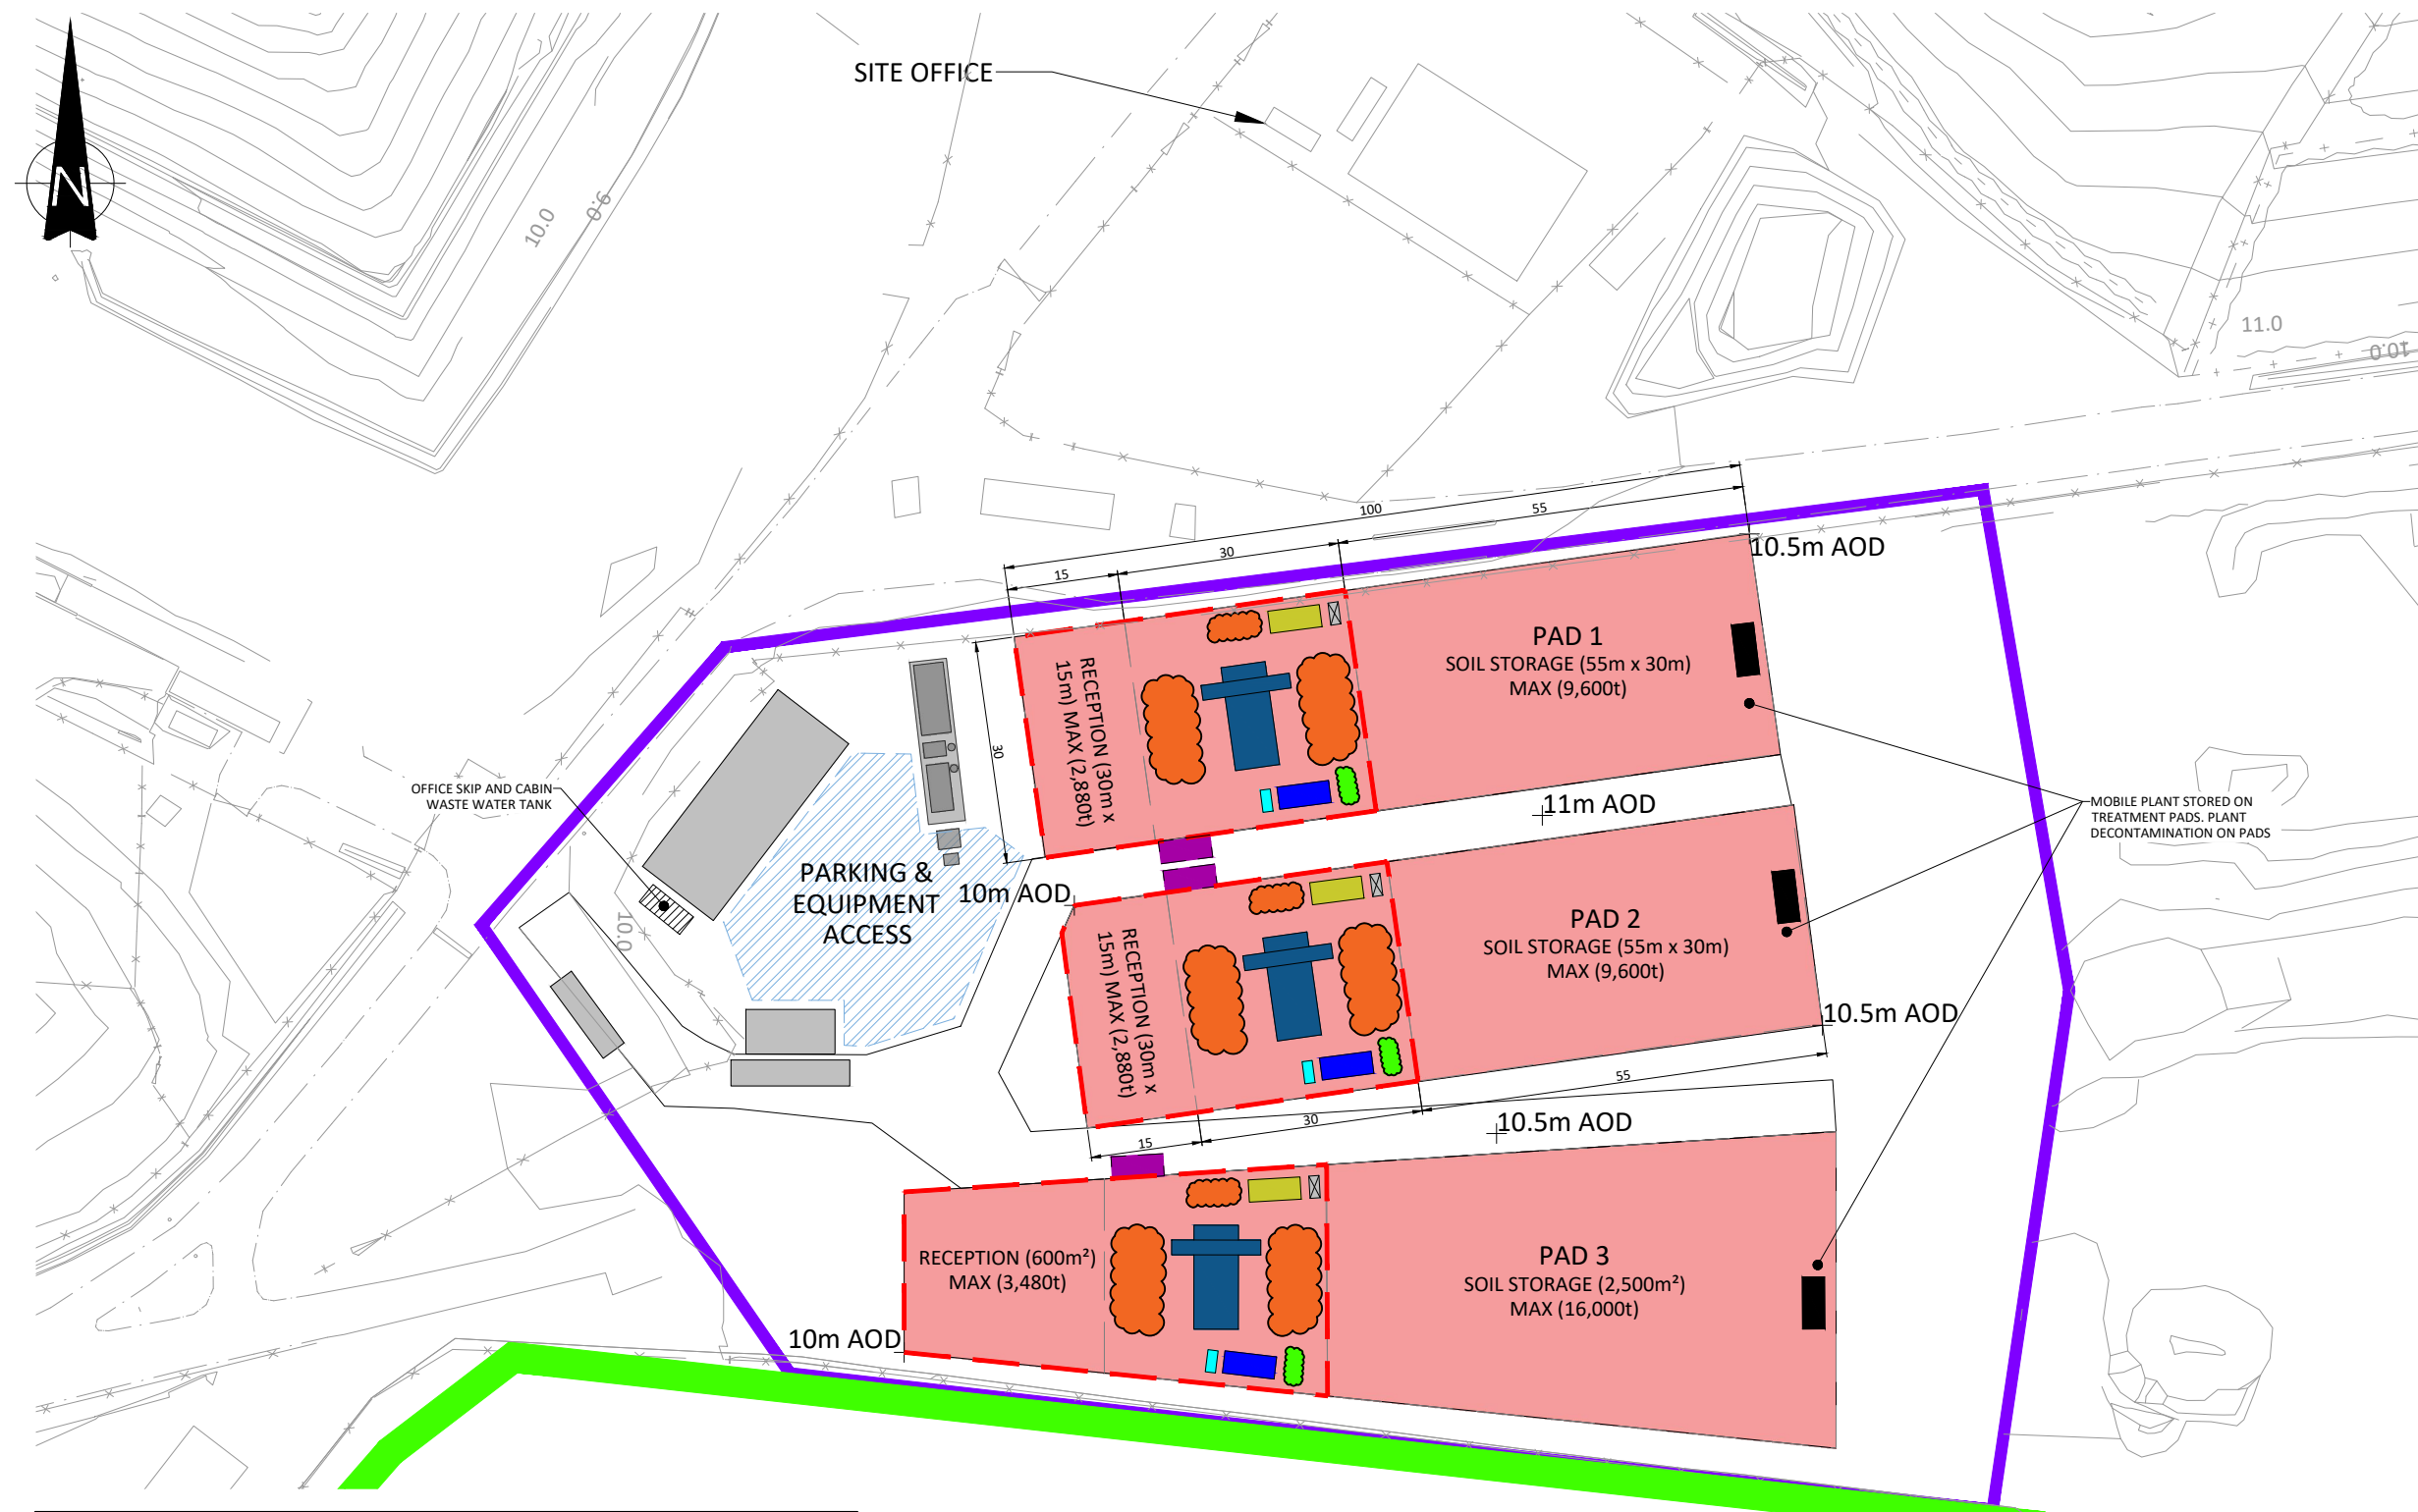
DRAWING NUMBER
3982-CAU-XX-XX-DR-V-1807

- LEGEND**
- AREA OF PROPOSED ACTIVITY
 - ASBESTOS CONTROLLED WORKING AREA
 - PICKING AREA
 - ASBESTOS SKIP
 - DECONTAMINATION AREA
 - INTEGRALLY BUNDED FUEL CUBE FOR PLANT USE
 - WASTE SKIPS - SOIL DERIVED REFUSE
 - 600kg BAGS OF AMMONIUM NITRATE IN WATERPROOF PACKAGING
 - 30m³ WOOD CHIP
 - FINES, OVERSIZE AND MID RANGE FRACTIONS
 - SOIL SCREENER

- 2.2.1 The STF is proposed to accept and process up to 29,999 tonnes per annum of hazardous containing visible bound pieces of asbestos and/or hydrocarbons and 20,001 tonnes of non-hazardous soils. The soils treated will be used for the restoration of the wider Daneshill Landfill site. The usual maximum biological treatment time for soils is 6 months in general with the majority being treated in periods of between 8-16 weeks.
- 2.2.2 The treatment areas consist of 2 treatment pads measuring at 3000m² and 3000m² for biotreatment/physical treatment and another 1 x 4000m² treatment pad solely for screening/processing. An indicative operational layout of the treatment and processing area and cross section is detailed in drawings referenced: 3982-CAU-XX-XX-DR-V-1805, 3982-CAU-XX-XX-DR-V-1806 and 3982-CAU-XX-XX-DR-V-1807.

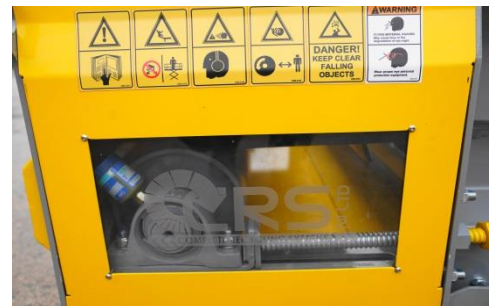
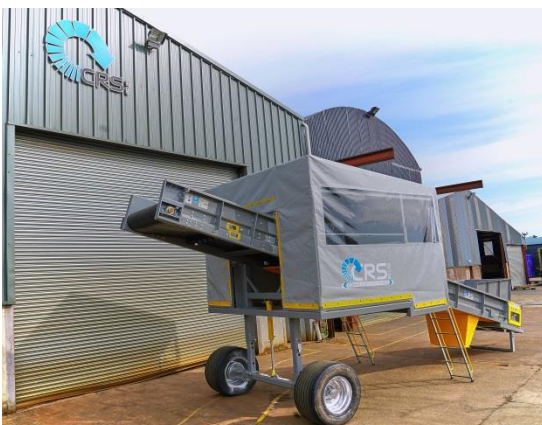
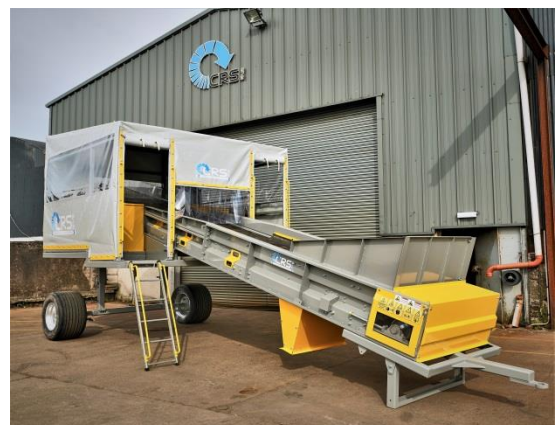
2.0 Picking Station

- 2-4 Man Picking
- 3.5mm Chequered Walkway
- 2 Dropboxes:
 - Width: 900mm
 - Depth: 452mm
 - Height: 989mm
- Access Step Ladders to Picking Station
- Canopy for Weather Protection
- Optional Hard Cover

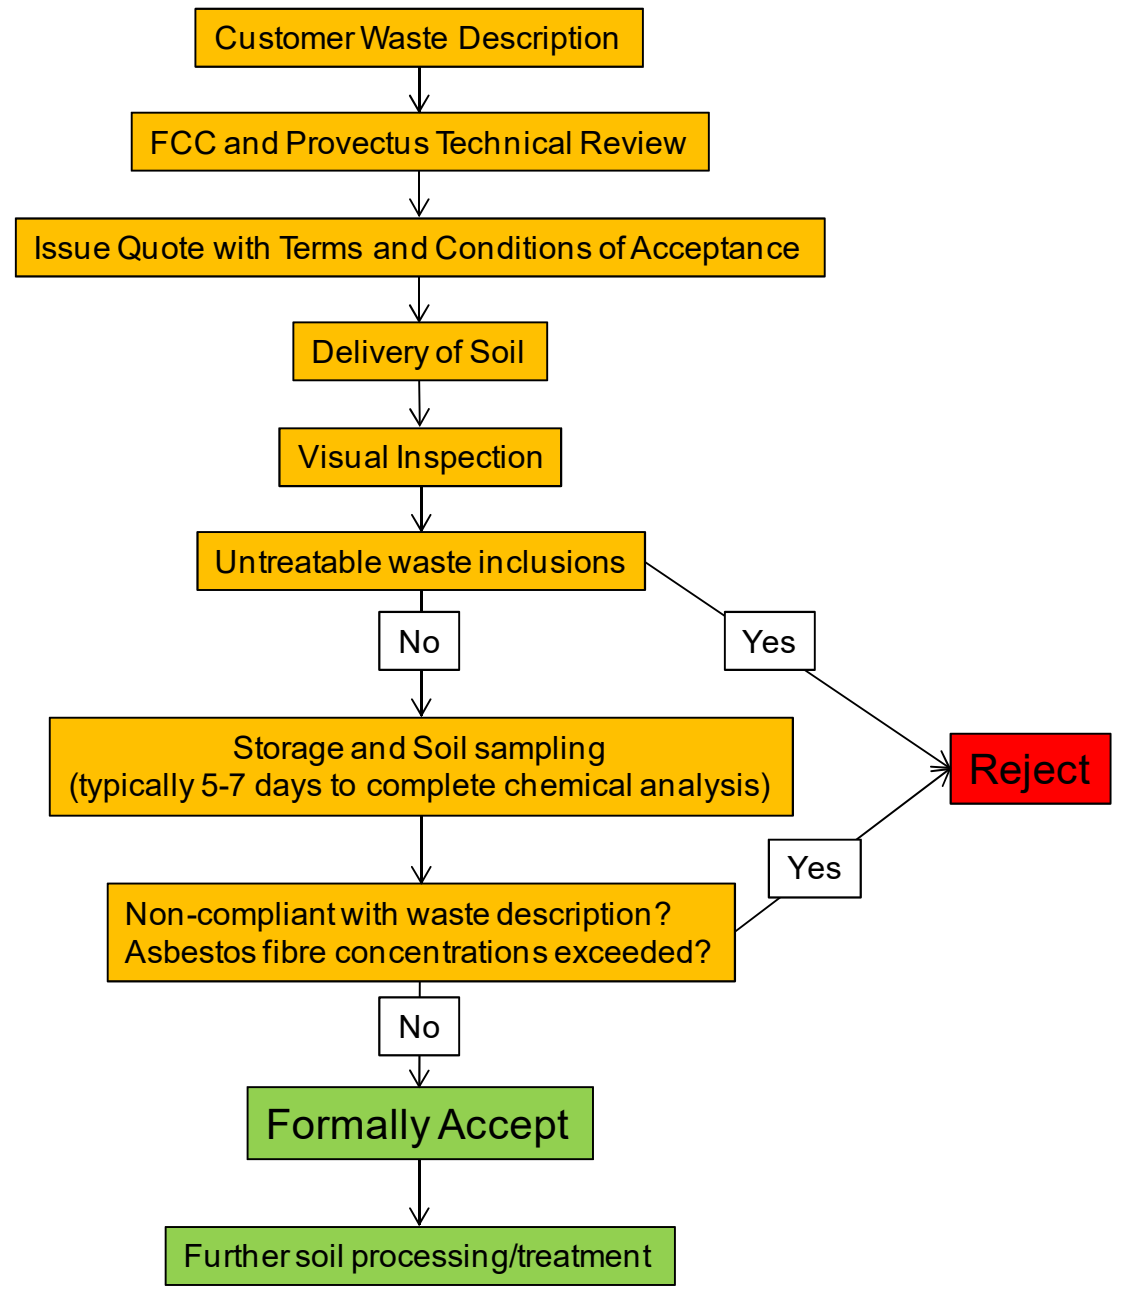
Figure 1. Summary of Waste Acceptance Procedure

Figure 1 is a flow diagram for the waste reception procedure. The procedure is implemented to ensure that the waste is only formally accepted once visual inspections and chemical analysis of received wastes has been successfully completed. This ensures that any soils that are formally accepted are suitable for further soil processing/treatment. All non-compliant wastes will be rejected.
