**Daneshill Soils Treatment Facility**

**FCC Recycling (UK) Limited**

**Emissions Management Plan**

**Document Reference:** 3982-CAU-XX-XX-RP-V-0307.A0-C2

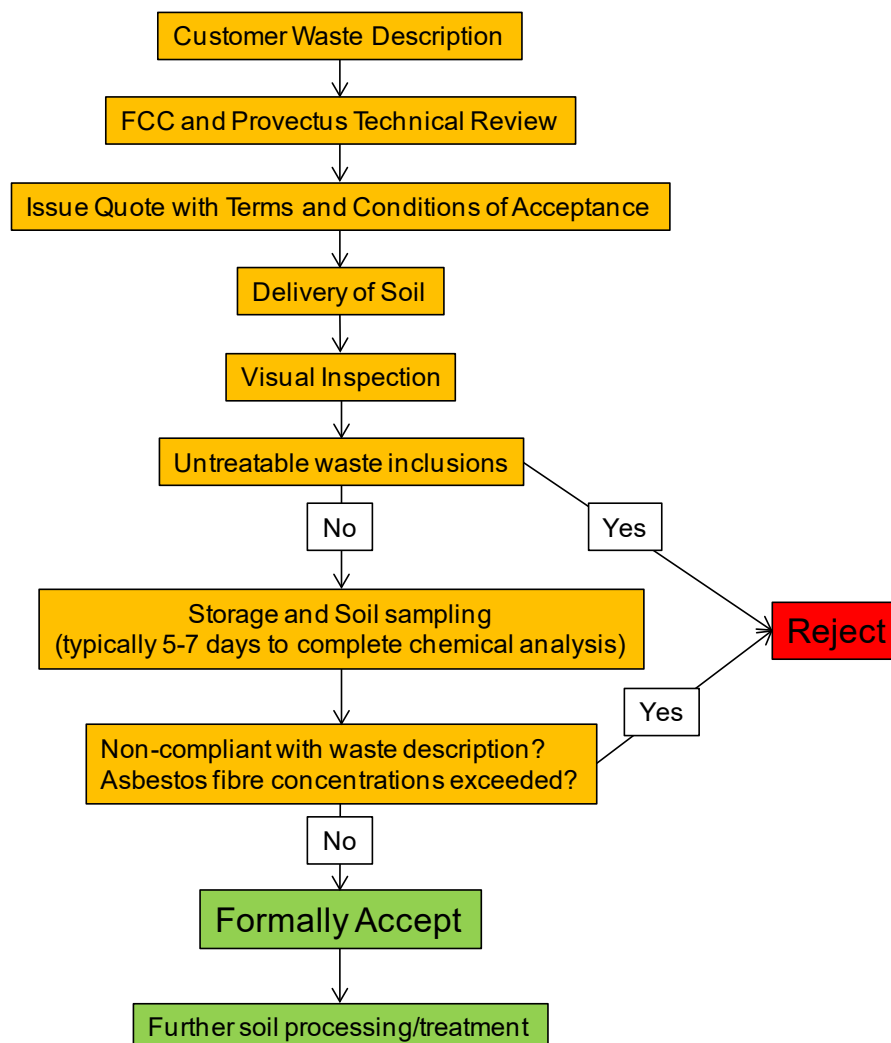
**Figure 1: Summary of Waste Acceptance Procedures – Asbestos containing wastes**

- 7.1.8 Soil with asbestos will be consigned by contractors and haulier as 17 05 03\* ‘soils and stones containing hazardous substances’ or 17 06 05\* ‘other construction materials containing asbestos’. All asbestos containing wastes will undergo visual inspection and chemical analysis to ensure that any soils that are formally accepted are suitable for further soil processing/treatment without the potential for any asbestos fibre emissions above the detection limit. A summary of waste acceptance is shown in Figure 1 below.

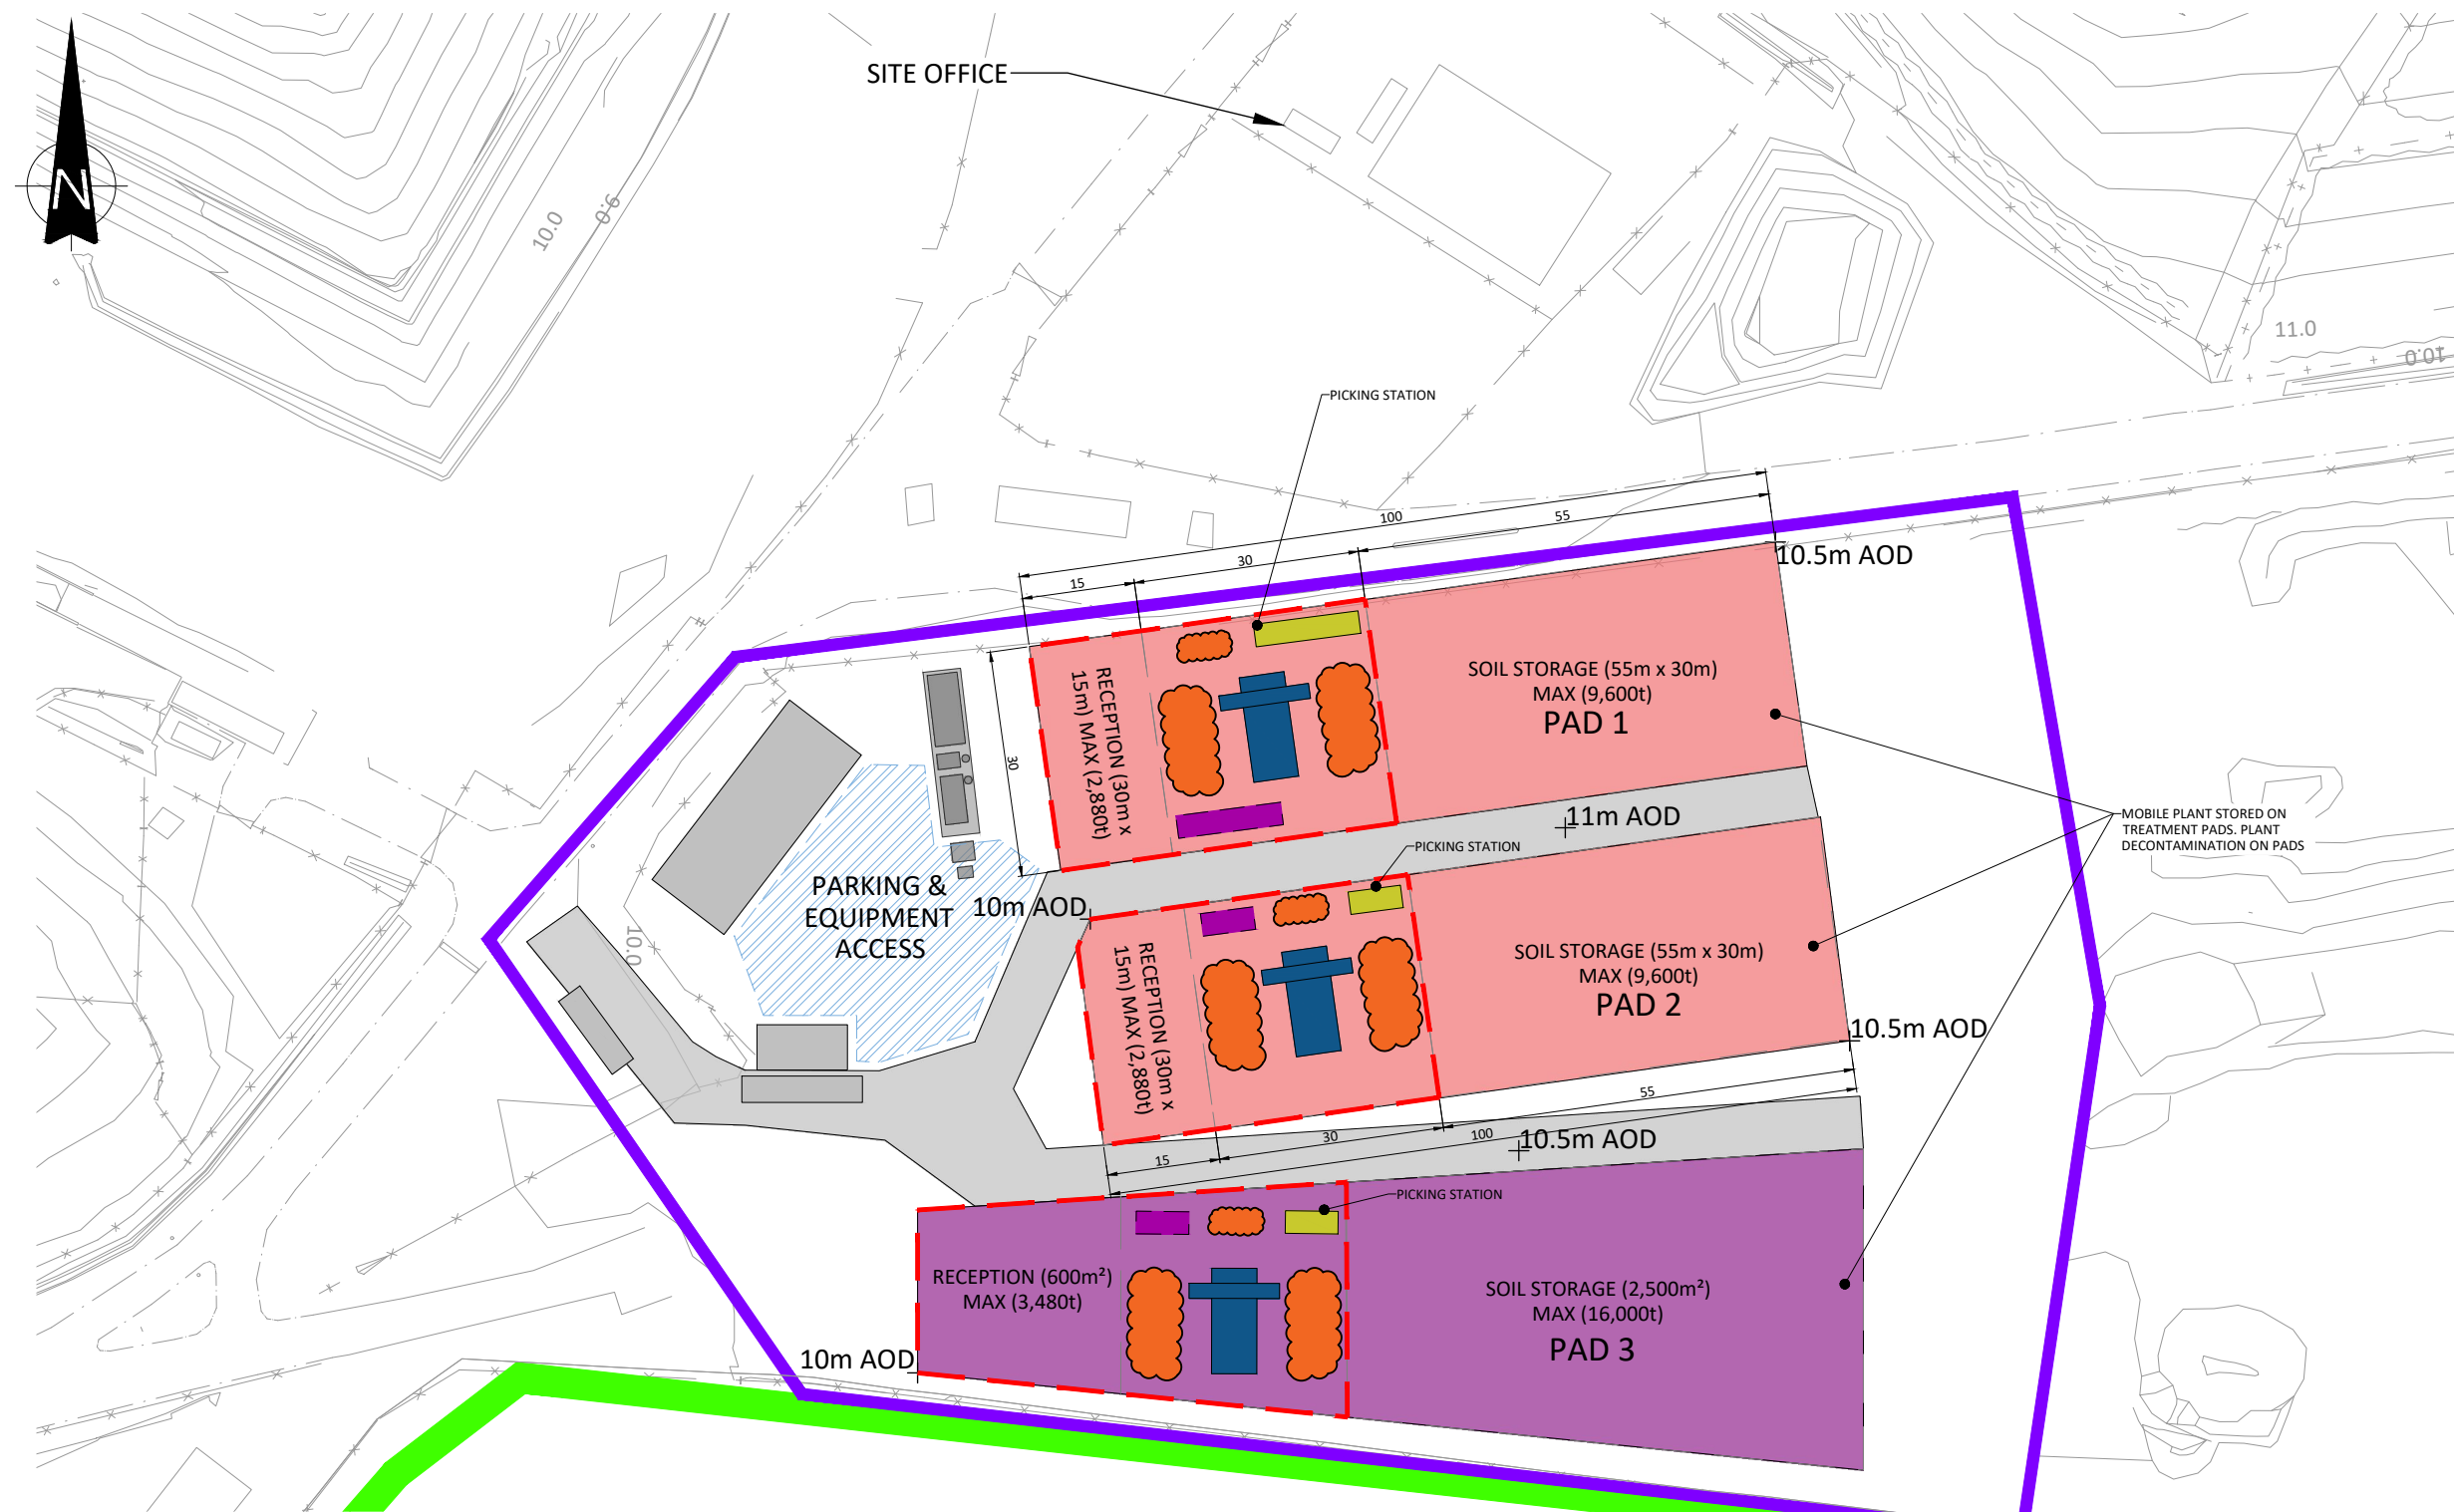
- LEGEND**
- AREA OF PROPOSED ACTIVITY
  - ASBESTOS CONTROLLED WORKING AREA
  - ASBESTOS SKIP
  - DECONTAMINATION AREA
  - FINES, OVERSIZE AND MID RANGE FRACTIONS
  - SOIL SCREENER

P02	WHEEL WASH POSITION AMENDED	EJD	KB	KB	01.10.21
P01	ISSUED FOR INFORMATION	EJD	KB	KB	30.09.21
REV	MODIFICATIONS	BY	RE	AP	DATE
PURPOSE OF ISSUE					STATUS
FOR INFORMATION					S2
CLIENT:					
PROJECT:					
<b>DANESHILL SOILS TREATMENT FACILITY</b>					
TITLE:					
<b>SOILS TREATMENT PADS 1 / 2 / 3 SITE LAYOUT PLAN</b>					
DESIGNED BY	DRAWN BY	REVIEWED BY	AUTHORISED BY		
KB	EJD	KB	KB		
DATE	SCALE @ A3	JOB REF:	REVISION		
29.09.2021	1:1000	3982	P02		
DRAWING NUMBER					
3982-CAU-XX-XX-DR-V-1807

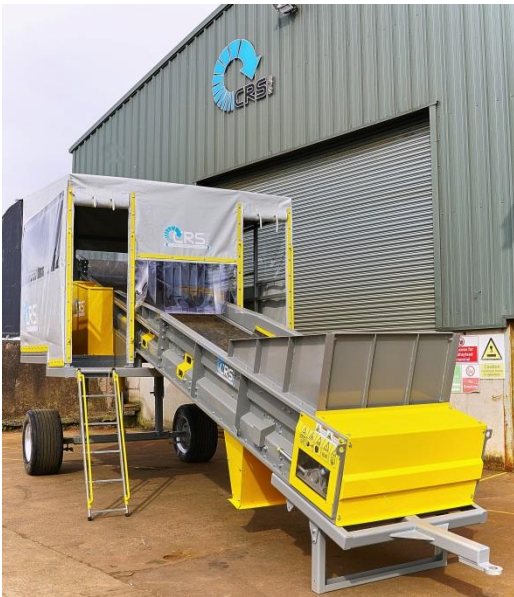
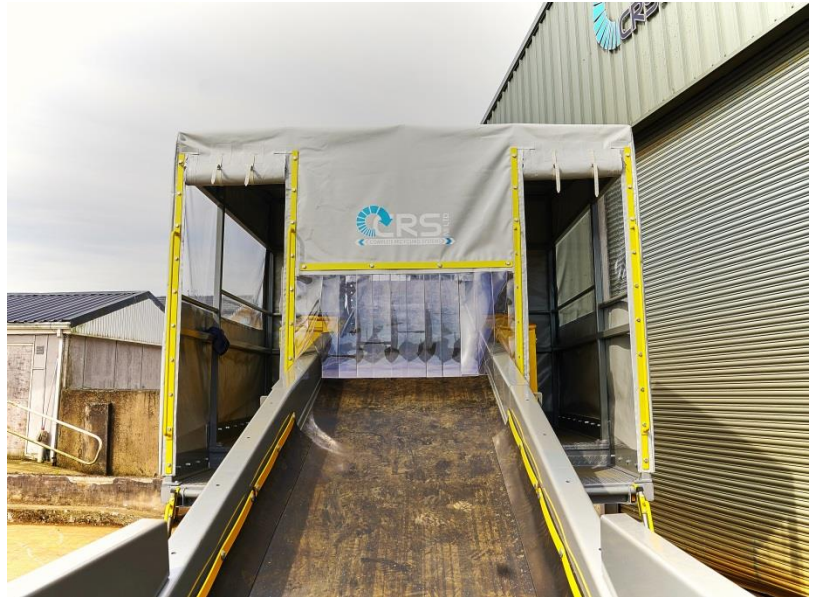
## 2.0 Picking Station

- 2-4 Man Picking
- 3.5mm Chequered Walkway
- 2 Dropboxes:
  - Width: 900mm
  - Depth: 452mm
  - Height: 989mm
- Access Step Ladders to Picking Station
- Canopy for Weather Protection
- Optional Hard Cover

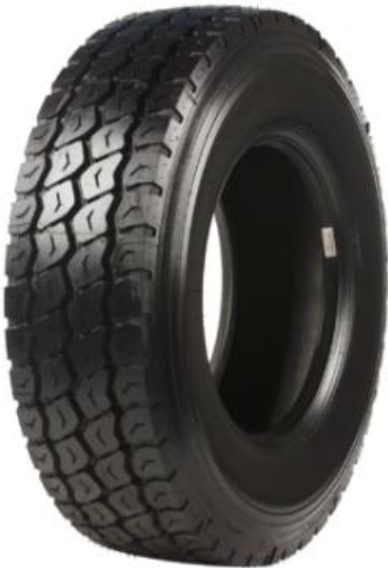
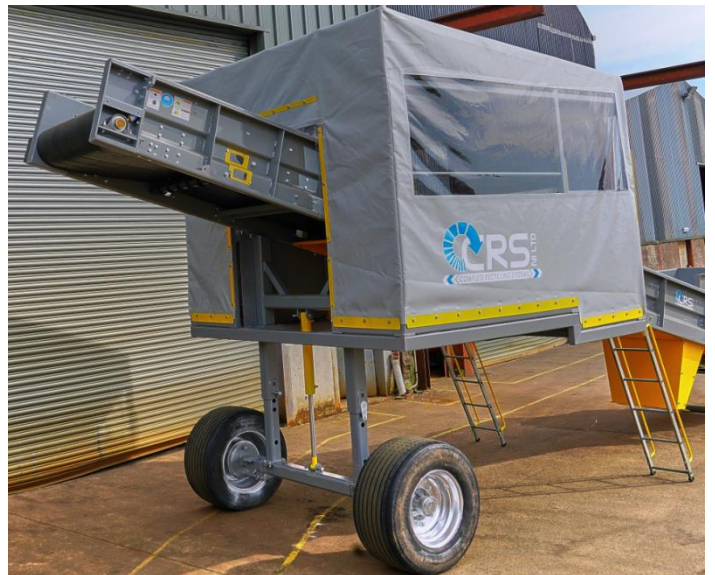
## 3.0 Wheel Assembly

- Adjustable Ram
- Handbrake Lever
- 300x80mm Stud Axle
- Super Single Tyres - 385/65 R22.5

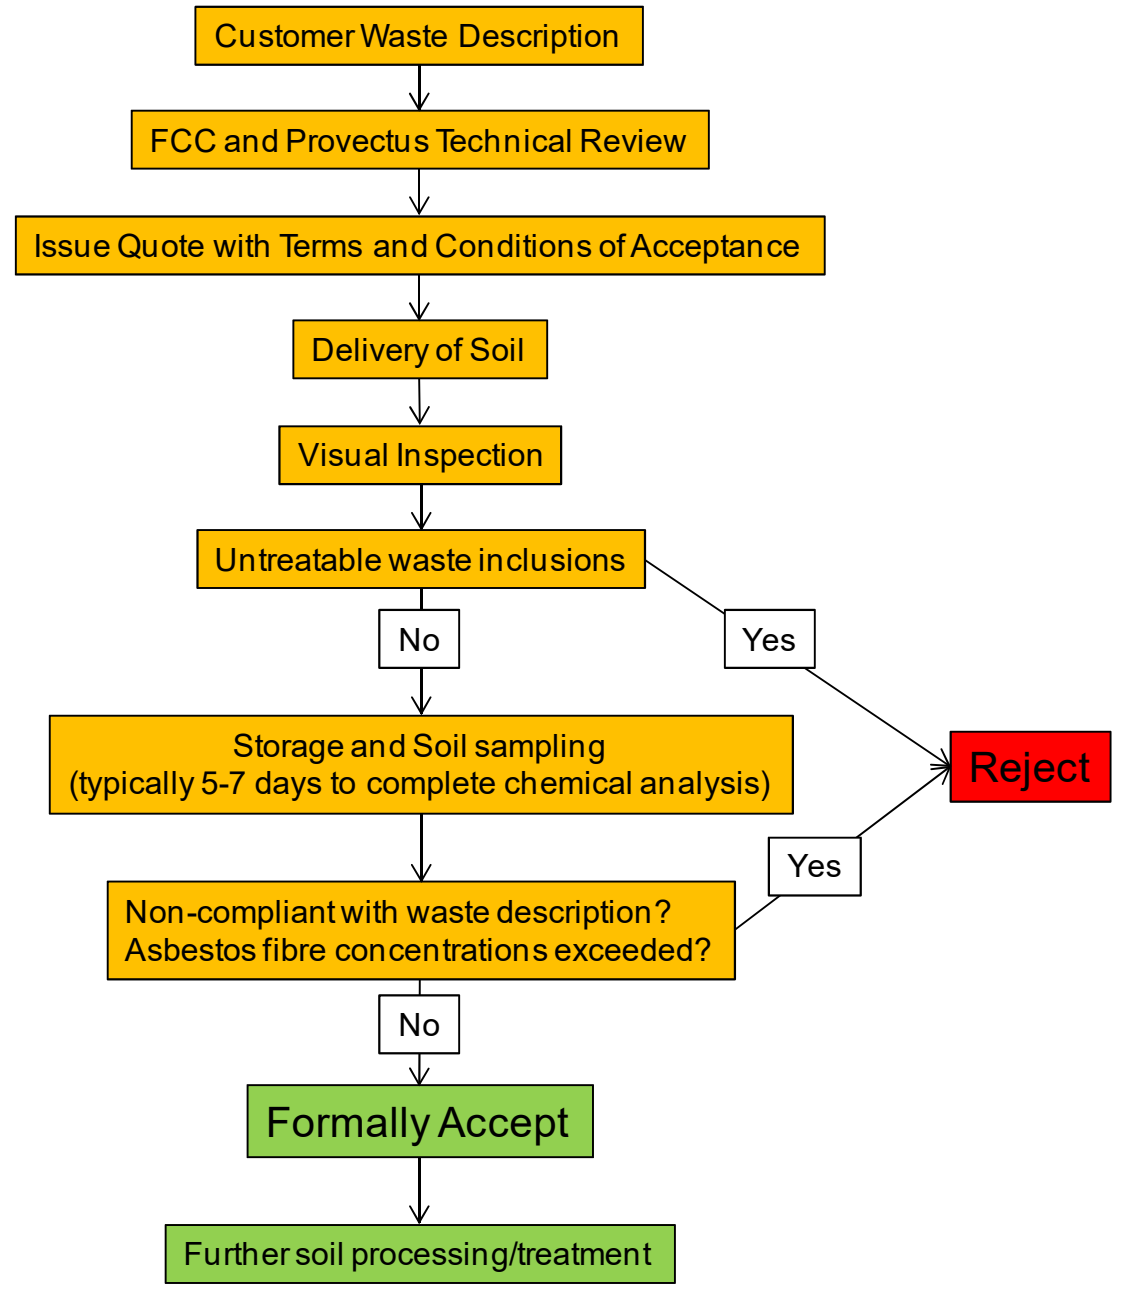
**Figure 1.** Summary of Waste Acceptance Procedure

Figure 1 is a flow diagram for the waste reception procedure. The procedure is implemented to ensure that the waste is only formally accepted once visual inspections and chemical analysis of received wastes has been successfully completed. This ensures that any soils that are formally accepted are suitable for further soil processing/treatment. All non-compliant wastes will be rejected.

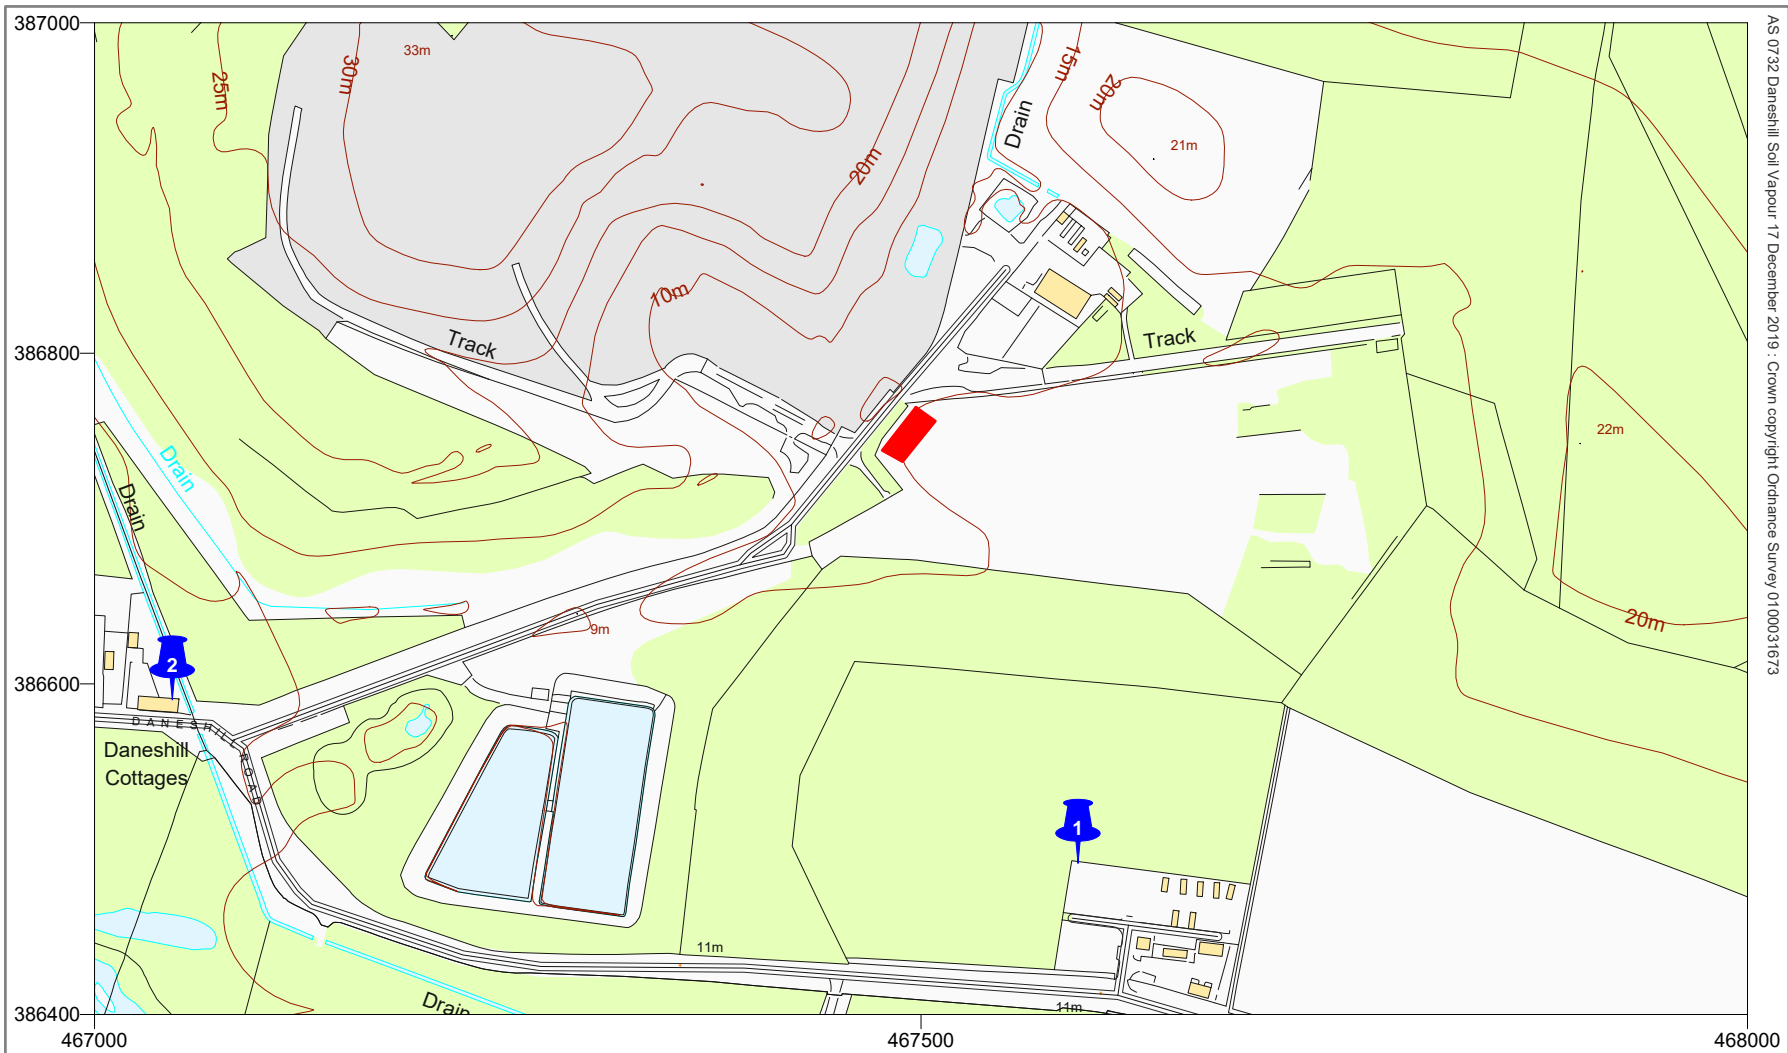
**Figure 2**

### Model Layout

- bio-filter
- sensitive receptor considered in study

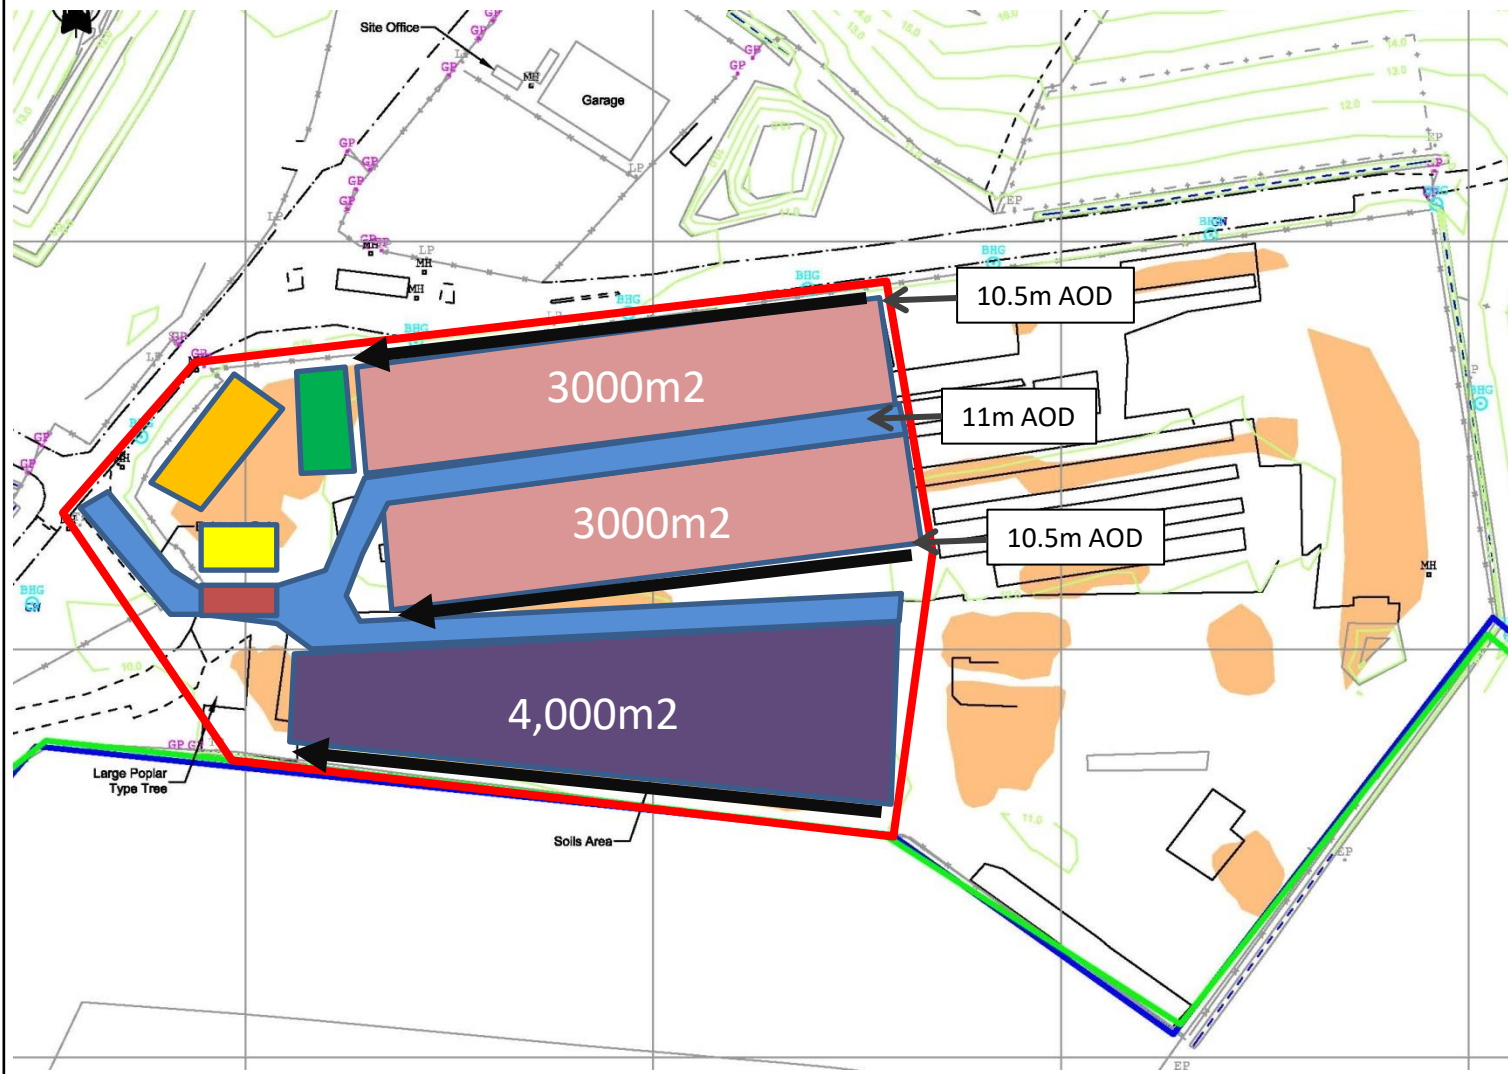
- Biofilter (475m<sup>2</sup>)
- Biotreatment Area
- Screening/Processing
- Soil and Water Treatment Equipment
- Site Office
- Relocated Weighbridge
- Access Roads
- ← Fall of Drainage

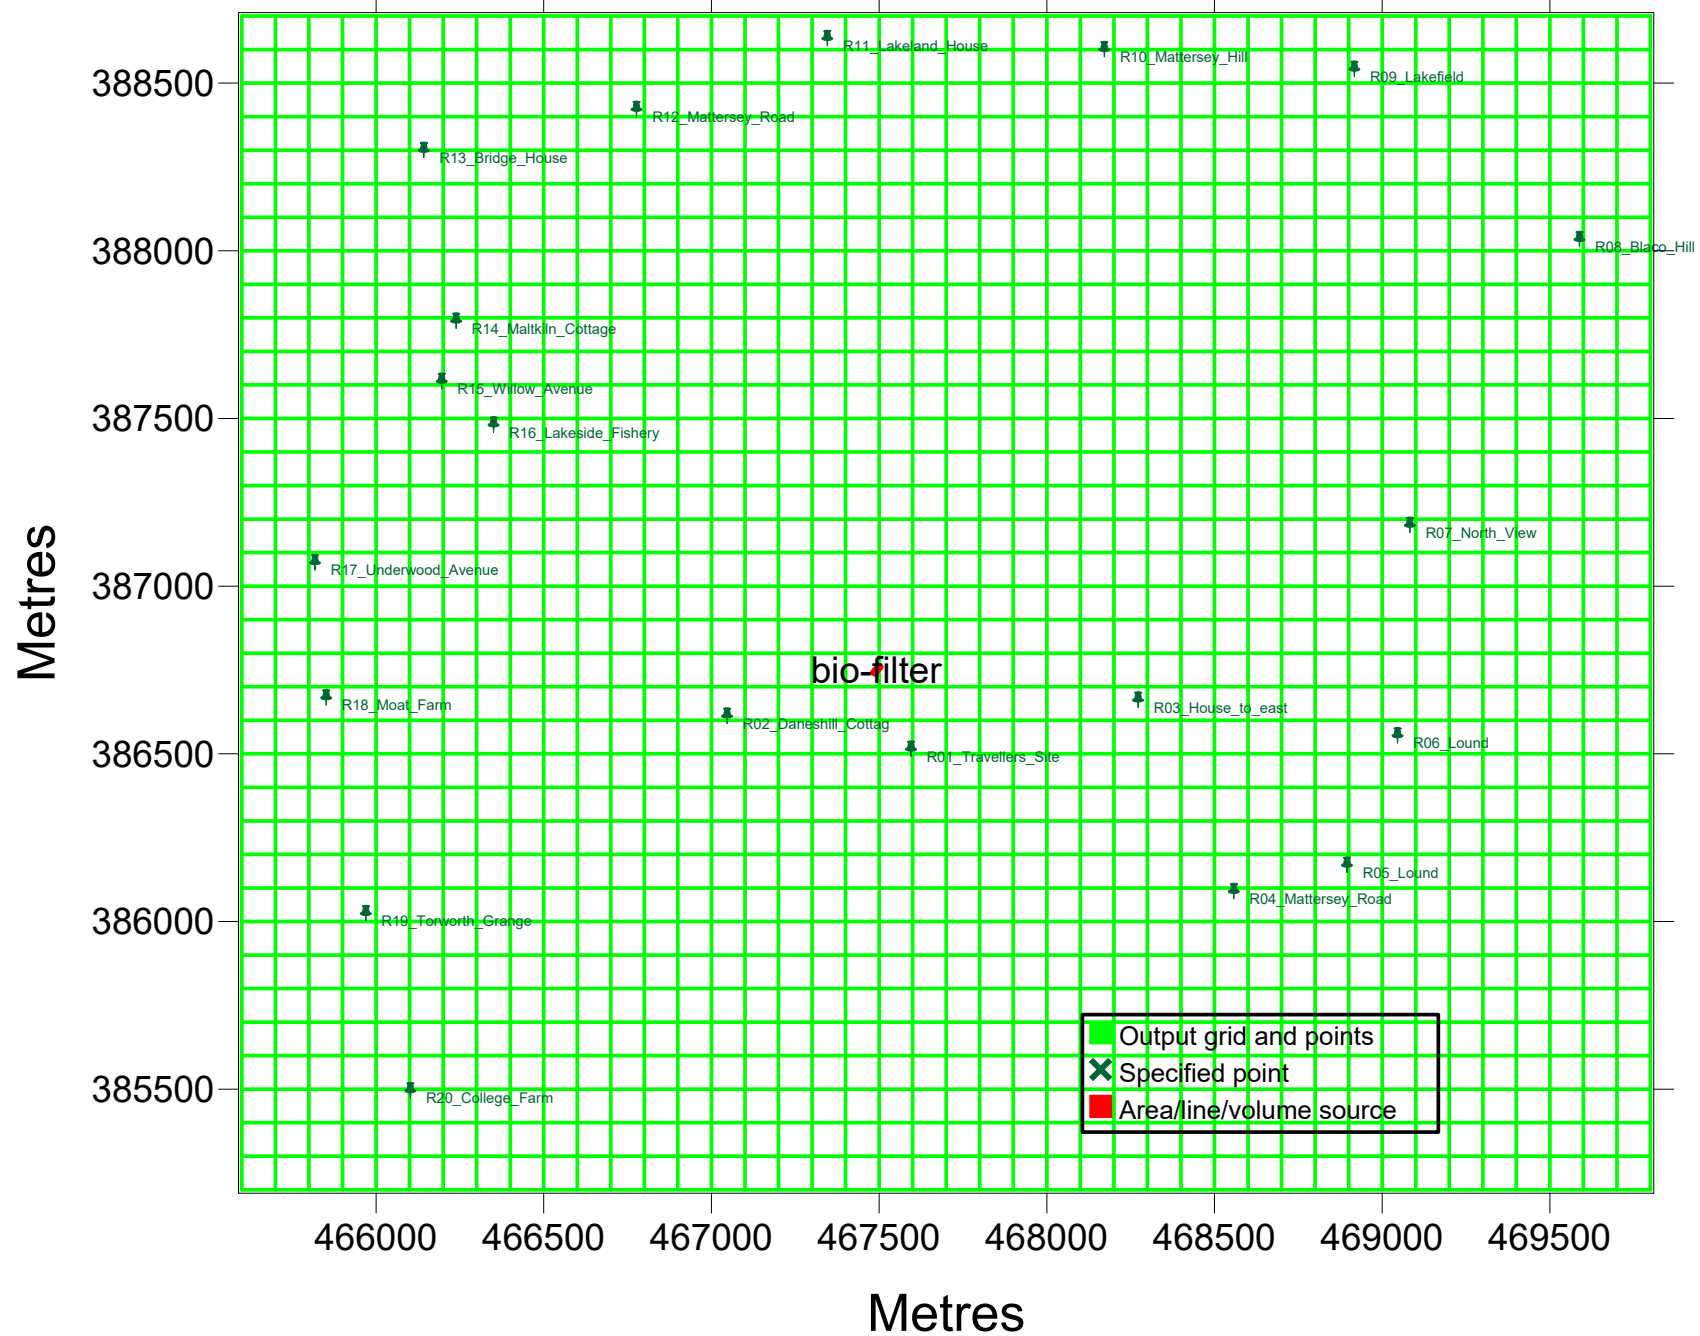
# Visualisation of ADMS input

P:\files\AS 0732 Daneshill Soil Vapour\model runs\Scenario 1.APL
