Viewpoint 3

Direction of view: North northwest
Distance to nearest site boundary: 0 m
Elevation: 126 m AOD
Grid reference: TL 46113 28652
Date photo was taken: 20.01.2022

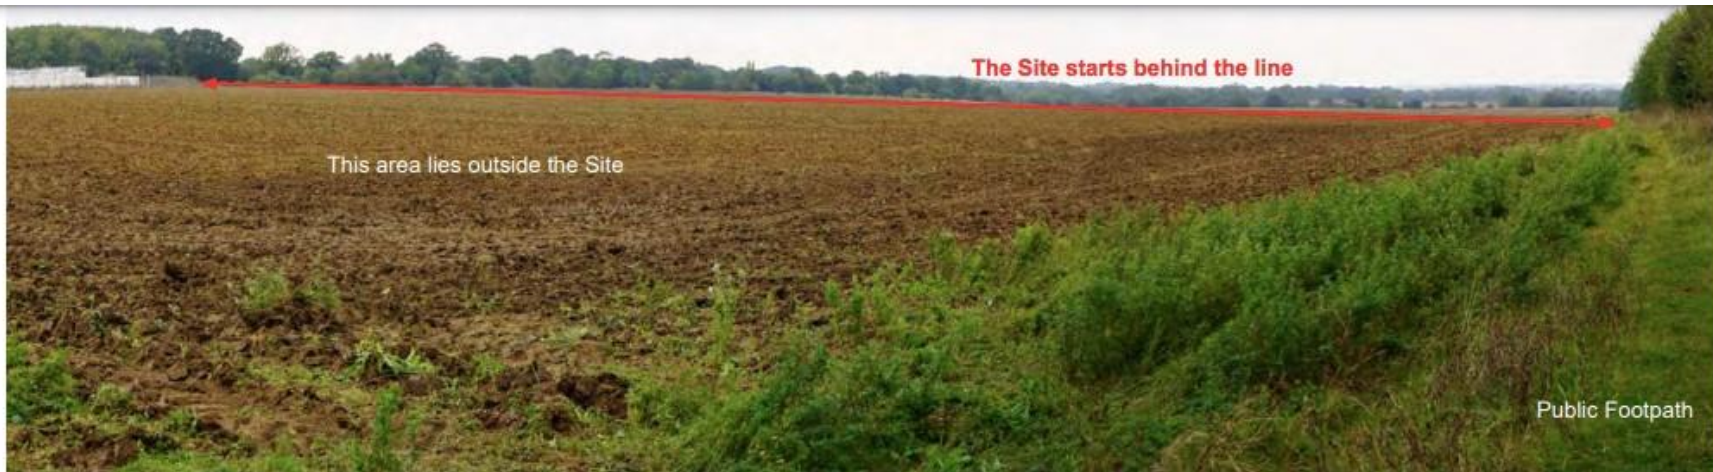
The existing view

PRoW 5/27 terminates at the boundary of the substation, joining with PRoW 5/25 which heads east to join with PRoW 5/26. Views towards the Site from PRoW 5/25 are very restricted by a substantial intervening hedgerow, even in winter. PRoW 5/26, however, heads south, first affording clear views over the Site, as at this point, and then it continues through the Site until it meets Ginns Lane.

The solar farm will be visible in the foreground, with the panels facing the viewer when heading north, seen through the deer fence. Walkers will then continue through the solar farm within a corridor flanked to the east by an existing hedge and the deer fence of the proposed solar farm set around 12 m from the hedge.

The sensitivity of walkers is High and the magnitude of change is High in winter and summer resulting in a Major adverse impact on visual amenity.

It is proposed to plant a native hedge set 2 m out from the deer fence to screen the proposed solar farm. Once established the hedge will be managed at a winter cut height of 3 m and 3 m wide at the base, leaving a 7 m wide grass corridor for the PRoW.

Once established the hedge will screen the solar farm from view in summer, resulting in a Minor impact on visual amenity (due mainly to the loss of openness). In winter it will be possible to glimpse the panels and fencing through the leafless branches (a Medium magnitude of change), resulting in an adverse impact of Moderate - Major significance.
