Construction noise and vibration Monthly Report – January 2024

London Borough of Hillingdon

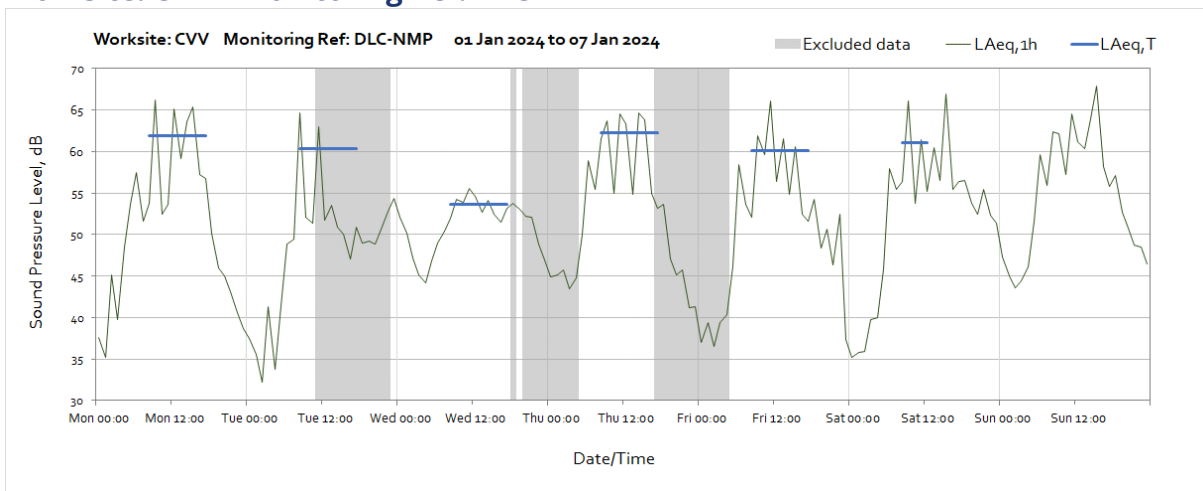
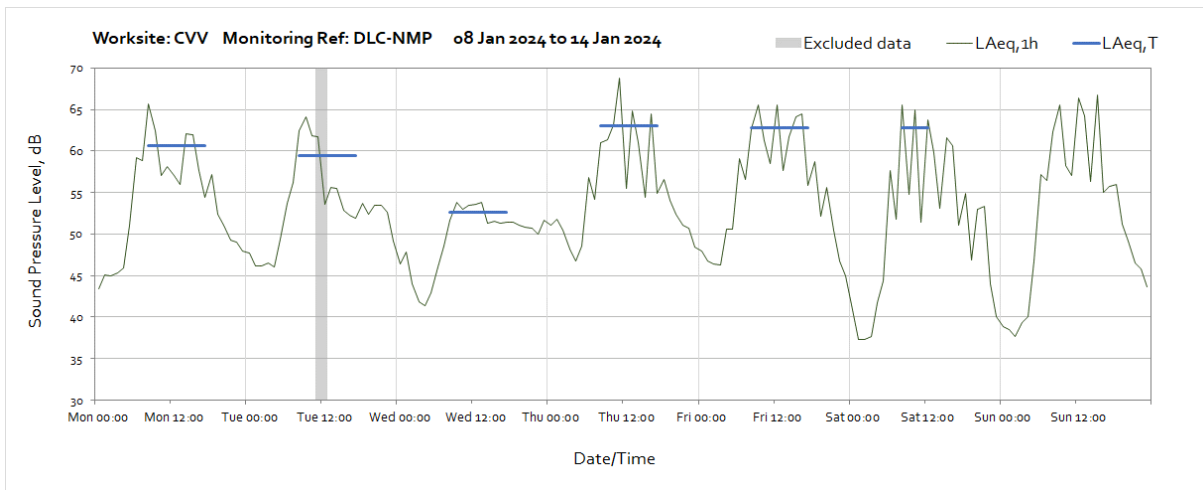
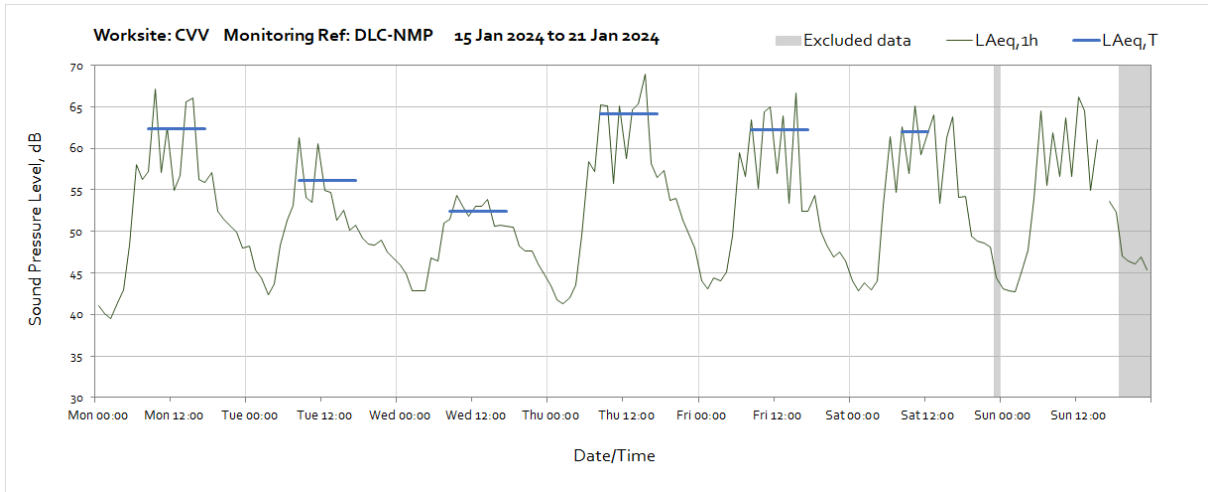
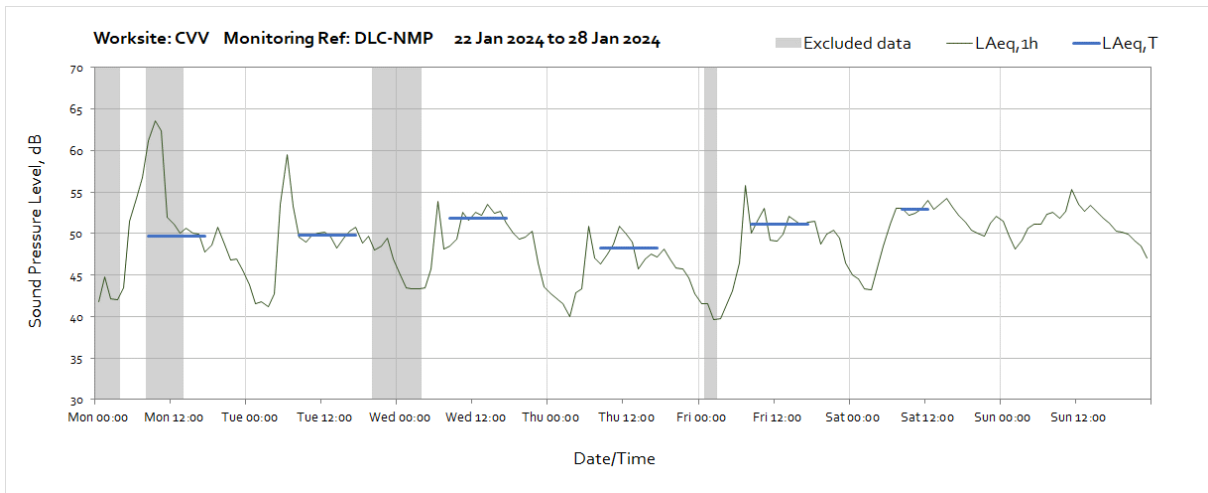
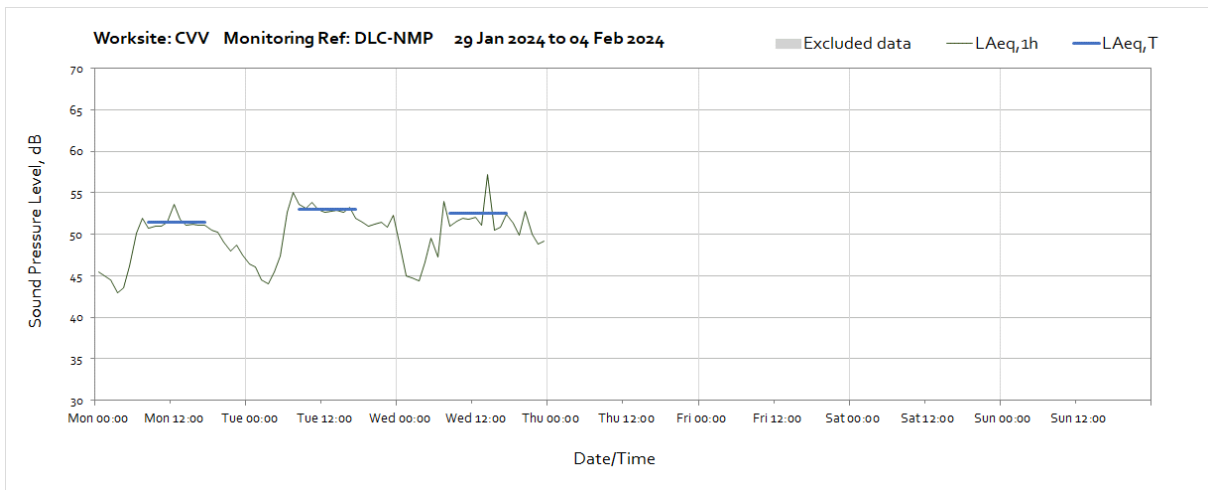
Worksite: CVV - Monitoring Ref: DLC-NMP

The following graphs show the hourly measured ambient noise level $L_{Aeq,1h}$ and, where relevant, the averaged noise level $L_{Aeq,T}$ values, where the time period T is as specified in Table 1 of HS2 Information Paper E23. Periods where noise levels are adversely affected by weather or only measured for part of the period, which are not representative of HS2 construction works, have been greyed out and excluded from the calculation of the $L_{Aeq,T}$ values in Table 3 of the main report.

Note: Missing data between 16:00 and 17:00 on Sunday 21st January was due to a communication error between the monitoring station and server.

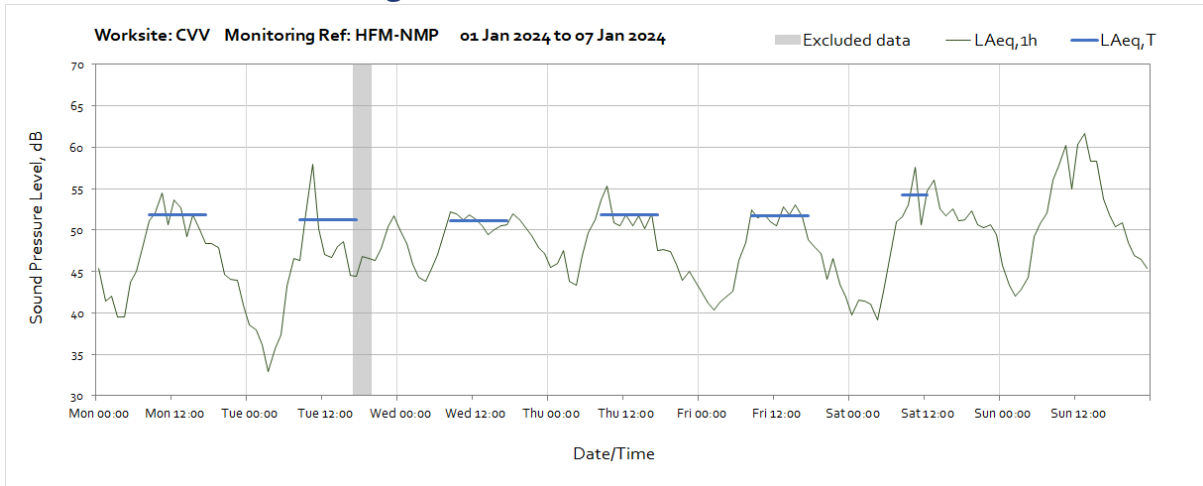
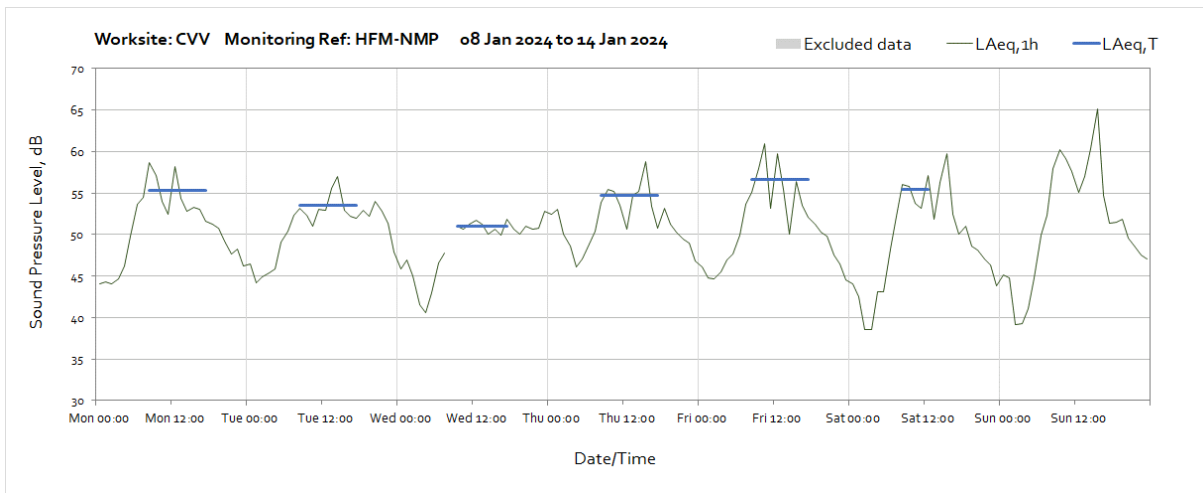
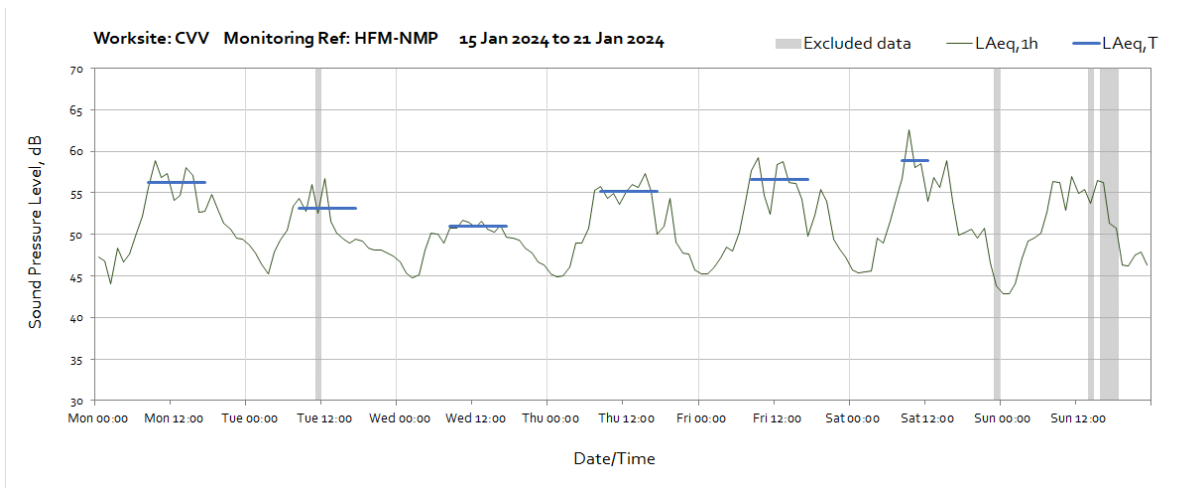
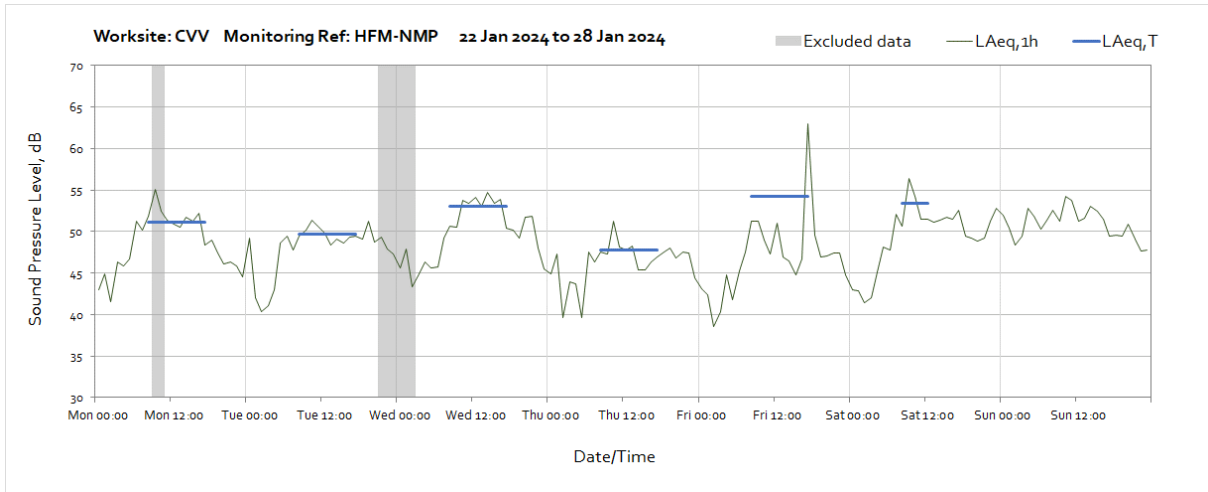
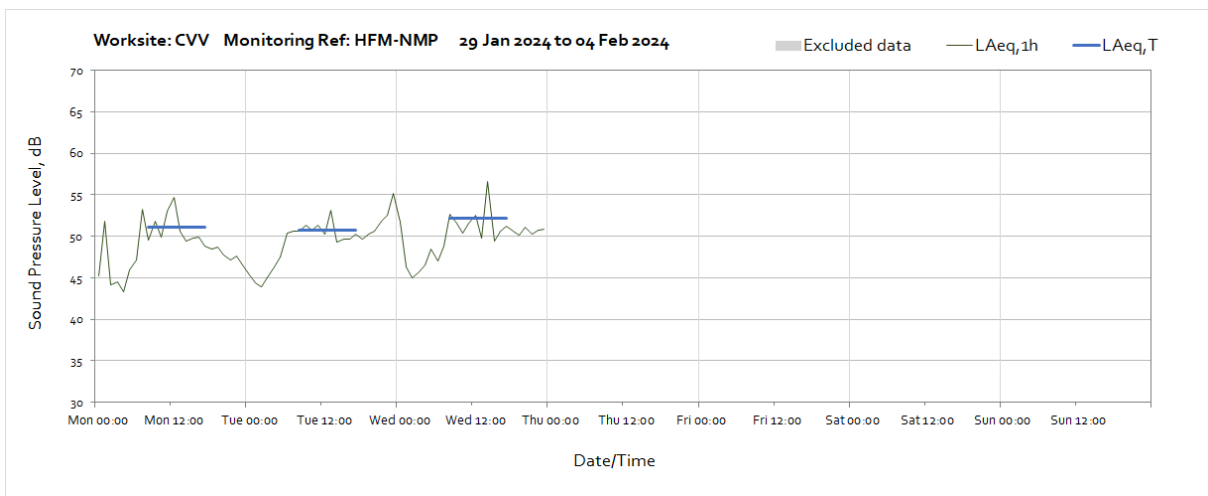
Worksite: CVV – Monitoring Ref: HFM-NMP

Note: Missing data between 08:00 and 09:00 on Wednesday 10th January was due to a communication error between the monitoring station and server.

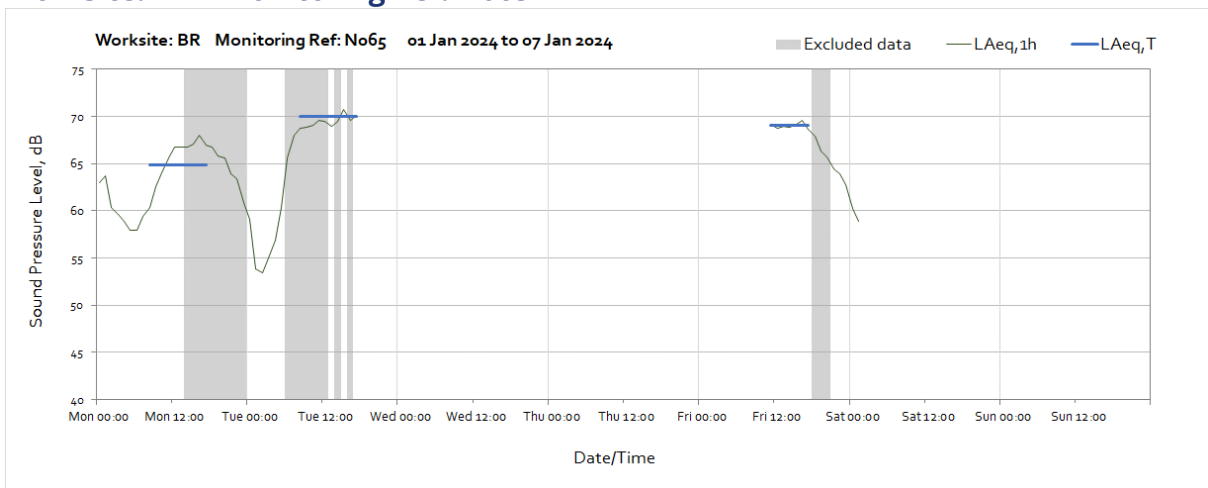
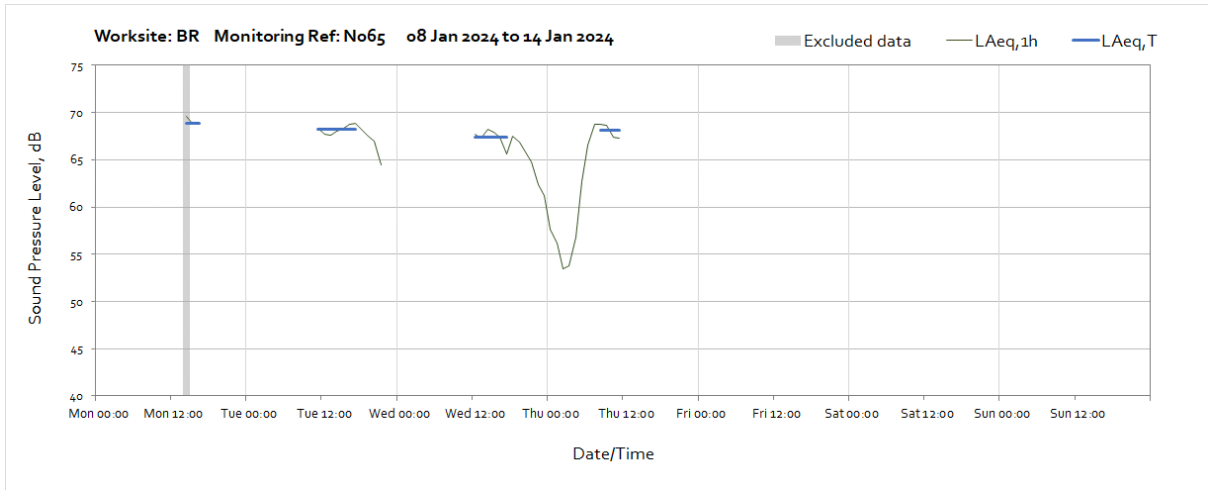
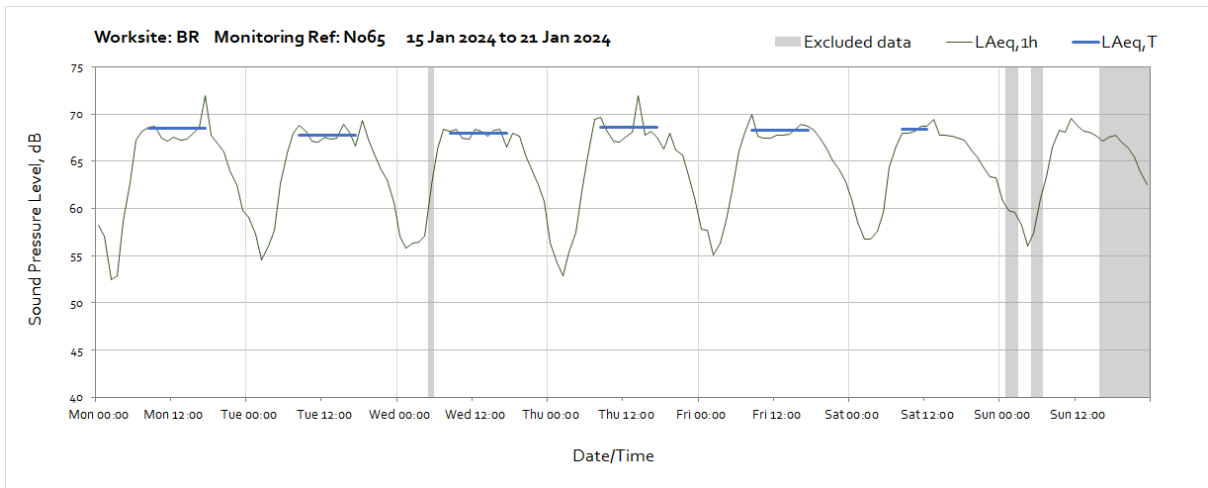
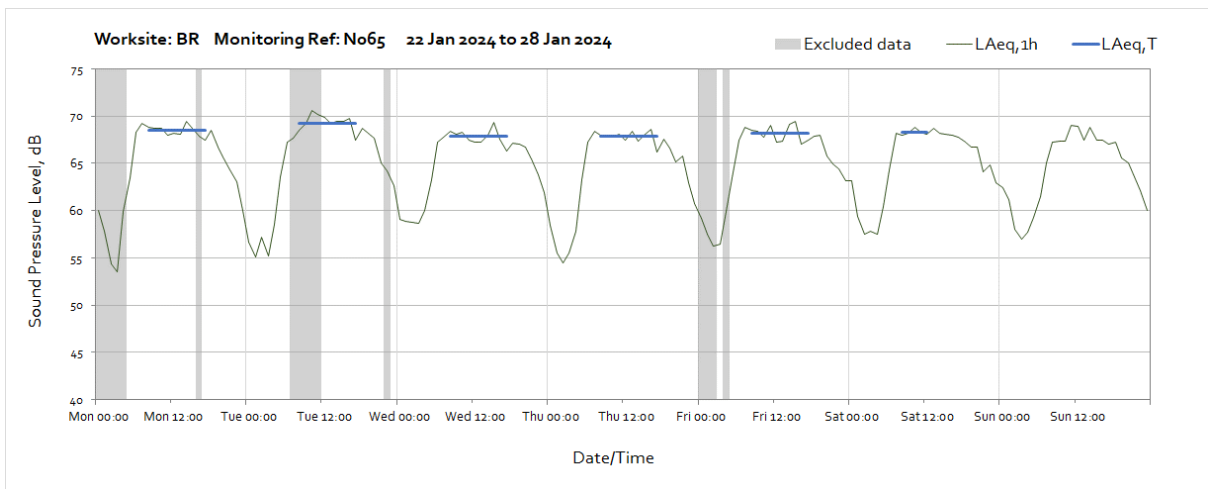
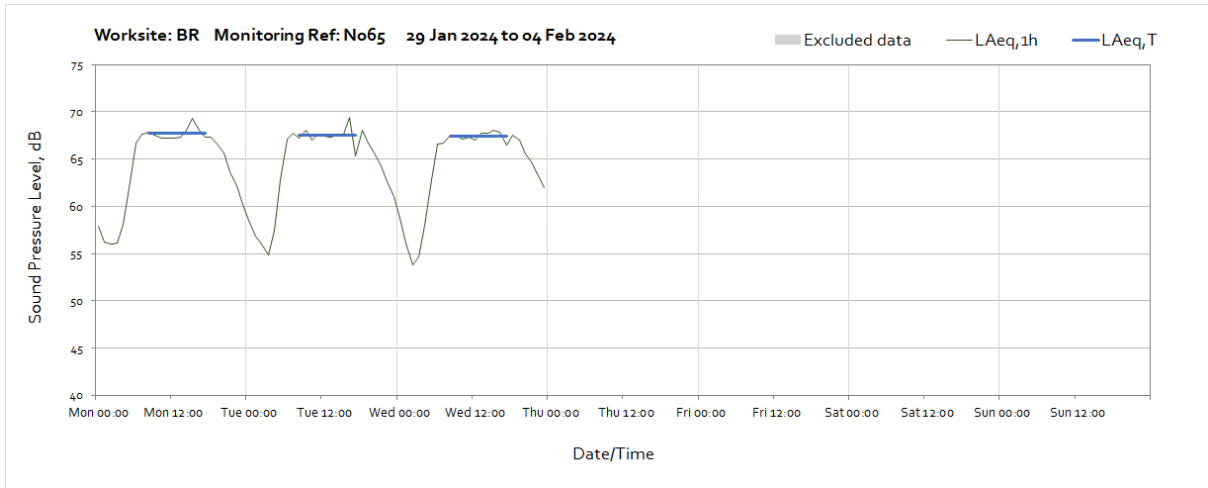
Worksite: BR – Monitoring Ref: N065

Note: Missing data throughout the week was due to a loss of power to the monitoring station caused by poor weather conditions preventing sufficient light to reach the solar panel.

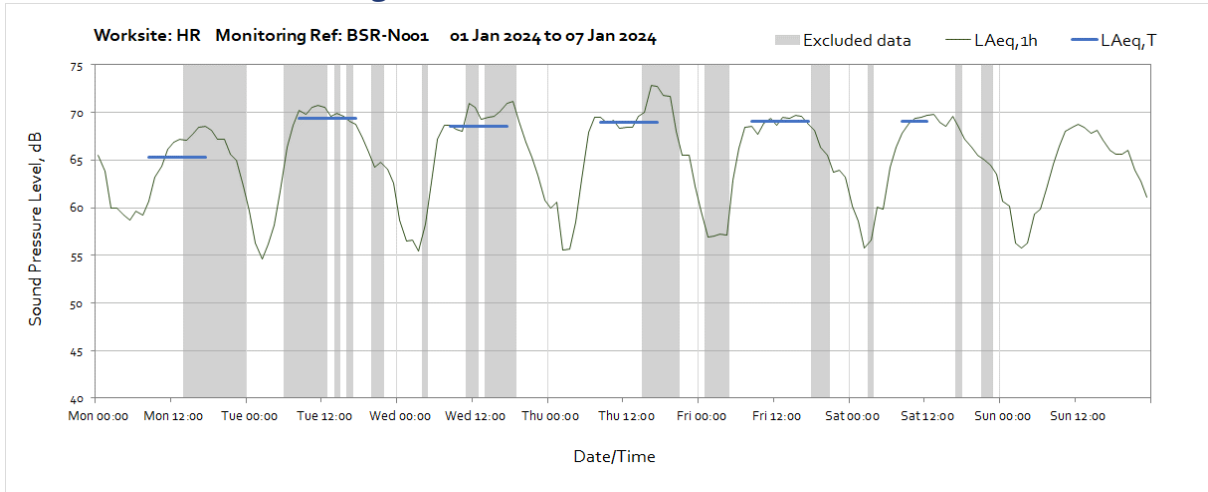
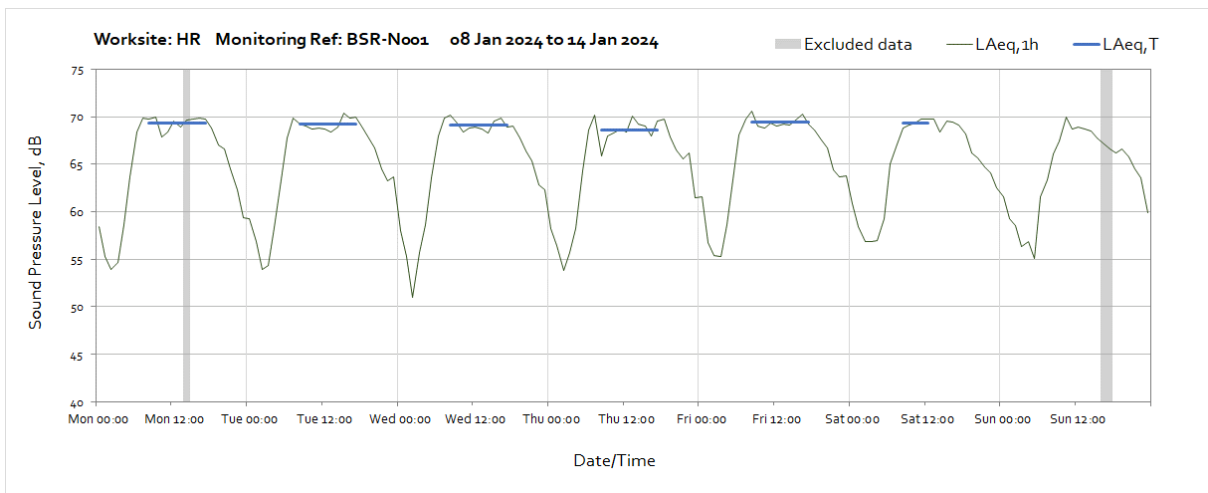
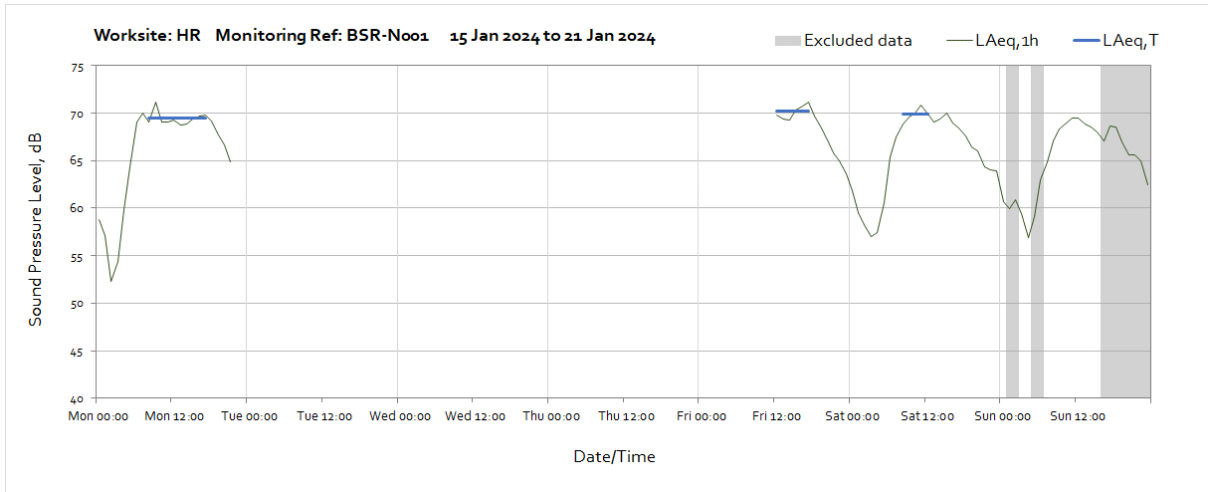
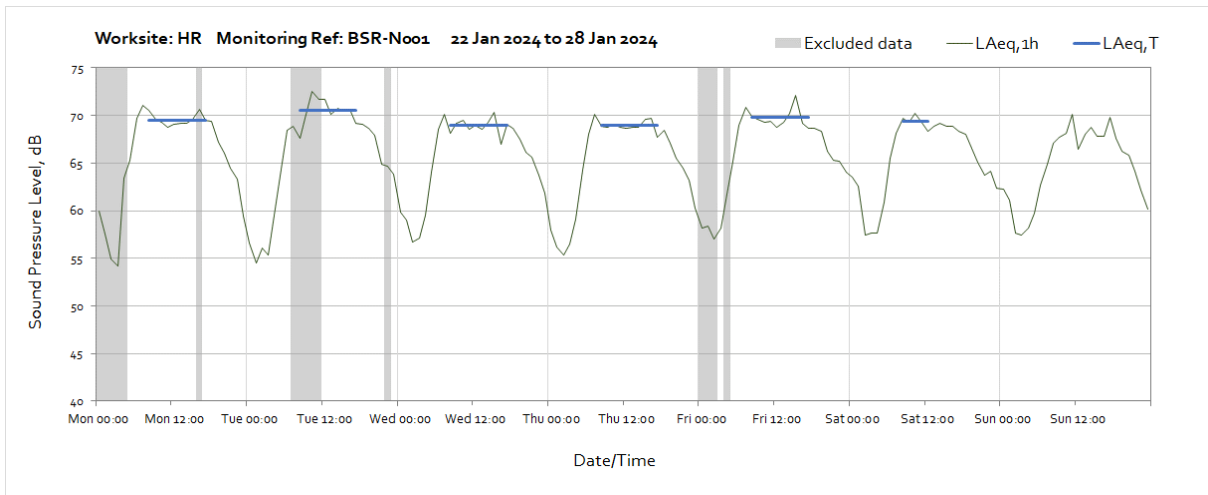
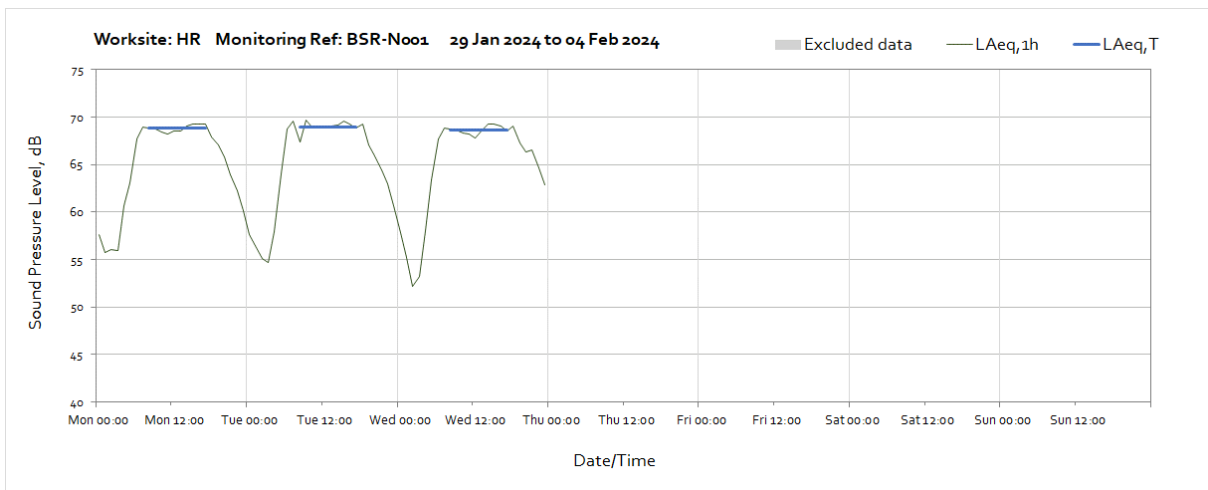
Worksite: HR – Monitoring Ref: BSR-N001

Note: Missing data between 22:00 on Monday 15th January and 12:00 on Friday 19th January was due to a loss of power to the monitoring station caused by poor weather conditions preventing sufficient light to reach the solar panel.

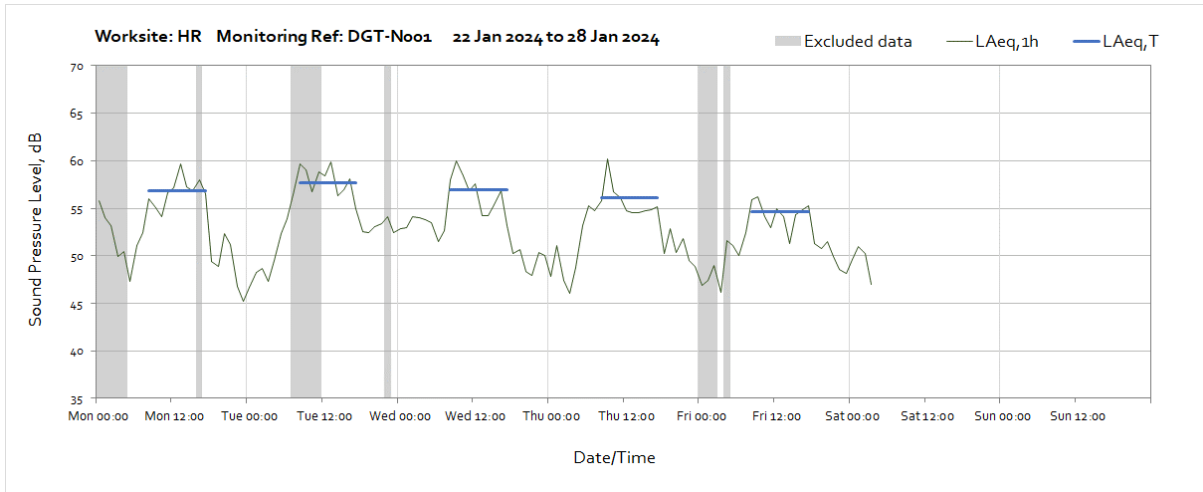
Worksite: HR – Monitoring Ref: DGT-N001

Note: Missing data from 04:00 on Saturday 27th January until the end on the month was due to a loss of power to the monitoring station caused by poor weather conditions preventing sufficient light to reach the solar panel.

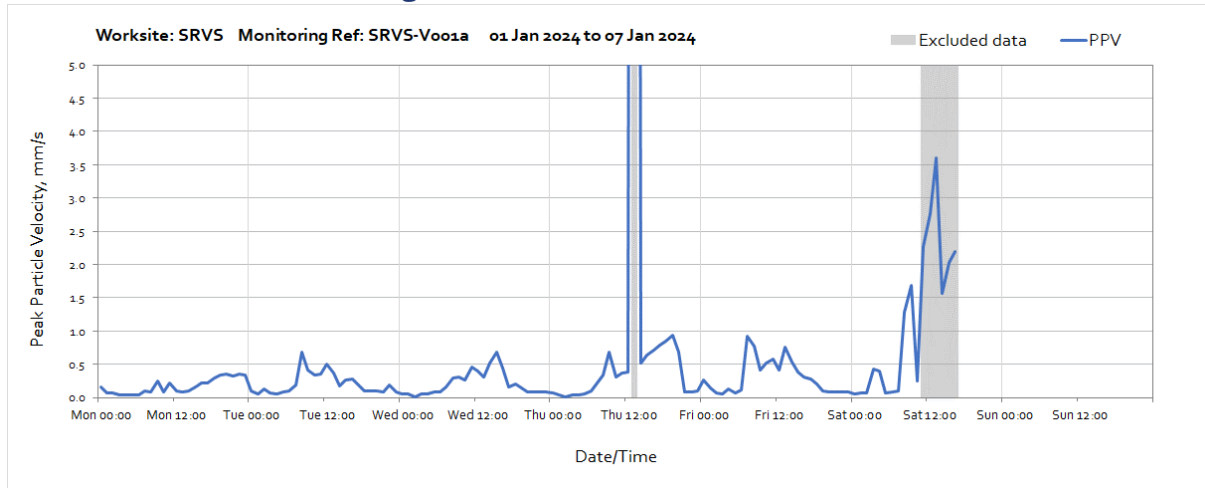
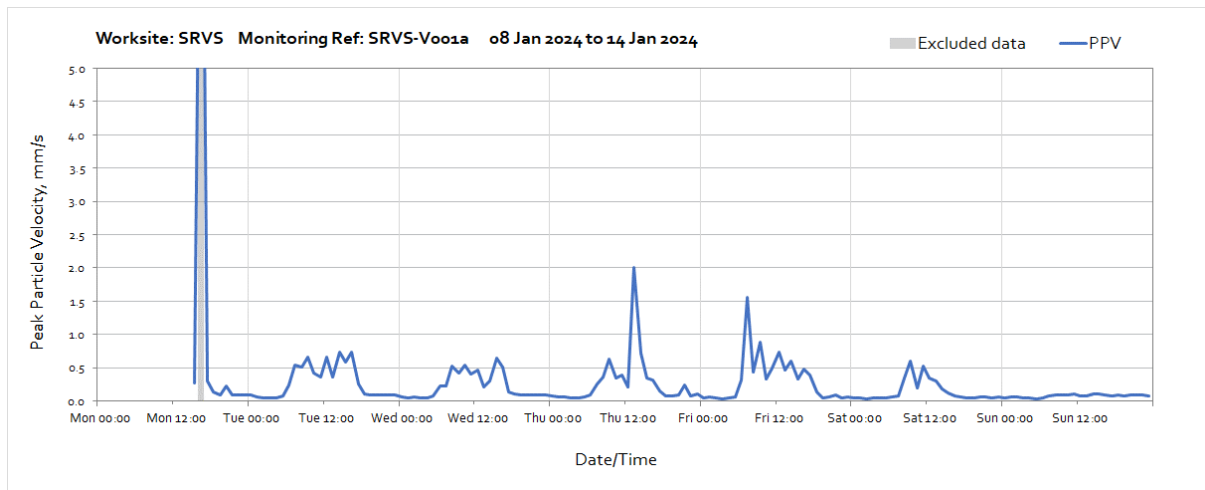
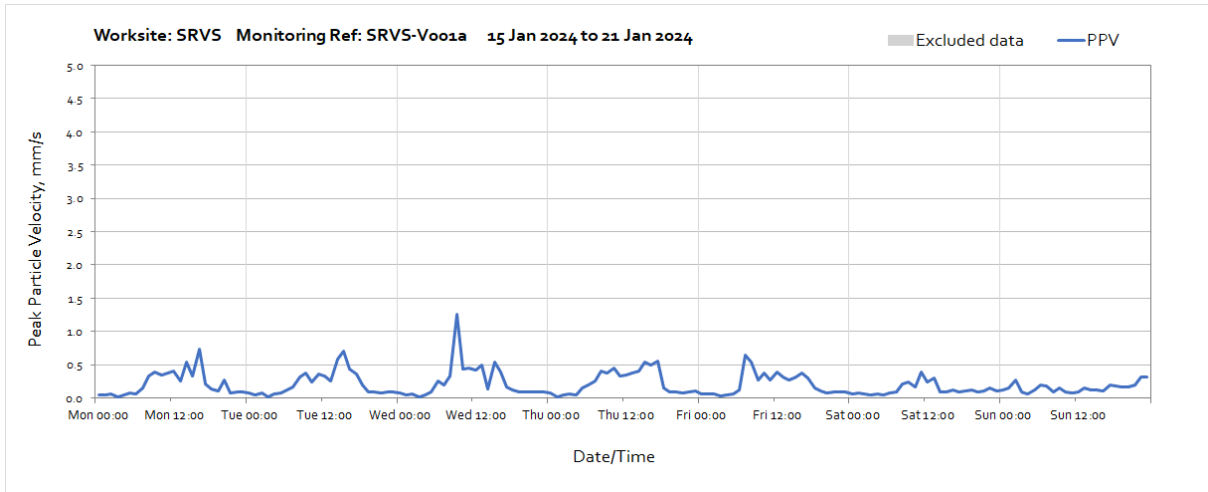
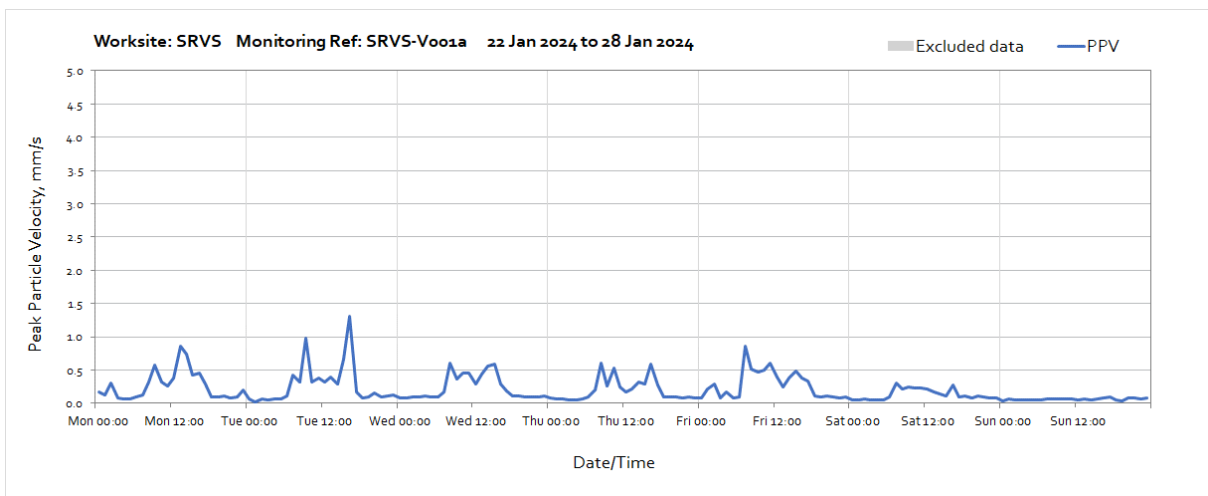
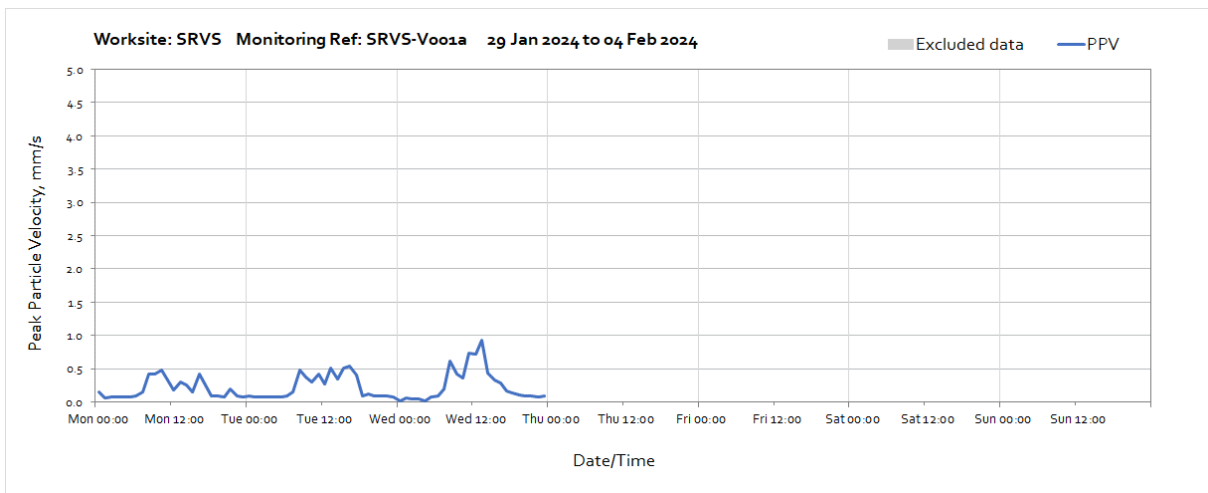
Worksite: SRVS – Monitoring Ref: SRVS-V001a

The following graphs show the hourly measured peak particle velocity PPV recorded during the monitoring period. The graphs show the highest PPV of the three orthogonal axis x, y, and z. Periods where PPV values have been affected by local interference with the vibration monitor or only measured for part of the period, which are not representative of HS2 construction works, have been greyed out and excluded when calculating values in Table 4 of the main report.

Note: Missing data between 17:00 on Saturday 6th January and 15:00 on Monday 8th January was due to a loss of power to the monitoring station caused by poor weather conditions preventing sufficient light reach the solar panel.

Worksite Reference	Measurement Reference	Monitor Address	Highest PPV measured in any axis, mm/s
WRP	GW-V001	95 The Greenway, Ickenham, Uxbridge	0.45 (Y-axis)
SRVS	SRVS-V001a	Braintree Road, Ruislip	2.00 (Z-axis)
