Construction Noise and Vibration Monthly Report – January 2024

Stratford-on-Avon District Council

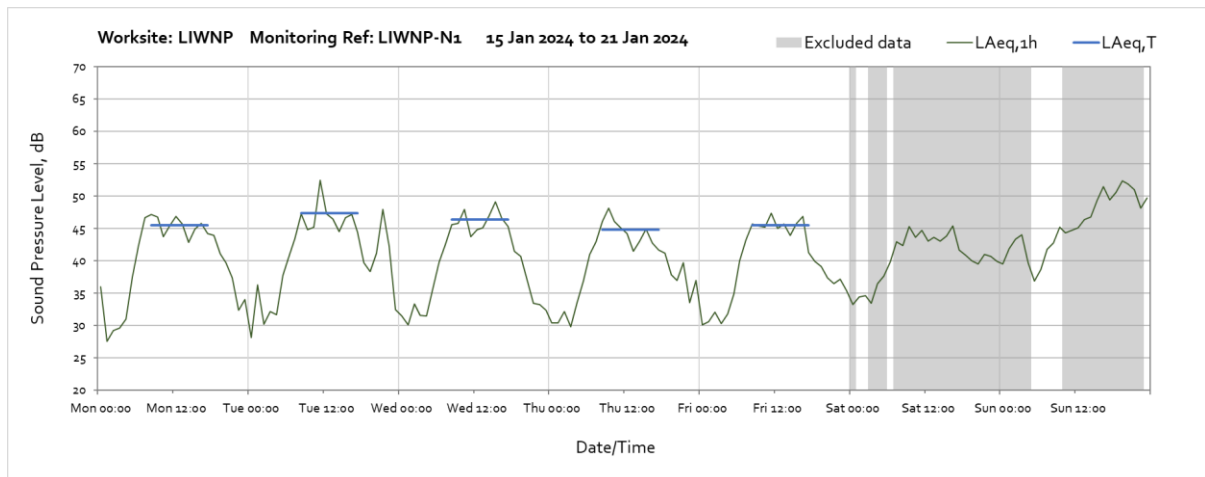
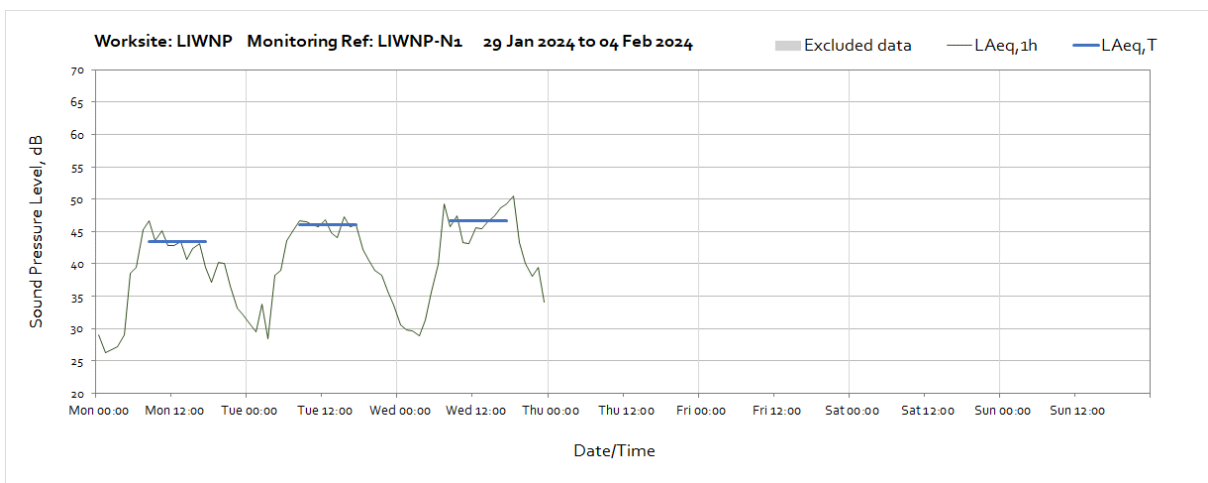
Worksite: LIWNP Monitoring Ref: LIWNP-N1

The following graphs show the hourly measured ambient noise level $L_{Aeq,1h}$ and, where relevant, the averaged noise level $L_{Aeq,T}$ values, where the time period T is as specified in Table 1 of HS2 Information Paper E23. Periods where noise levels are adversely affected by weather or only measured for part of the period, which are not representative of HS2 construction works, have been greyed out and excluded from the calculation of the $L_{Aeq,T}$ values in Table 3 of the main report.

Note: Missing data from the beginning of the month until 12:00 on Thursday 11th January was due to a loss of power to the monitoring station caused by depletion of battery power, which has since been replaced.

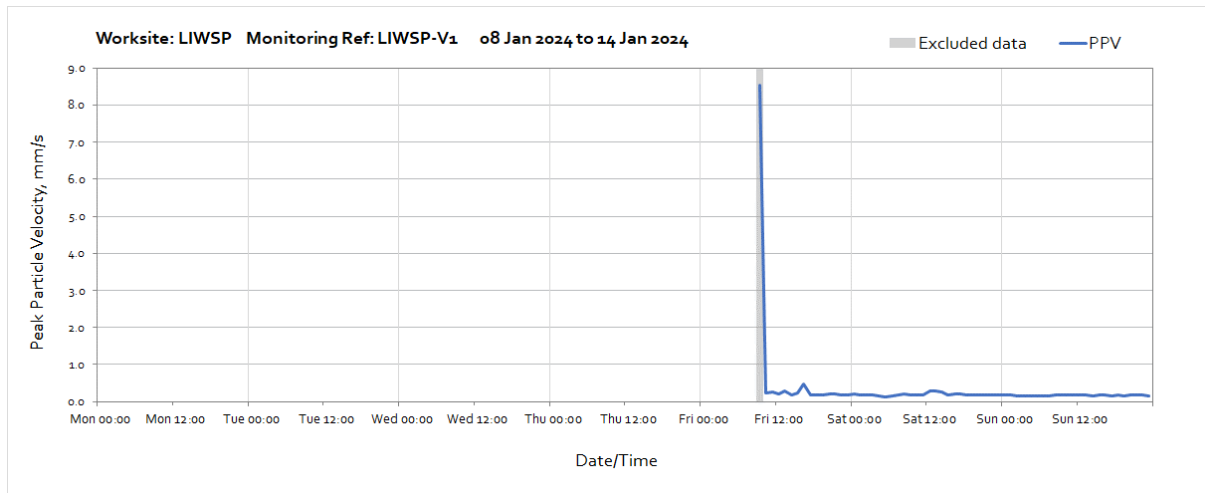
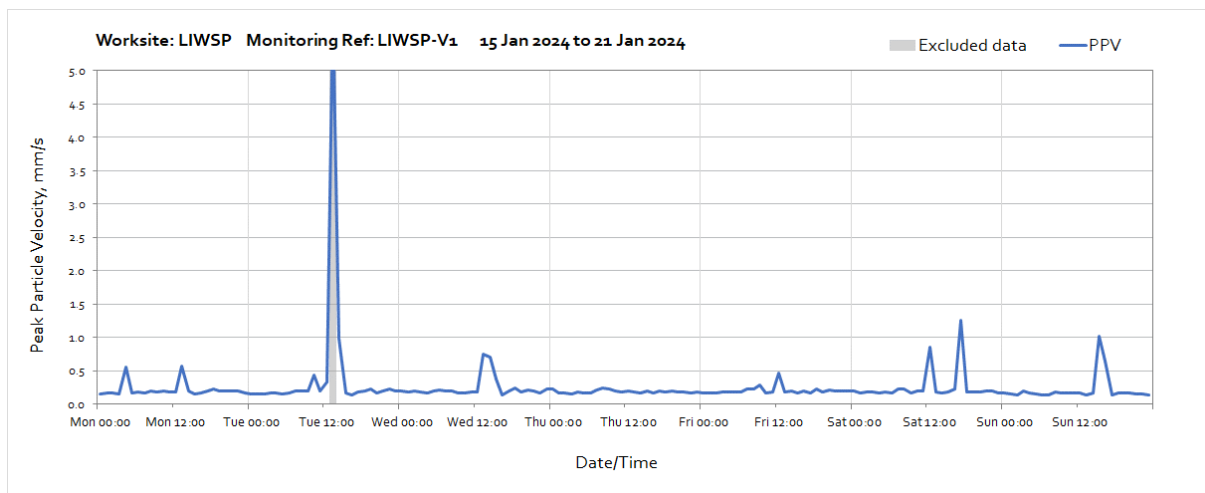
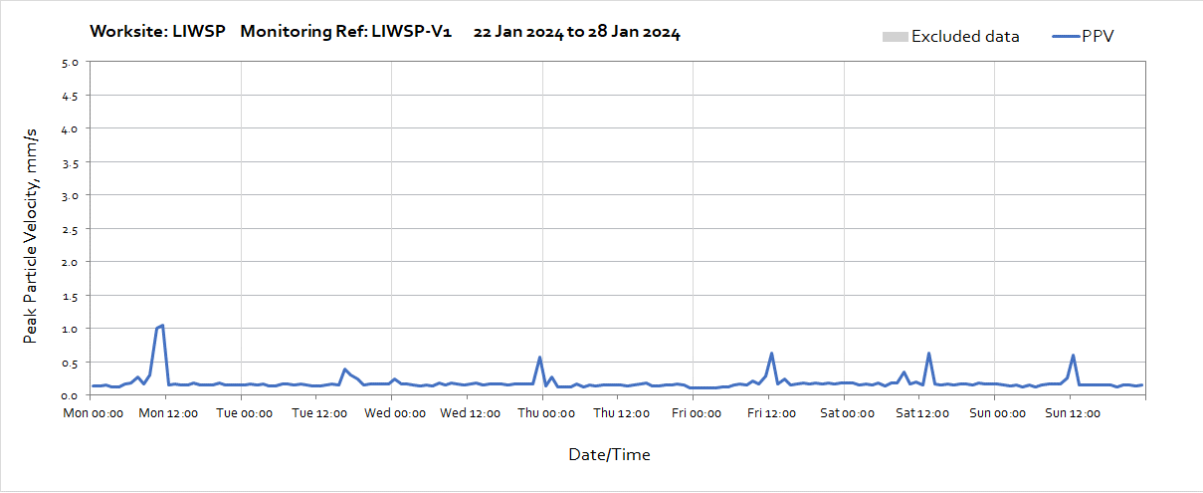
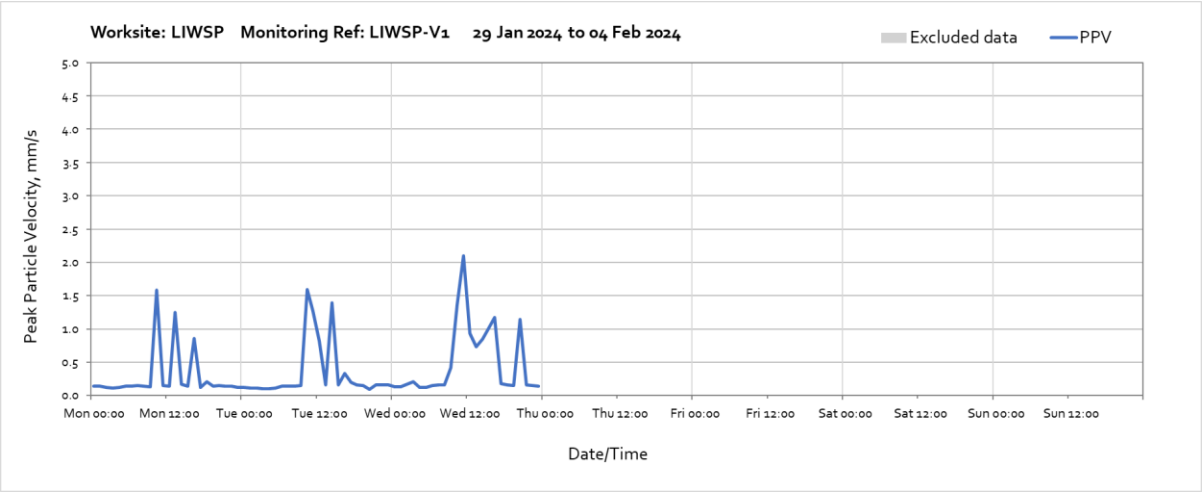
Worksite: LIWSP Monitoring Ref: LIWSP-V1

The following graphs show the hourly measured peak particle velocity PPV recorded during the monitoring period. The graphs show the highest PPV of the three orthogonal axes x, y and z. Periods where PPV values have been affected by local interference with the vibration monitor or only measured for part of the period, which are not representative of HS2 construction works, have been greyed out and excluded when calculating values in Table 4 of the main report.

Note: Missing data from the beginning of the month until 09:00 on Friday 12th January was due to a loss of power to the monitoring station caused by poor weather conditions preventing sufficient light from reaching the solar panel.

Worksite Reference	Measurement Reference	Monitor Address	Highest PPV measured in any axis, mm/s
LIWSP	LIWSP-V1	Woodside House, Bascote Heath, Southam	1.90 (Z-axis)
