Public service vehicle (PSV) inspection manual

Public Service Vehicle Revision Record

About this Manual

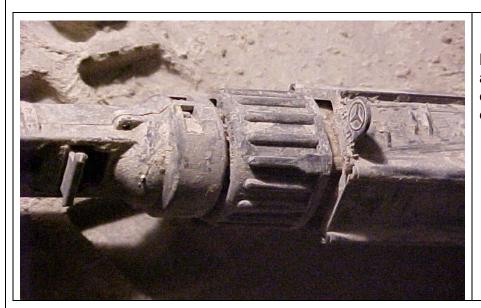
Plastic sleeve seals are acceptable but will require an embossed identification, (see example to left).
