Air Quality and Dust Monitoring Monthly Report - February 2024

Cherwell District Council

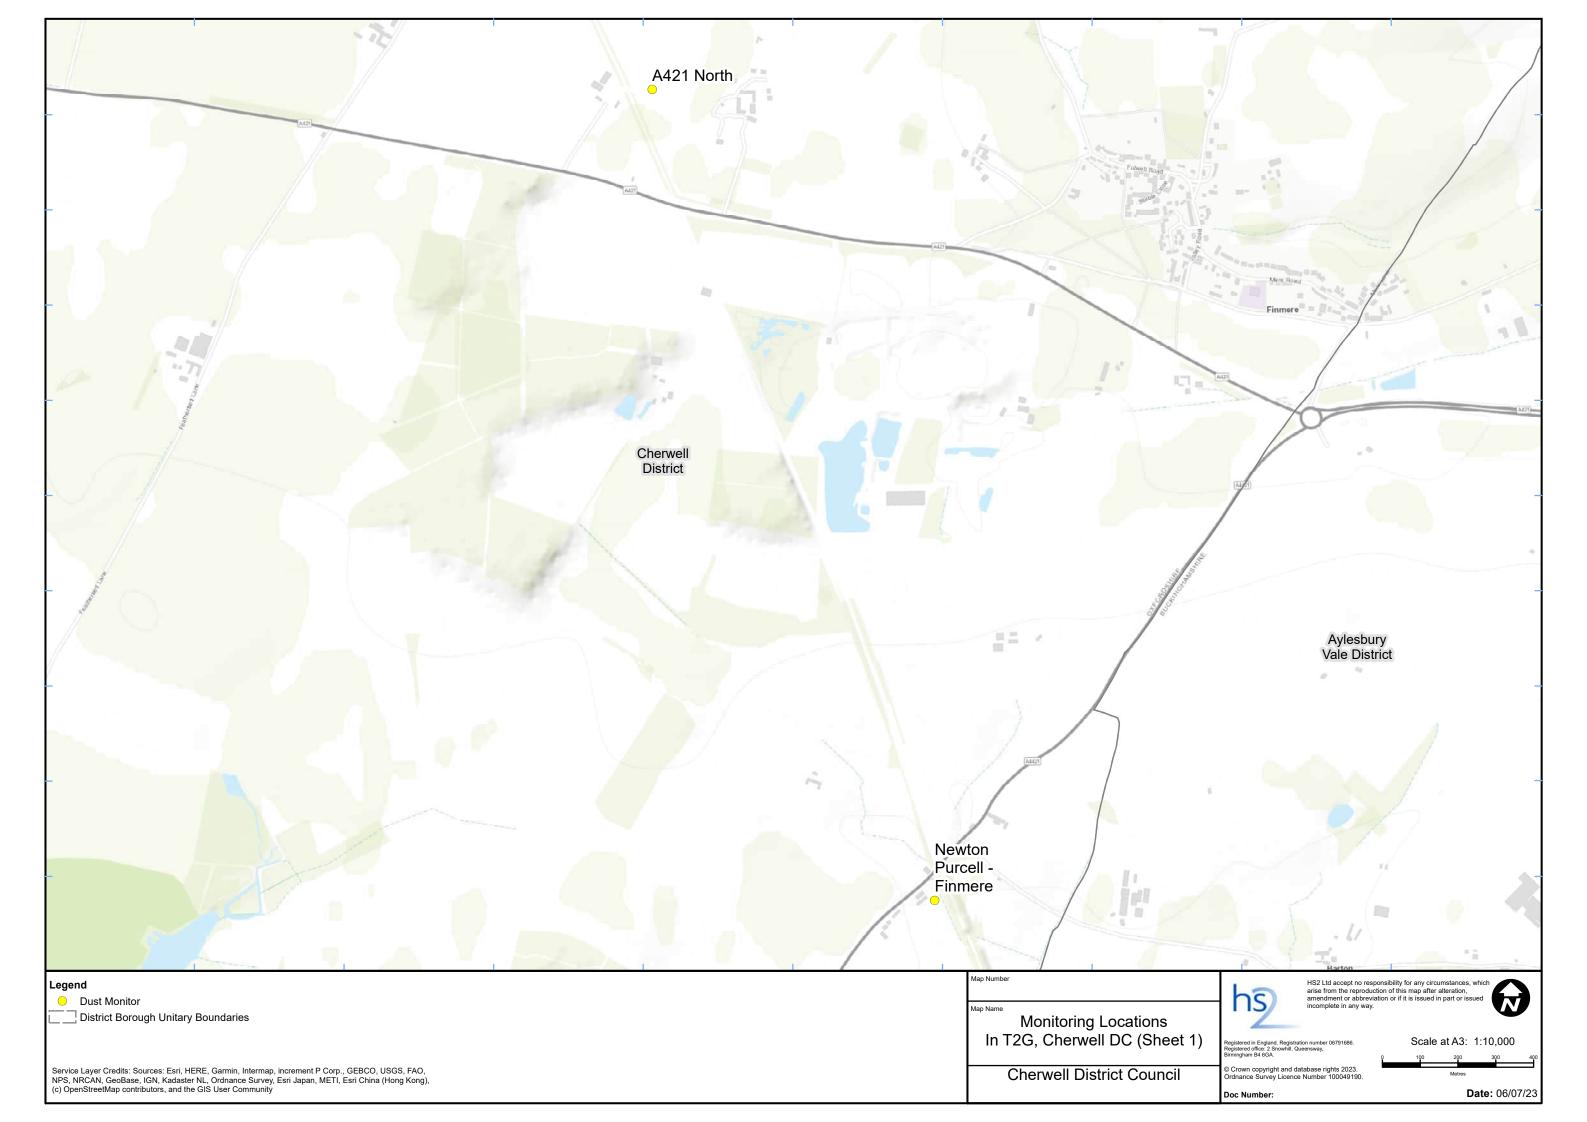
Figure 1: Worksite and Monitoring locations within CDC

- 1.1.4 The current worksites, as presented in Appendix A, Figure 1, include:

A4421 Overbridge

- Stone deliveries
- Landscape bund construction.
- Ramp reinforcement.
- Aggregate deliveries
- Backfill around abutment 3 and abutment 0 (West and East)
- Steel beam instillation

A421 Overbridge worksite

- Backfilling around the pile caps
- Blinding to the pile cap level
- Steel fixing of the piers
- 1.1.5 Two (2) dust monitors are installed around these worksites, where works are underway. These sites returned a medium dust risk rating.
- 1.1.6 Dust monitoring locations and results are presented in Appendix B, Table 1, together with line charts of monthly data from each dust monitor presented in Figure 2. All continuous dust monitoring is undertaken using indicative monitors. Despite being Environment Agency (MCERTS) certified, indicative monitors carry a higher level of uncertainty than reference monitors, and therefore cannot be strictly compared with Air Quality Standards for human health and the environment. The purpose of the monitoring undertaken is to ensure the effectiveness of the on-site mitigation.

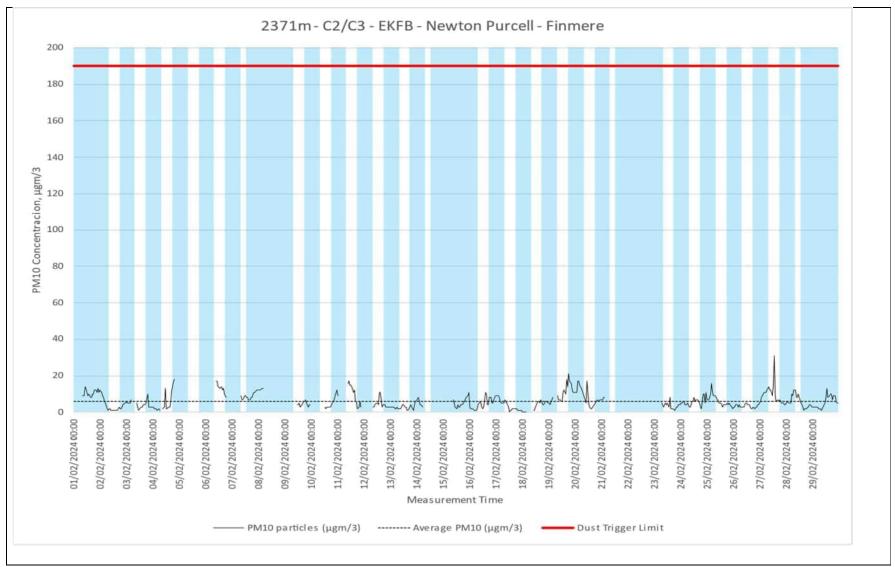
Figure 2: Continuous dust 1-hour mean indicative PM₁₀ concentration for all monitors

- 1.1.7 The trigger level for PM_{10} concentrations of 190 μ g/m³, over a 1-hour period, in accordance with the updated guidance document 'Guidance on Monitoring in the Vicinity of Demolition and Construction Sites (October 2018)' has been applied.
- 1.1.8 No (0) dust trigger alerts were recorded during the monitoring period (February 2024).
- 1.1.9 Data capture was below 90% for two (2) monitors due to a lack of solar charge at the A4421 Overbridge monitor. No data was captured at the A421 North worksite for the month of February 2024 due to a fault with the PT10 part resulting in the monitor not receiving power. The monitor was retrieved on 8th December 2023.
- 1.1.10 There were no (0) complaints received during the reporting period (February 2024).
