Air Quality and Dust Monitoring Monthly Report – February 2024

West Northamptonshire District Council

A report prepared by EWCs and MWCCs on behalf of HS2 Ltd.

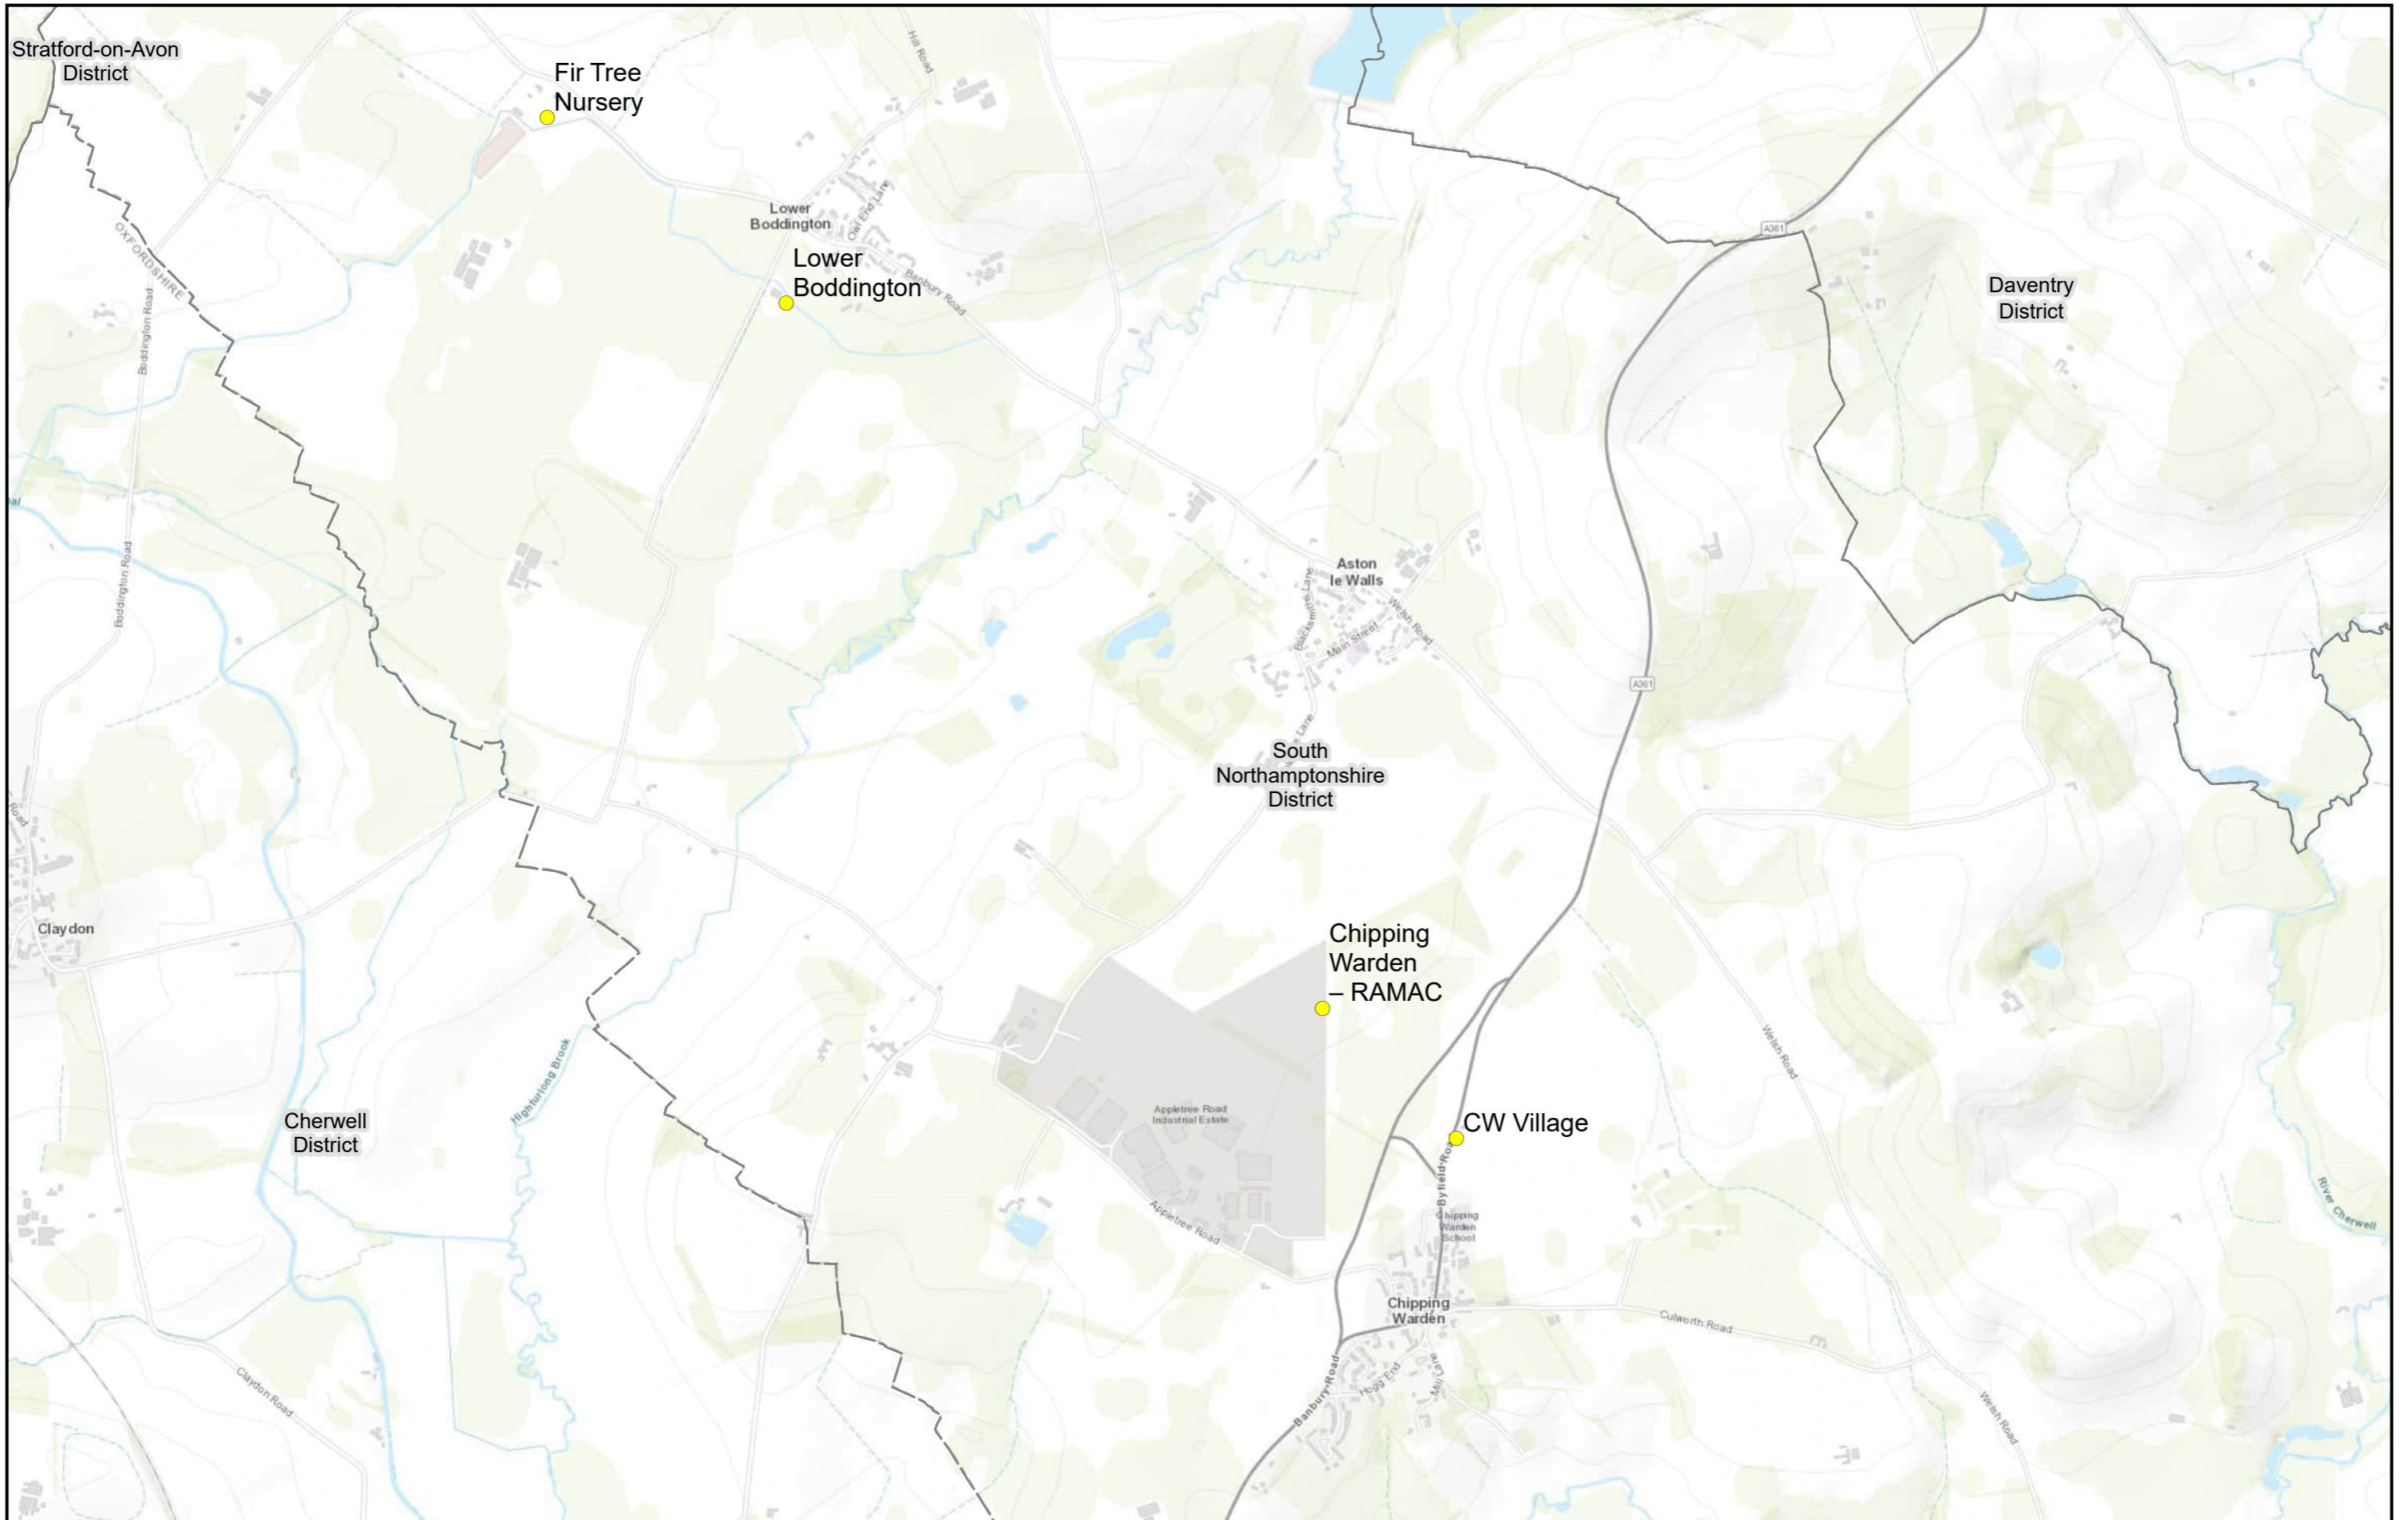
Map Number
 Map Name
**Monitoring Locations
 In WNDC (Sheet 1)**
 West Northamptonshire Council

- 1.1.2 Figure 1 and Figure 2 in Appendix A present the current worksites together with the dust monitoring locations.
- 1.1.3 This summary should be read in conjunction with the overview monitoring report available from www.gov.uk/government/collections/monitoring-the-environmental-effects-of-hs2, which highlights: the applicable standards and guidance, as well as the air quality and dust monitoring methodologies to be implemented by nominated undertakers throughout construction.

- 1.1.4 The current worksites, as presented in Appendix A, Figure 1 and Figure 2, include:

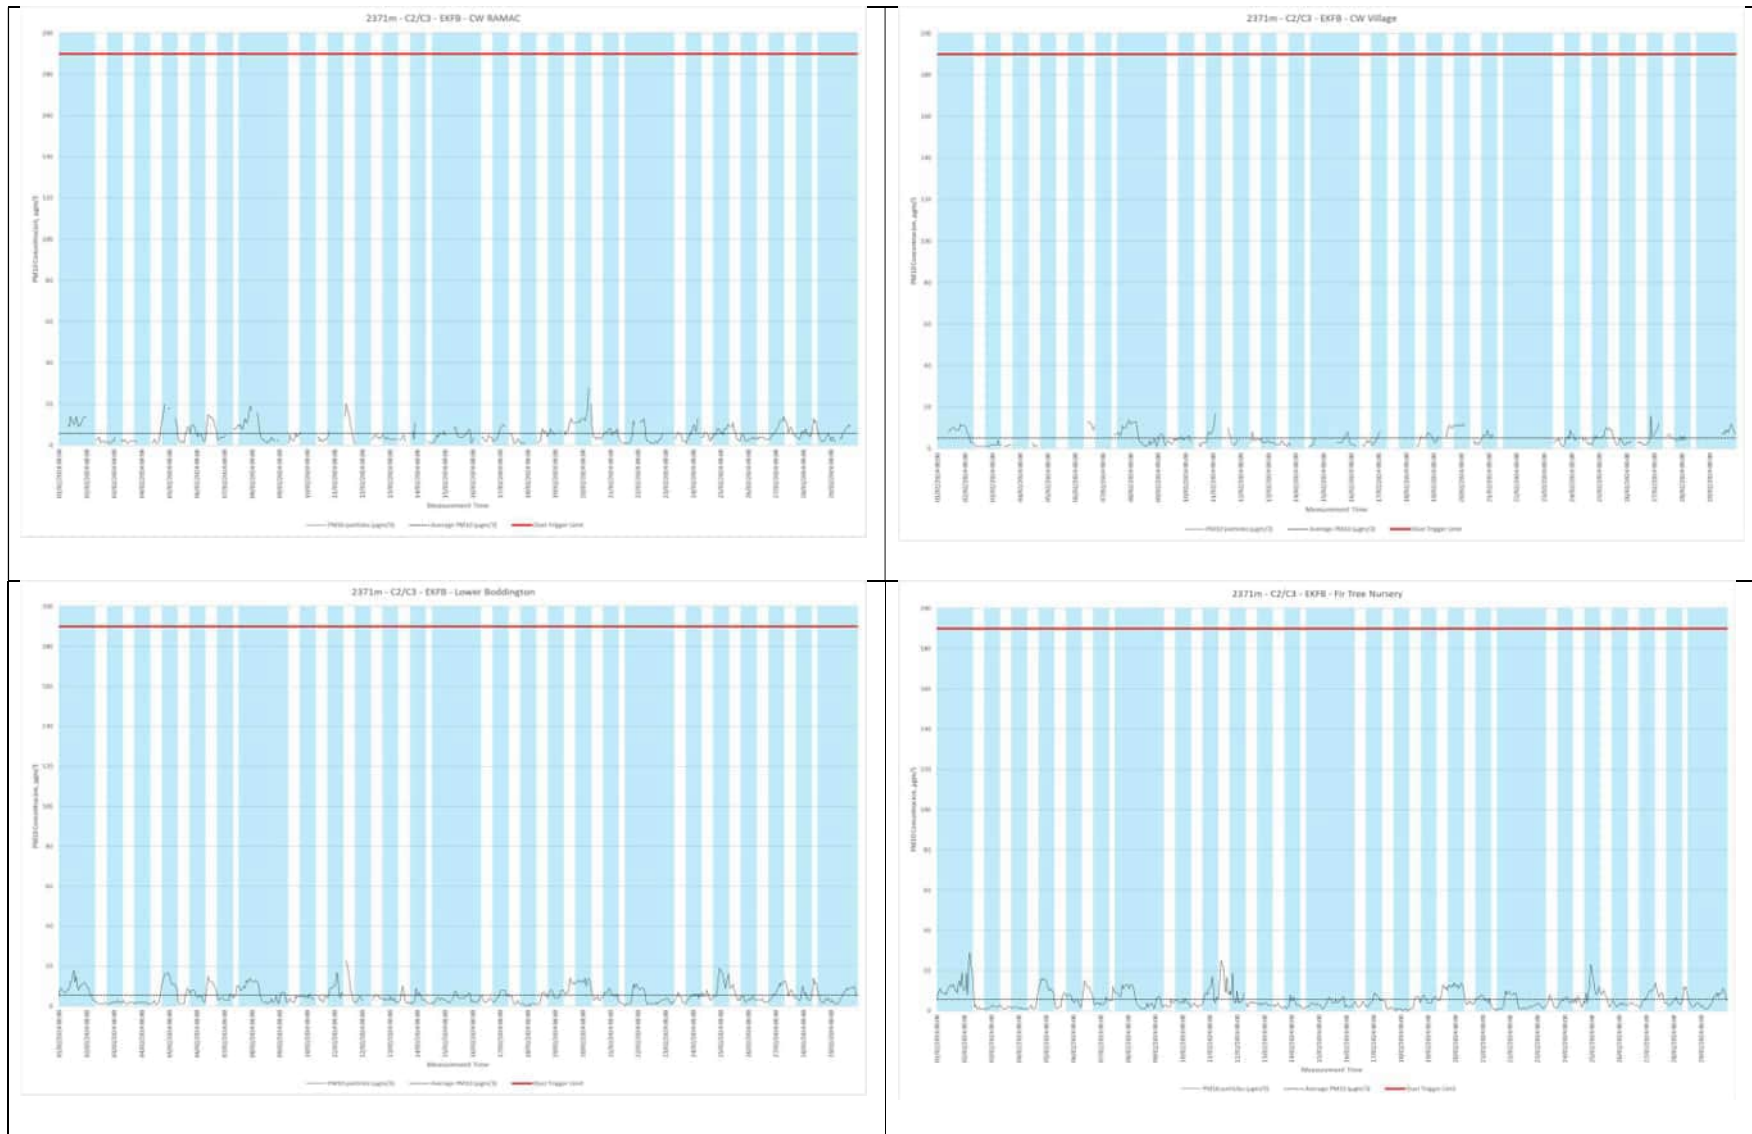
Figure 3: Continuous dust 1-hour mean indicative PM₁₀ concentration for all monitors

1.1.6 Dust monitoring locations and results are presented in Appendix B, Table 1, together with line charts of monthly data from each dust monitor, presented in Figure 3. All continuous dust monitoring is undertaken using indicative monitors. Despite being Environment Agency (MCERTS) certified, indicative monitors carry a higher level of uncertainty than reference monitors, and therefore cannot be strictly compared with Air Quality Standards for human health and the environment. The purpose of the monitoring undertaken is to ensure the effectiveness of the on-site mitigation.

1.1.7 The trigger level for PM₁₀ concentrations of 190 µg/m³, over a 1-hour period, in accordance with the updated guidance document '*Guidance on Monitoring in the Vicinity of Demolition and Construction Sites - (October 2018)*' has been applied.

1.1.8 No (0) dust trigger alerts were recorded during the monitoring period (February 2024).

1.1.9 Data capture was below 90% for multiple monitors due to a lack of solar charge. Greatworth Village monitor had a fault with the connected noise monitor effecting data capture. Hall

Farm and Greatworth Hall monitors were collected for laboratory calibration. The Radstone monitor had a power fault.
