Construction noise and vibration Monthly Report – February 2024

London Borough of Hillingdon

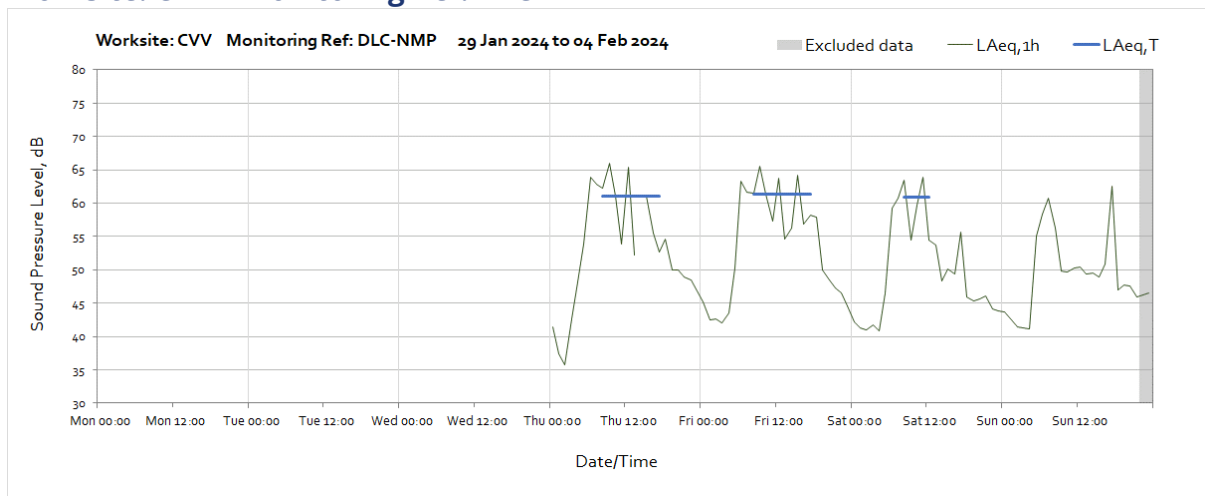
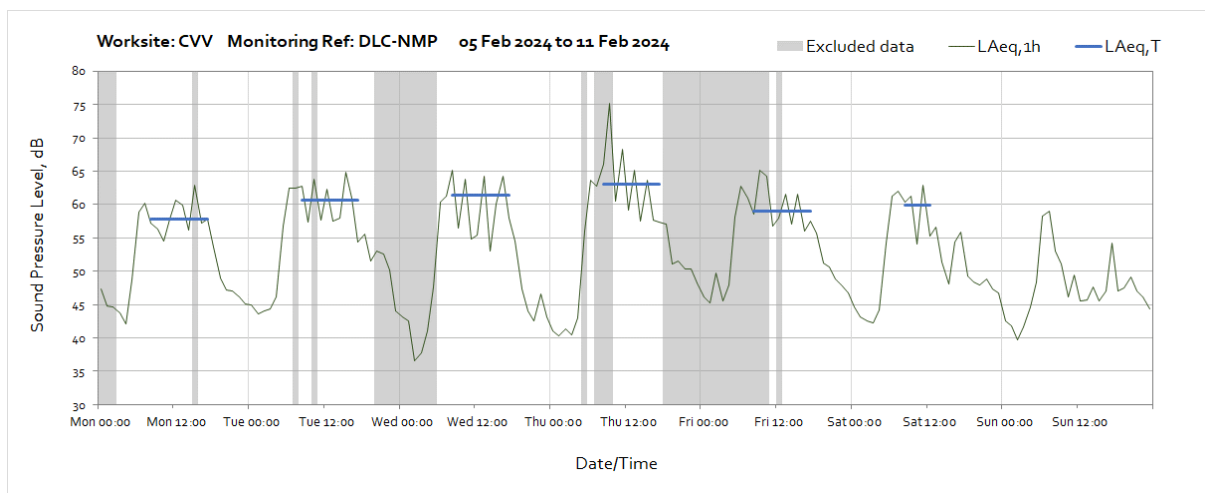
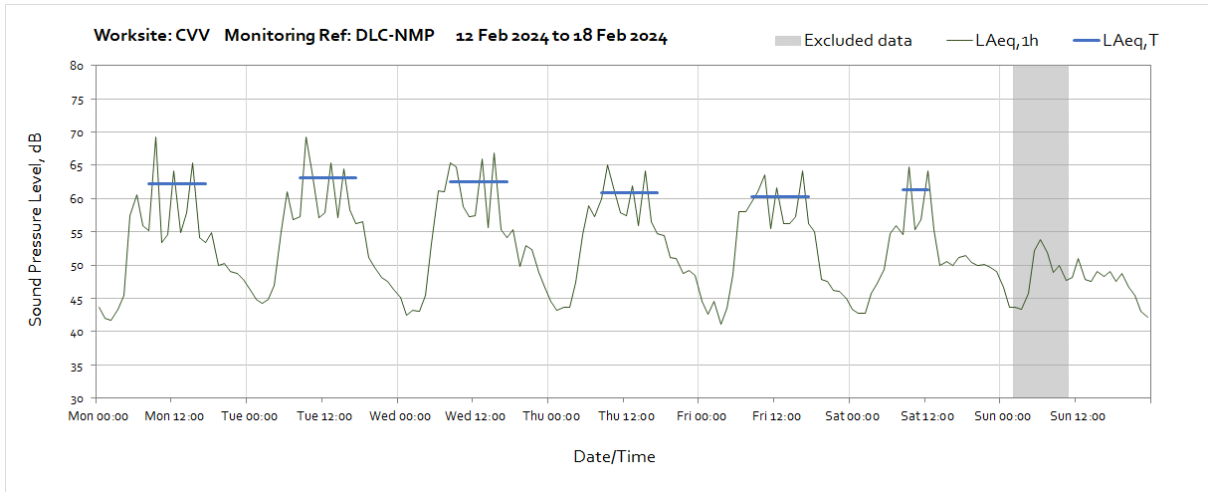
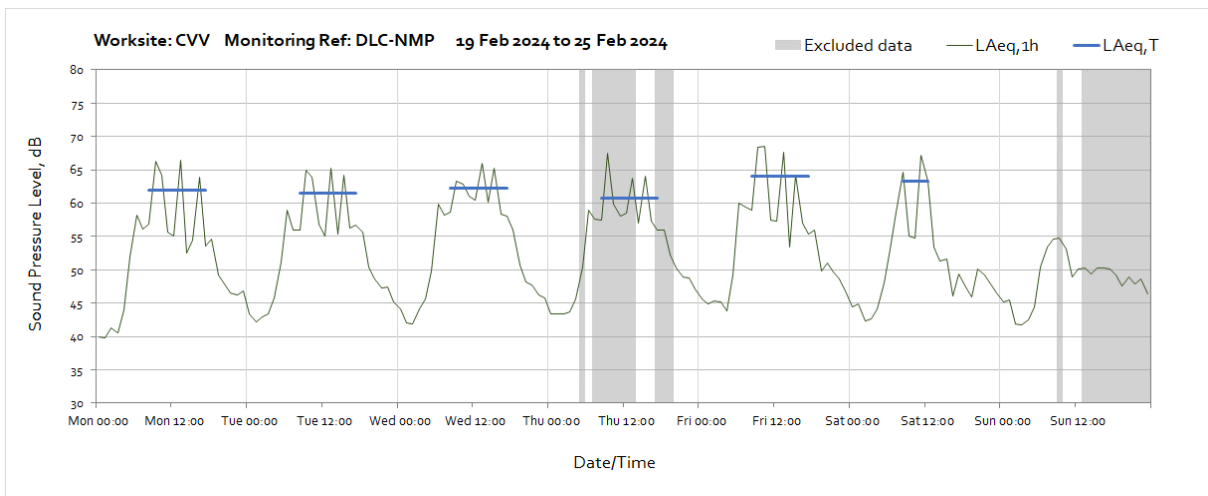
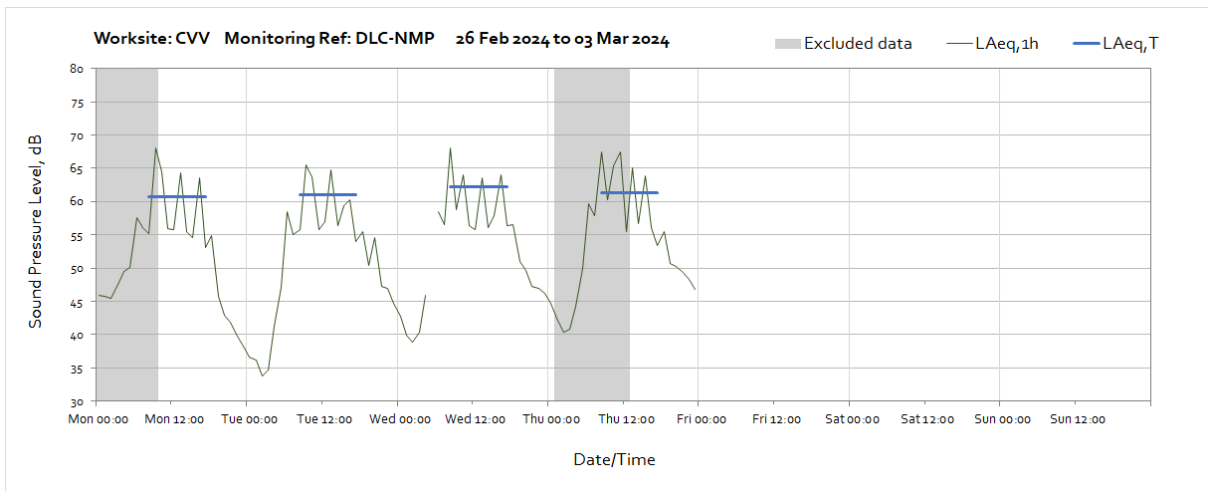
Worksite: CVV – Monitoring Ref: DLC-NMP

Note: Missing data between 14:00 and 15:00 on Thursday 1st February was due to monitor field calibration.

Note: Missing data between 05:00 and 06:00 on Wednesday 28th February was due to a communication error between the monitoring station and server.

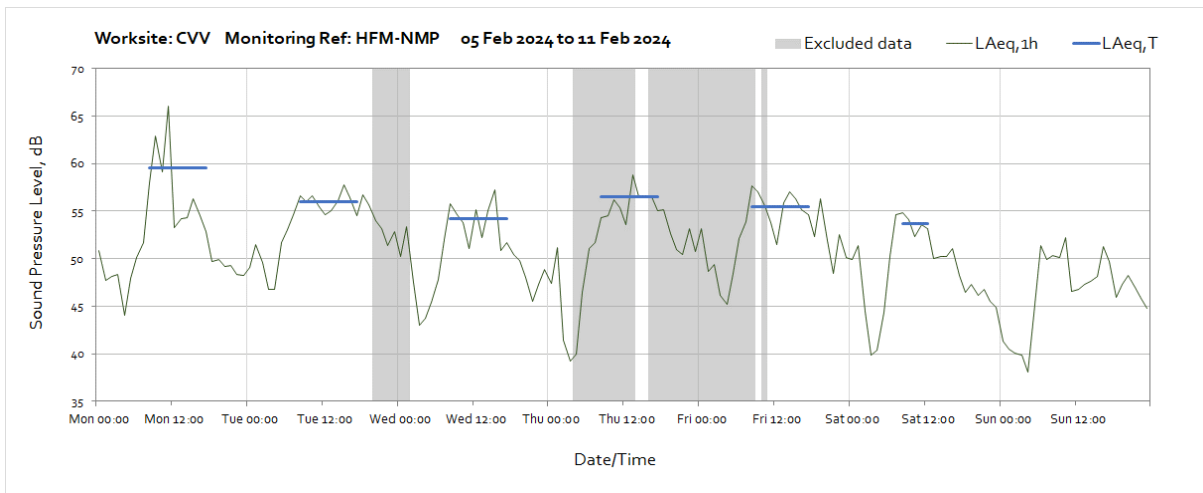
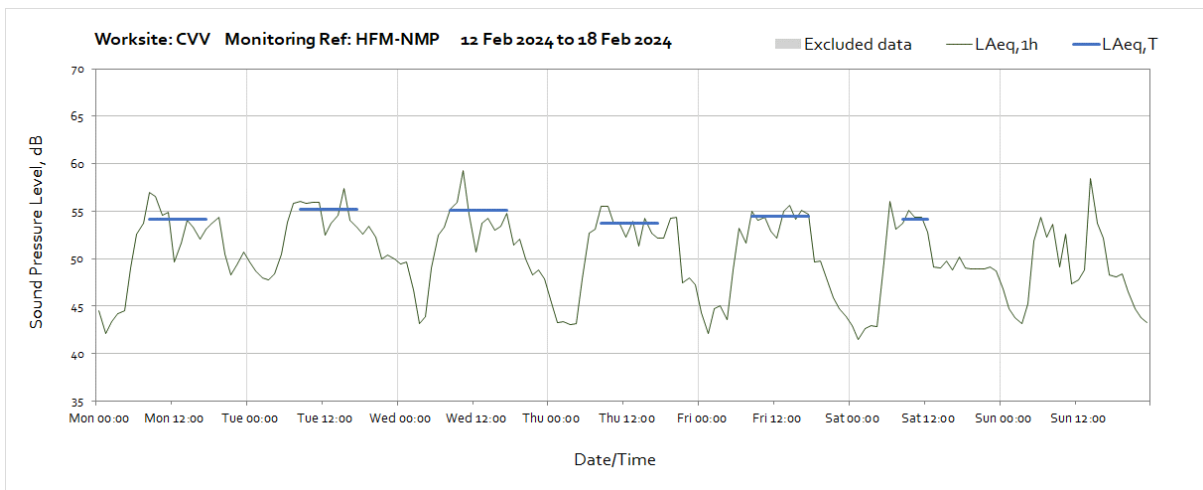
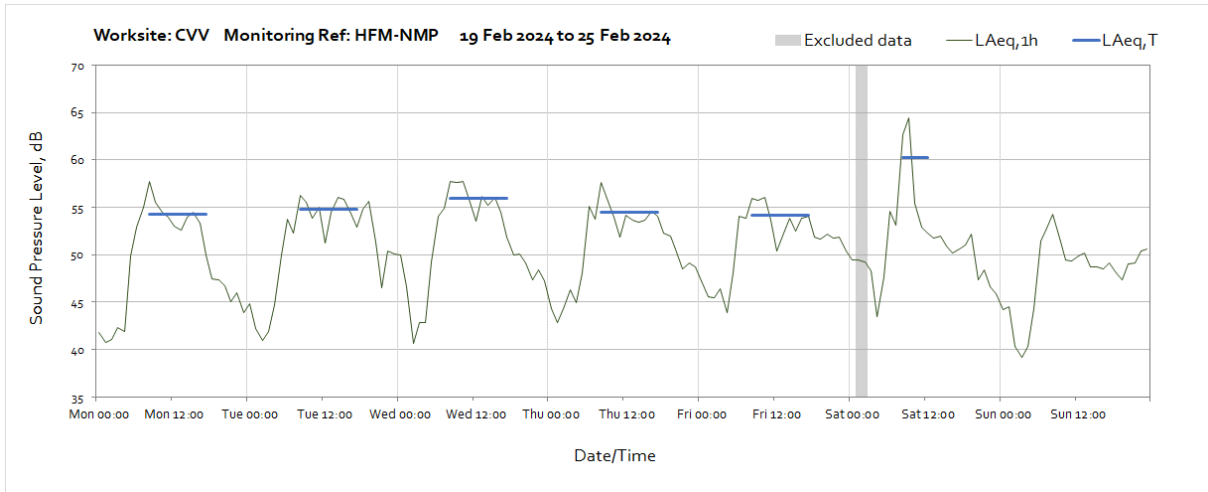
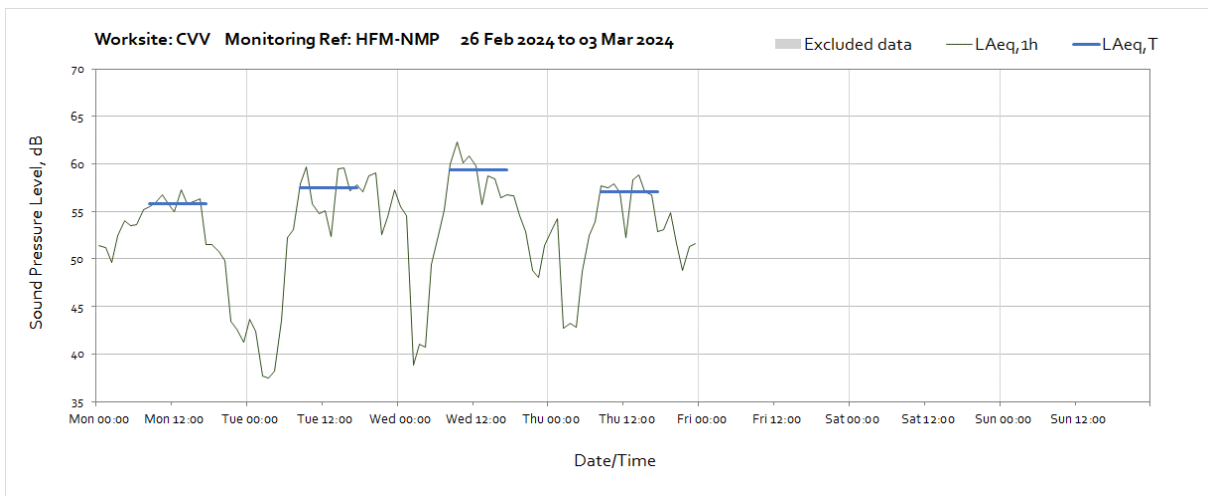
Worksite: CVV – Monitoring Ref: HFM-NMP

2.2.8 Five (5) SOAEL exceedances were recorded due to HS2 construction works during February 2024. The exceedance occurred at HFM-NMP during night-time periods.

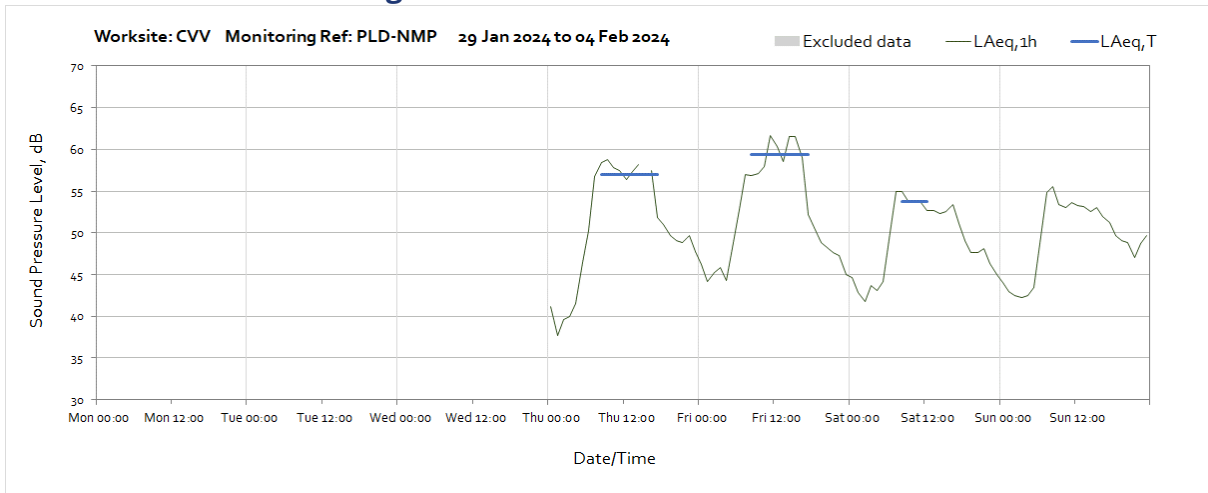
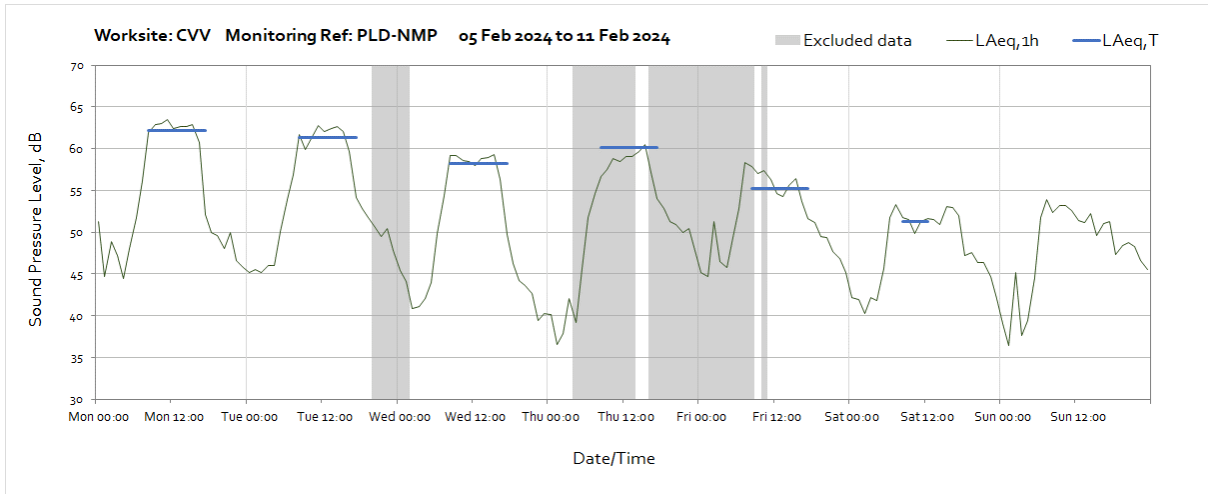
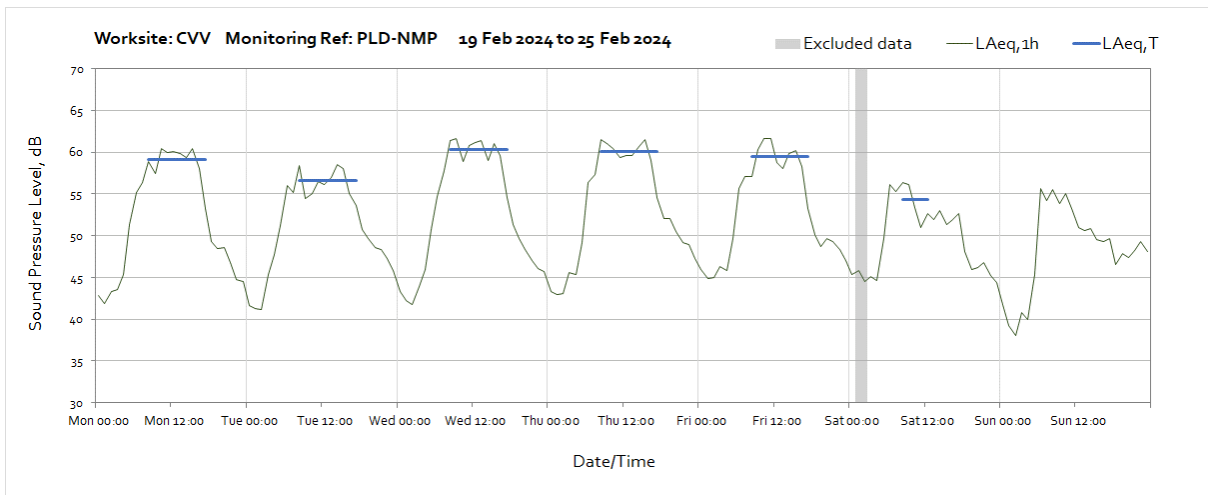
Worksite: CVV – Monitoring Ref: PLD-NMP

Note: Missing data between 15:00 and 16:00 on Thursday 1st February was due to monitor field calibration.

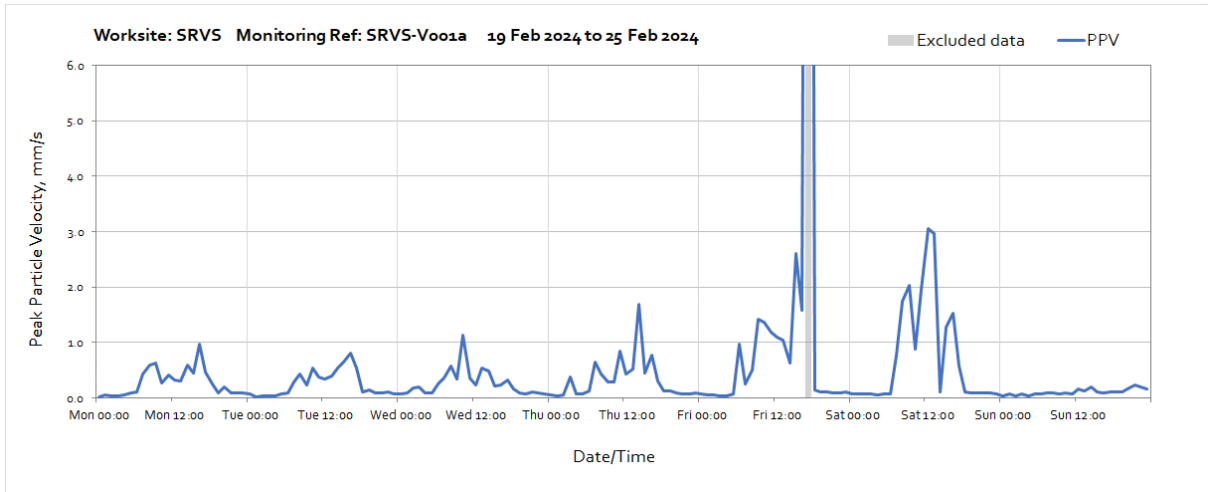
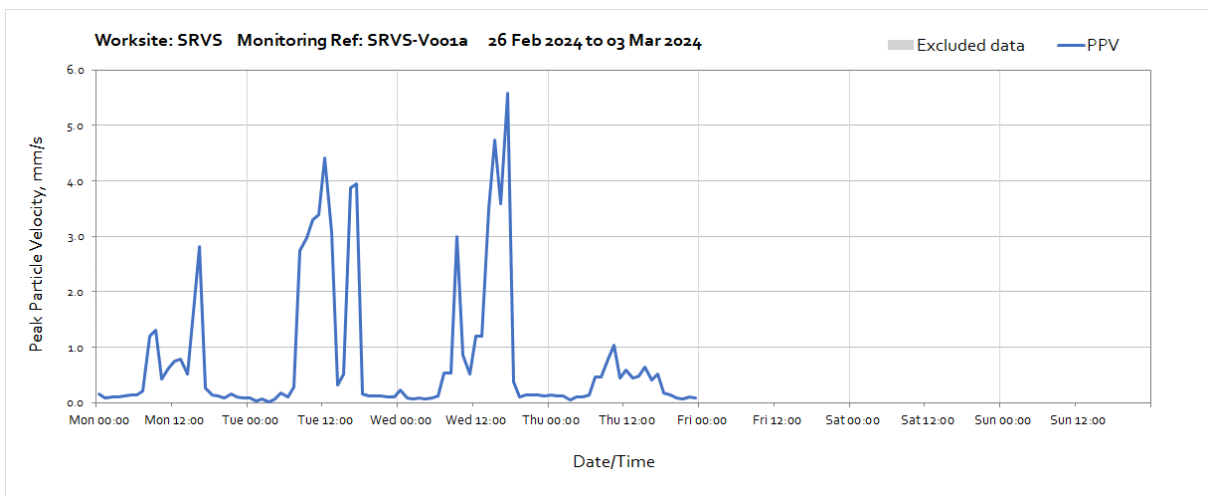
Worksite: SRVS – Monitoring Ref: SRVS-V001a

Worksite Reference	Measurement Reference	Monitor Address	Highest PPV measured in any axis, mm/s
WRP	GW-V001	95 The Greenway, Ickenham, Uxbridge	0.40 (Y-axis)
SRVS	SRVS-V001a	Braintree Road, Ruislip	5.58 (Z-axis)
