## **Construction Noise and Vibration Monthly Report – February 2024**

**Lichfield District Council**

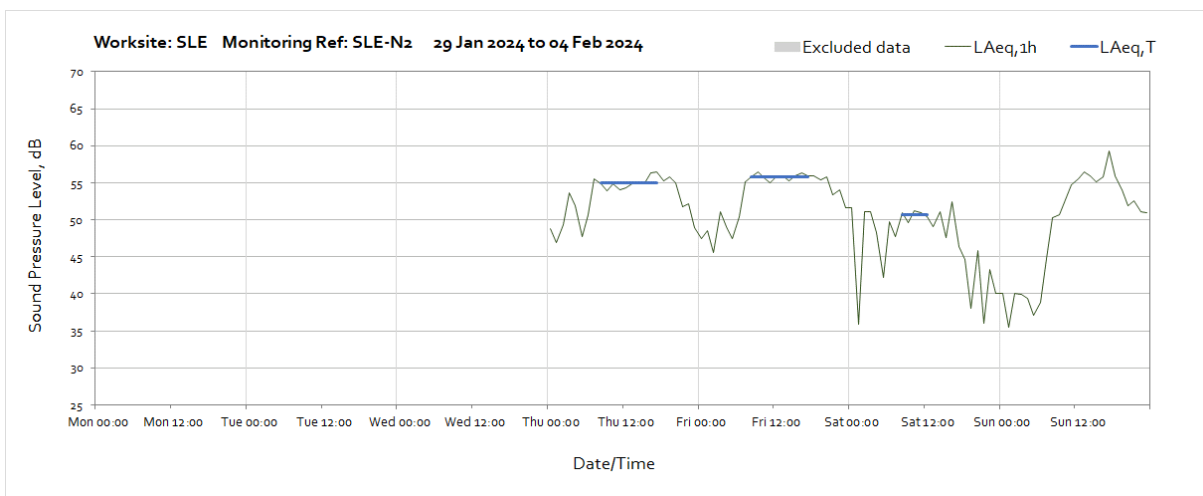
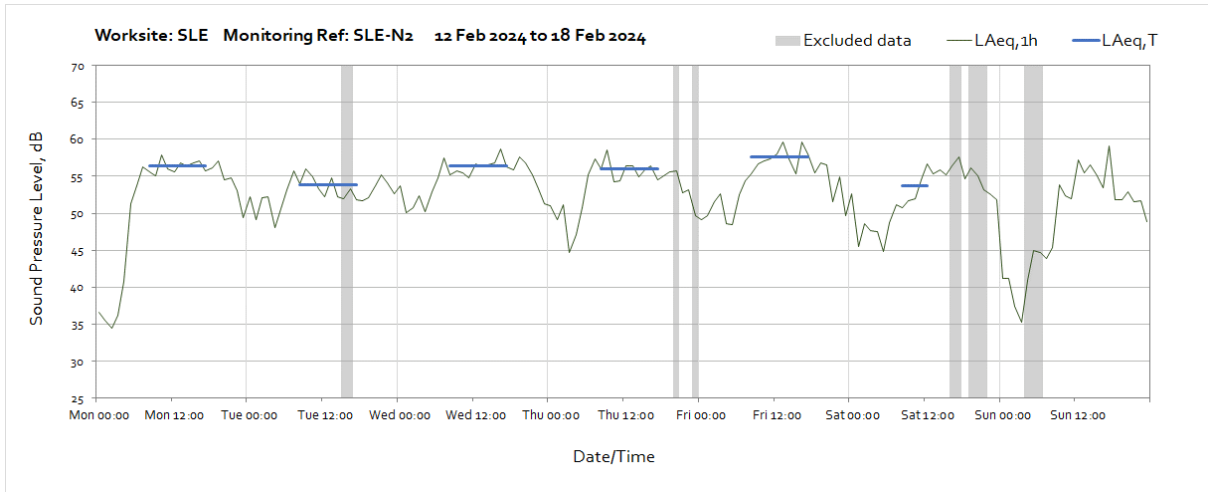
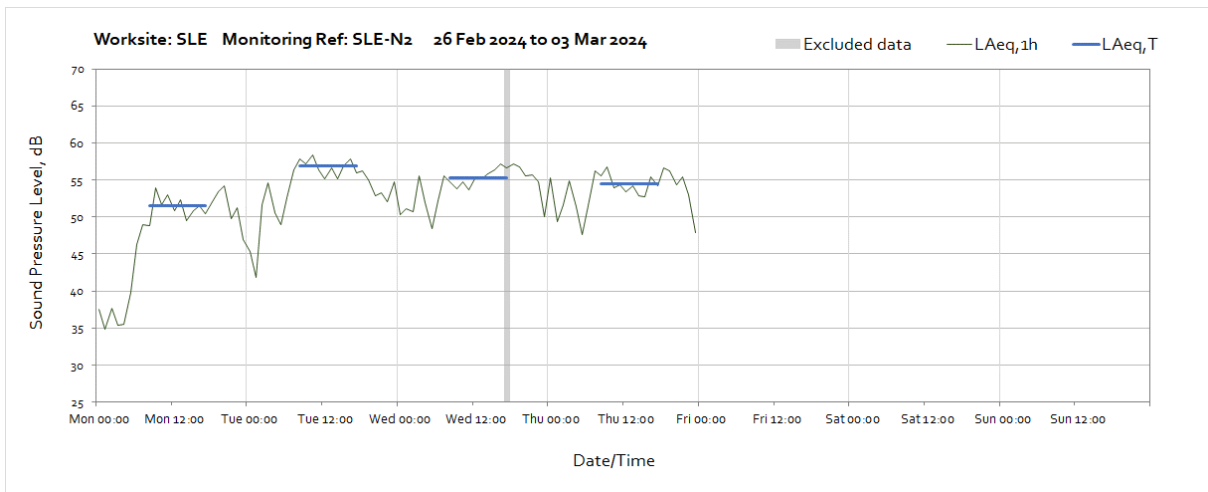
### Worksite:SLE - Monitoring Ref: SLE-N2

The following graphs show the hourly measured ambient noise level LAeq,1h and, where relevant, the averaged noise level LAeq,T values, where the time period T is as specified in Table 1 of HS2 Information Paper E23. Periods where noise levels are adversely affected by weather or only measured for part of the period, which are not representative of HS2 construction works, have been greyed out and excluded from the calculation of the LAeq,T values in Table 3 of the main report.
