Construction Noise and Vibration Monthly Report – February 2024

North Warwickshire Borough Council

Non-Technical Summary

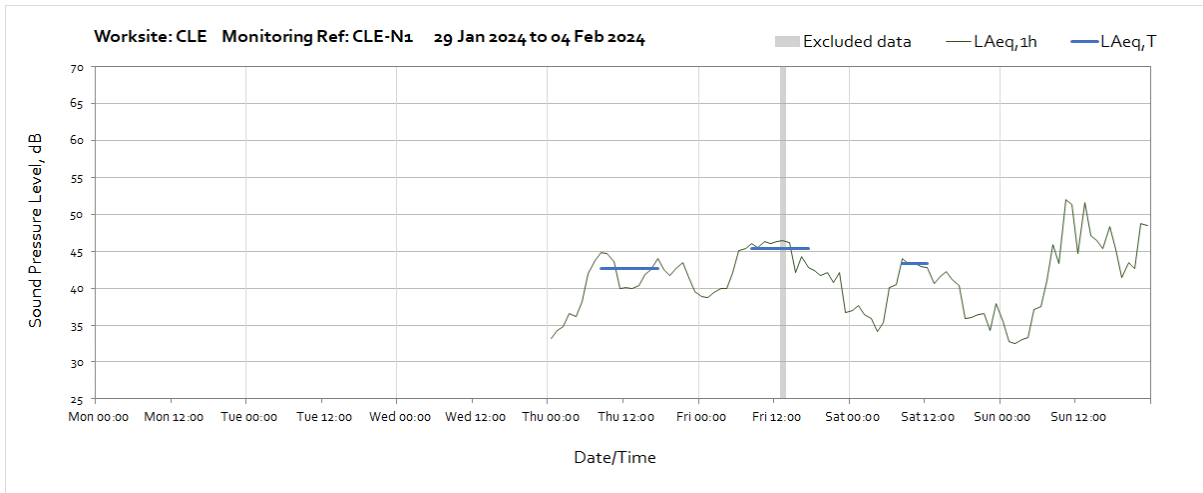
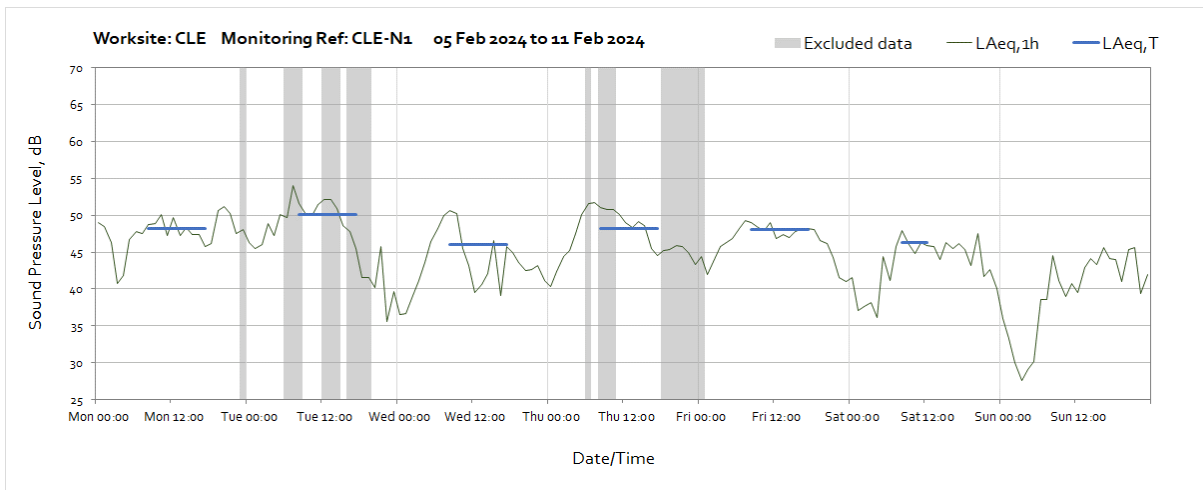
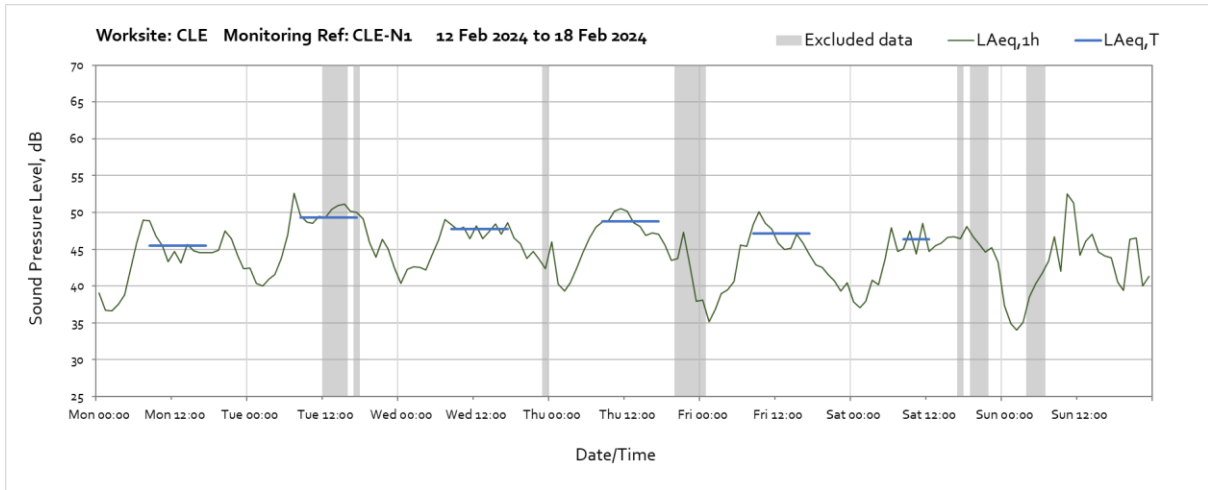
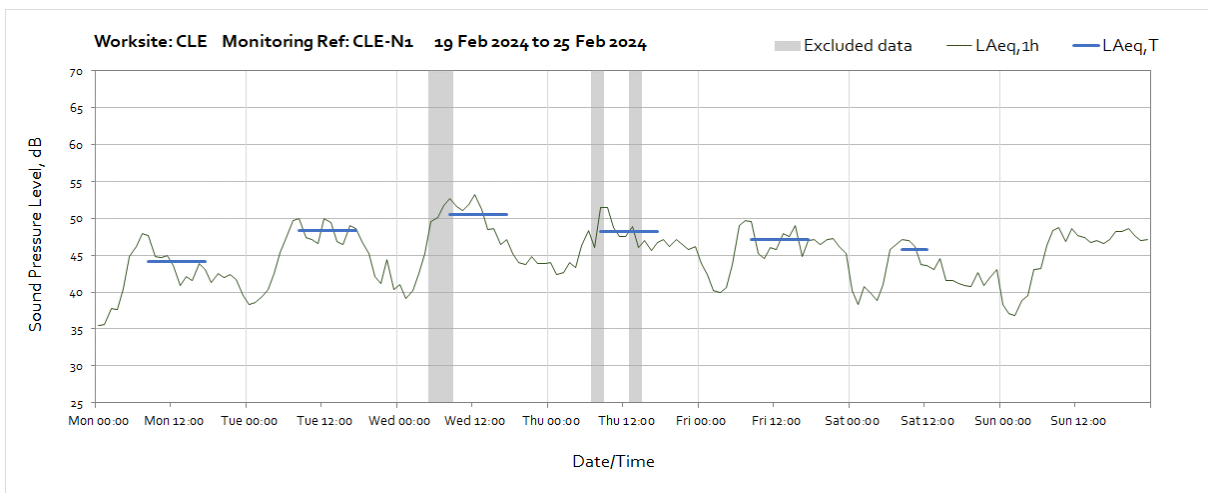
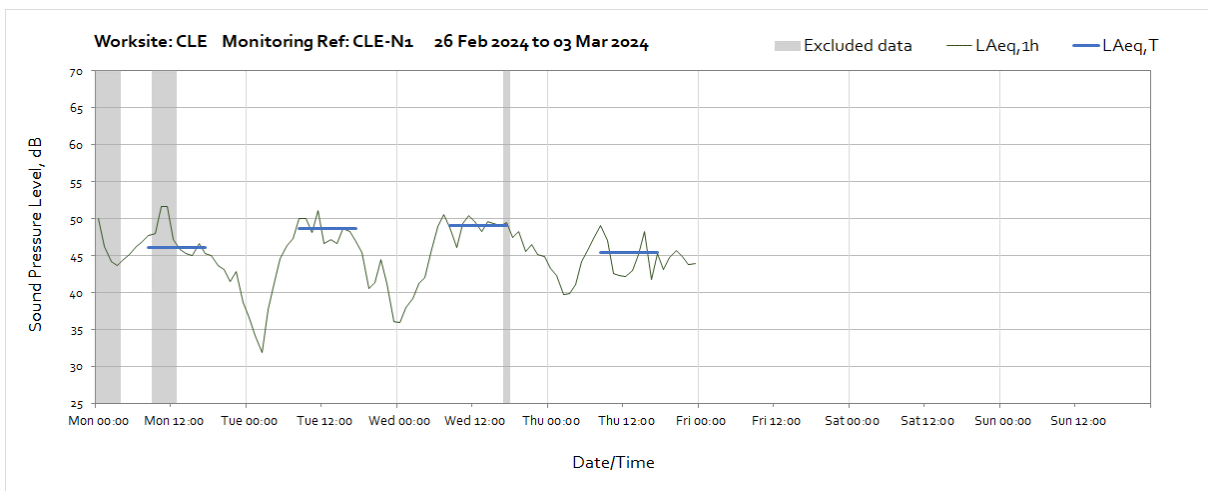
Worksite: CLE – Monitoring Ref: CLE-N1

The following graphs show the hourly measured ambient noise level $L_{Aeq,1h}$ and, where relevant, the averaged noise level $L_{Aeq,T}$ values, where the time period T is as specified in Table 1 of HS2 Information Paper E23. Periods with adversely weather affected noise levels are greyed out and have been excluded from the calculation of the $L_{Aeq,T}$ values in Table 3 of the main report.:

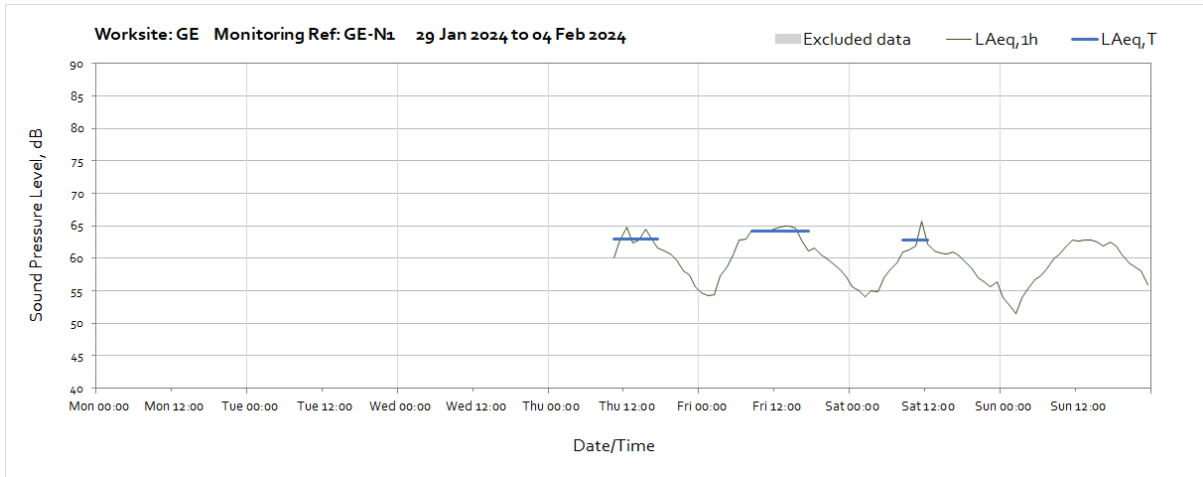
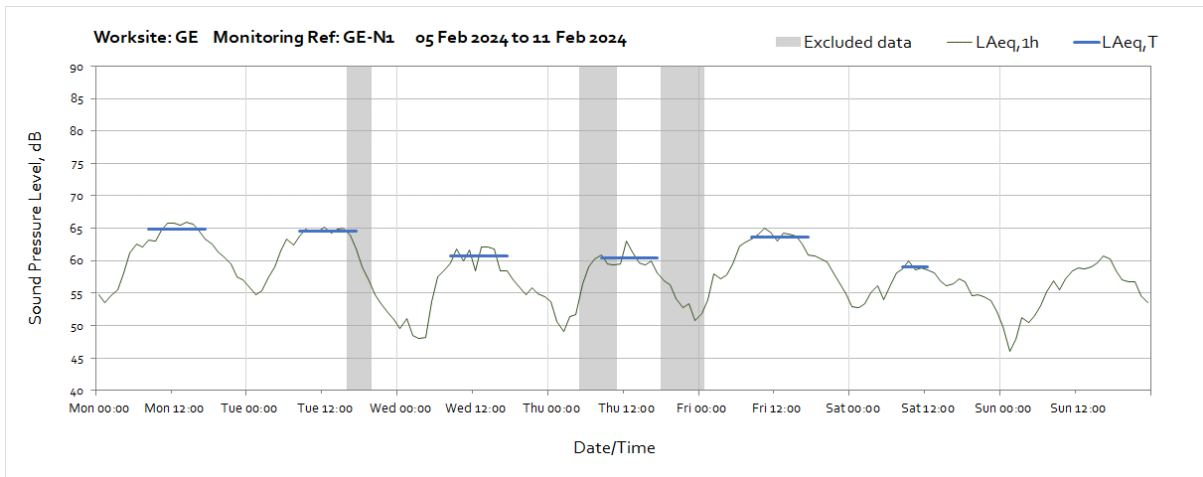
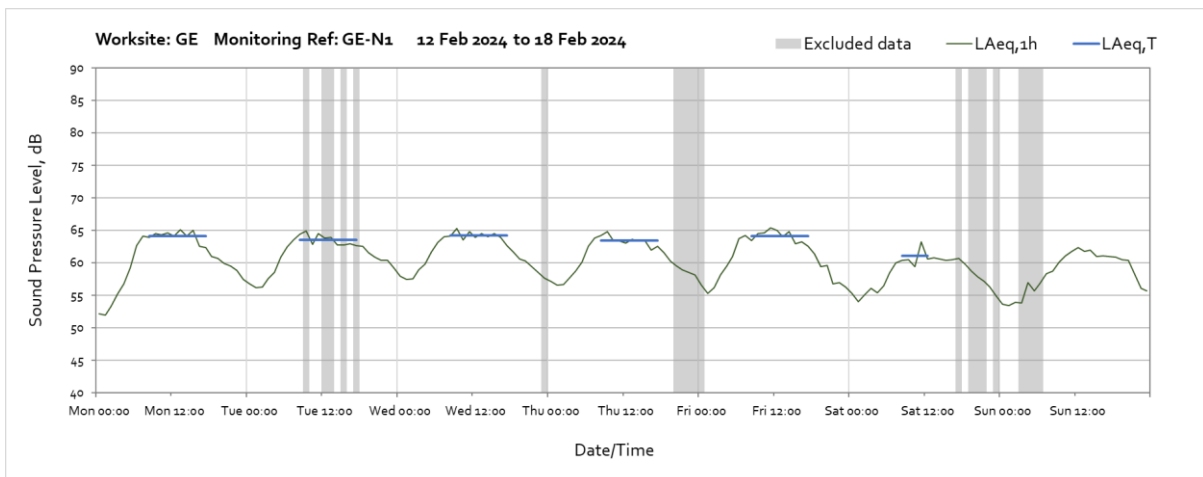
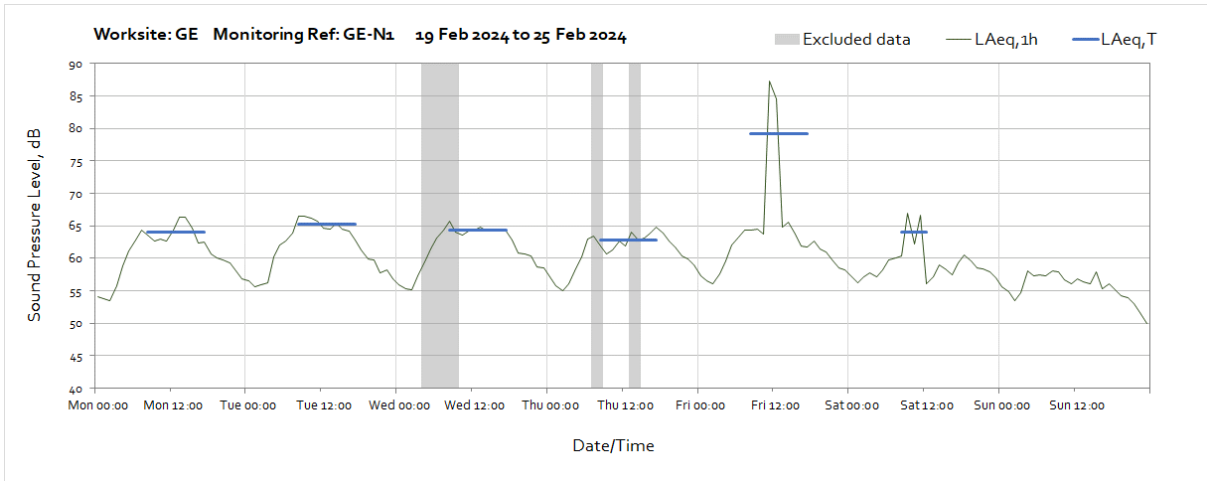
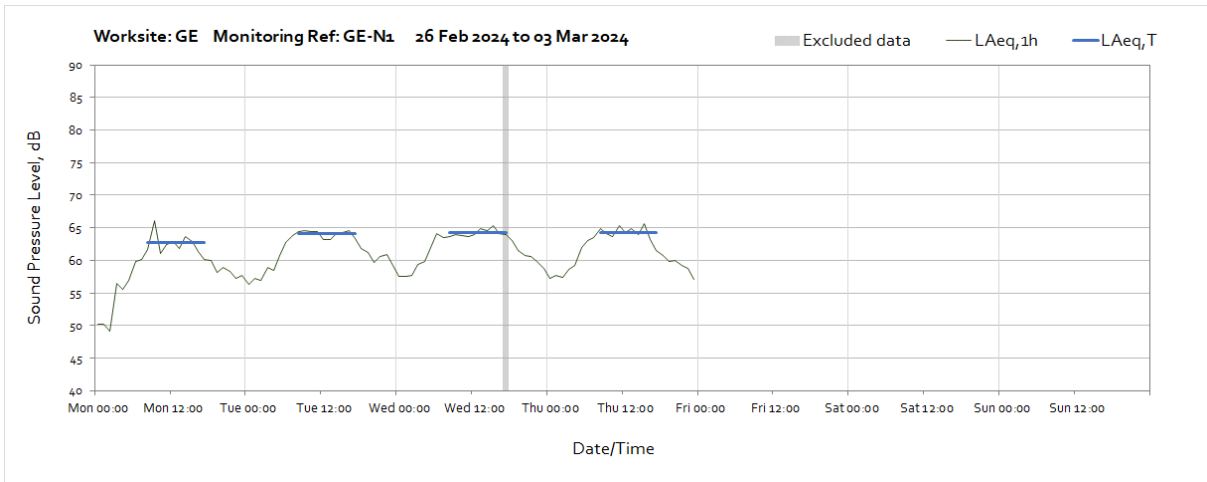
Worksite: GE – Monitoring Ref: GE-N1

Note: Missing data from the beginning of the month until 10:00 on Thursday 1st February was due to the loss of power at the monitoring station caused by the disconnection of mains power.

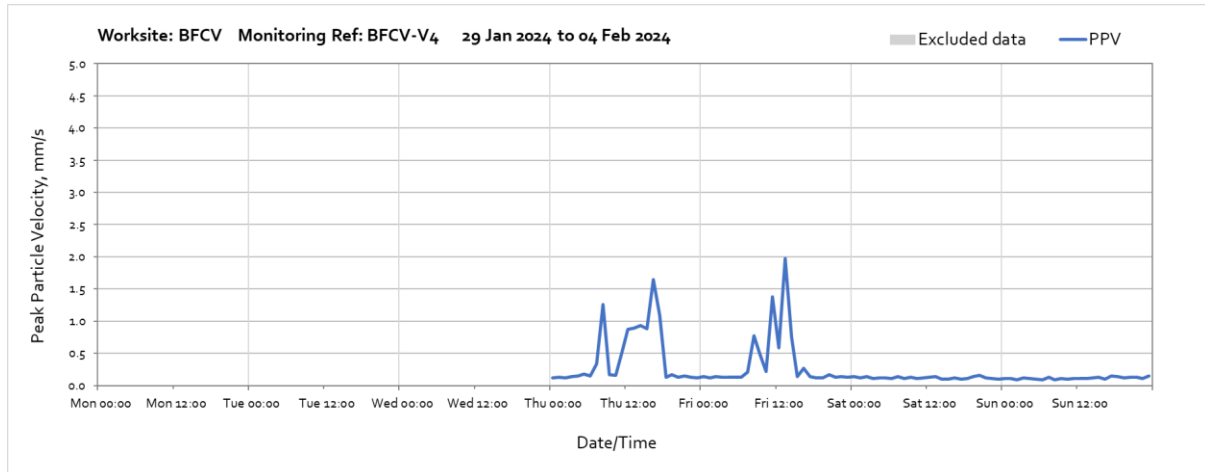
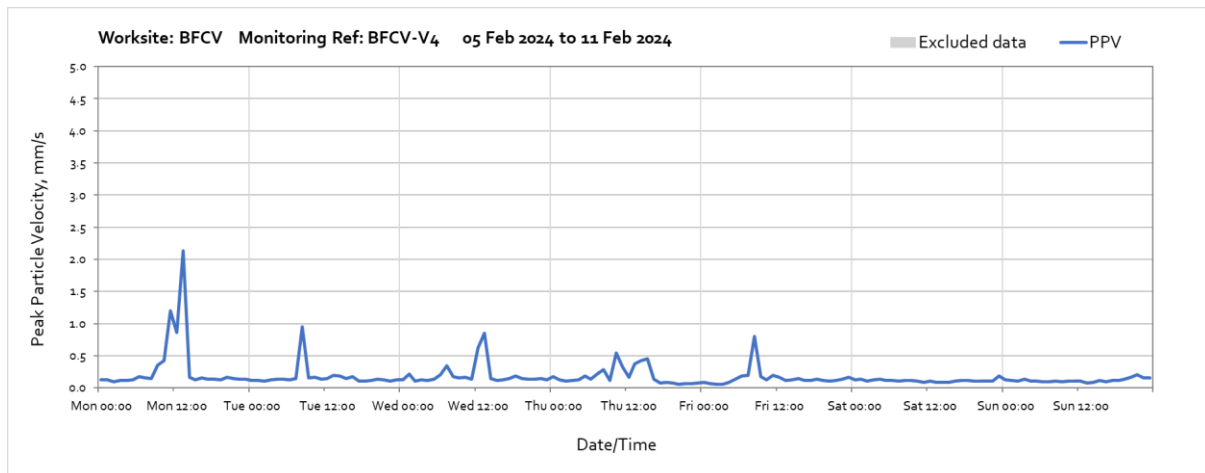
Worksite: BFCV – Monitoring Ref: BFCV-V4

The following graphs show the hourly measured peak particle velocity PPV recorded during the monitoring period. The graphs show the highest PPV of the three orthogonal axes x, y and z. Where high values of PPV were caused by local interference with the vibration monitor, which are not representative of HS2 construction works, these values have been greyed out in the following charts and have been excluded to calculate values in Table 4 of the main report.

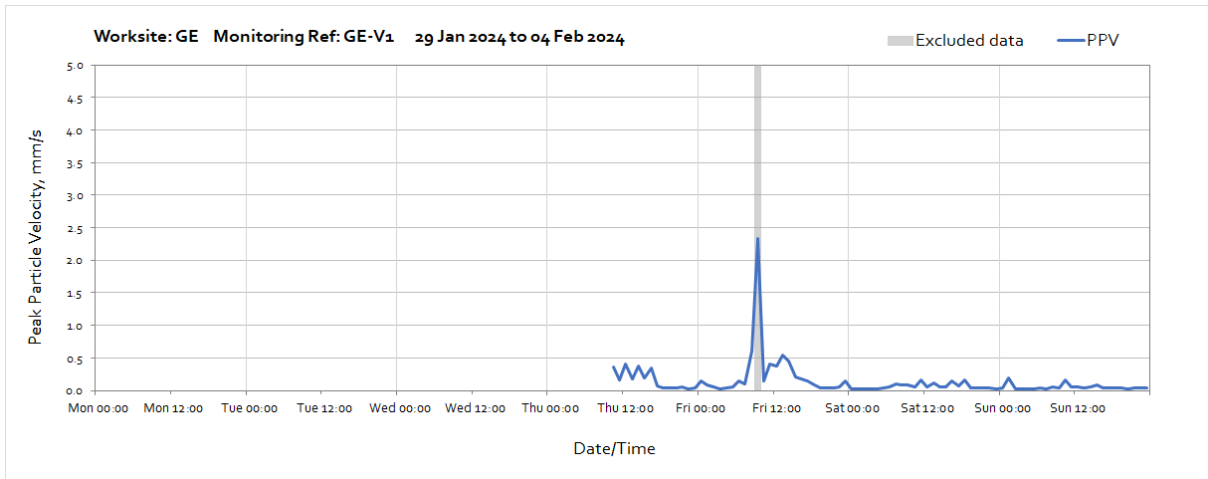
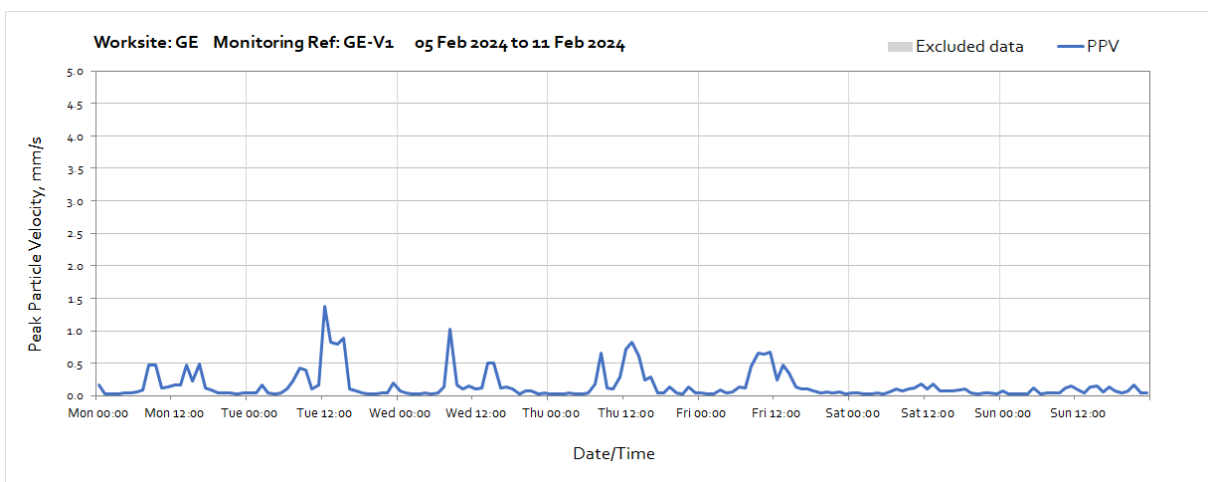
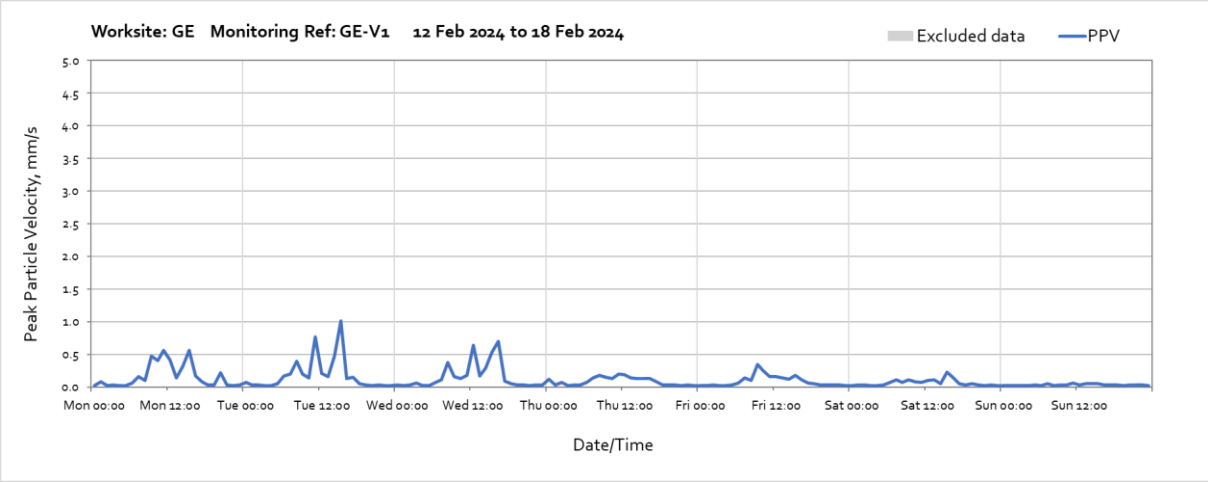
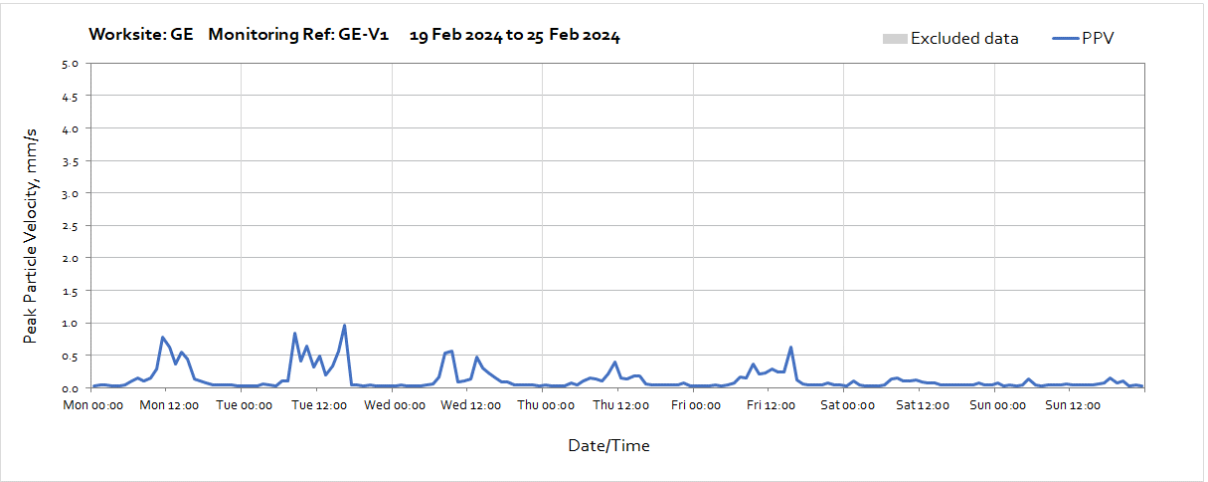
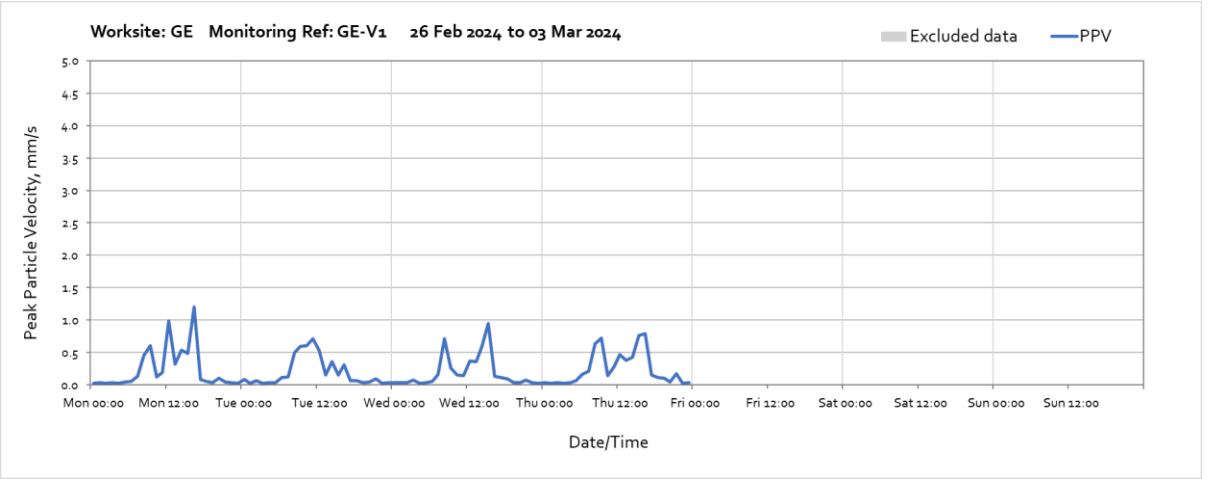
Worksite: GE - Monitoring Ref: GE-V1

Note: Missing data from the beginning of the month until 10:00 on Thursday 1st February was due to the loss of power at the monitoring station caused by the disconnection of mains power.
