Construction Noise and Vibration Monthly Report – February 2024

Stratford-on-Avon District Council

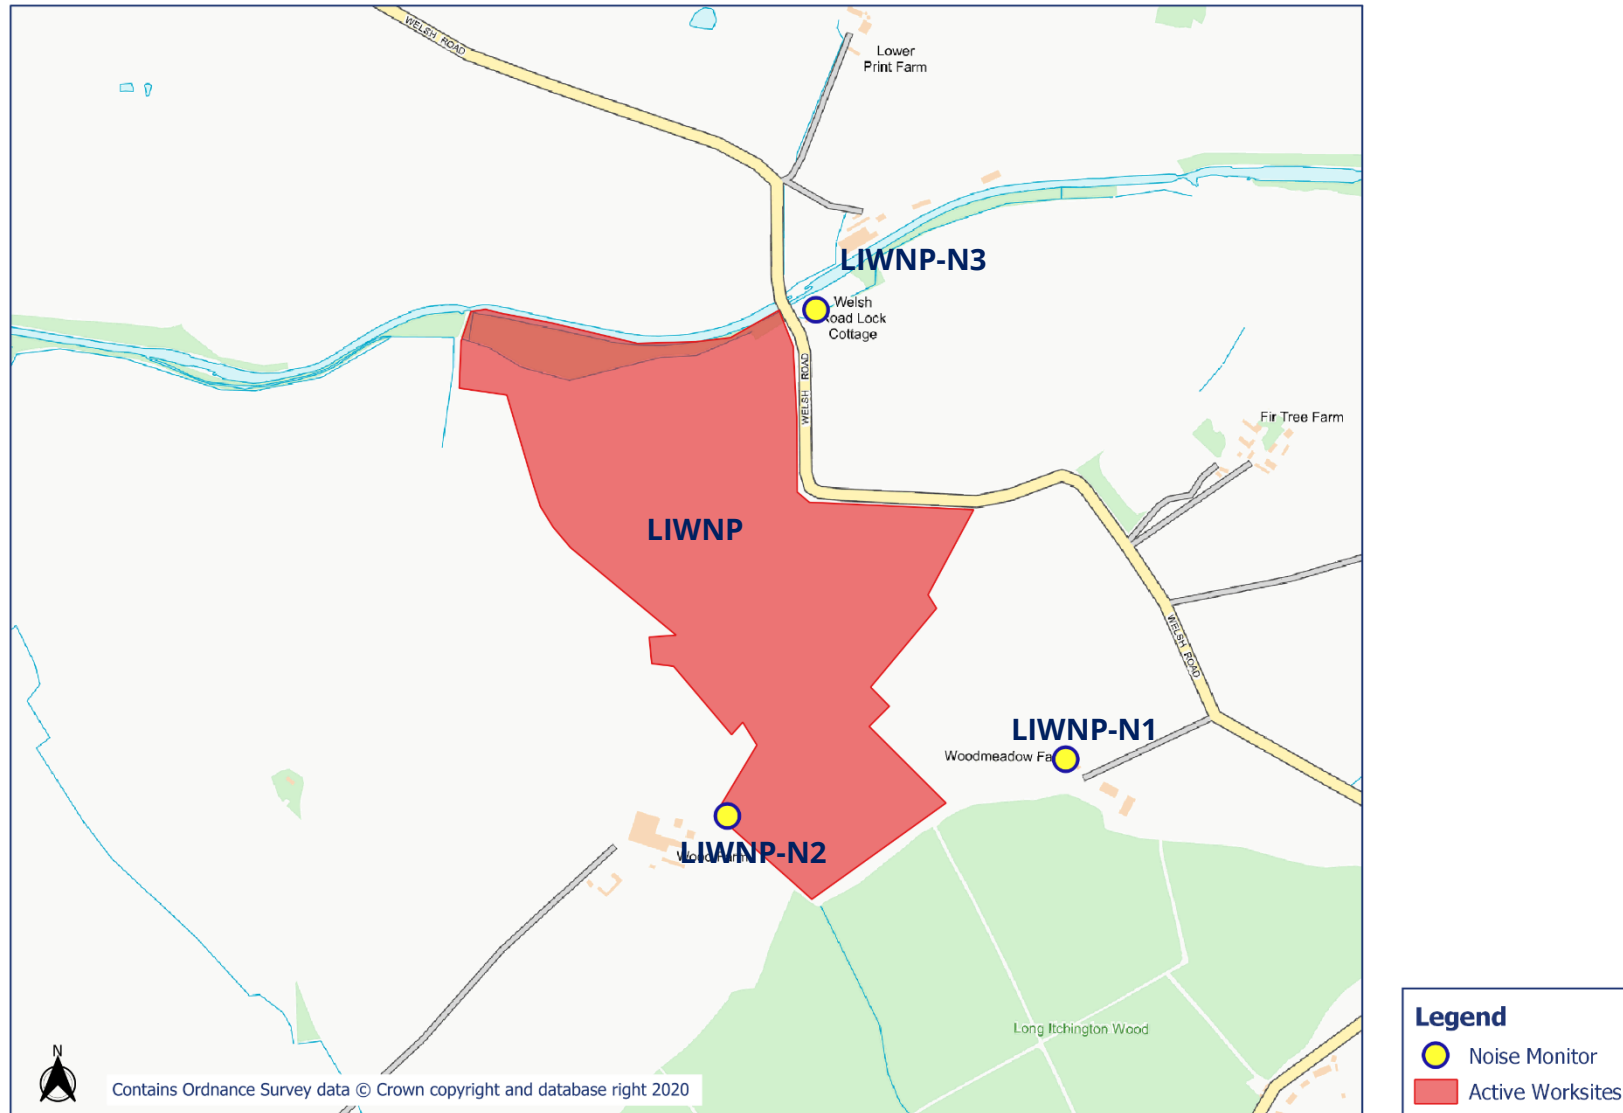
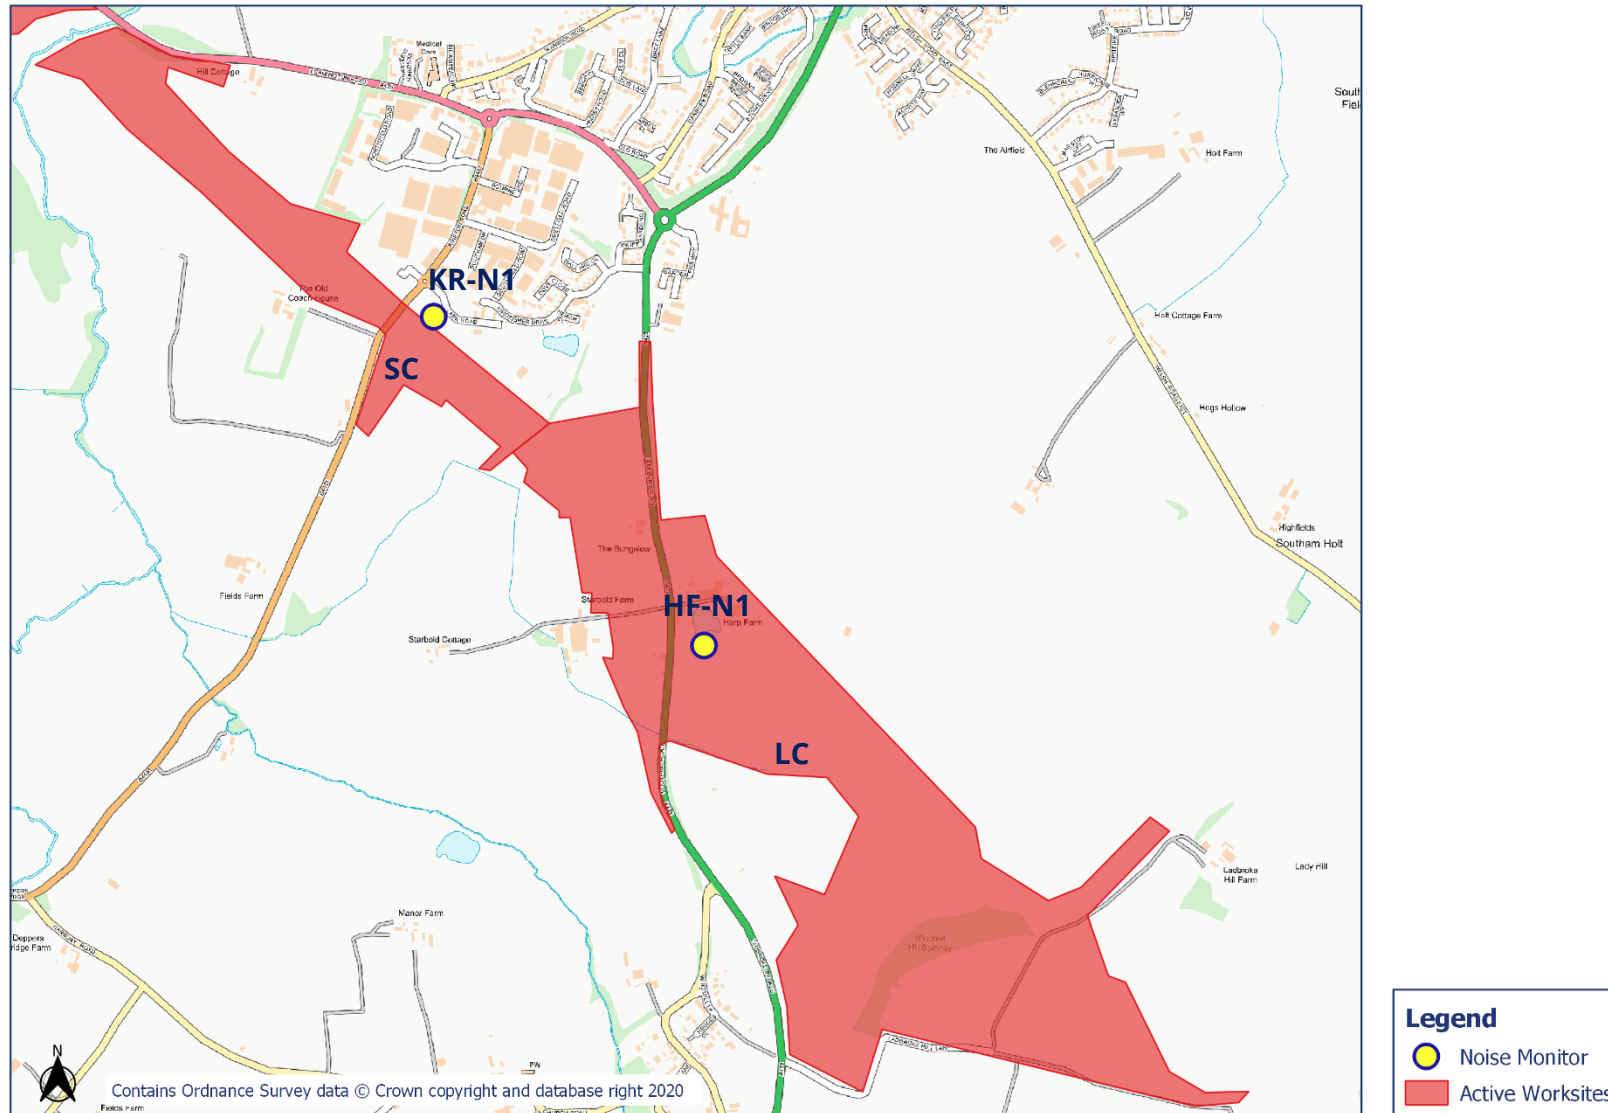
Appendix B Monitoring Locations

- 1.2.1 Seven (7) noise and one (1) vibration monitoring installation were active in February 2024 in the SADC area.
- 1.2.2 Table 2 summarises the position of noise and vibration monitoring installations within the SADC area in February 2024.
- 1.2.3 An additional noise monitor, LIWNP-N2, was installed at Wood Farm, worksite LIWNP, on the 8th of February.
- 1.2.4 Maps showing the position of noise monitoring installations are presented in Appendix B.

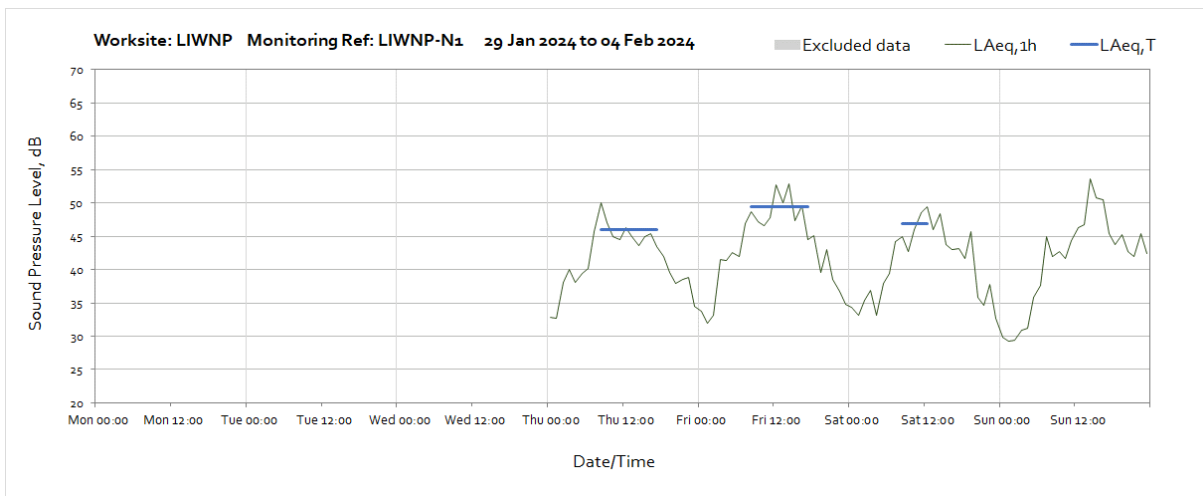
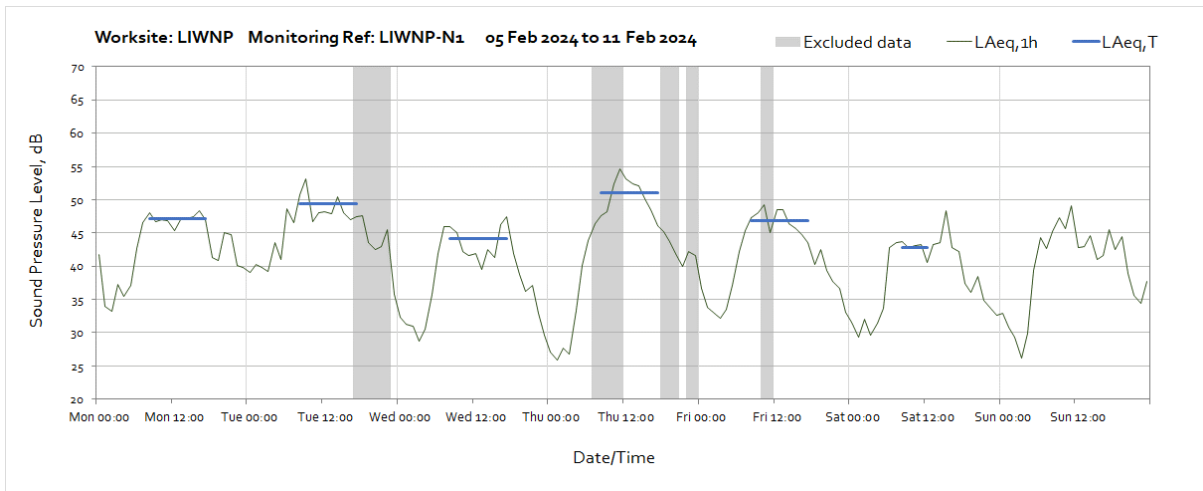
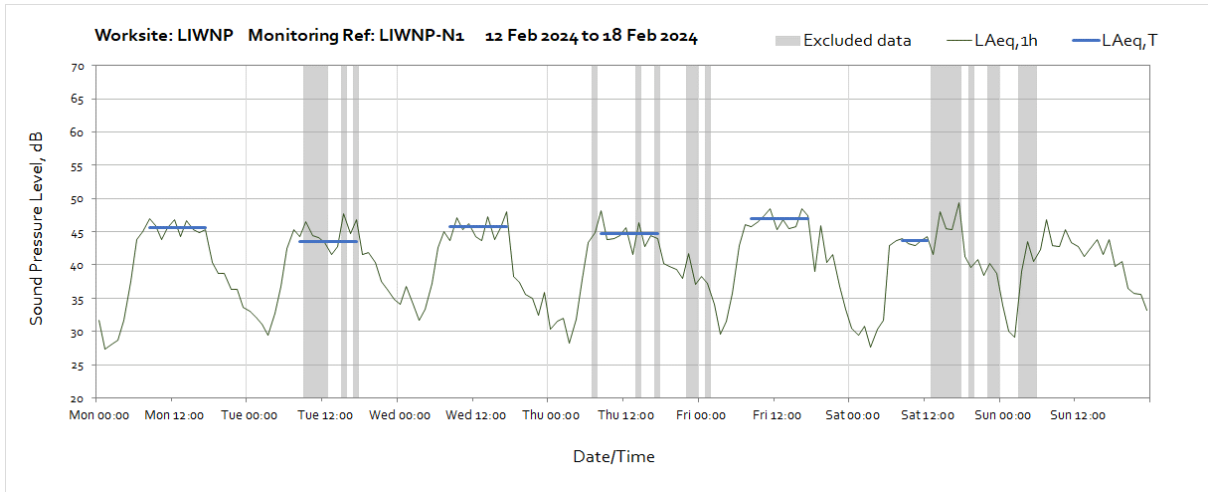
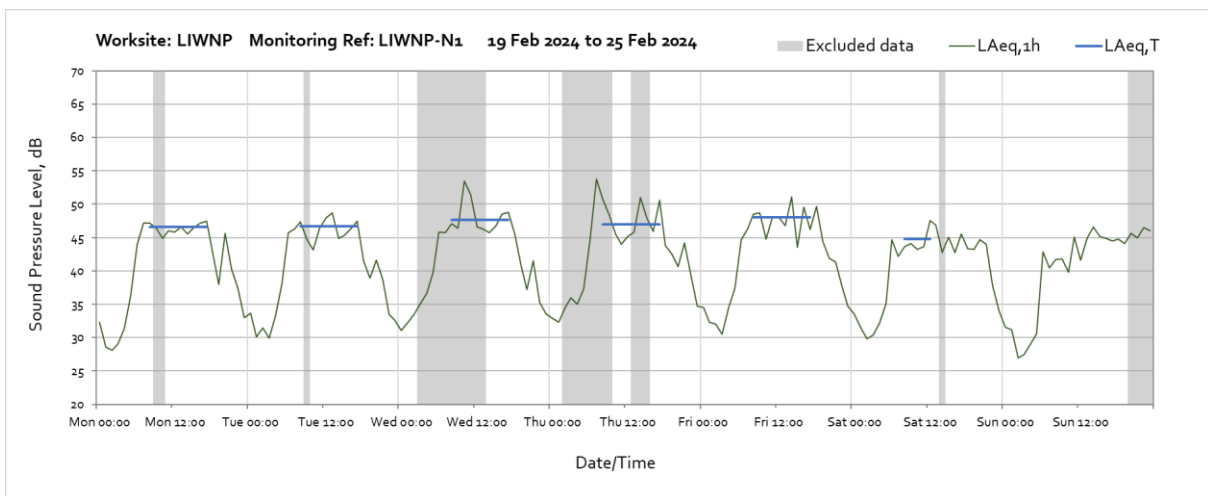
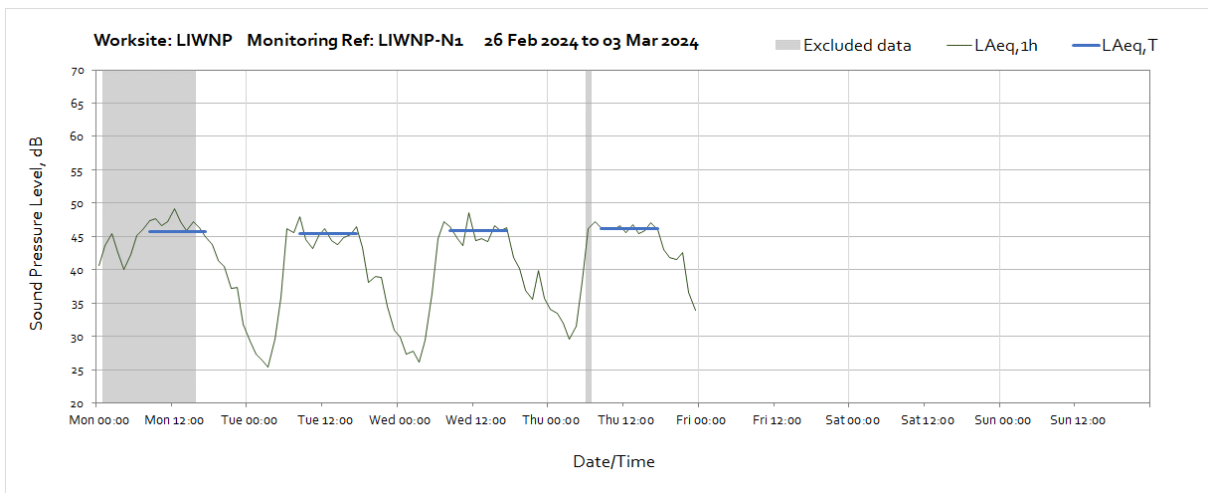
Worksite: LIWNP Monitoring Ref: LIWNP-N1

The following graphs show the hourly measured ambient noise level $L_{Aeq,1h}$ and, where relevant, the averaged noise level $L_{Aeq,T}$ values, where the time period T is as specified in Table 1 of HS2 Information Paper E23. Periods where noise levels are adversely affected by weather or only measured for part of the period, which are not representative of HS2 construction works, have been greyed out and excluded from the calculation of the $L_{Aeq,T}$ values in Table 3 of the main report.

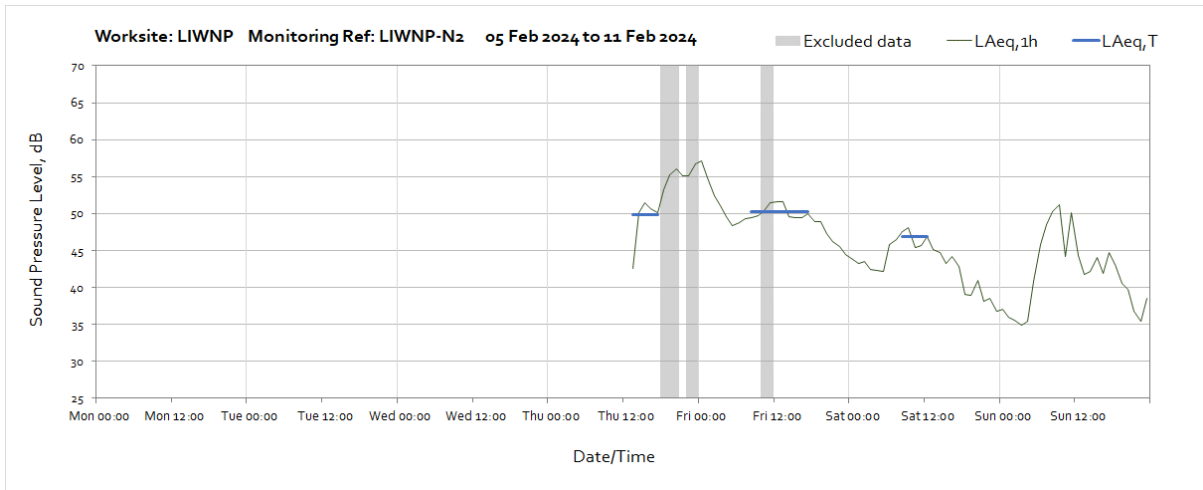
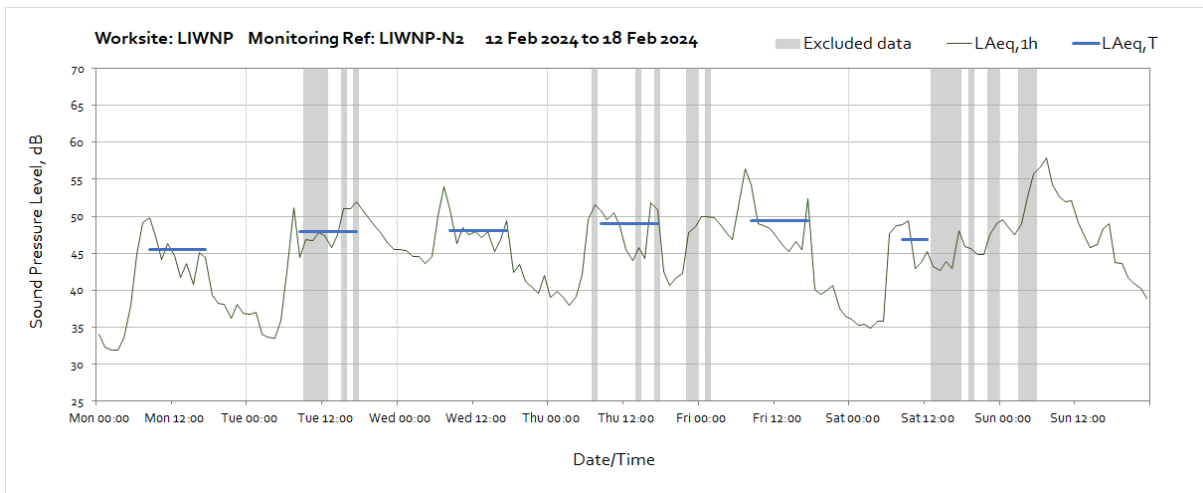
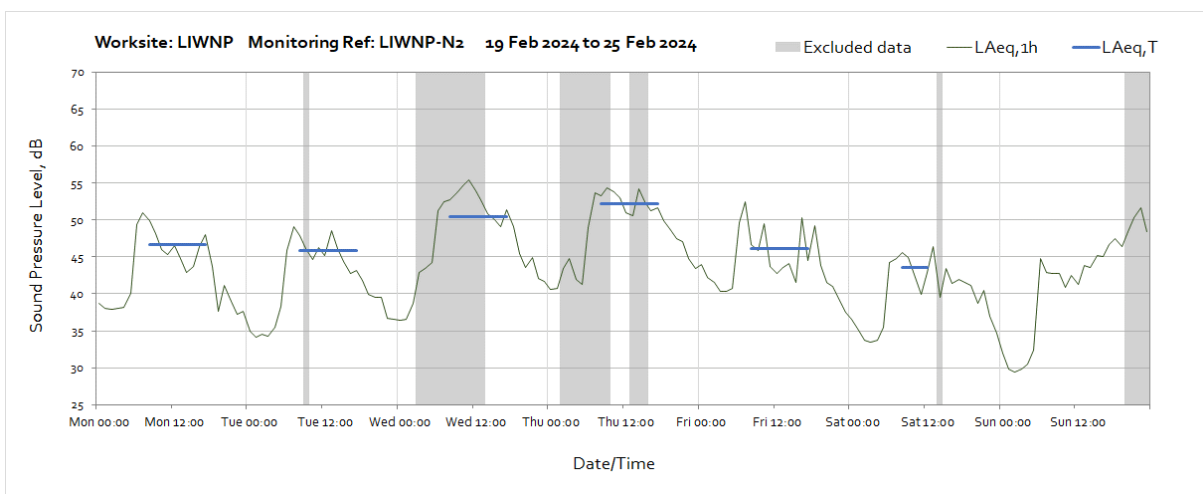
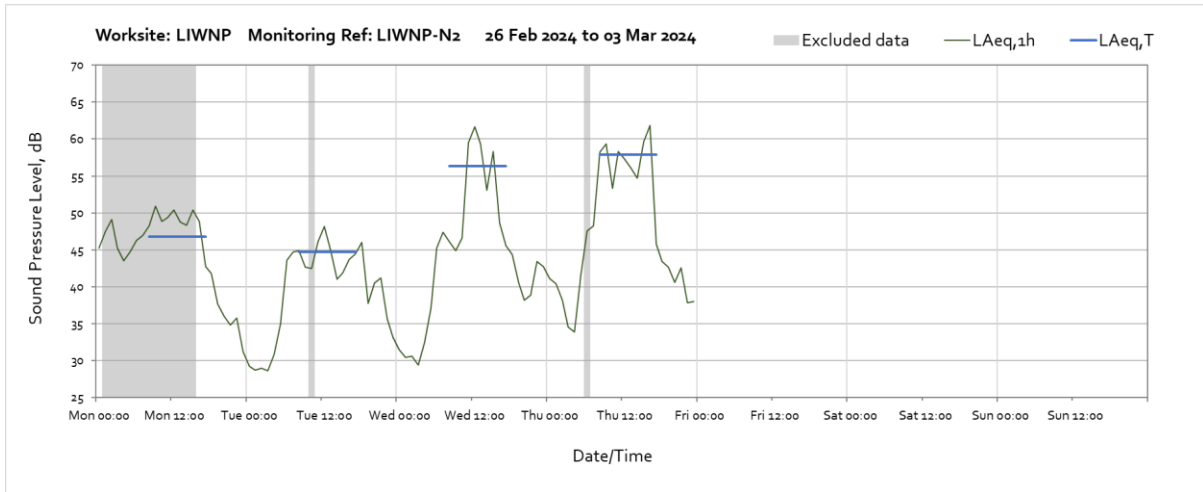
Worksite: LIWNP Monitoring Ref: LIWNP-N2

Note: Monitor installed at 13:00 on Thursday 8th February.

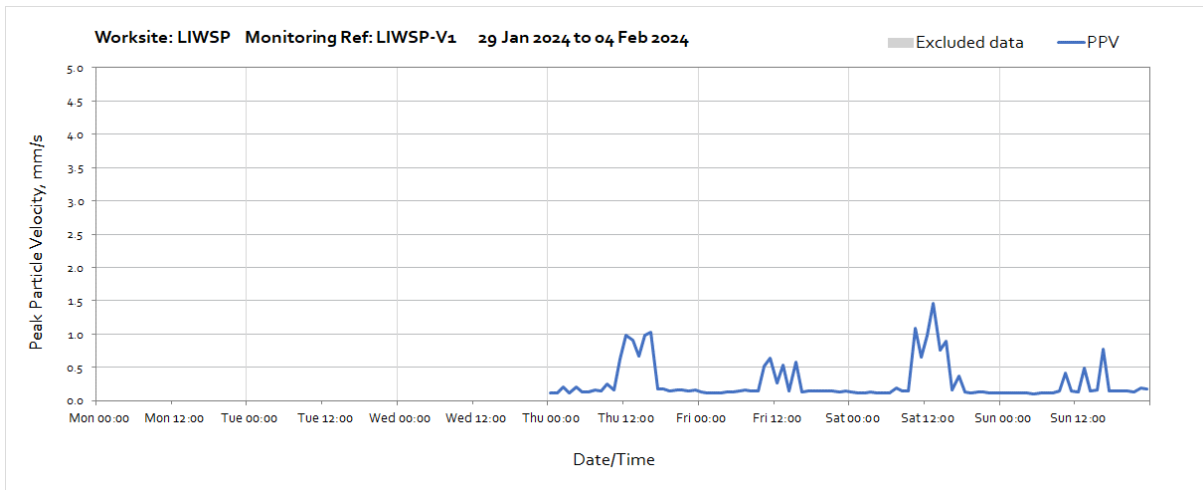
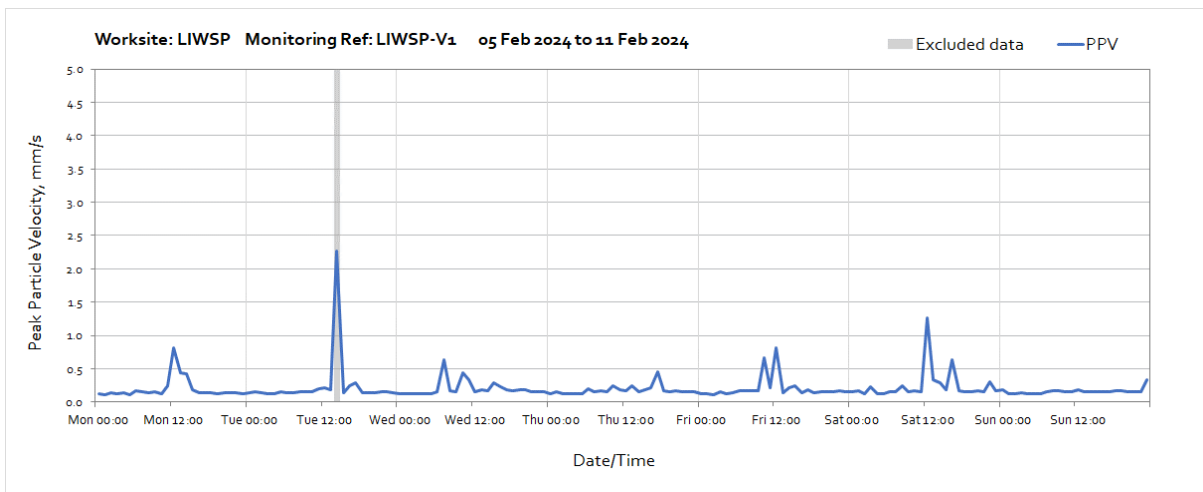
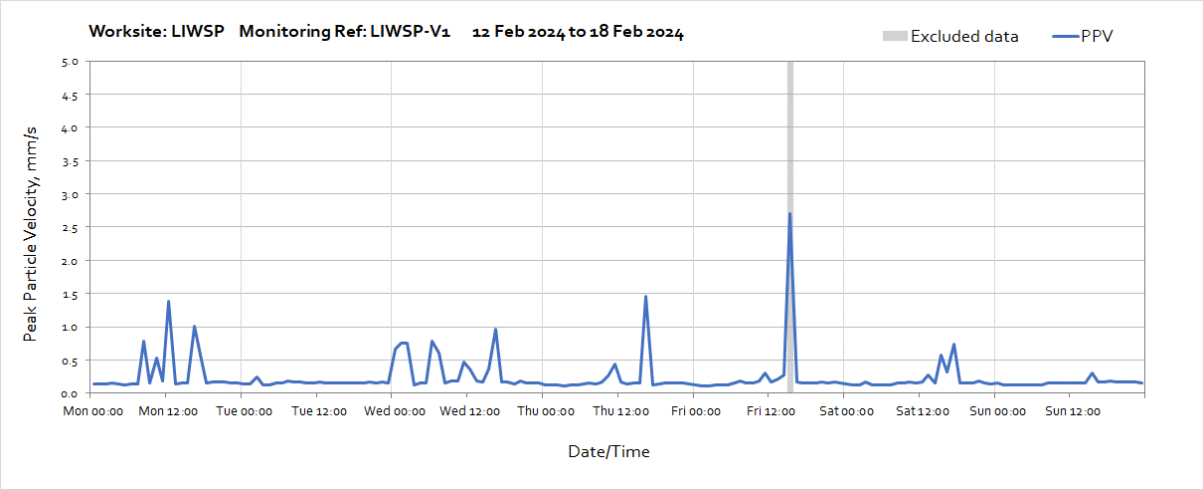
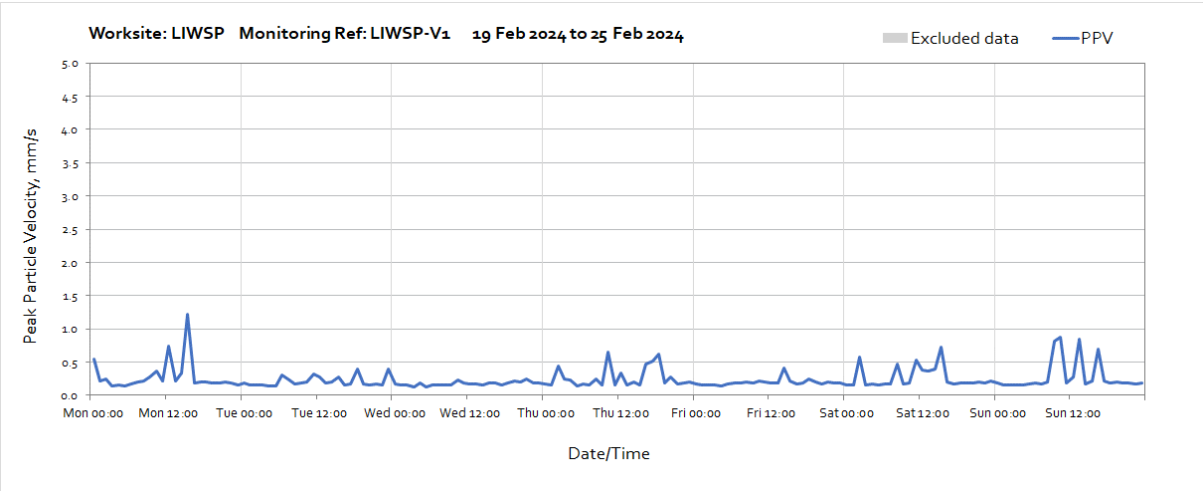
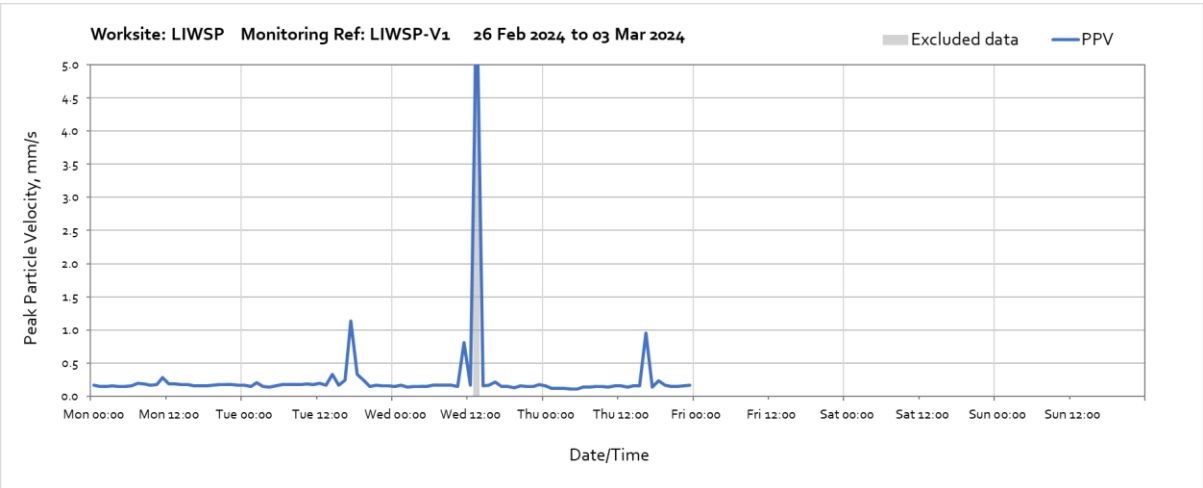
Worksite: LIWSP Monitoring Ref: LIWSP-V1

The following graphs show the hourly measured peak particle velocity PPV recorded during the monitoring period. The graphs show the highest PPV of the three orthogonal axes x, y and z. Periods where PPV values have been affected by local interference with the vibration monitor or only measured for part of the period, which are not representative of HS2 construction works, have been greyed out and excluded when calculating values in Table 4 of the main report.

Worksite Reference	Measurement Reference	Monitor Address	Highest PPV measured in any axis, mm/s
LIWSP	LIWSP-V1	Woodside House, Bascote Heath, Southam	1.36 (Z-axis)
