Construction Noise and Vibration Monthly Report – February 2024

West Northamptonshire District Council

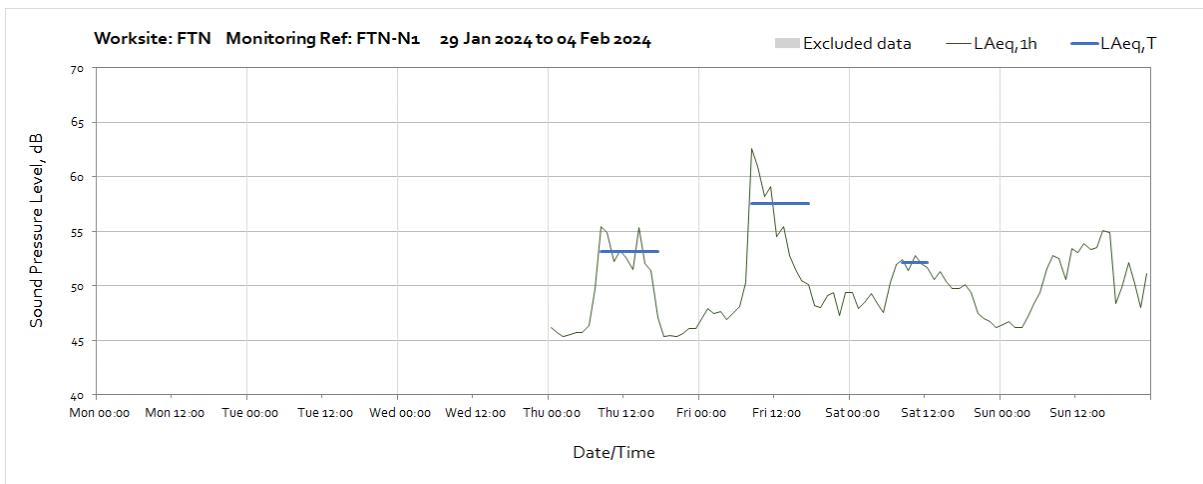
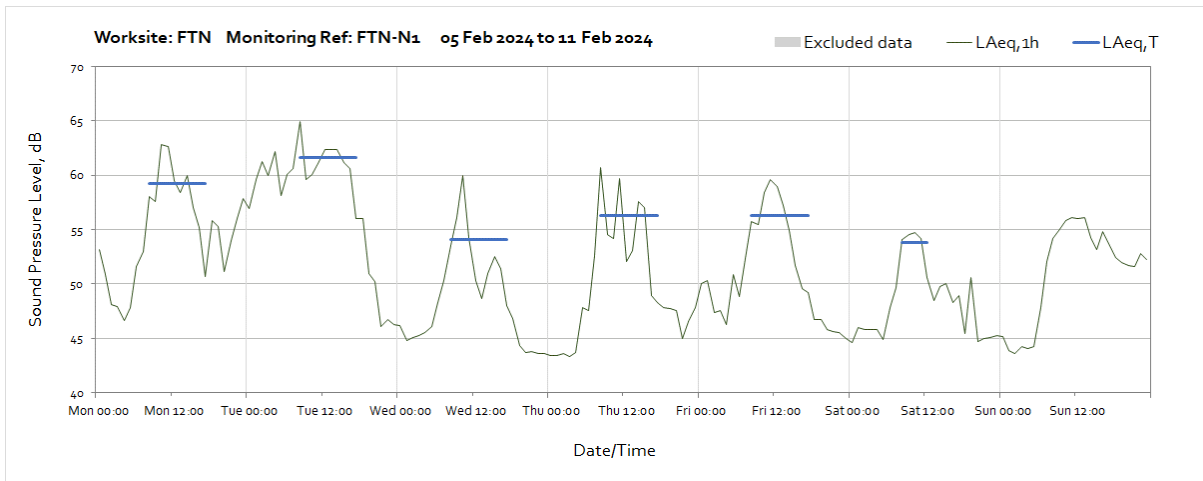
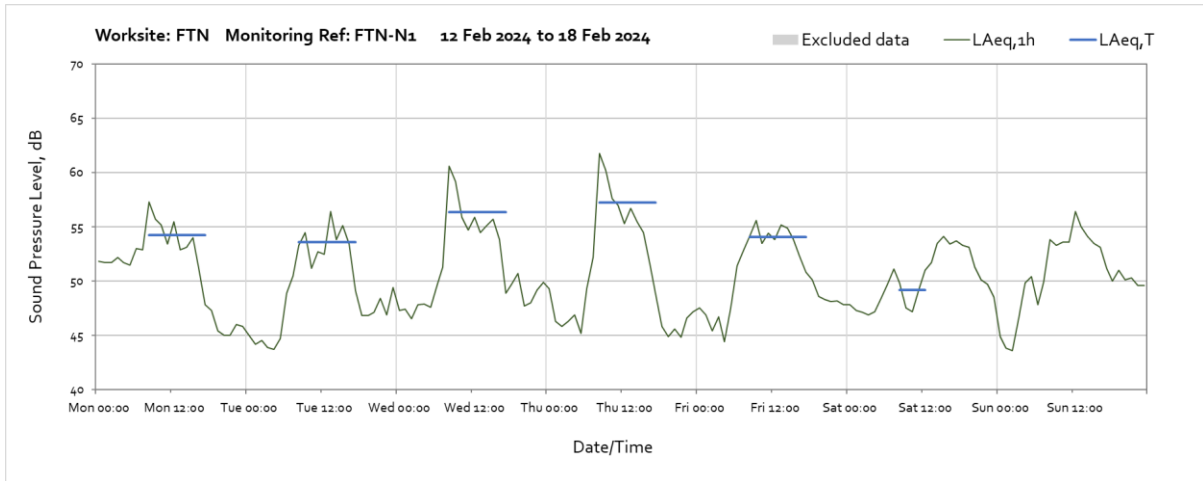
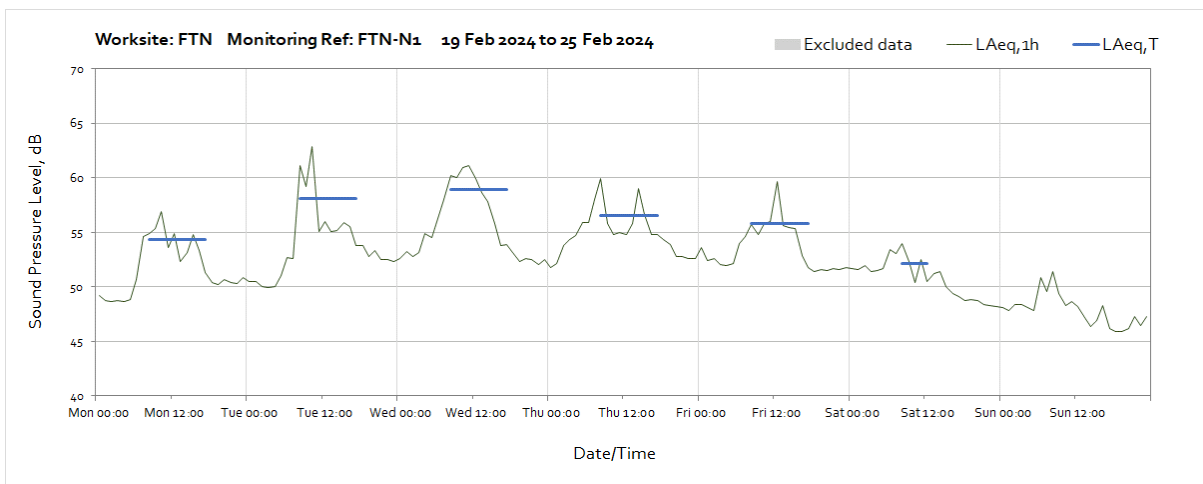
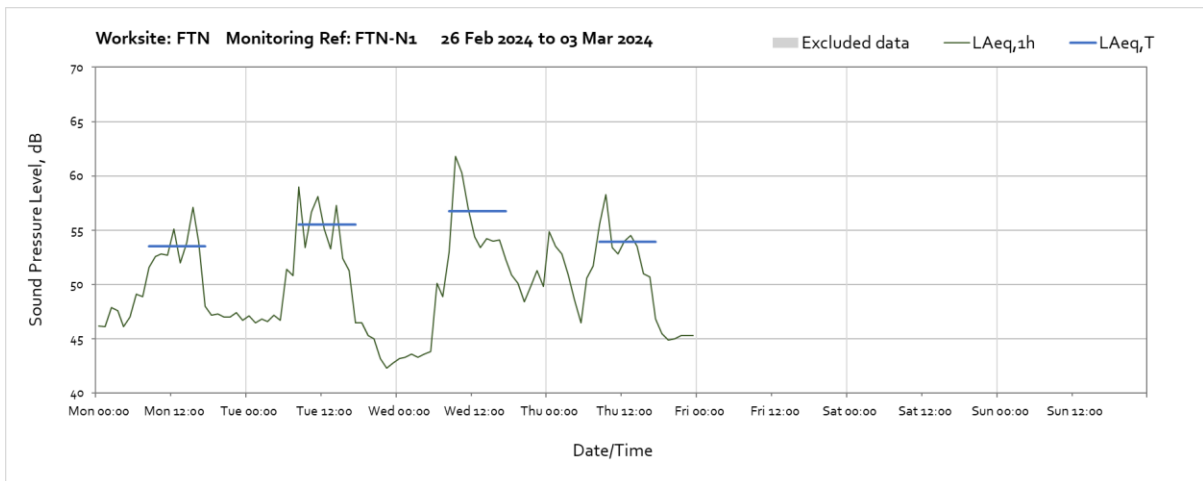
Worksite: FTN – Monitoring Ref: FTN-N1

The following graphs show the hourly measured ambient noise level $L_{Aeq,1h}$ and, where relevant, the averaged noise level $L_{Aeq,T}$ values, where the time period T is as specified in Table 1 of HS2 Information Paper E23. Periods where noise levels are adversely affected by weather or only measured for part of the period, which are not representative of HS2 construction works, have been greyed out and excluded from the calculation of the $L_{Aeq,T}$ values in Table 3 of the main report.

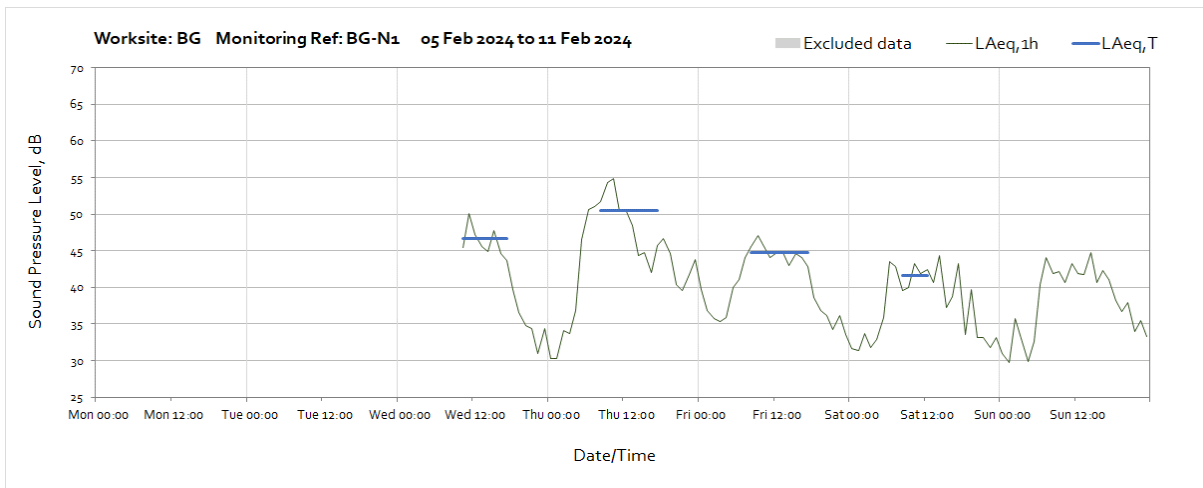
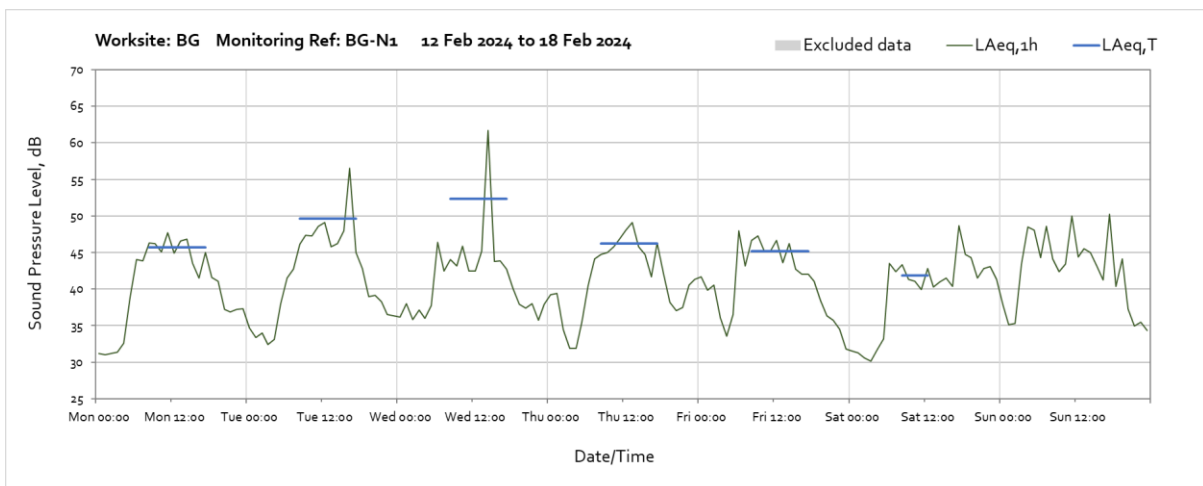
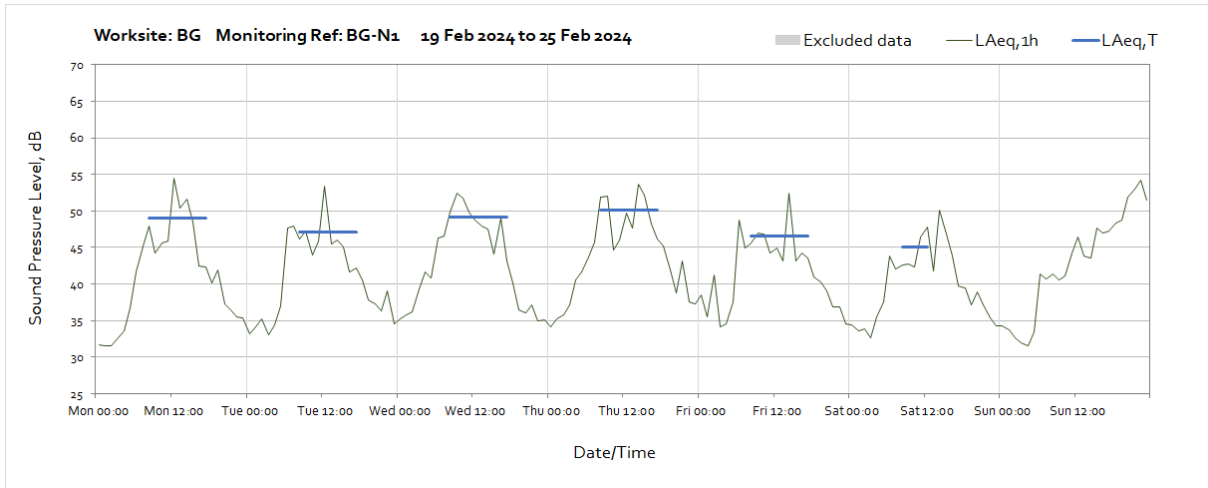
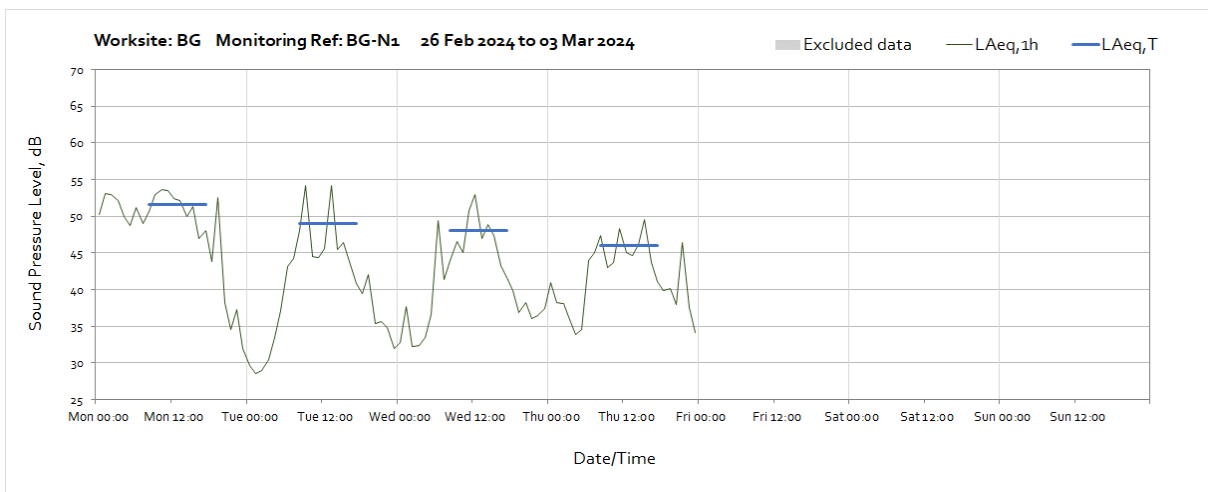
Worksite: BG – Monitoring Ref: BG-N1

Note: Missing data from the beginning of the month until 10:00 on Wednesday 10th February was due to loss of power caused by a fault with the solar panel.

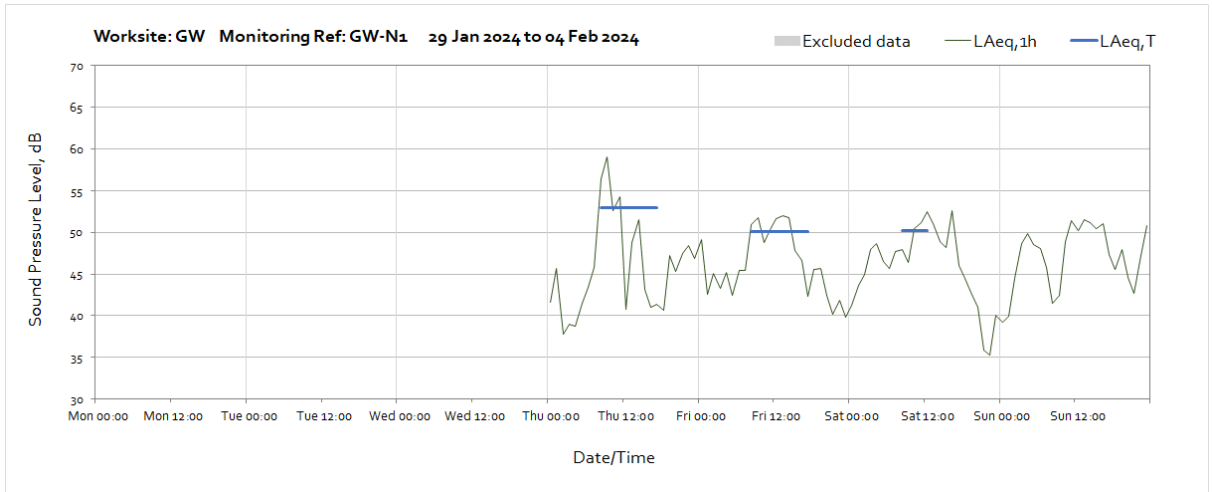
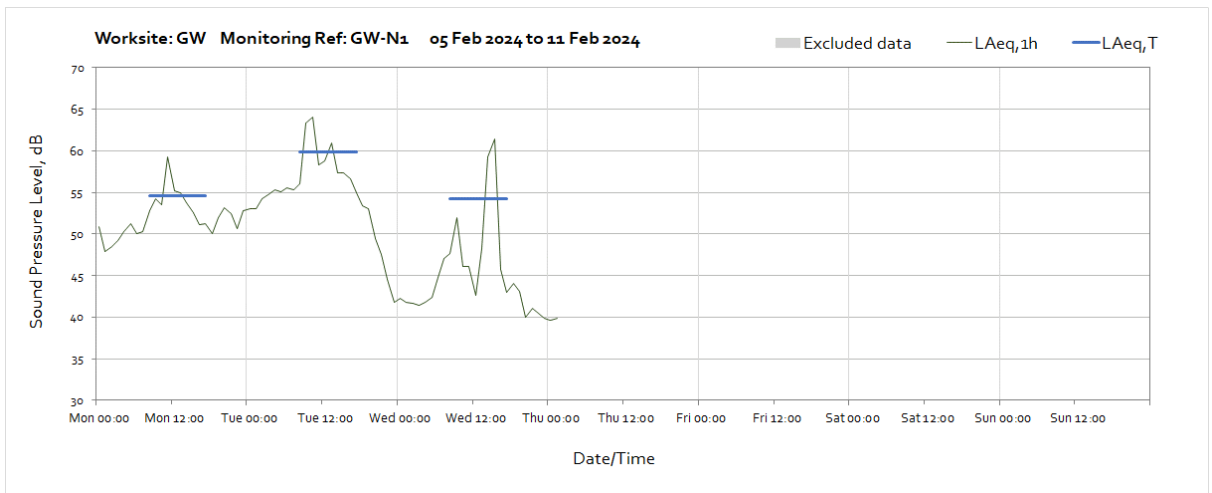
Worksite: GW - Monitoring Ref: GW-N1

Note: Missing data from 02:00 on Thursday 8th February until the end of the month was due to water ingress into the noise monitor causing it to go offline.

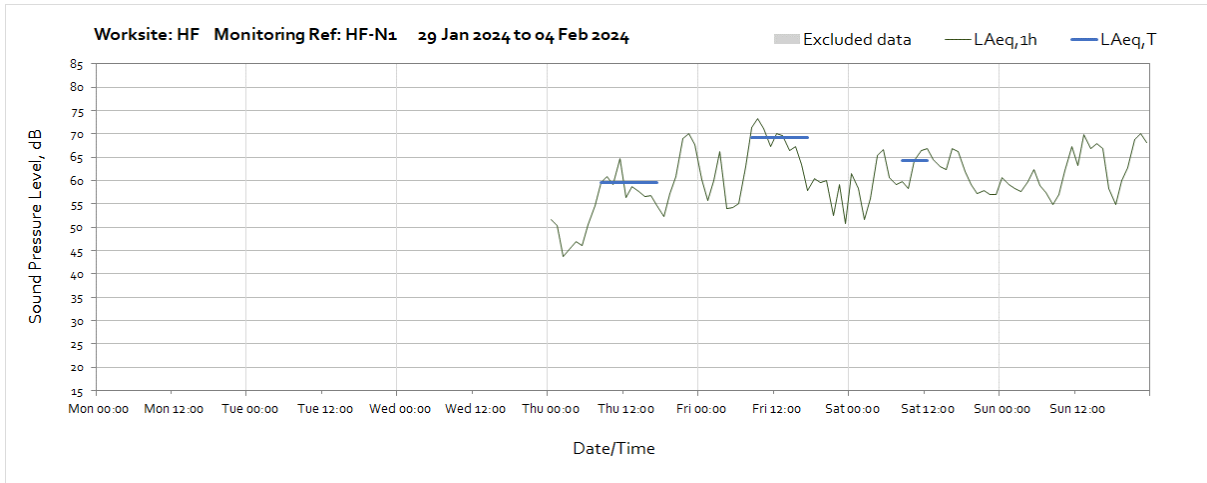
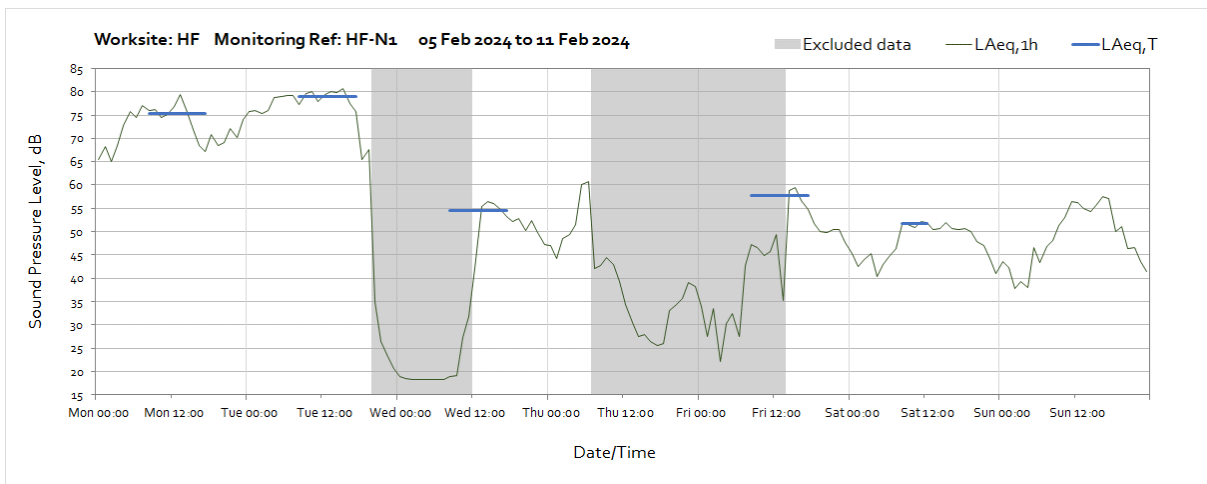
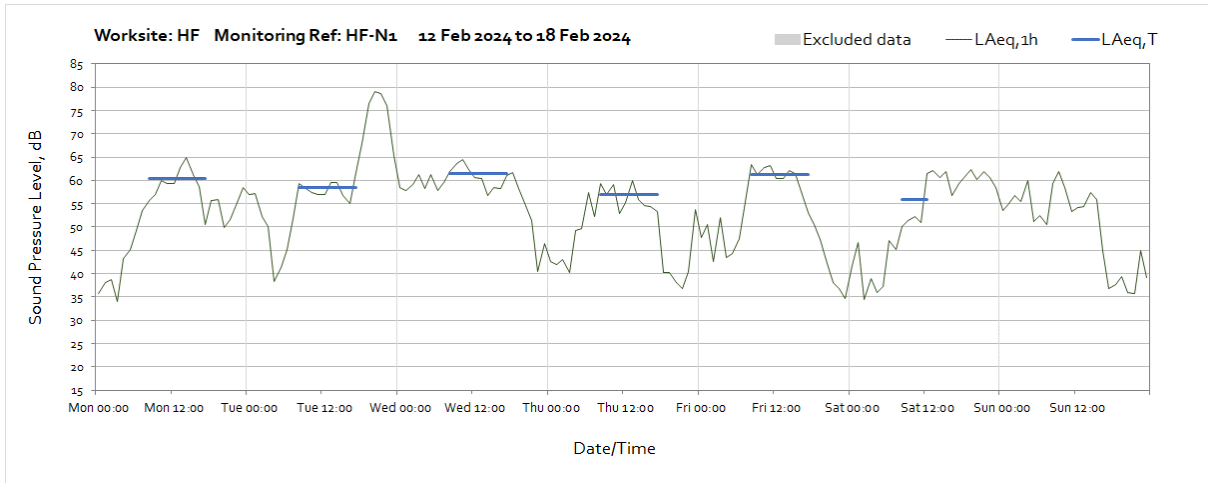
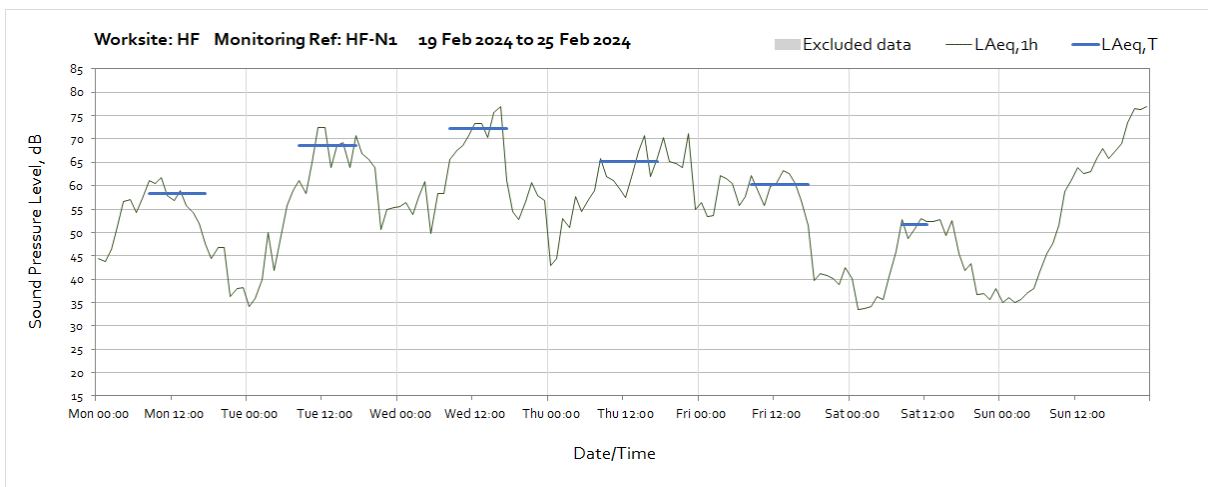
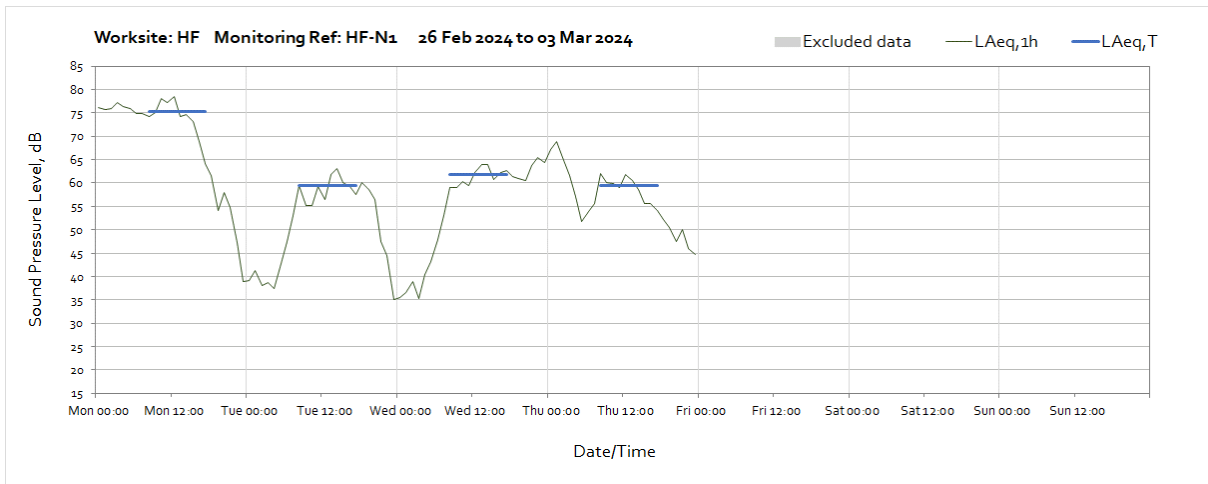
Worksite: HF - Monitoring Ref: HF-N1

Note: Data between 20:00 on Tuesday 06th of February and 11:00 on Wednesday 07th of February and between 07:00 on Thursday 08th of February and 13:00 on Friday 09th of February has been excluded as potentially invalid and is currently under investigation.
