## Coal Mining Risk Assessment

20 Conway Road

Report Ref: B648/24

February 2024

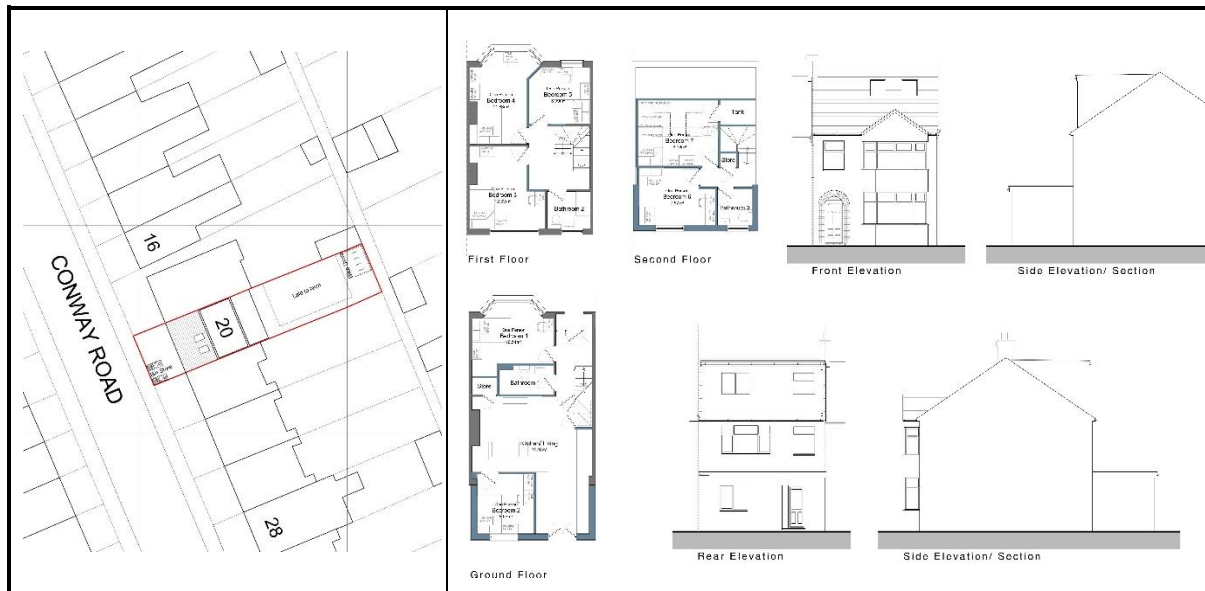
**Figure 1 – Proposed Development Details**

- 1.3 It is understood the site will be redeveloped for residential purposes.
- 1.4 Details of the proposed development are shown in Figure 1 below.

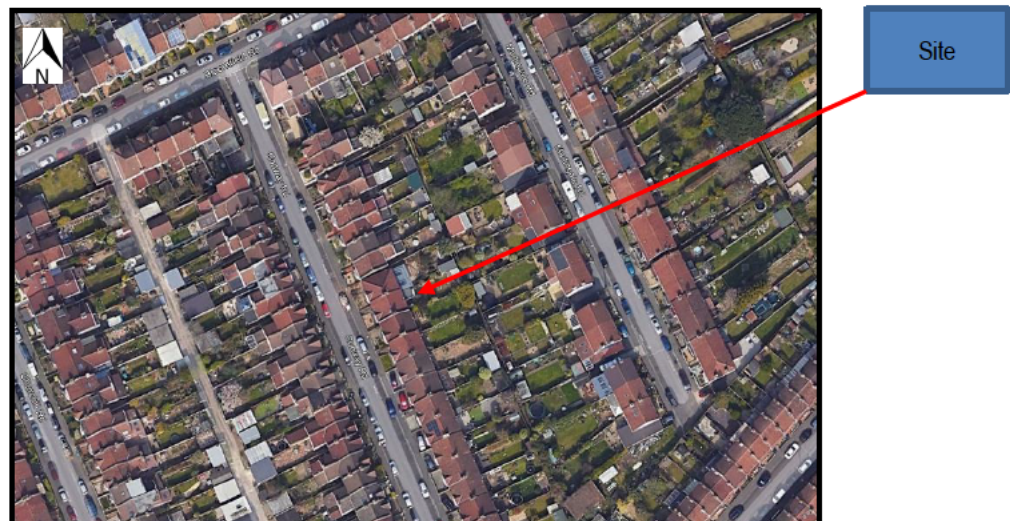
Figure 3 – Aerial Photograph Showing Site and Surrounding Area

2.2 The site is located in a residential area and is currently occupied by the existing property (No. 20) and associated garden. The site and surrounding area are shown in the aerial photograph (Figure 3) below.
