Public service vehicle (PSV) inspection manual

Public Service Vehicle Revision Record

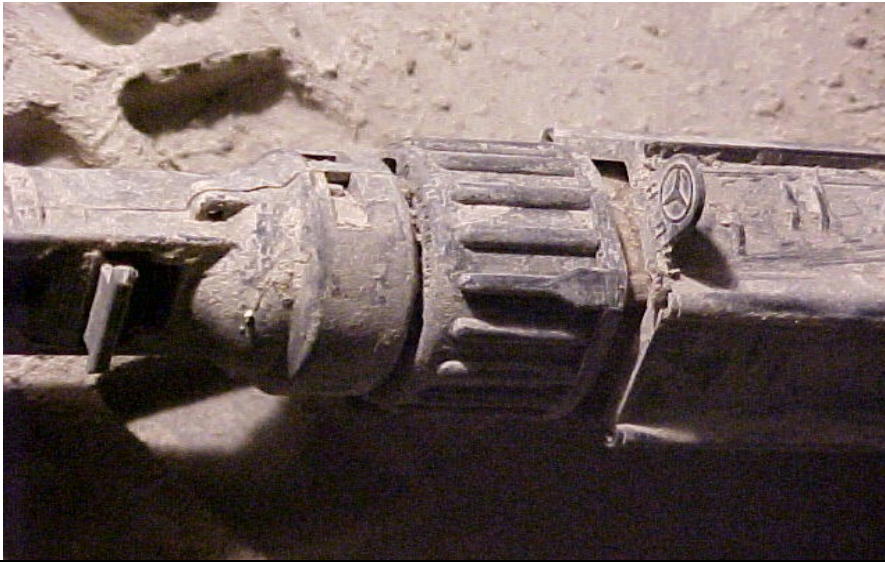
Plastic sleeve seals are acceptable but will require an embossed identification, (see example to left).

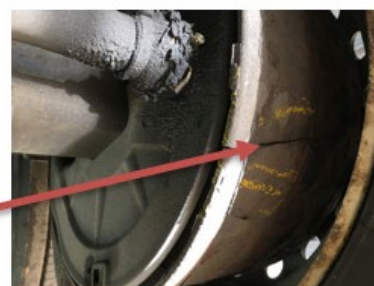
Brake drum fracture = not acceptable
