Construction Noise and Vibration Monthly Report – April 2024

London Borough of Ealing

Non-Technical Summary

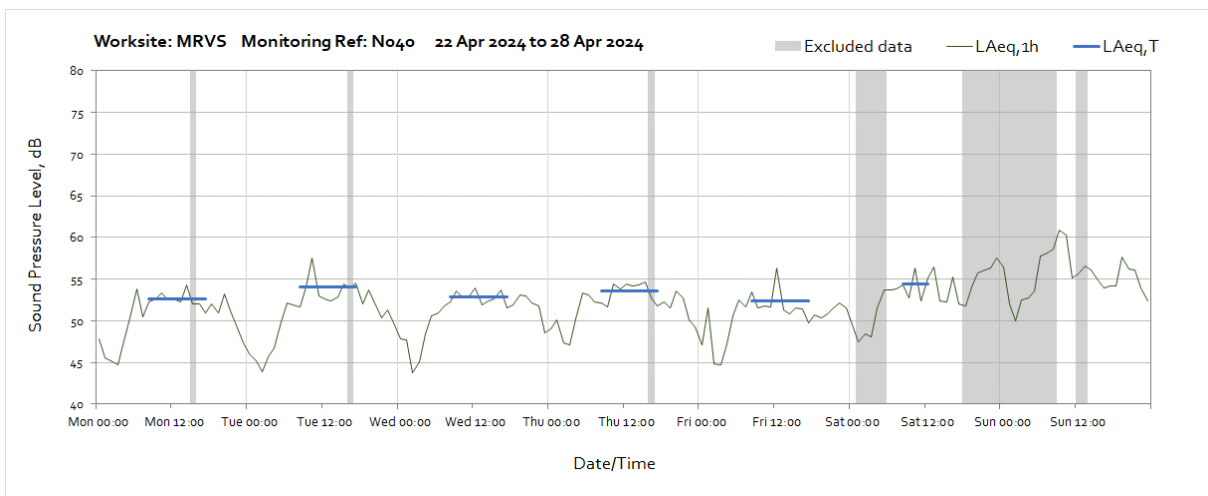
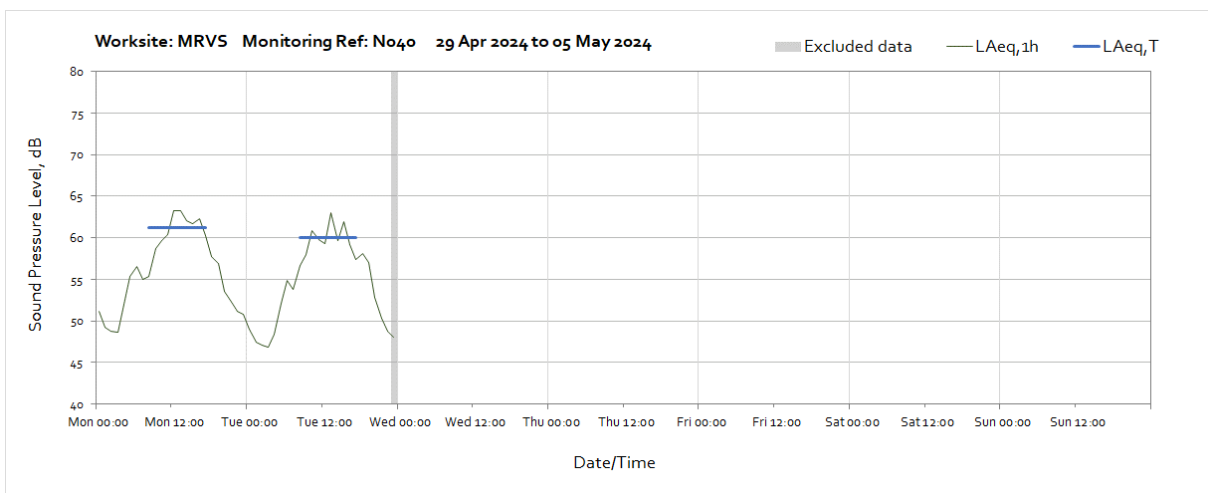
Worksite: MRVS – Monitoring Ref: N040

The following graphs show the hourly measured ambient noise level $L_{Aeq,1h}$ and, where relevant, the averaged noise level $L_{Aeq,T}$ values, where the time period T is as specified in Table 1 of HS2 Information Paper E23. Periods where noise levels are adversely affected by weather or only measured for part of the period, which are not representative of HS2 construction works, have been greyed out and excluded from the calculation of the $L_{Aeq,T}$ values in Table 3 of the main report.

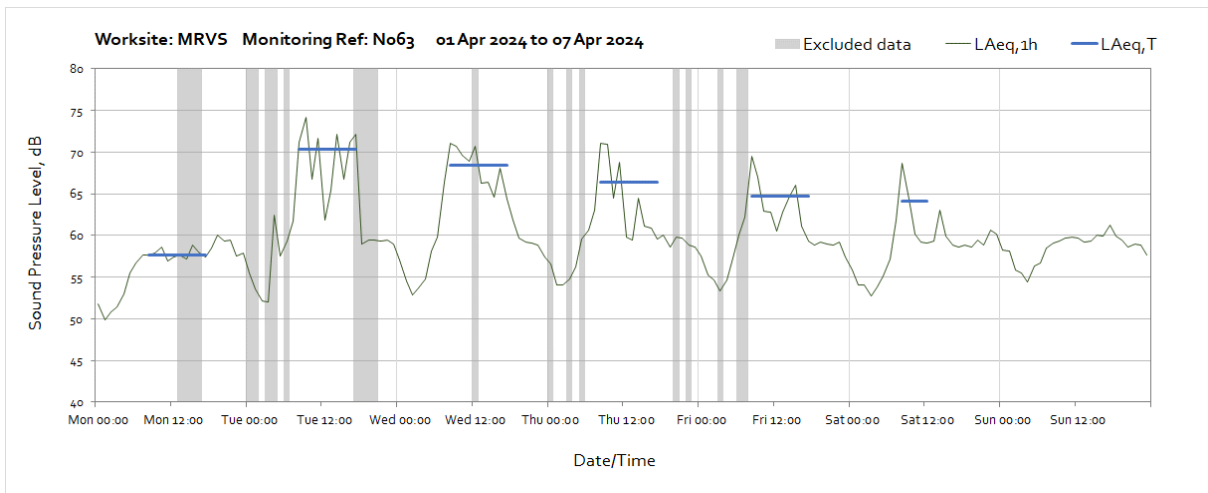
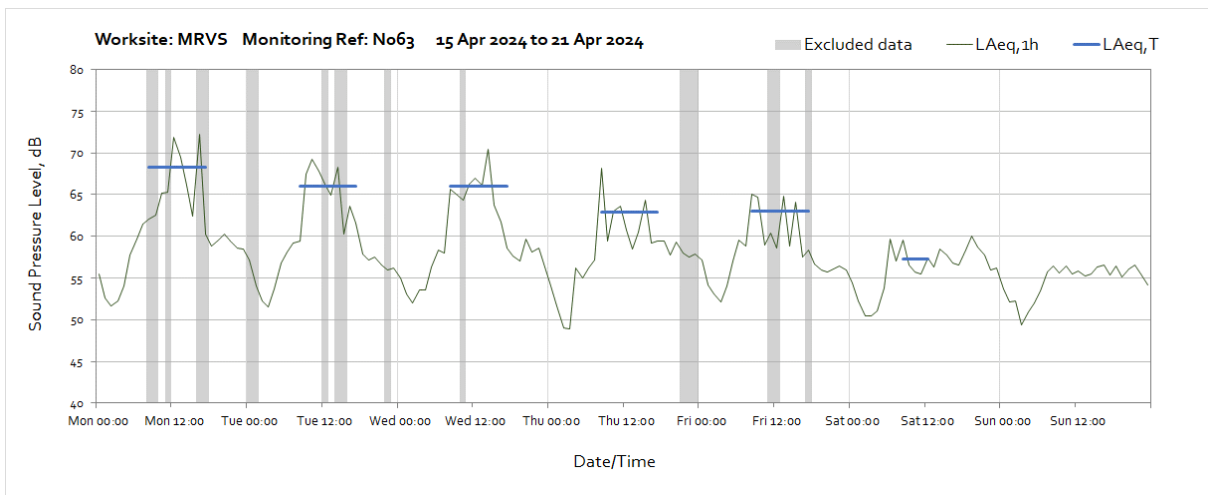
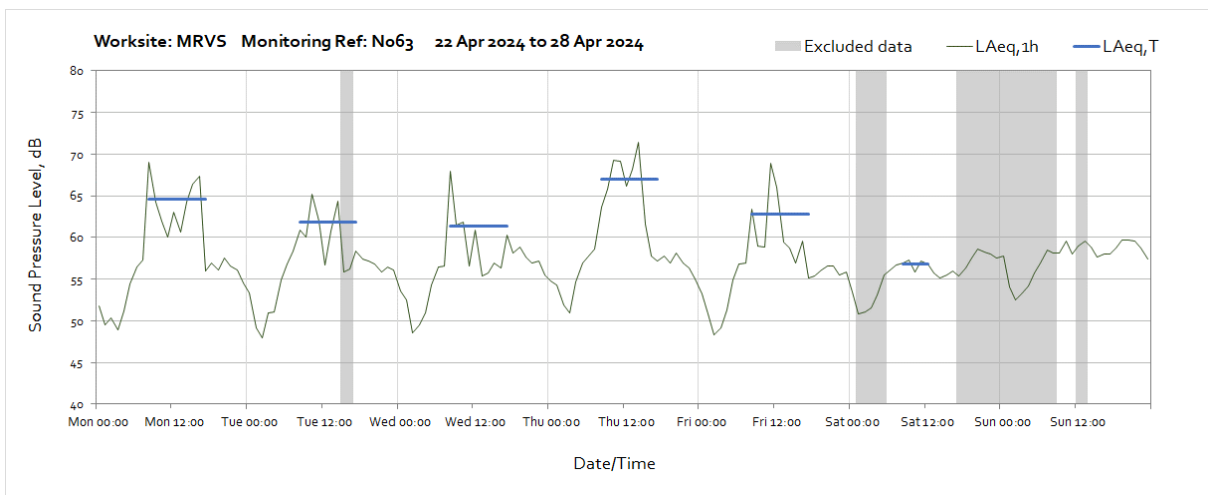
Worksite: MRVS – Monitoring Ref: N063

2.2.7 Twenty-two (22) SOAEL exceedances were recorded due to HS2 construction works during April 2024. The exceedance occurred at N063 and OOC-N03 during weekday evening and night periods.

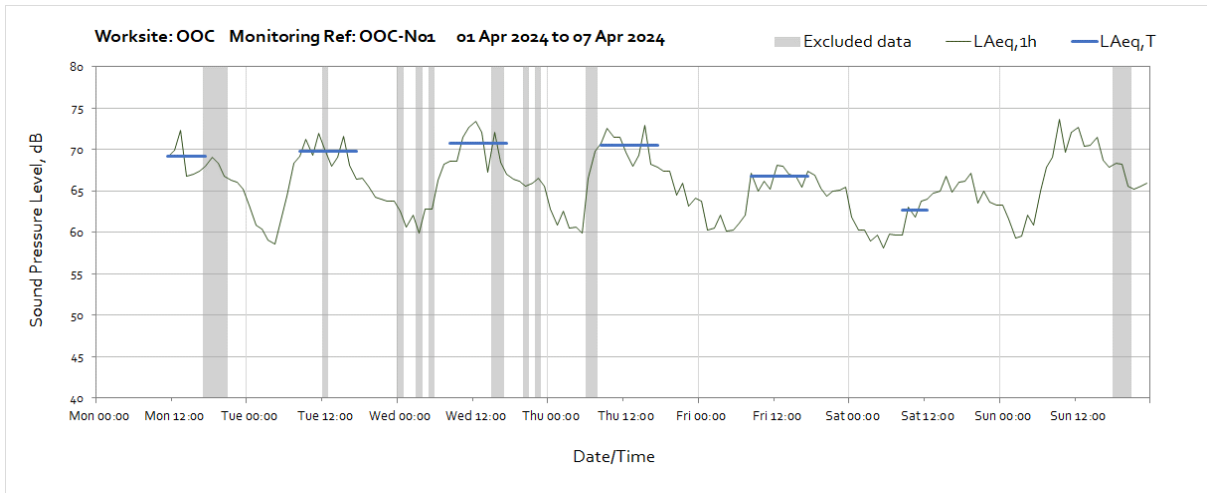
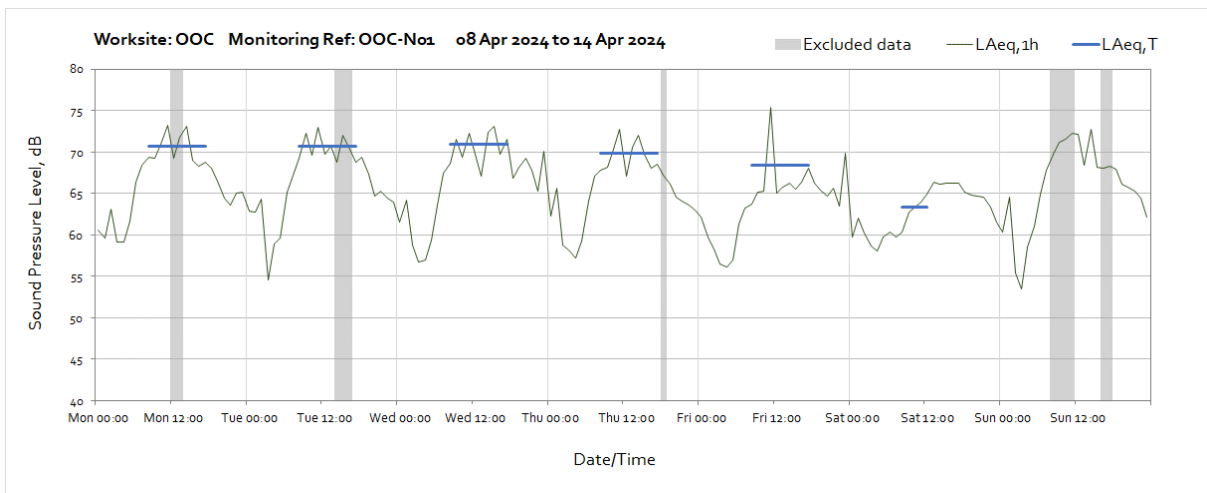
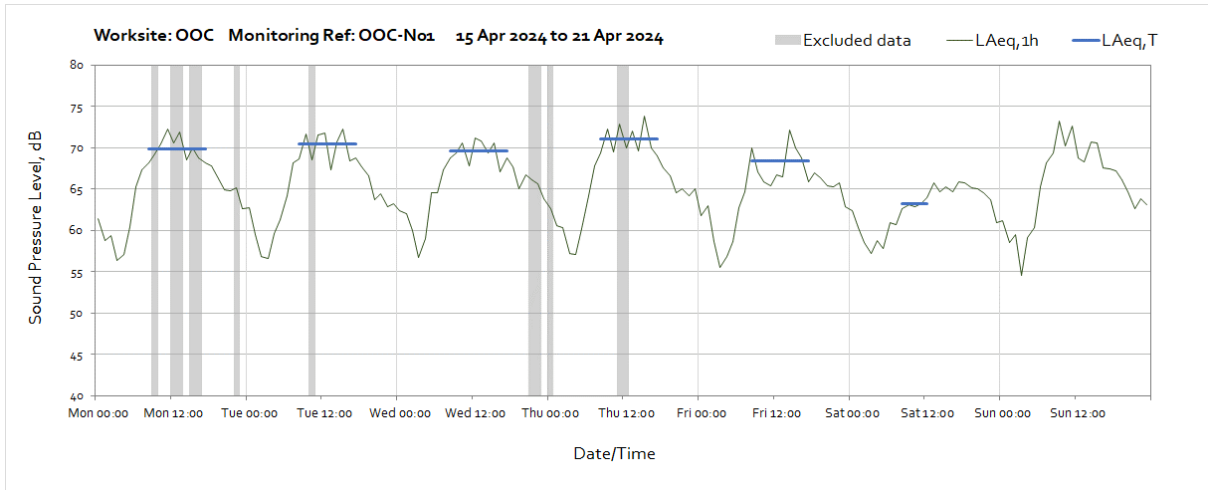
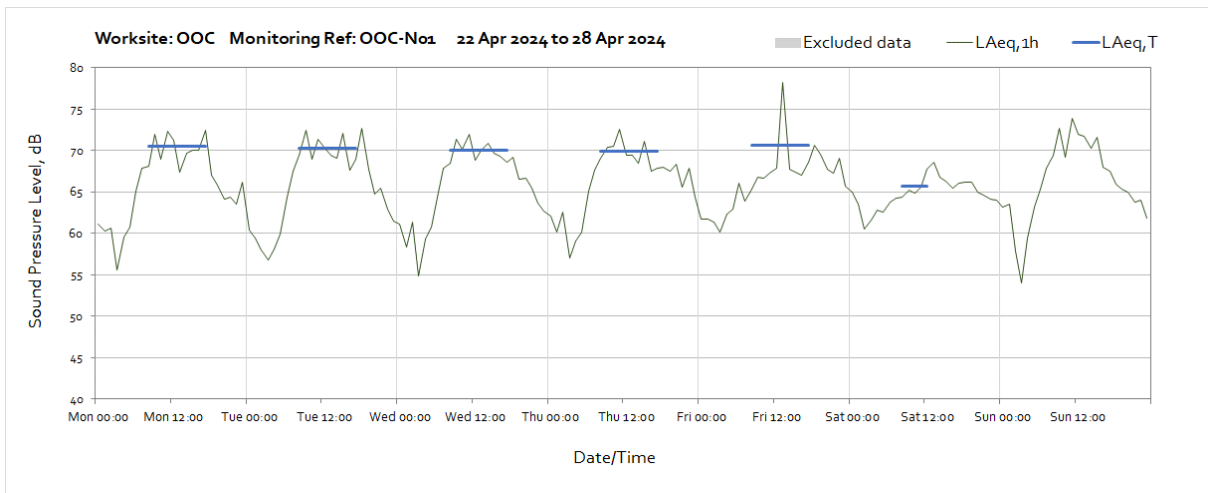
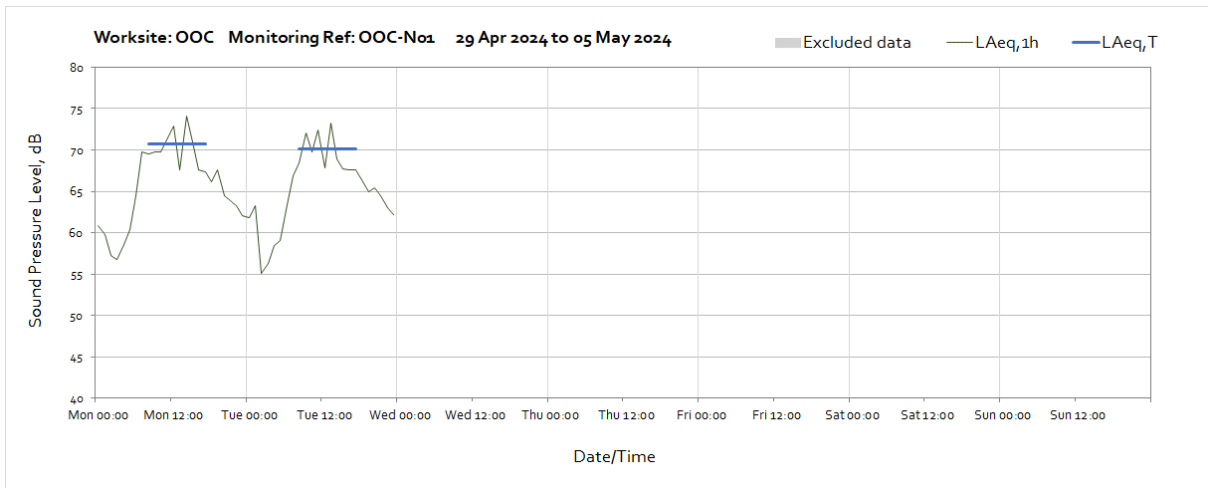
Worksite: OOC – Monitoring Ref: OOC-N01

Note: Missing data from the start of the month until 11:00 on Monday 1st April was due to a monitoring station data logging error.

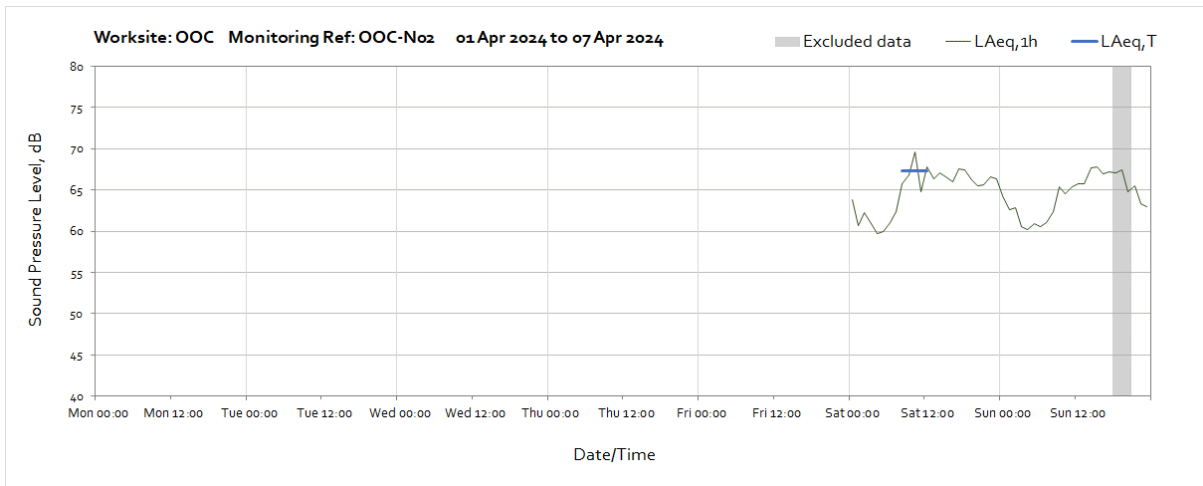
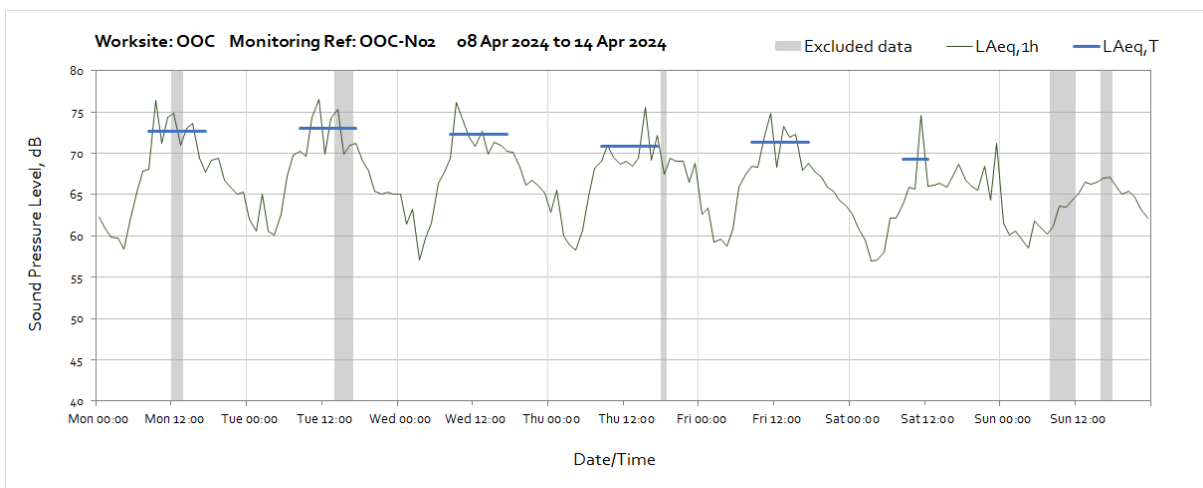
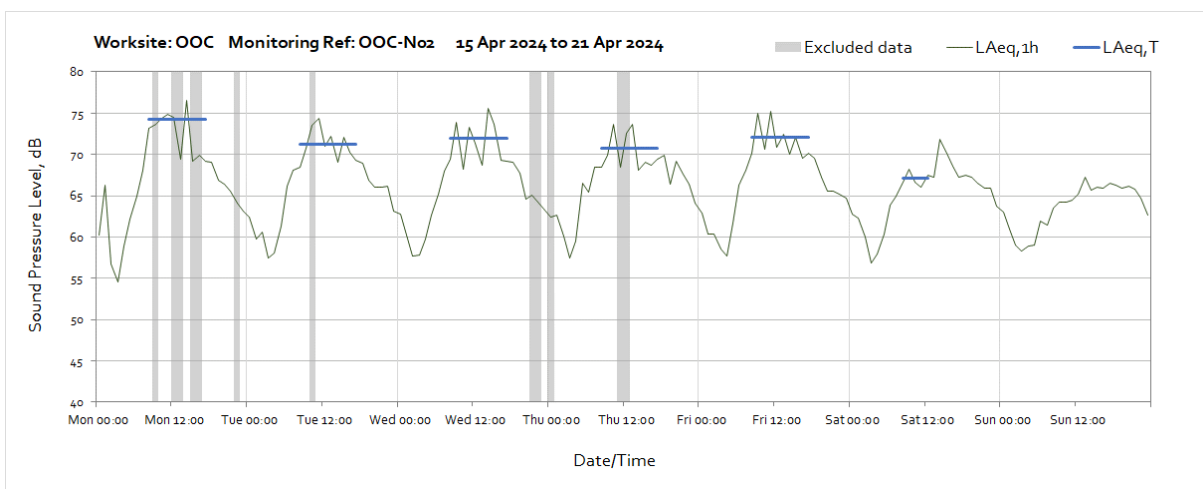
Worksite: OOC – Monitoring Ref: OOC-N02

Note: Missing data from the start of the month until 00:00 on Saturday 6th April was due to lack of remote access to the monitoring station which resulted in automatic deletion of the data. A new monitor has been installed and remote access has been reinstated with view of minimising loss of data in the future.

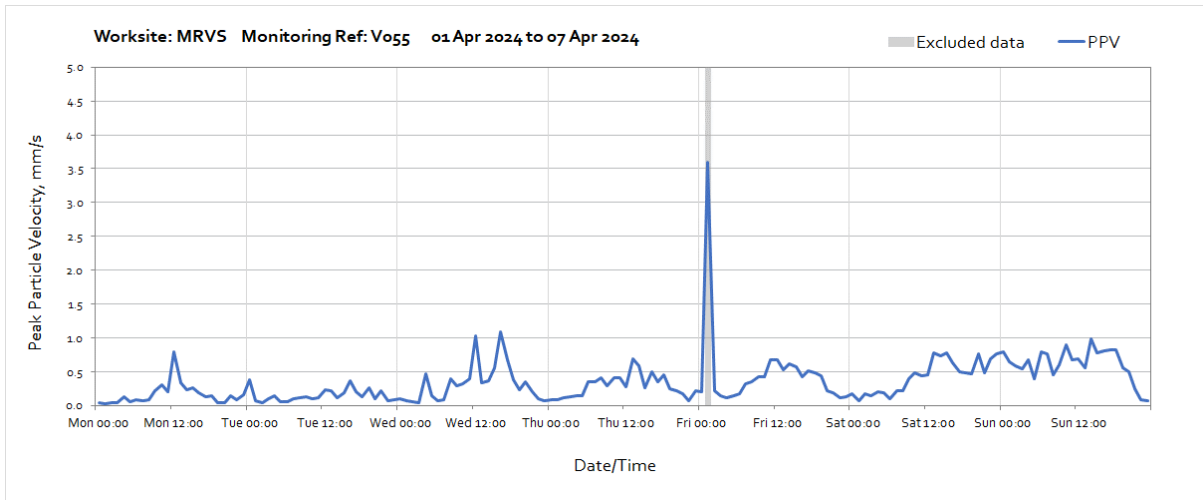
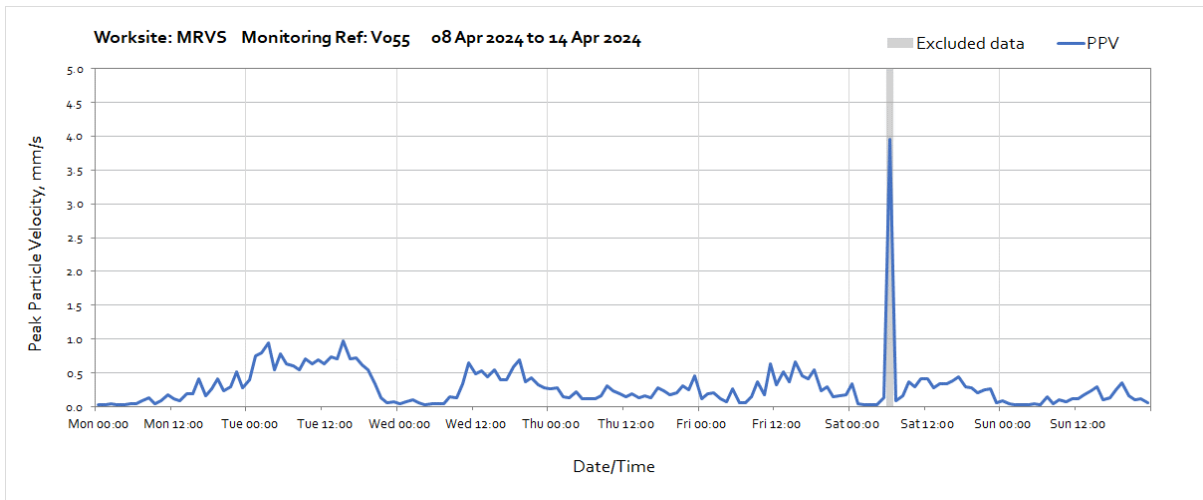
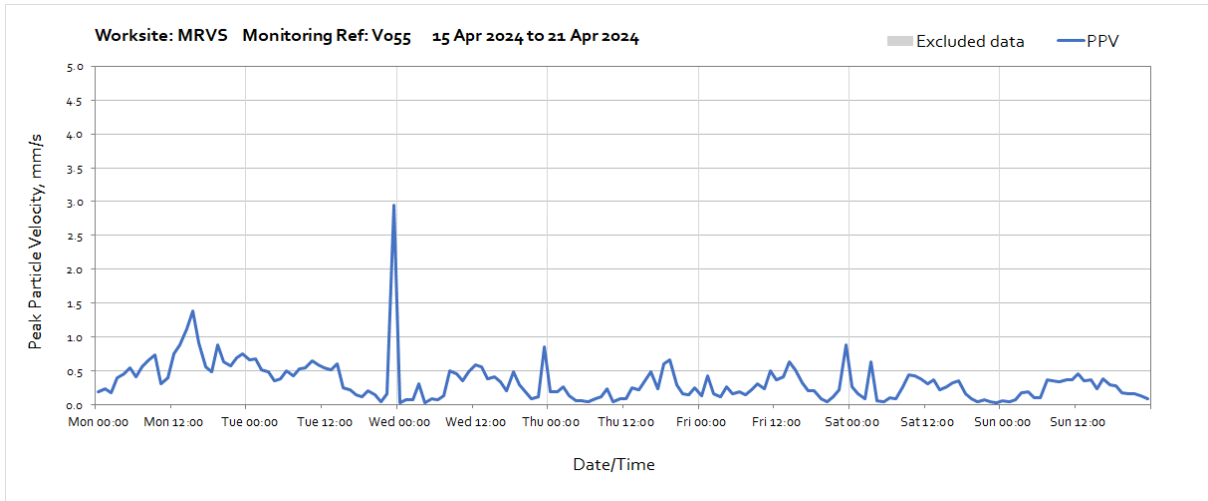
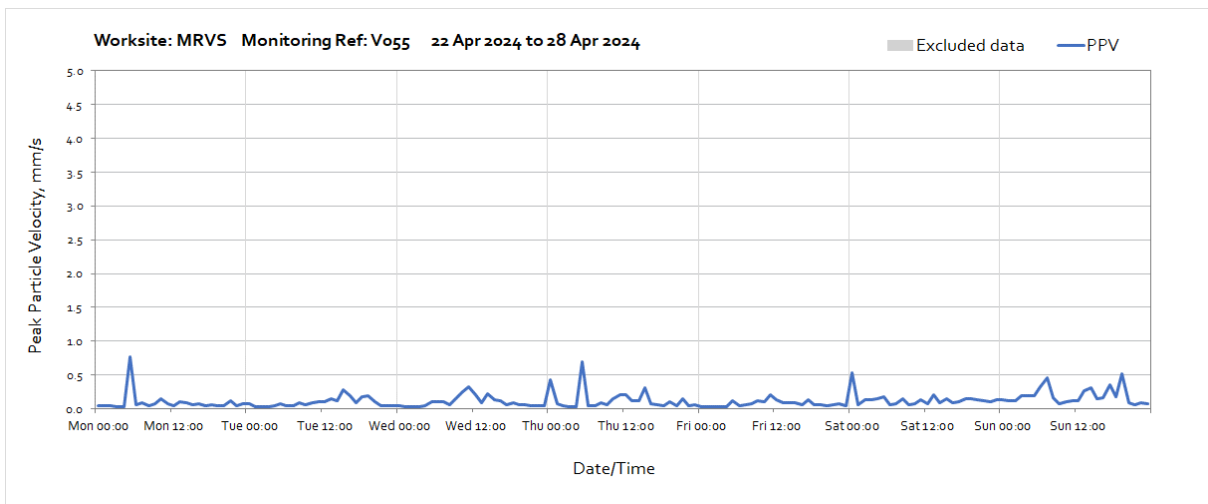
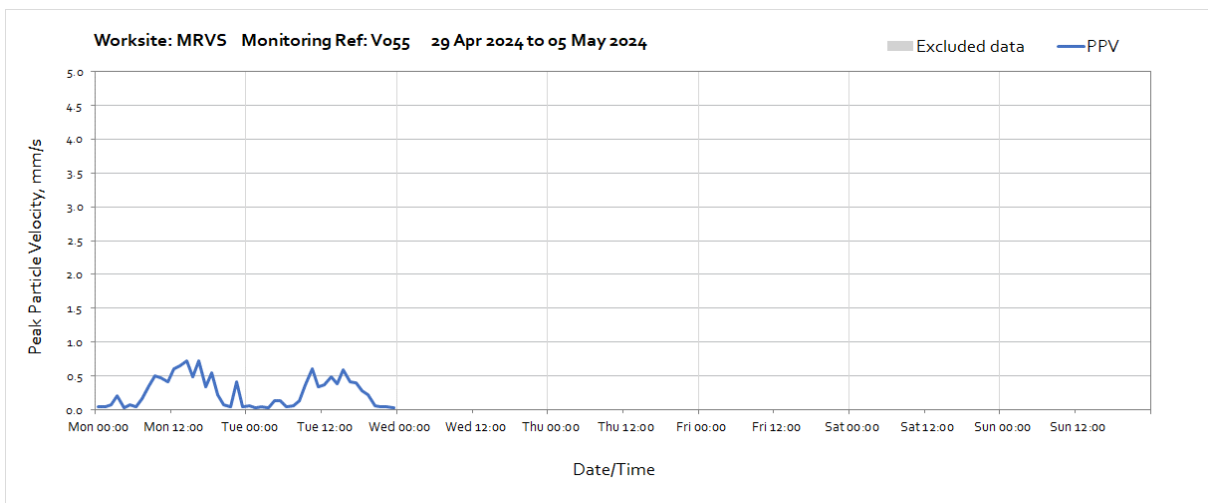
Worksite: MRVS – Monitoring Ref: V055

The following graphs show the hourly measured peak particle velocity PPV recorded during the monitoring period. The graphs show the highest PPV of the three orthogonal axis x, y and z. Periods where PPV values have been affected by local interference with the vibration monitor or only measured for part of the period, which are not representative of HS2 construction works, have been greyed out and excluded when calculating values in Table 4 of the main report.

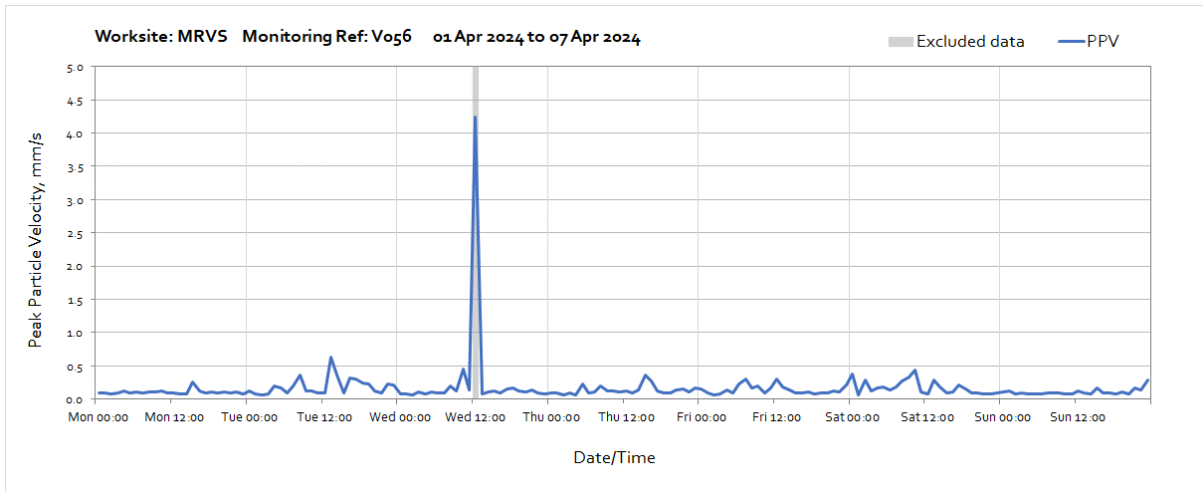
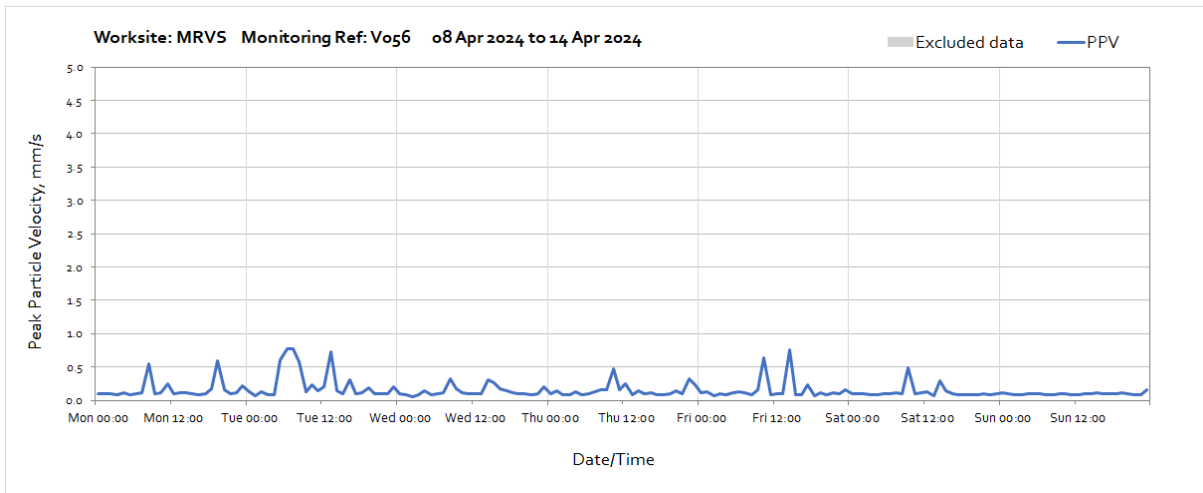
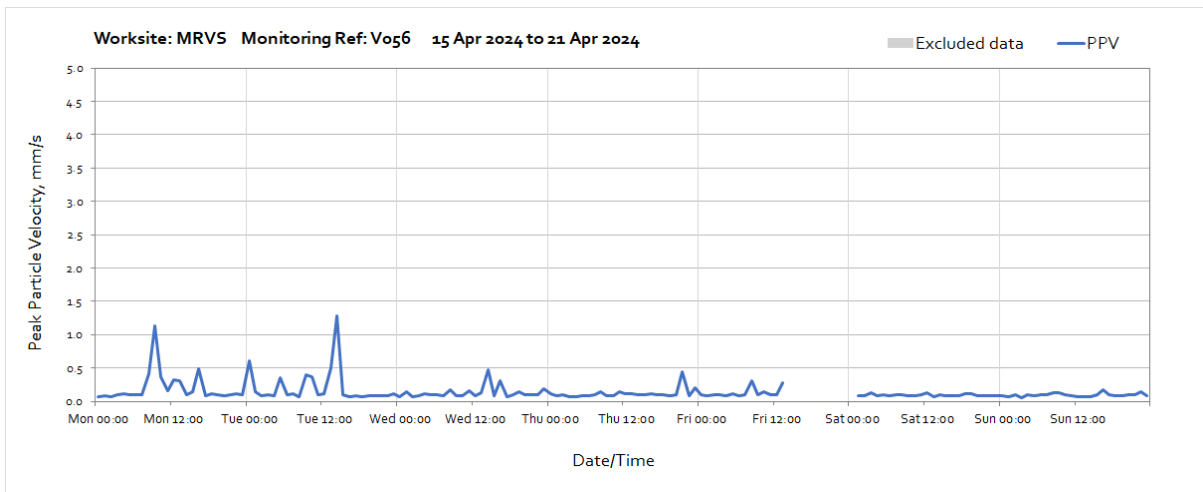
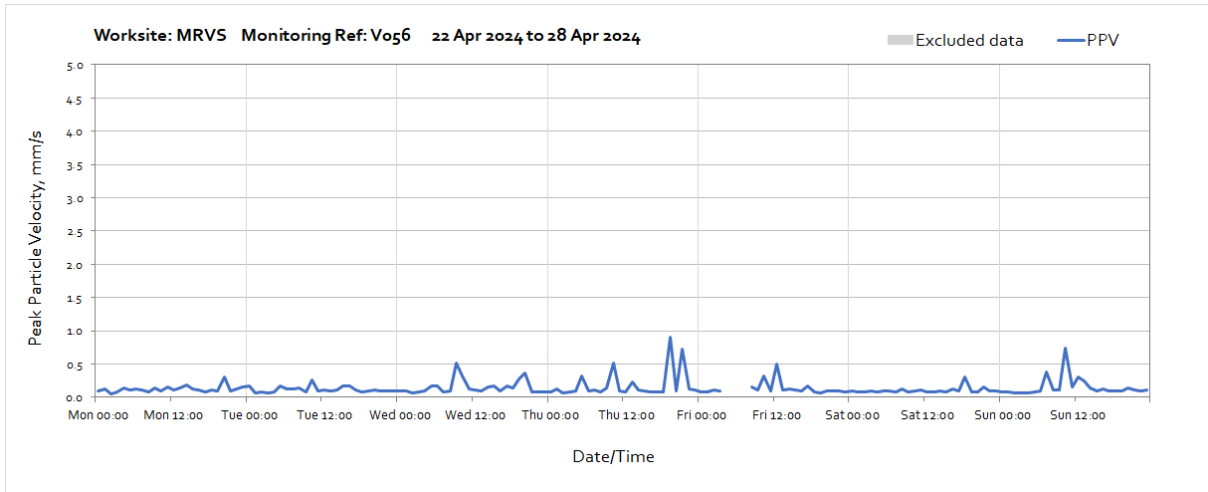
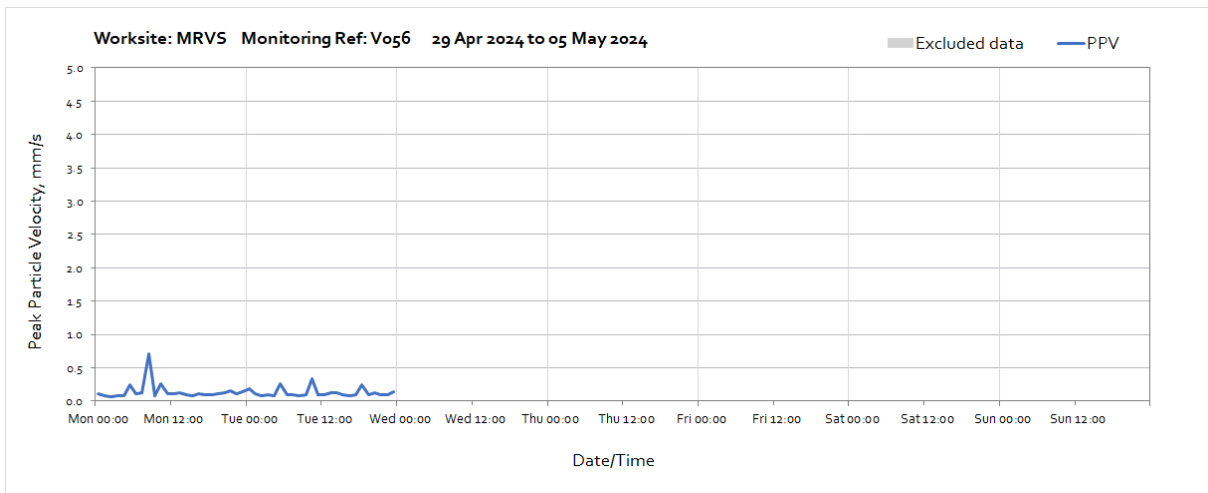
Worksite: MRVS – Monitoring Ref: V056

Note: Missing data from 14:00 on Friday 19th until 01:00 on Saturday 20th April was due to ____.

Note: Missing data from 04:00 until 08:00 on Friday 26th April was due to ____.
