Construction Noise and Vibration Monthly Report – April 2024

London Borough of Hillingdon

This Noise and Vibration Monitoring Report fulfils HS2 Limited's commitment detailed in the Environmental Minimum Requirements (EMRs), Annex 1, Code of Construction Practice, to present the results of noise monitoring carried out within the London Borough of Hillingdon during the month of April 2024.

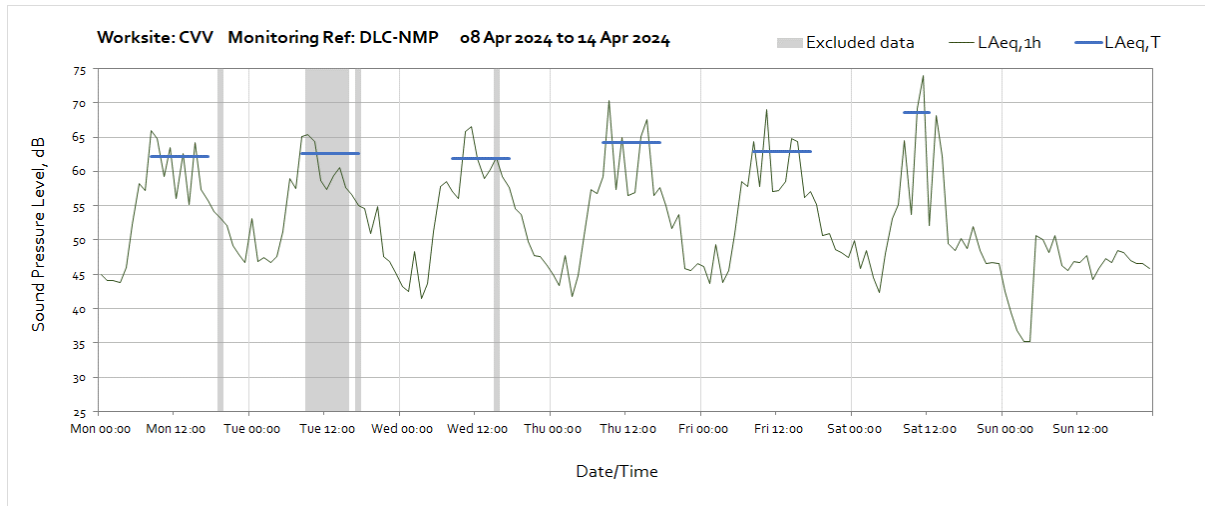
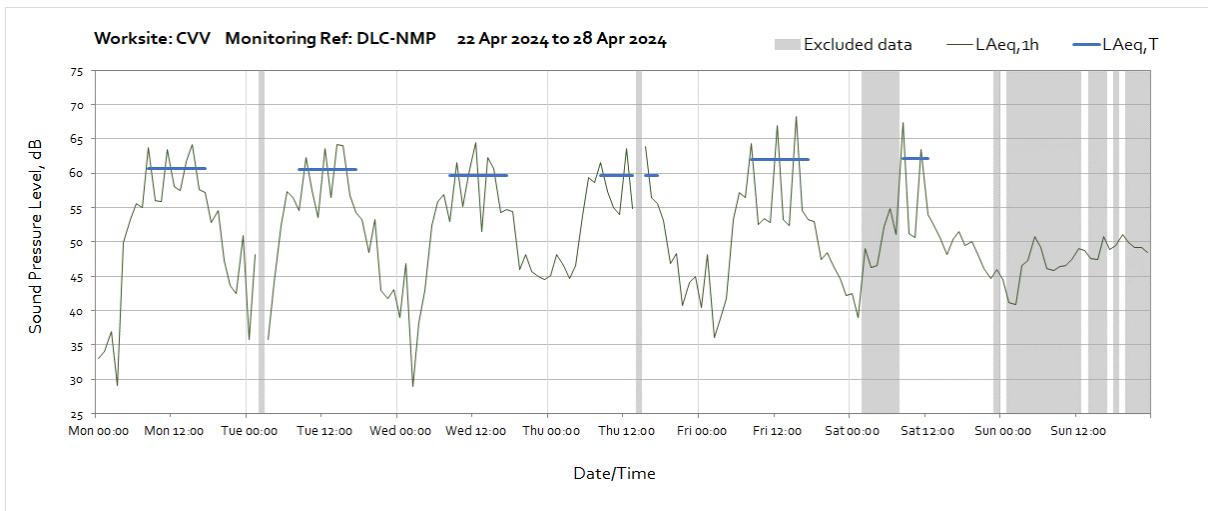
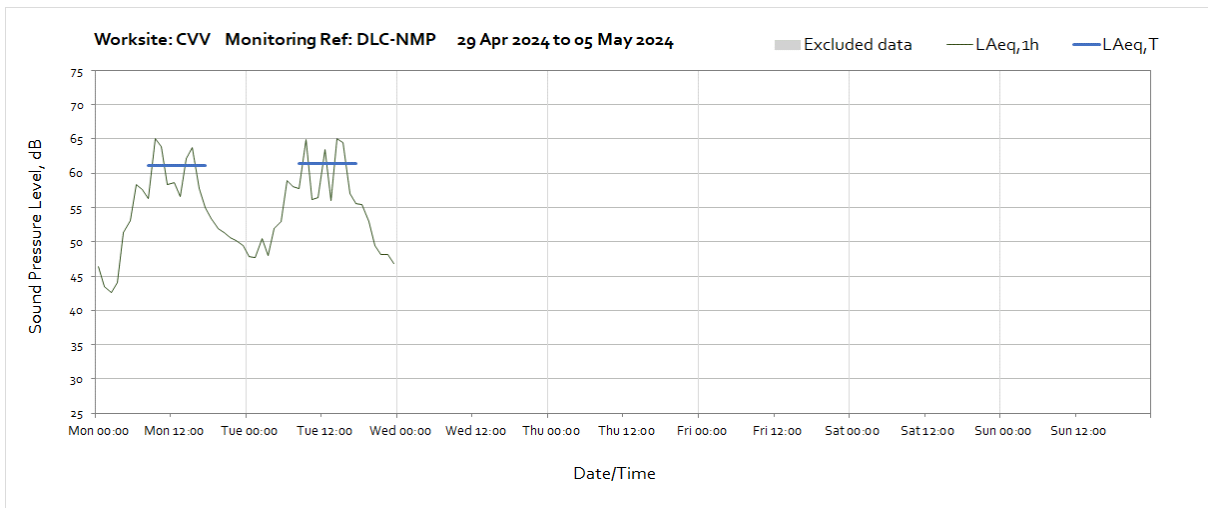
Worksite: CVV - Monitoring Ref: DLC-NMP

The following graphs show the hourly measured ambient noise level $L_{Aeq,1h}$ and, where relevant, the averaged noise level $L_{Aeq,T}$ values, where the time period T is as specified in Table 1 of HS2 Information Paper E23. Periods where noise levels are adversely affected by weather or only measured for part of the period, which are not representative of HS2 construction works, have been greyed out and excluded from the calculation of the $L_{Aeq,T}$ values in Table 3 of the main report.

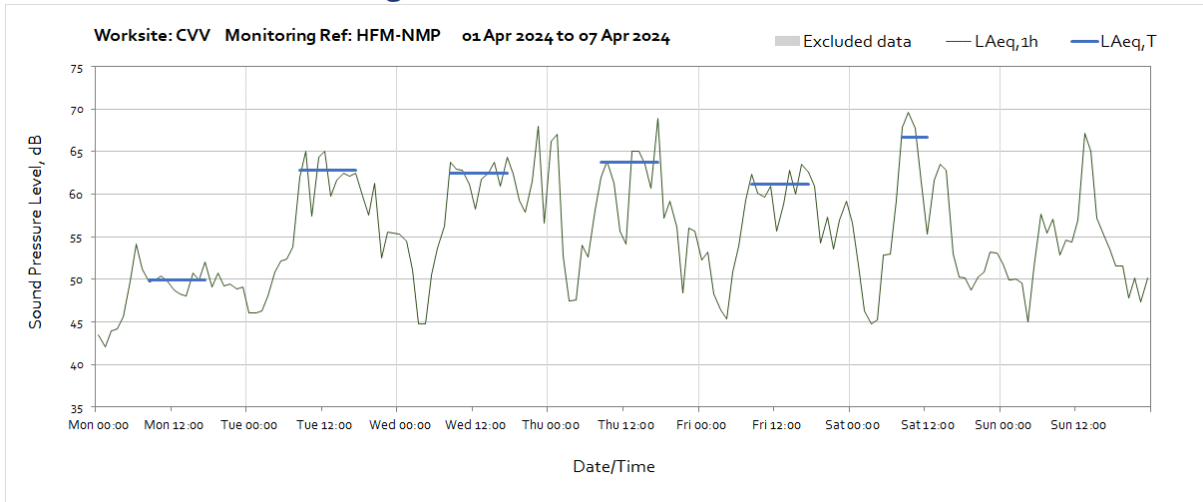
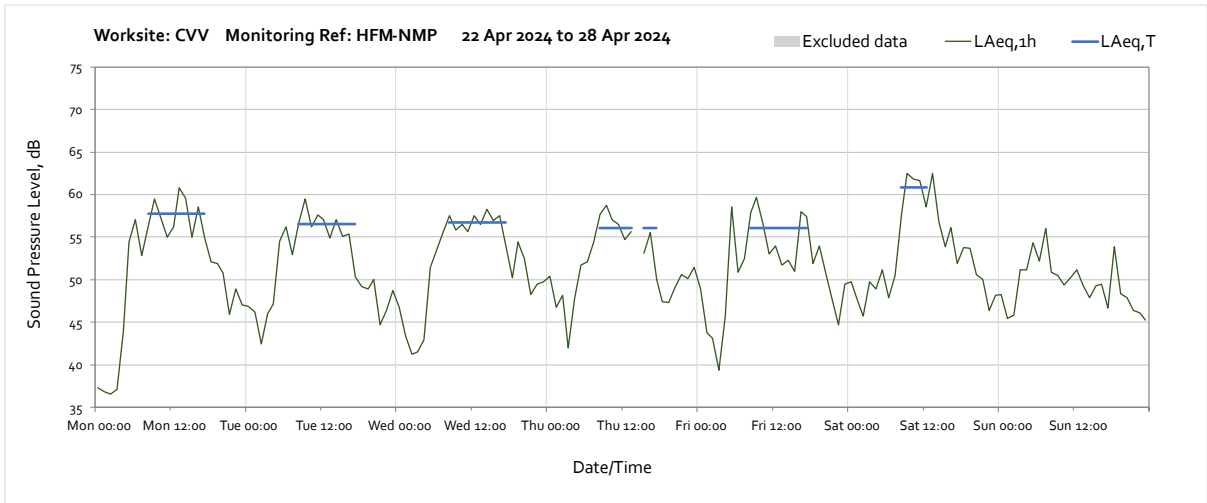
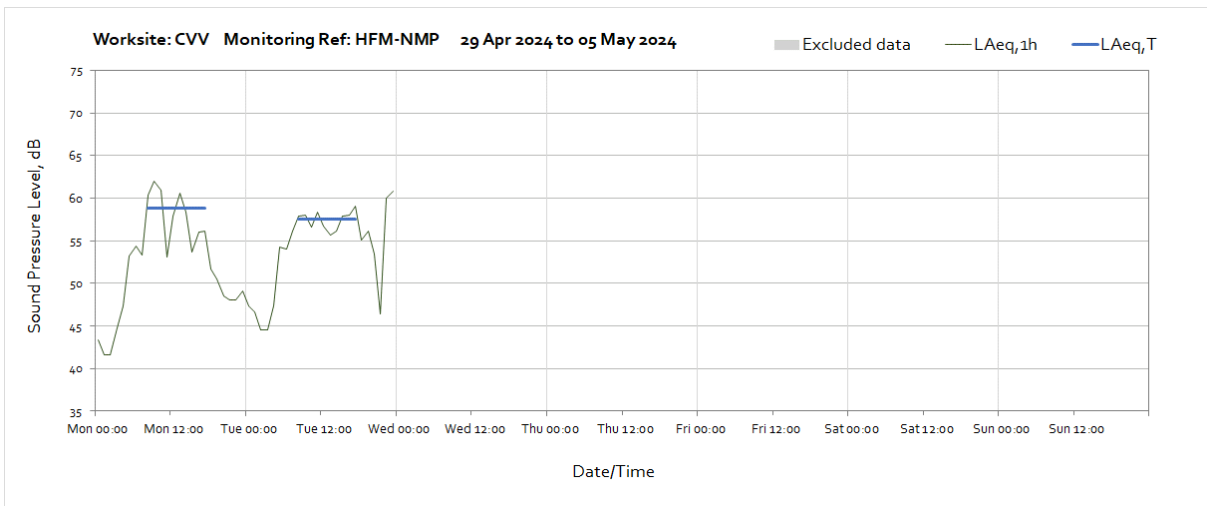
Worksite: CVV – Monitoring Ref: HFM-NMP

2.2.8 Twelve (12) SOAEL exceedances were recorded due to HS2 construction works during April 2024. The exceedance occurred at HFM-NMP during weekday, Saturday and night-time periods.

Note: Missing data between 14:00 and 15:00 on Thursday 25th April was due to the monitor field calibration.

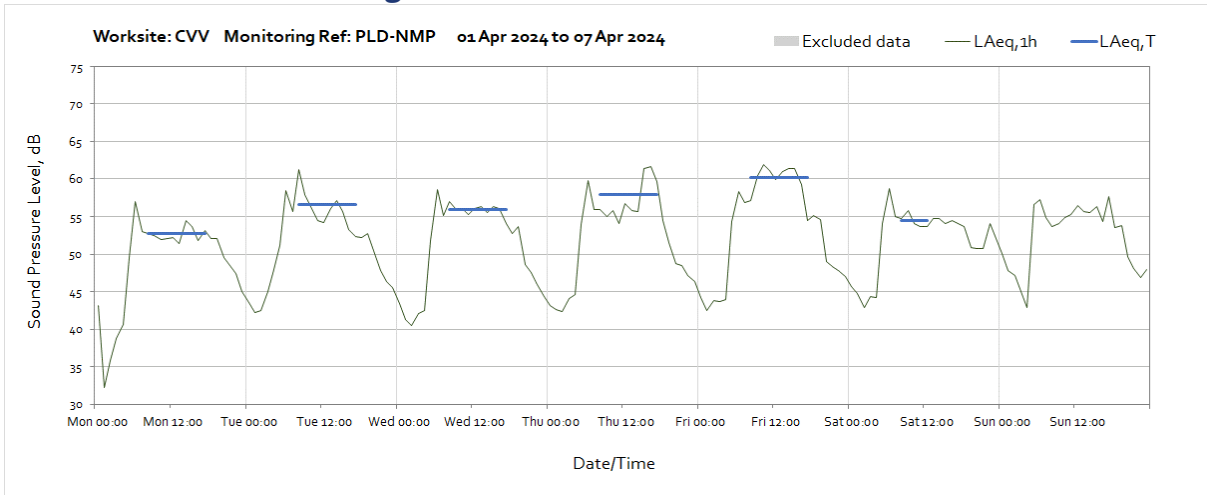
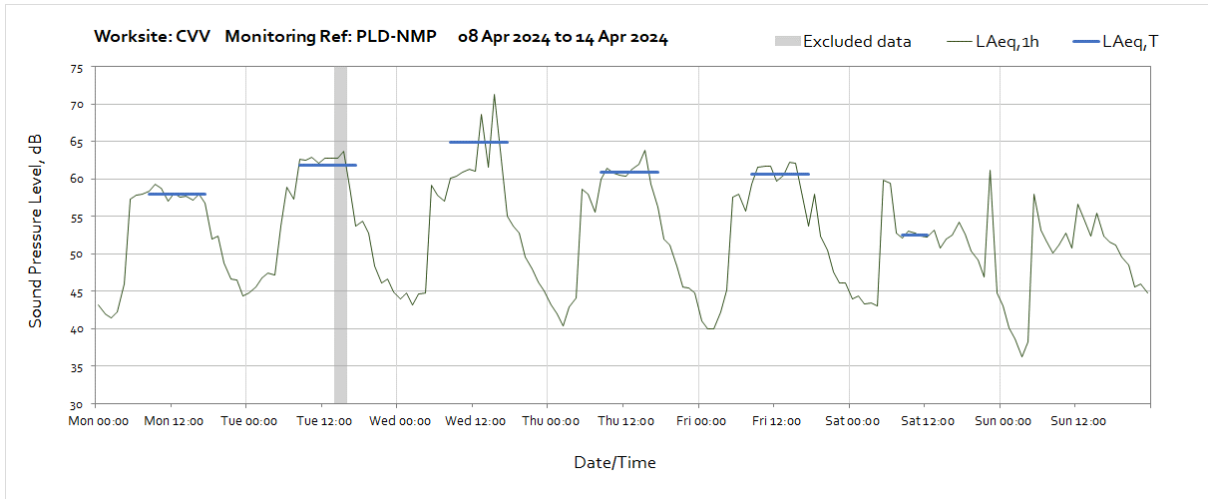
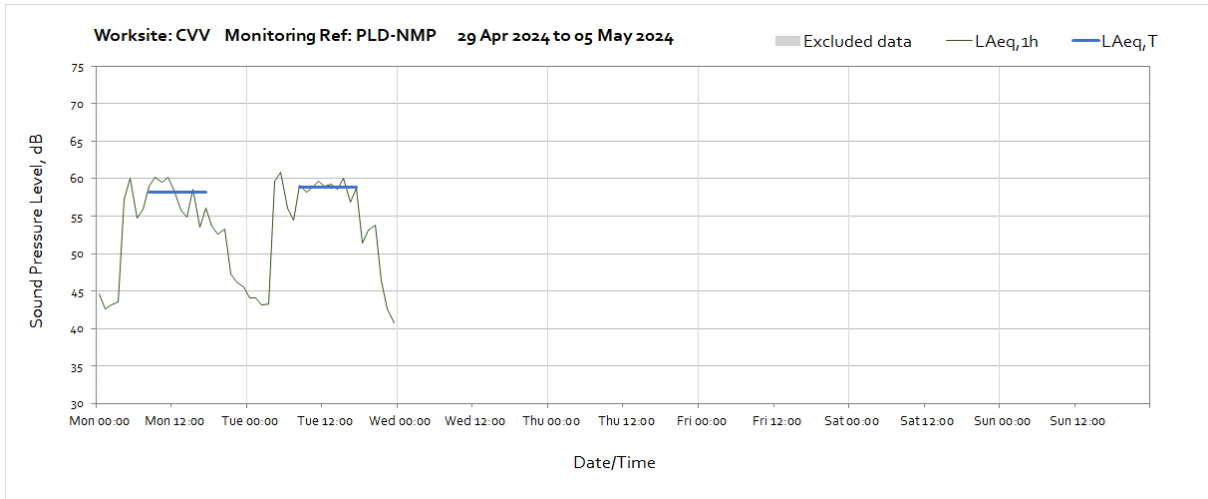
Worksite: CVV – Monitoring Ref: PLD-NMP

Note: Missing data between 14:00 and 15:00 on Thursday 25th April was due to the monitor field calibration.

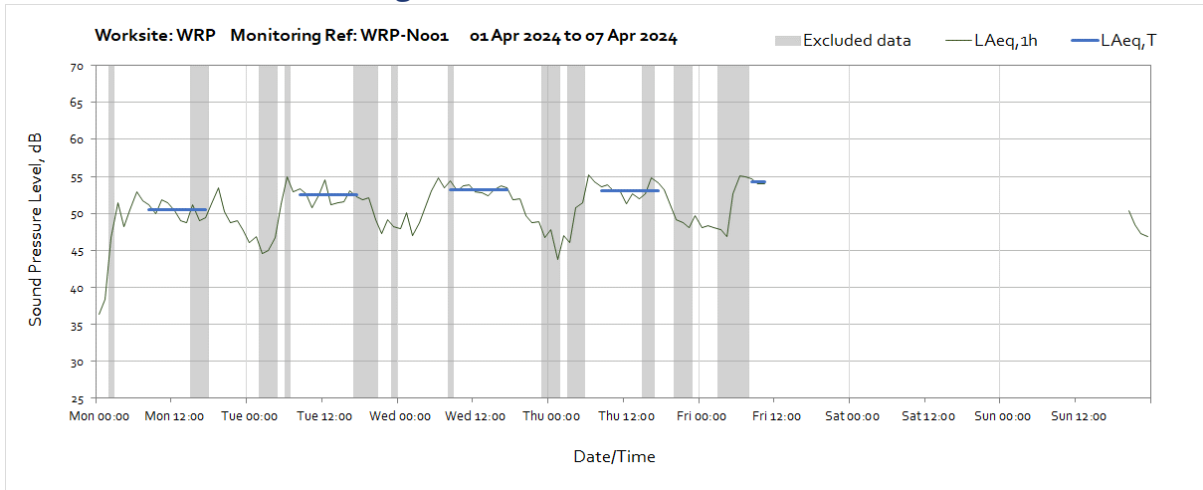
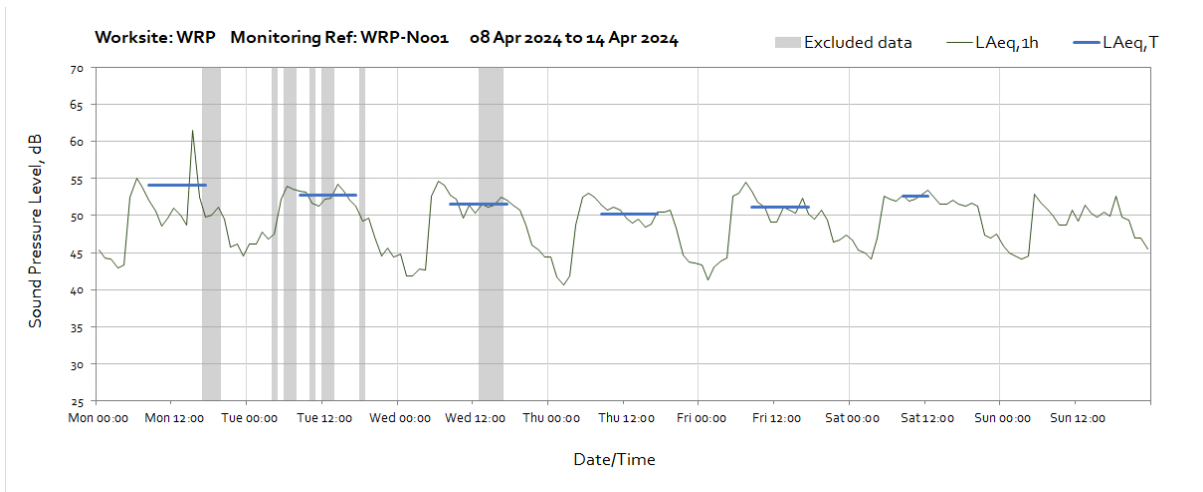
Worksite: WRP – Monitoring Ref: WRP-N001

Note: Missing data between 11:00 on Friday 5th April and 20:00 on Sunday 7th April was due to a faulty battery and power cables which were replaced.
