Construction Noise and Vibration Monthly Report – April 2024

Lichfield District Council

Non-Technical Summary

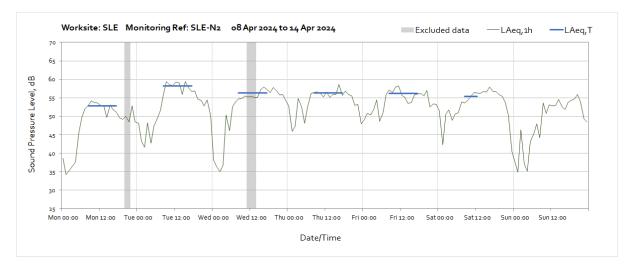
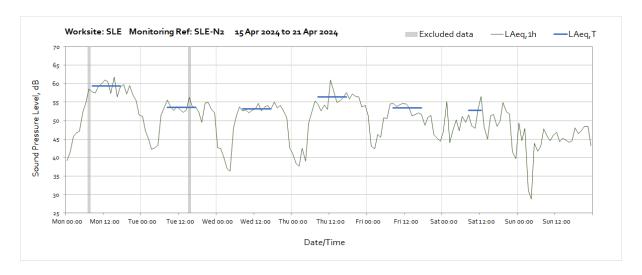
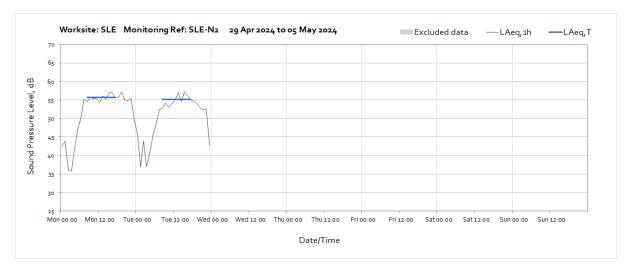
Worksite:SLE - Monitoring Ref: SLE-N2

The following graphs show the hourly measured ambient noise level LAeq,1h and, where relevant, the averaged noise level LAeq,T values, where the time period T is as specified in Table 1 of HS2 Information Paper E23. Periods where noise levels are adversely affected by weather or only measured for part of the period, which are not representative of HS2 construction works, have been greyed out and excluded from the calculation of the LAeq,T values in Table 3 of the main report.

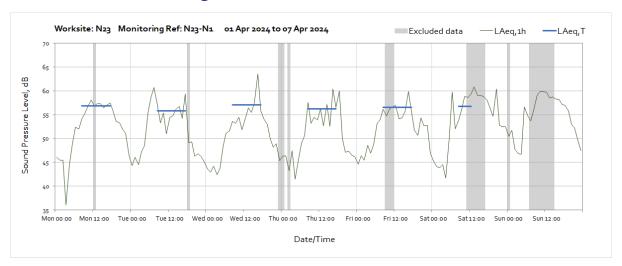
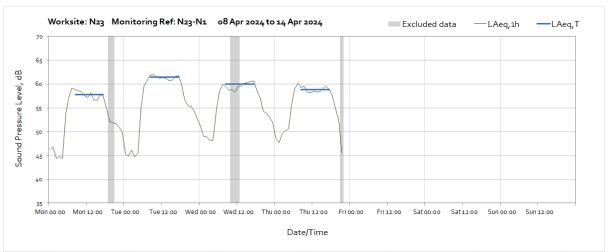
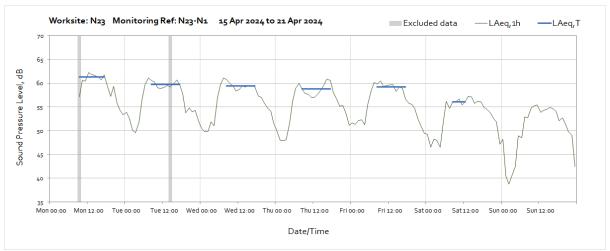
Worksite: N23 - Monitoring Ref: N23-N1

Note: Missing data between 22:00 on Thursday 11th of April and 08:00 on Monday 15th of April is due to communication error between monitoring station and the server.

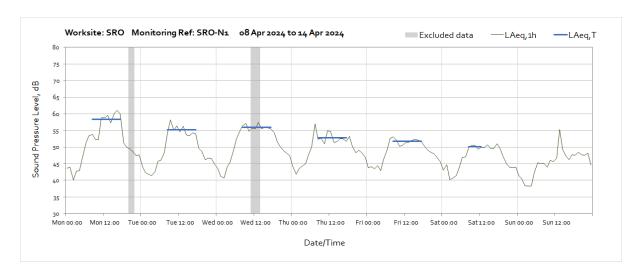
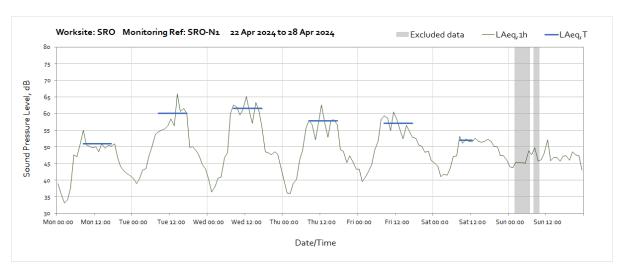
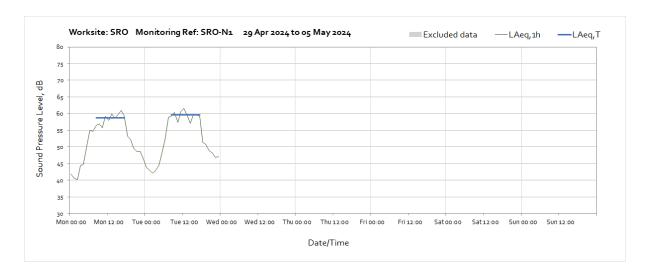
Worksite: SRO - Monitoring Ref: SRO-N1

SRO	SRO-N1	Sutton Road, Drayton Bassett, Mile Oak	Weekday Weekday	0700-0800 0800-1800	3 3	No exceedance
	SRO-N3	White House Farm, Bangley Lane, Tamworth	All days	All periods	No exceedance	No exceedance
DLC	DLC-N1	Oak Dairy Farm, Drayton Lane	All days	All periods	No exceedance	No exceedance

- 2.2.6 Exceedances of the LOAEL were recorded at four (4) noise monitor during weekday daytime and Saturday periods.
- 2.2.7 No exceedances of the SOAEL were recorded at any monitoring location during April 2024.

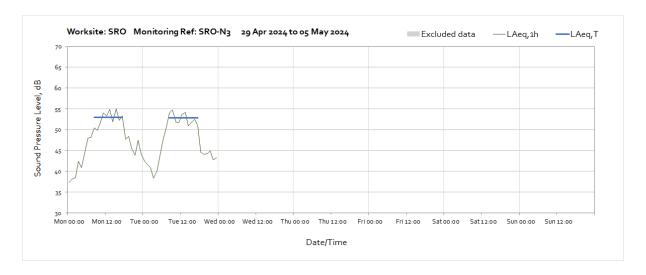
Worksite: SRO - Monitoring Ref: SRO-N3

Note: The noise monitor was installed at 11:00 on Thursday 25th of April.

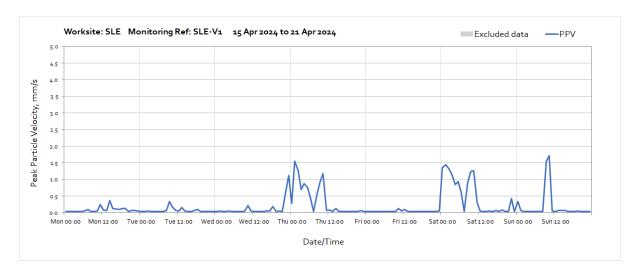
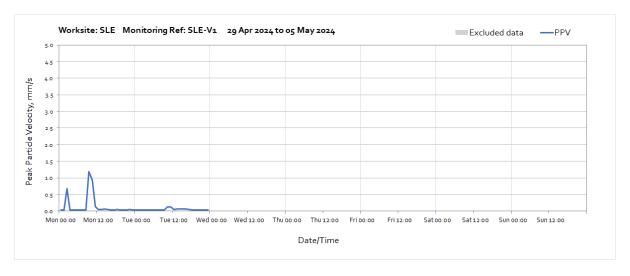
Worksite: SLE - Monitoring Ref: SLE-V1

Worksite Reference	Measurement Reference	Monitor Address	Highest PPV measured in any axis, mm/s
SLE	SLE-V1	Shaw Lane Carpark, Tuppenhurst Lane	1.72 (Z-axis)
FEW	FEW-V3	Wood End Farm, Wood End Lane	1.37 (Y-axis)
CLC	CLC-V1	lvy Cottage, Park Lane, Fradley and Streethay, Whittington	0.65 (Z-axis)
TROS	TROS-V2	The Bungalow, Tamworth Road	2.63 (Y-axis)
SRO	SRO-V2	Bangley Lane, Hints	1.12 (Z-axis)
	SRO-V3	White House Farm, Bangley Lane, Tamworth	0.38 (X-axis)

The following graphs show the hourly measured peak particle velocity PPV recorded during the monitoring period. The graphs show the highest PPV of the three orthogonal axes x, y and z. Periods where PPV values have been affected by local interference with the vibration monitor or only measured for part of the period, which are not representative of HS2 construction works, have been greyed out and excluded when calculating values in Table 4 of the main report.

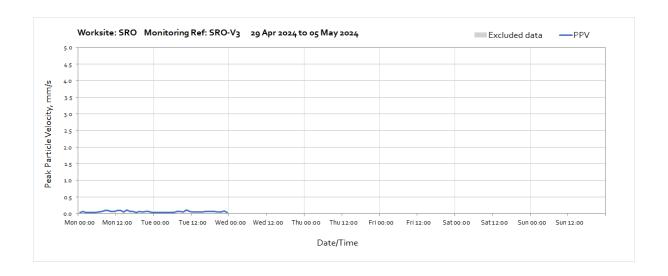
Worksite: SRO - Monitoring Ref: SRO-V3

Note: The vibration monitor was installed at 10:00 on Thursday 25th of April.
