## **Construction Noise and Vibration Monthly Report – April 2024**

**North Warwickshire Borough Council**

This Noise and Vibration Monitoring Report fulfils HS2 Limited's commitment detailed in the Environmental Minimum Requirements (EMRs), Annex 1, Code of Construction Practice, to present the results of noise and vibration monitoring carried out within North Warwickshire Borough Council (NWBC) area during the month of April 2024.

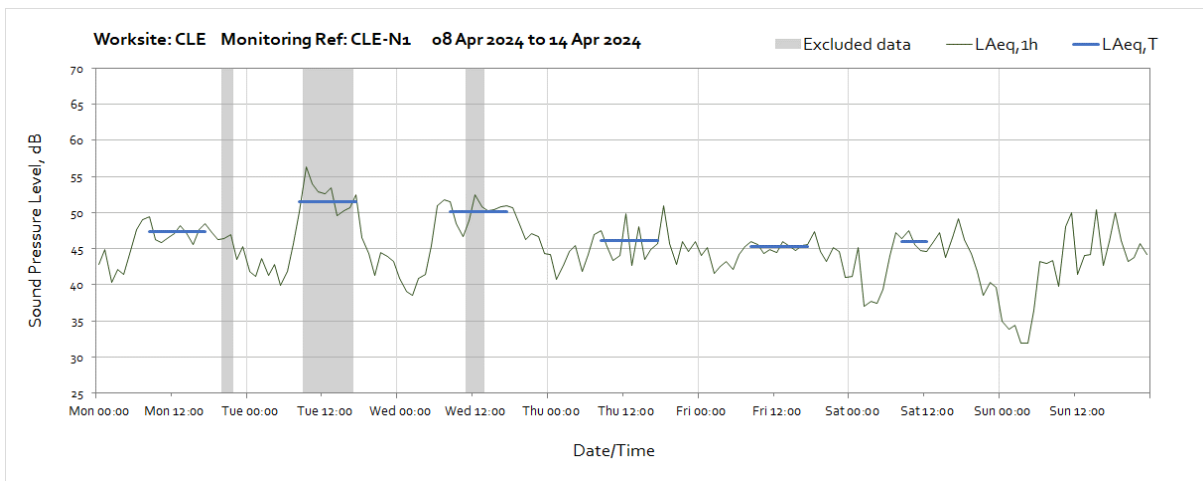
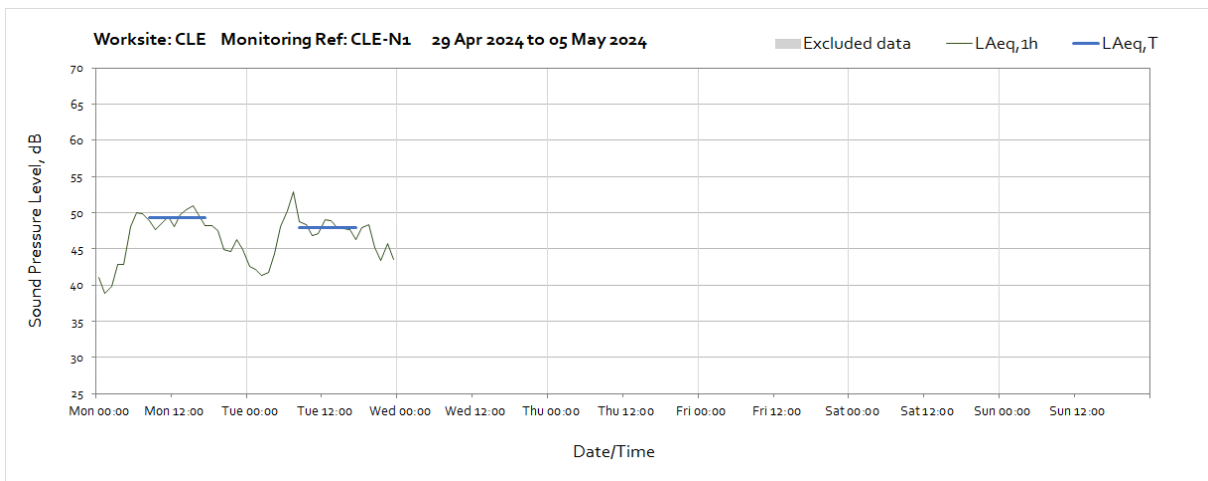
### Worksite: CLE – Monitoring Ref: CLE-N1

The following graphs show the hourly measured ambient noise level  $L_{Aeq,1h}$  and, where relevant, the averaged noise level  $L_{Aeq,T}$  values, where the time period T is as specified in Table 1 of HS2 Information Paper E23. Periods with adversely weather affected noise levels are greyed out and have been excluded from the calculation of the  $L_{Aeq,T}$  values in Table 3 of the main report.:
