# **Construction Noise and Vibration Monthly Report – April 2024**

**Solihull Metropolitan Borough Council**

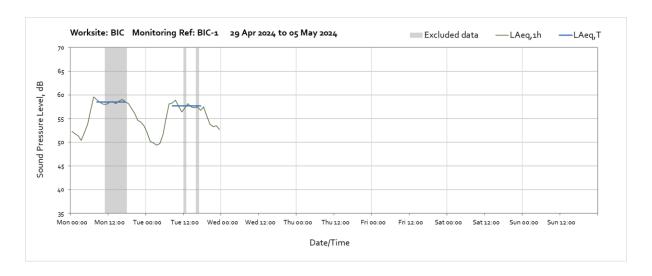
## **Worksite: BIC - Monitoring Ref: BIC-1**

The following graphs show the hourly measured ambient noise level  $L_{Aeq,1h}$  and, where relevant, the averaged noise level  $L_{Aeq,T}$  values, where the time period T is as specified in Table 1 of HS2 Information Paper E23. Periods where noise levels are adversely affected by weather or only measured for part of the period, which are not representative of HS2 construction works, have been greyed out and excluded from the calculation of the  $L_{Aeq,T}$  values in of the main report.
