# **Construction Noise and Vibration Monthly Report – April 2024**

**West Northamptonshire District Council**

This Noise and Vibration Monitoring Report fulfils HS2 Limited's commitment detailed in the Environmental Minimum Requirements (EMRs), Annex 1, Code of Construction Practice, to present the results of noise and vibration monitoring carried out within West Northamptonshire District Council (WNDC) area during the month of April 2024.

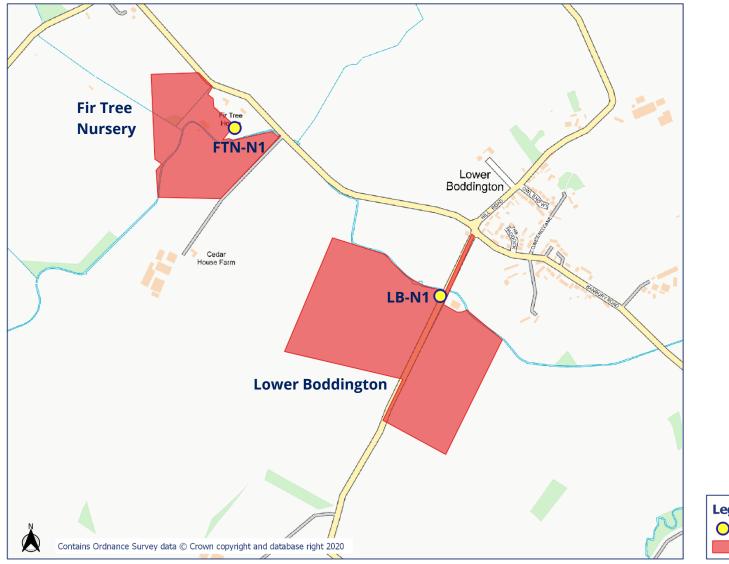
### **Noise Monitoring Plan - 1**

- 1.2.1 Eight (8) noise monitoring installations were active in April in the WNDC area. Table 2 summarises the position of noise monitoring installations within the WNDC area in April 2024.
- 1.2.2 Monitor CW-N1 was not active for the month of April 2024, due to a measurement configuration issue.
- 1.2.3 Maps showing the position of noise monitoring installations are presented in Appendix B.

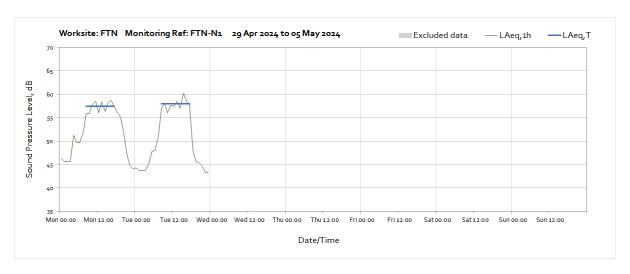
#### **Worksite: FTN - Monitoring Ref: FTN-N1**

The following graphs show the hourly measured ambient noise level  $L_{Aeq,1h}$  and, where relevant, the averaged noise level  $L_{Aeq,T}$  values, where the time period T is as specified in Table 1 of HS2 Information Paper E23. Periods where noise levels are adversely affected by weather or only measured for part of the period, which are not representative of HS2 construction works, have been greyed out and excluded from the calculation of the  $L_{Aeq,T}$  values in Table 3 of the main report.

Note: Missing data between 00:00 and 01:00 on Monday 1st of April was due to a network error.

Note: Missing data between 05:00 and 06:00 on Tuesday 9<sup>th</sup> of April was due to a network error.

2.1.2 Appendix C presents graphs of the noise monitoring data over the month for each of the measurement locations. Noise data presented consists of the hourly L<sub>Aeq</sub> values and, where relevant, the L<sub>Aeq,T</sub> values (where the time period T has been taken to be the averaging period as specified in Table 1 of HS2 Information Paper E23). The full data set for the monitoring equipment can be found at the following location: <a href="https://data.gov.uk/dataset/24542ae7-dd44-444f-b259-871c4cc43b5e/environmental-monitoring-data">https://data.gov.uk/dataset/24542ae7-dd44-444f-b259-871c4cc43b5e/environmental-monitoring-data</a>.

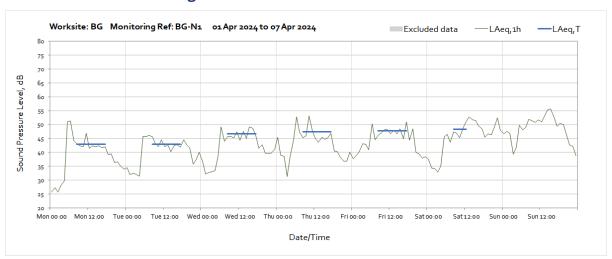
#### **Worksite: BG - Monitoring Ref: BG-N1**

Note: Missing data between 05:00 and 06:00 on Tuesday 9<sup>th</sup> of April was due to a network error.

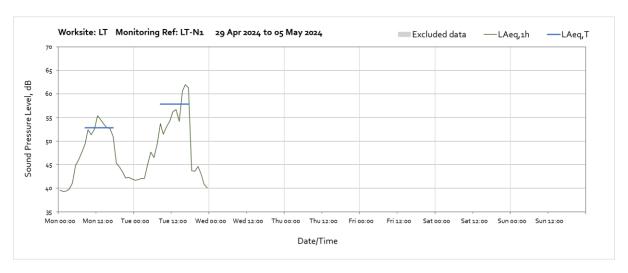
#### Worksite: LT - Monitoring Ref: LT-N1

Note: Missing data between 05:00 and 06:00 on Tuesday 9<sup>th</sup> of April was due to a network error.

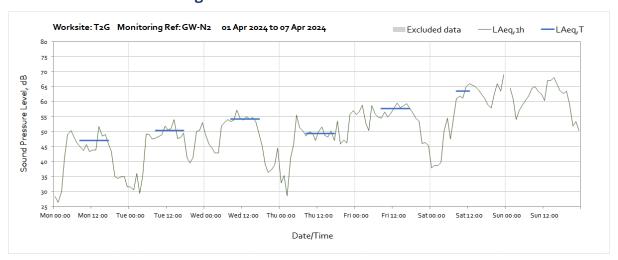
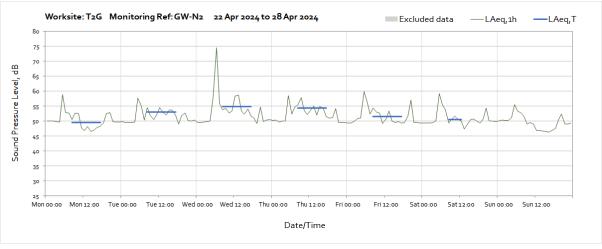
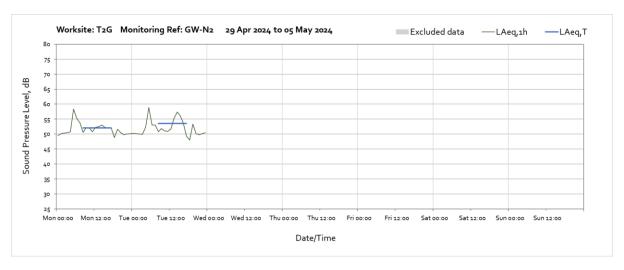
#### Worksite: GW - Monitoring Ref: GW-N2

Note: Missing data between 00:00 and 01:00 on Sunday 6<sup>th</sup> of April was due to a network error.

Note: Missing data between 05:00 and 06:00 on Tuesday 9th of April was due to a network error.

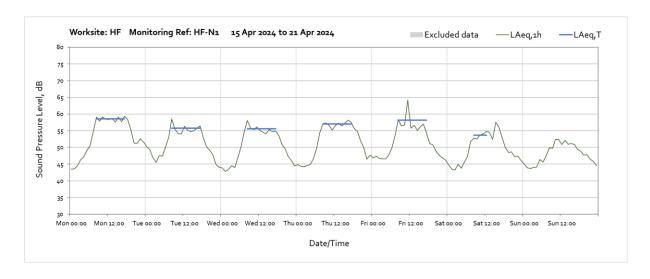
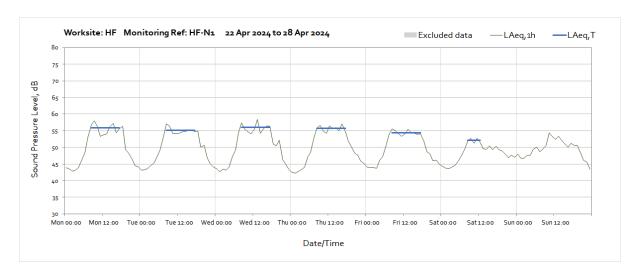
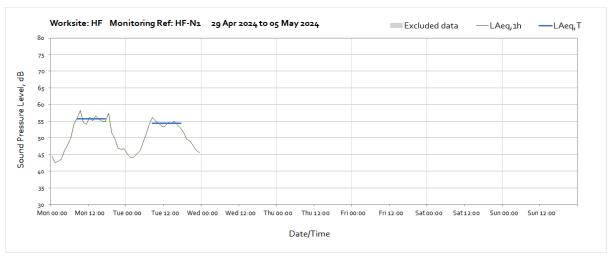
#### **Worksite: HF - Monitoring Ref: HF-N1**

Note: Missing data between 00:00 and 01:00 on Sunday 6<sup>th</sup> of April was due to a network error.

Note: Missing data between 05:00 and 06:00 on Tuesday 9<sup>th</sup> of April was due to a network error.
