Air Quality and Dust Monitoring Monthly Report - April 2024

West Northamptonshire District Council

Monthly Summary

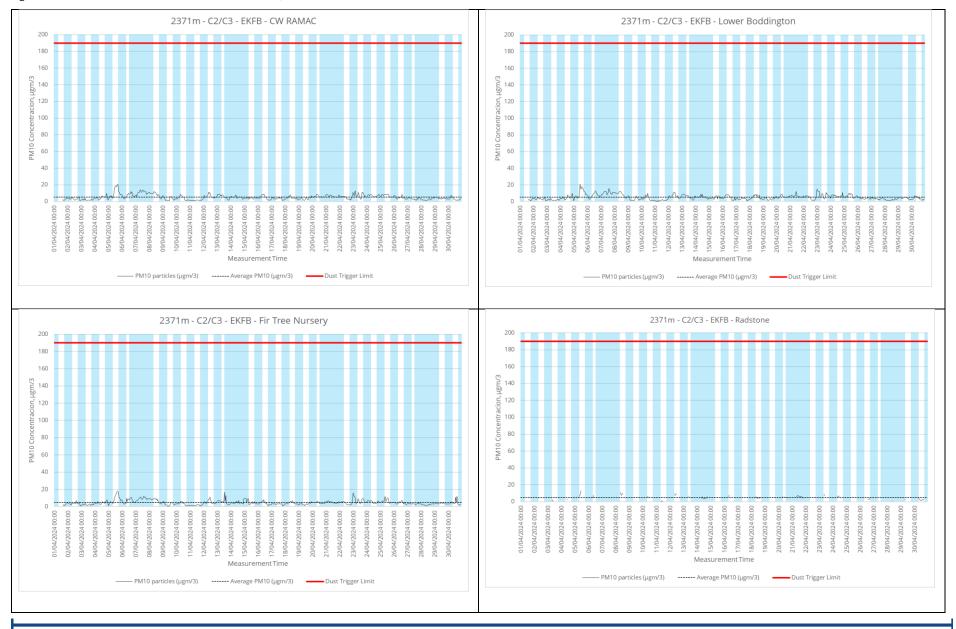
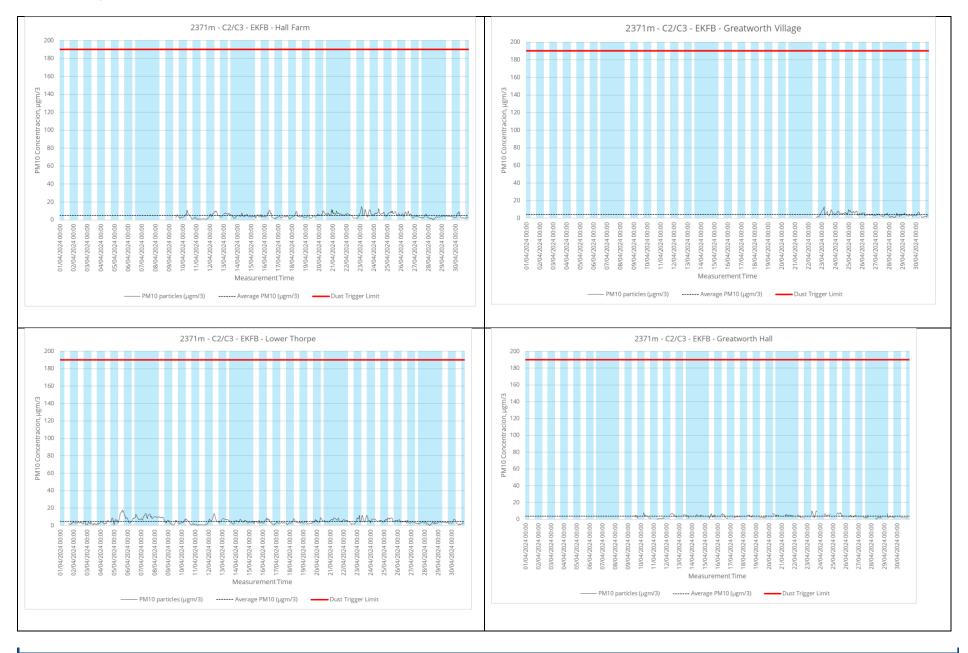
Figure 3: Continuous dust 1-hour mean indicative PM₁₀ concentration for all monitors

- 1.1.6 Dust monitoring locations and results are presented in Appendix B, Table 1, together with line charts of monthly data from each dust monitor, presented in Figure 3. All continuous dust monitoring is undertaken using indicative monitors. Despite being Environment Agency (MCERTS) certified, indicative monitors carry a higher level of uncertainty than reference monitors, and therefore cannot be strictly compared with Air Quality Standards for human health and the environment. The purpose of the monitoring undertaken is to ensure the effectiveness of the on-site mitigation.

- 1.1.7 The trigger level for PM_{10} concentrations of 190 μ g/m³, over a 1-hour period, in accordance with the updated guidance document 'Guidance on Monitoring in the Vicinity of Demolition and Construction Sites (October 2018)' has been applied.

- 1.1.8 No (0) dust trigger alerts were recorded during the monitoring period (April 2024).
- 1.1.9 Data capture was below 90% for multiple monitors due to the Radstone monitor having a battery and PT10 fault. Hall Farm was re-installed on 9th April from lab calibration. Greatworth Hall monitor had a solar and battery fault. Greatworth Village monitor had

monitor configuration issues. No data was captured at CW Village monitor due to the monitor not being reinstated.
