Construction Noise and Vibration Monthly Report – May 2024

London Borough of Ealing

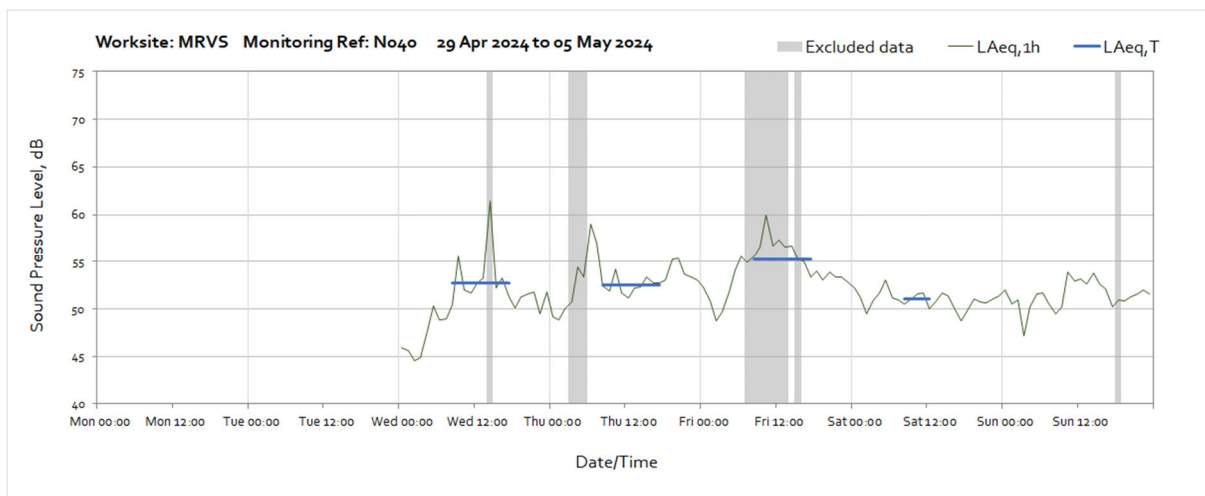
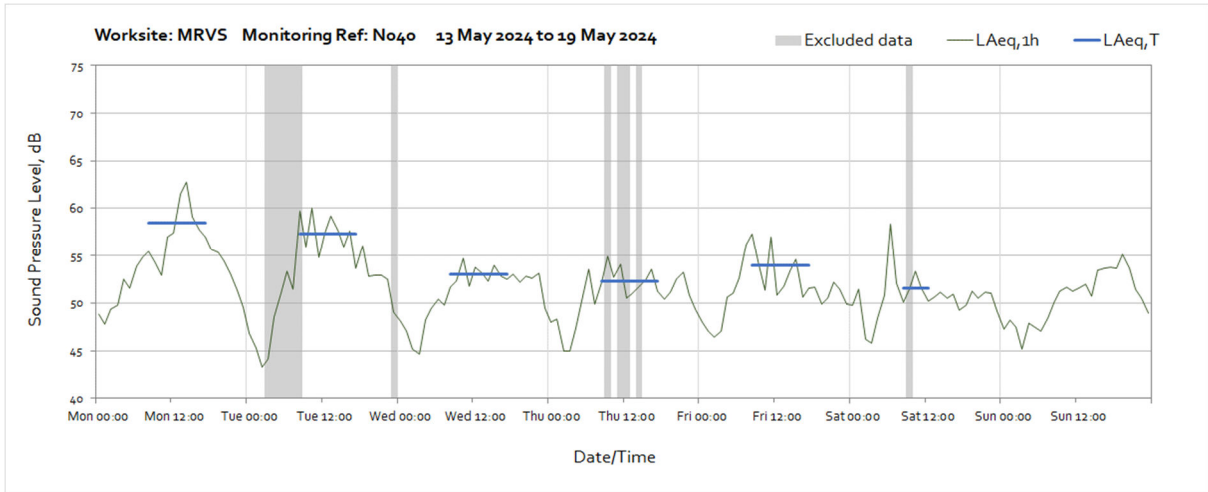
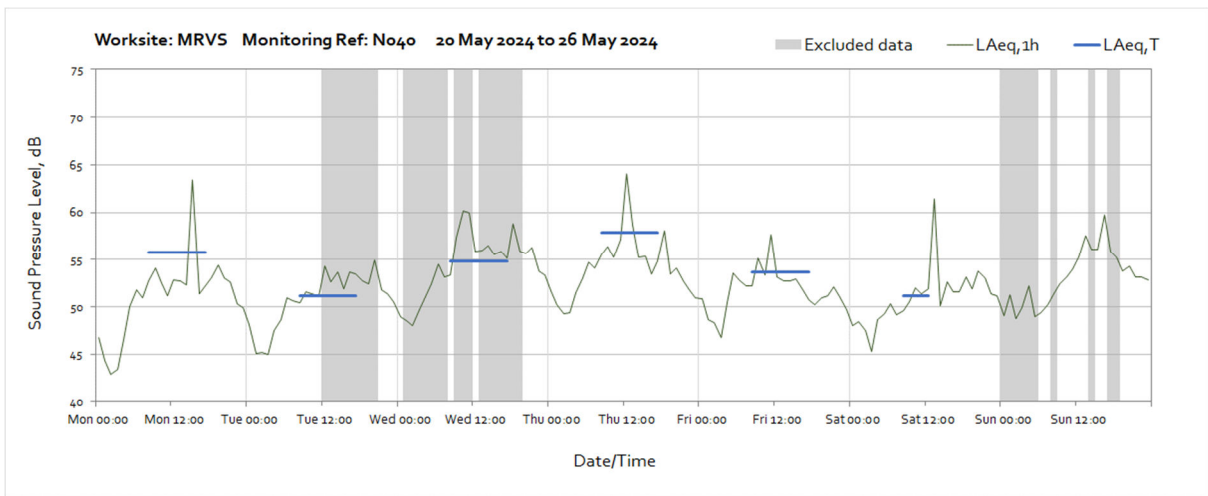
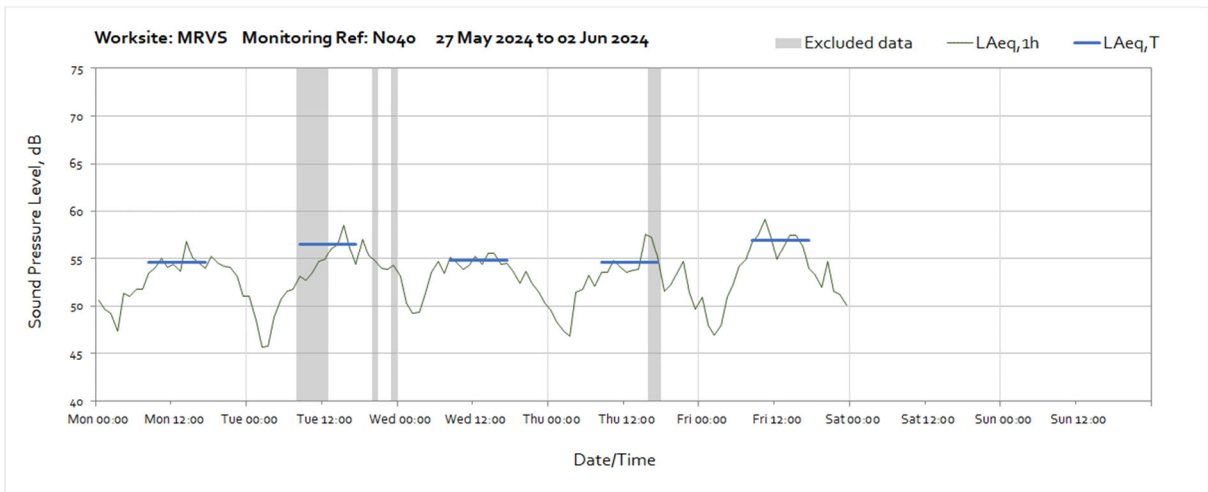
Worksite: MRVS – Monitoring Ref: N040

The following graphs show the hourly measured ambient noise level $L_{Aeq,1h}$ and, where relevant, the averaged noise level $L_{Aeq,T}$ values, where the time period T is as specified in Table 1 of HS2 Information Paper E23. Periods where noise levels are adversely affected by weather or only measured for part of the period, which are not representative of HS2 construction works, have been greyed out and excluded from the calculation of the $L_{Aeq,T}$ values in Table 3 of the main report.

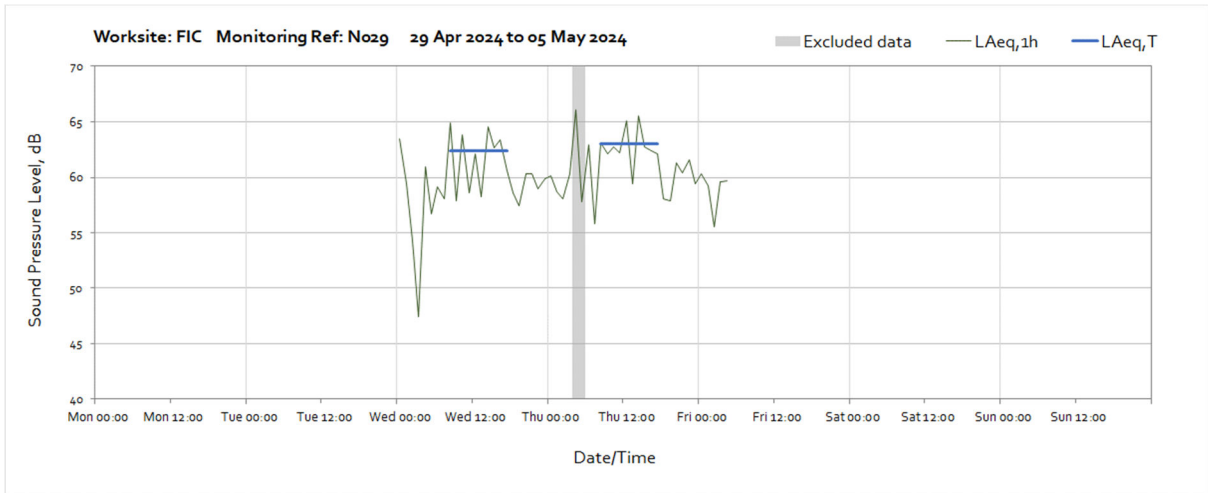
Worksite: FIC – Monitoring Ref: N029

Note: Missing data from 05:00 on Friday 3rd May until the end of the month was due to loss of site power which powers the monitoring station. The monitoring contractor are awaiting site access and electrician availability to restore power to the monitoring station.

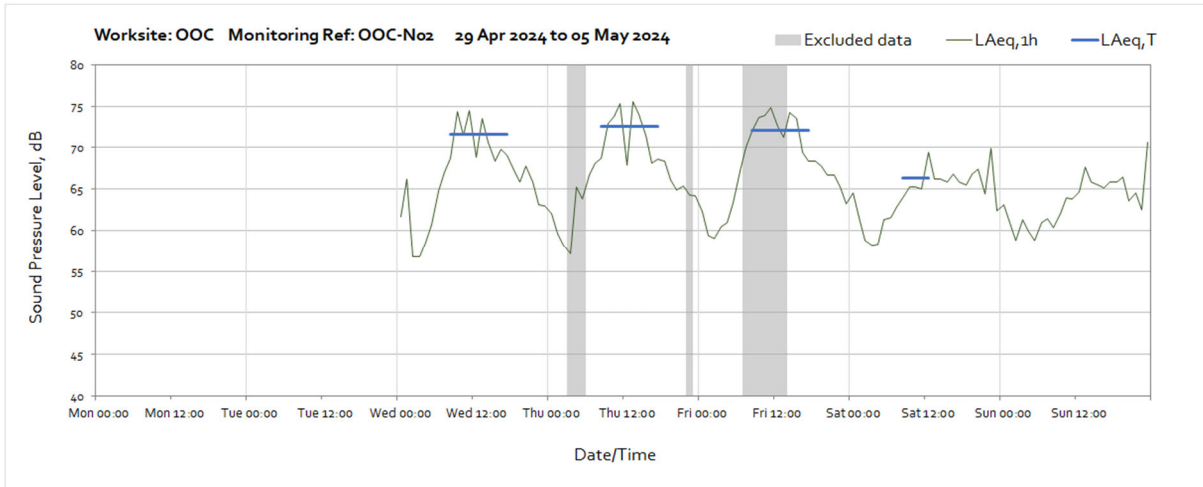
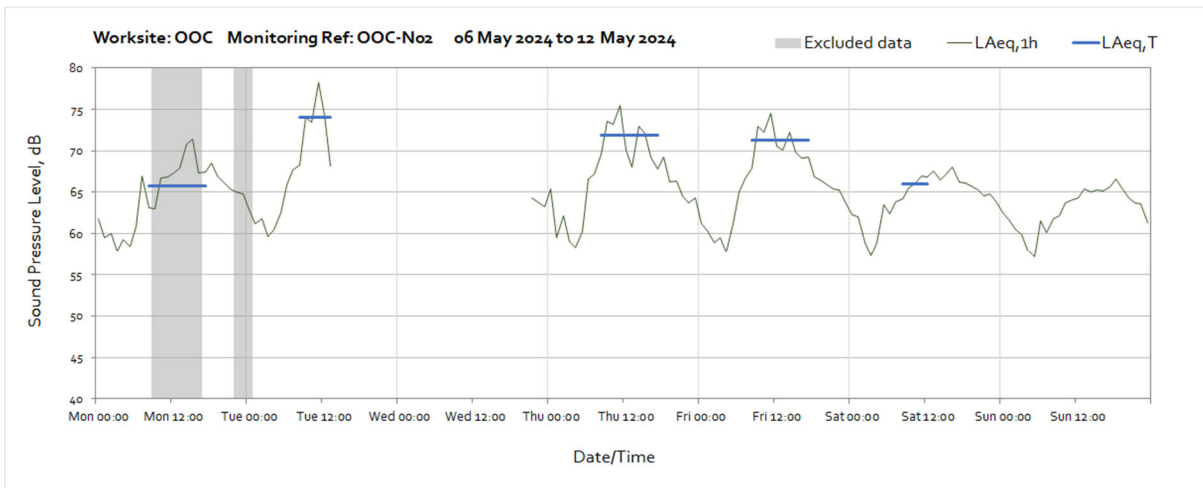
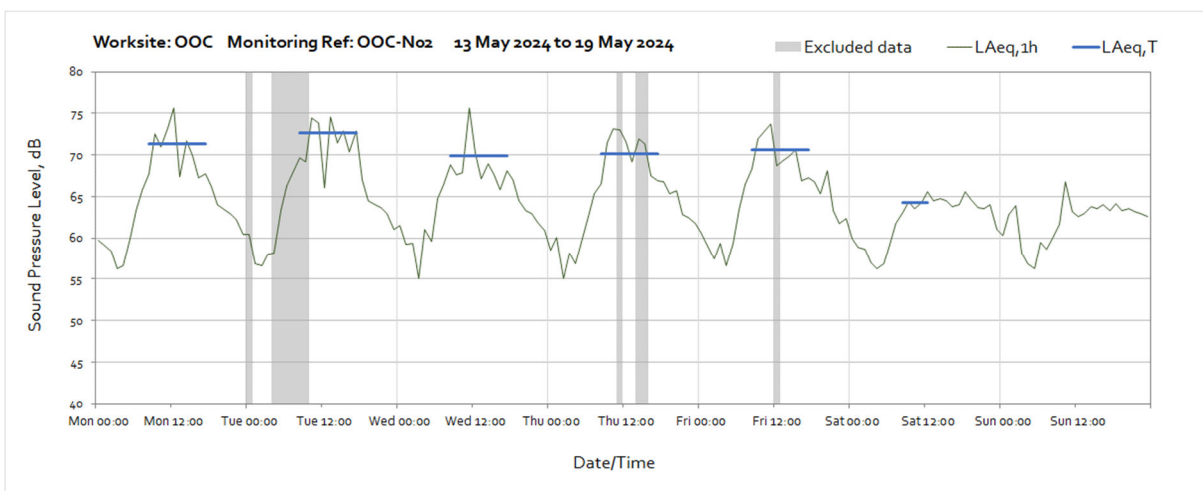
Worksite: OOC – Monitoring Ref: OOC-N02

Note: Missing data from 14:00 on Tuesday 7th until 21:00 on Wednesday 8th May was due to the swapping of the monitoring station.

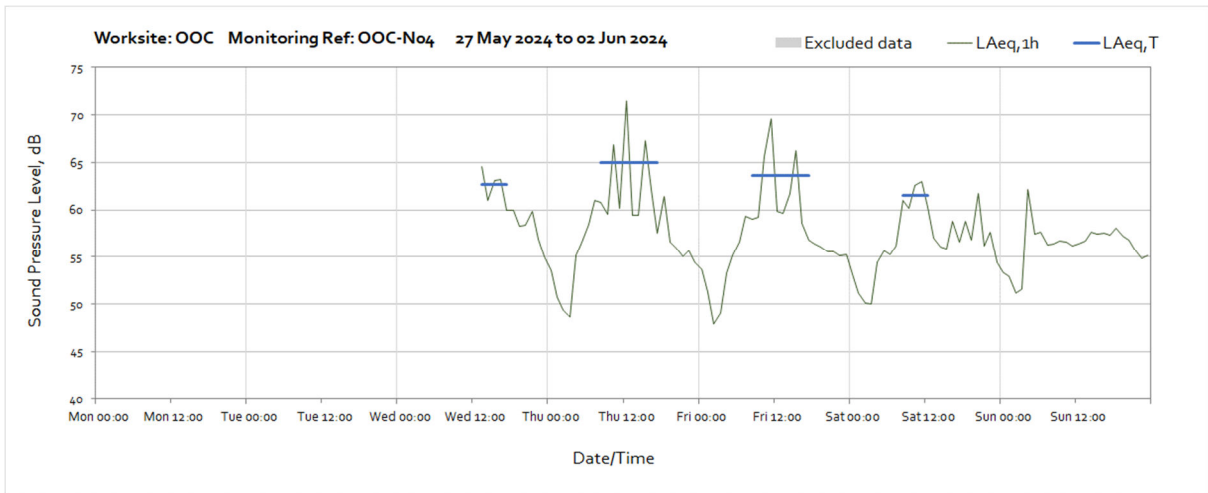
Worksite: OOC – Monitoring Ref: OOC-N04

Note: Monitoring station installed at 13:00 on Wednesday 22nd May.

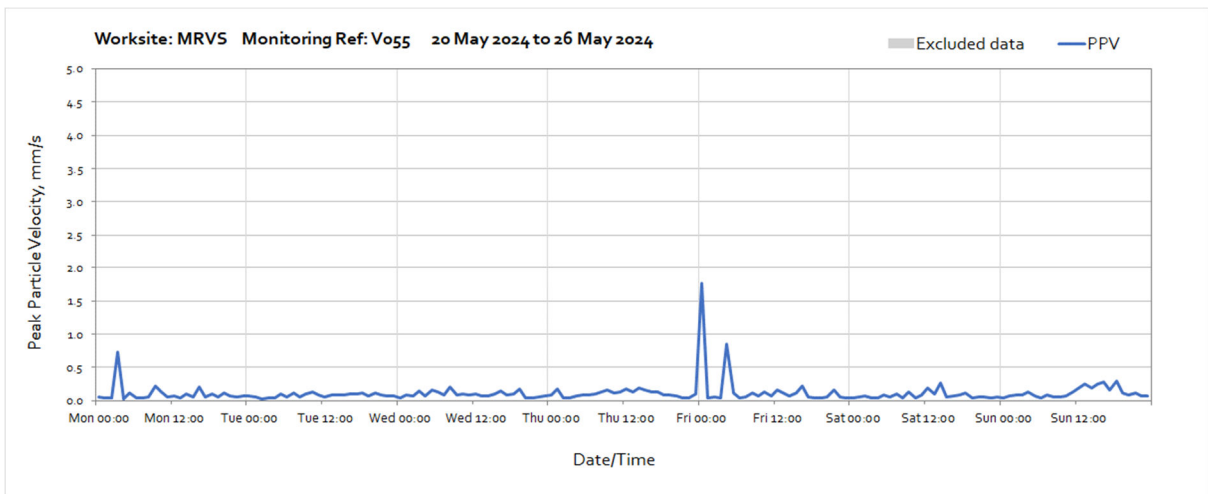
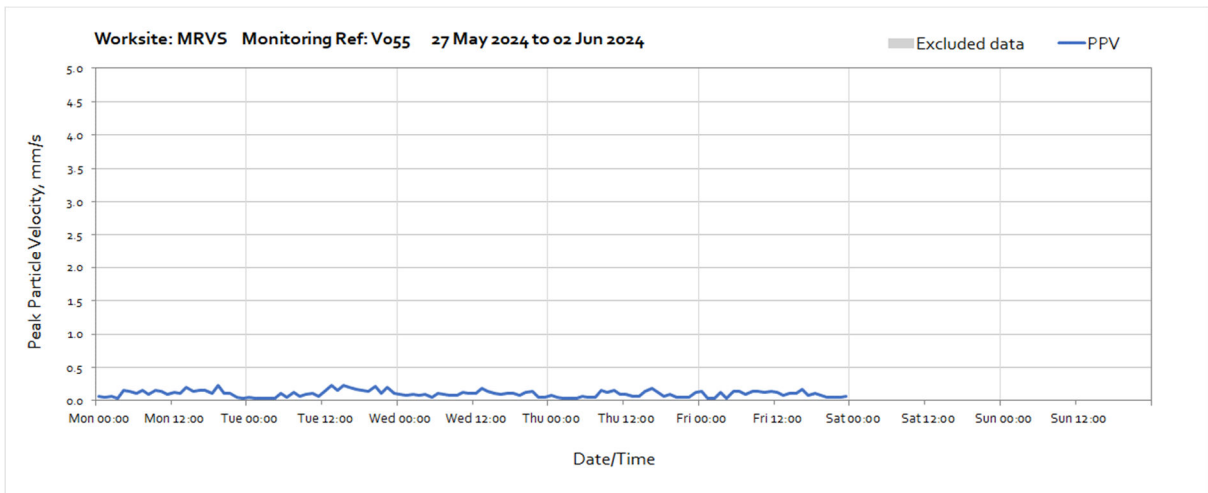
Worksite: MRVS – Monitoring Ref: V055

The following graphs show the hourly measured peak particle velocity PPV recorded during the monitoring period. The graphs show the highest PPV of the three orthogonal axis x, y and z. Periods where PPV values have been affected by local interference with the vibration monitor or only measured for part of the period, which are not representative of HS2 construction works, have been greyed out and excluded when calculating values in Table 4 of the main report.

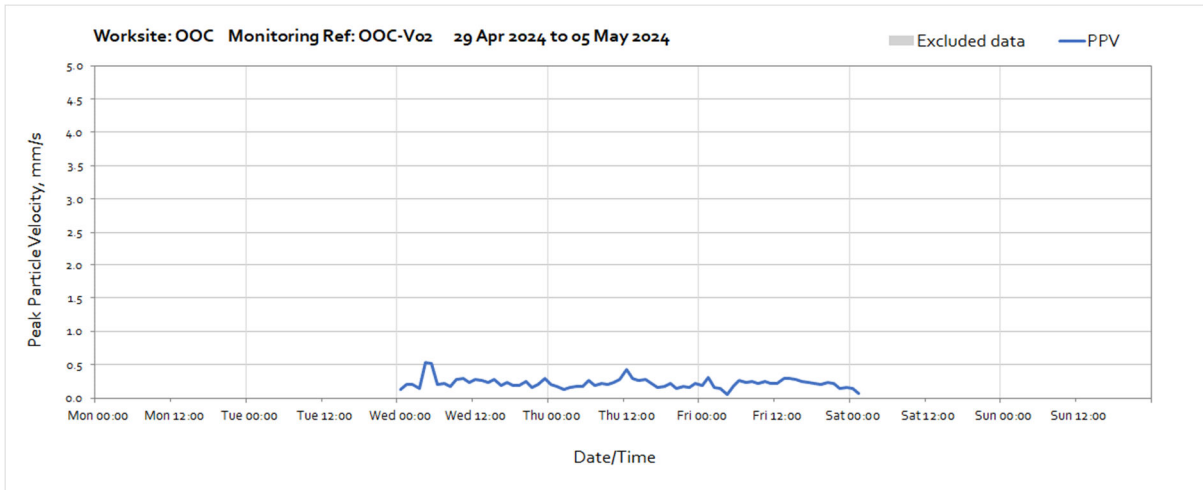
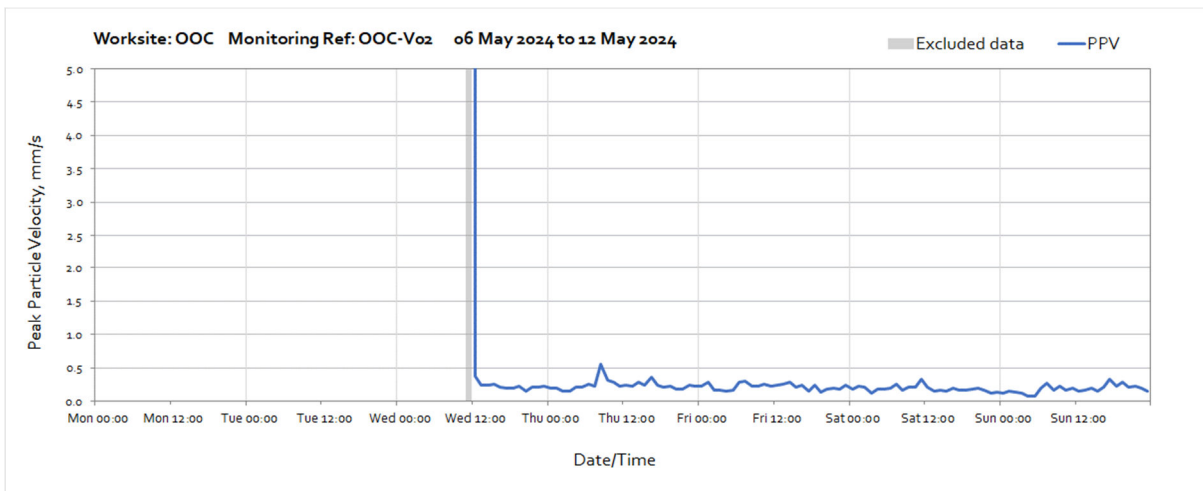
Worksite: OOC – Monitoring Ref: OOC-V02

Note: Missing data from 02:00 on Saturday 5th until 11:00 on Wednesday 8th May was due to depletion of the battery which supplies power to the monitoring station.
