Construction Noise and Vibration Monthly Report – June 2024

London Borough of Ealing

Non-Technical Summary

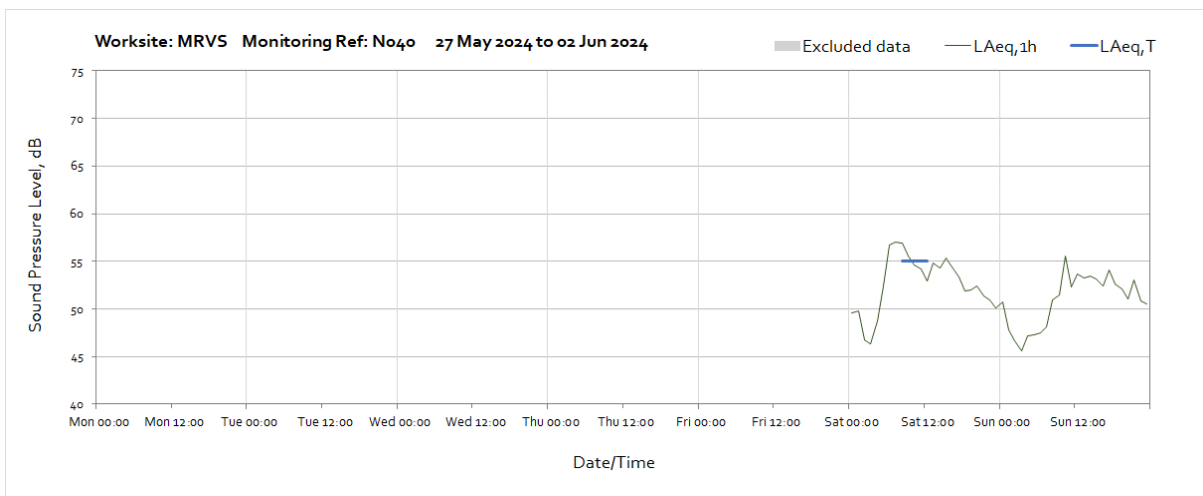
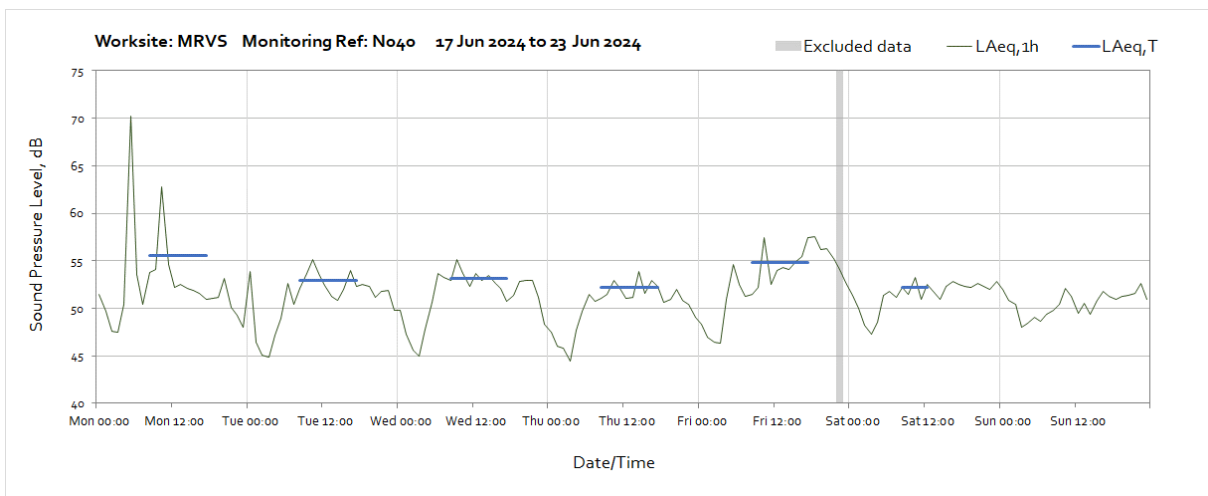
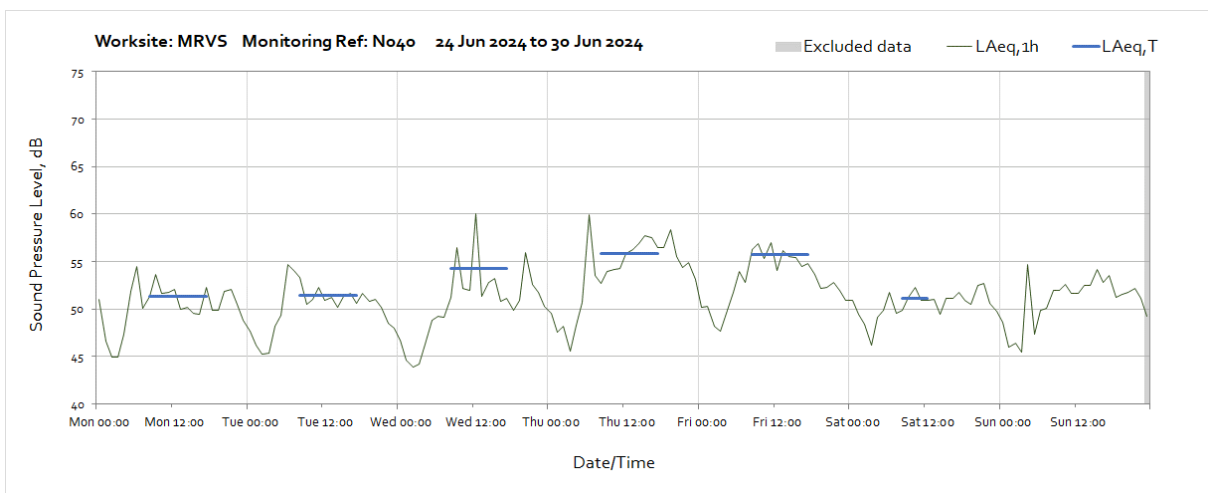
Worksite: MRVS – Monitoring Ref: N040

The following graphs show the hourly measured ambient noise level $L_{Aeq,1h}$ and, where relevant, the averaged noise level $L_{Aeq,T}$ values, where the time period T is as specified in Table 1 of HS2 Information Paper E23. Periods where noise levels are adversely affected by weather or only measured for part of the period, which are not representative of HS2 construction works, have been greyed out and excluded from the calculation of the $L_{Aeq,T}$ values in Table 3 of the main report.

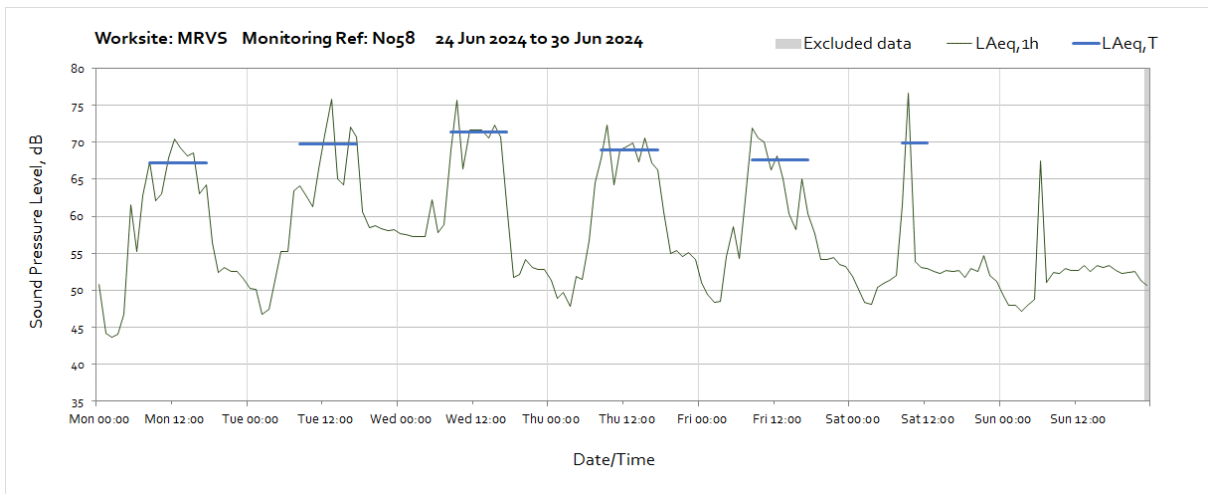
Worksite: MRVS – Monitoring Ref: N058

2.2.7 Thirteen (13) SOAEL exceedances were recorded due to HS2 construction works during June 2024. The exceedances occurred at N058 during daytime periods and at OOC-N03 during night periods.

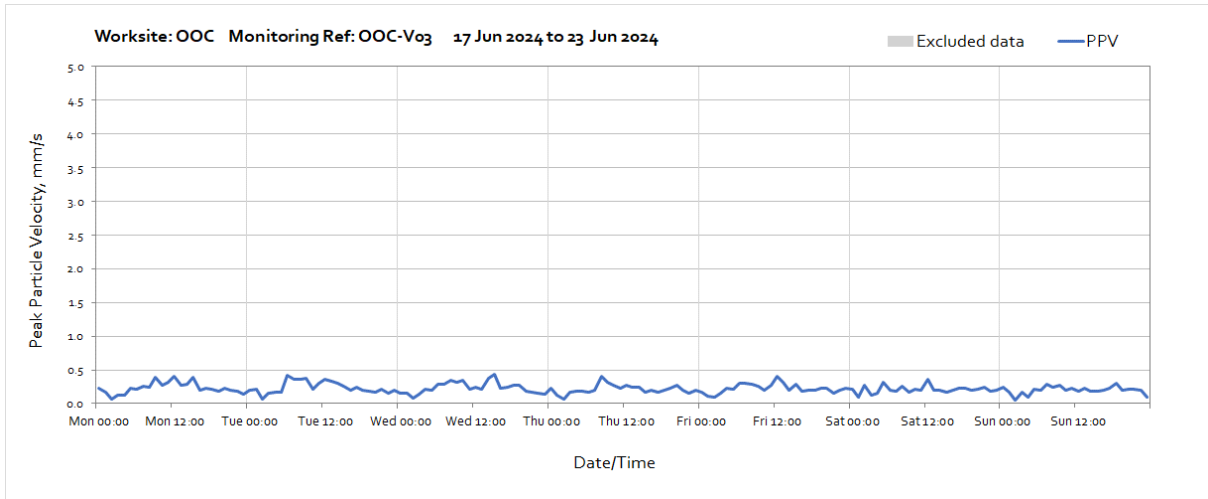
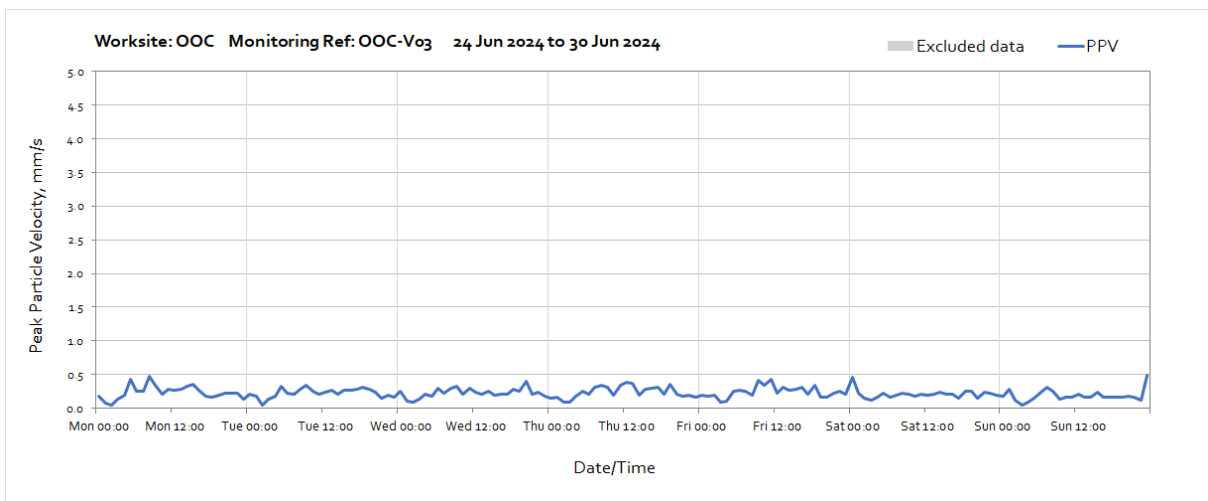
Worksite: OOC – Monitoring Ref: OOC-V03

The following graphs show the hourly measured peak particle velocity PPV recorded during the monitoring period. The graphs show the highest PPV of the three orthogonal axis x, y and z. Periods where PPV values have been affected by local interference with the vibration monitor or only measured for part of the period, which are not representative of HS2 construction works, have been greyed out and excluded when calculating values in Table 4 of the main report.
