Construction noise and vibration Monthly Report – June 2024

London Borough of Hillingdon

Non-Technical Summary

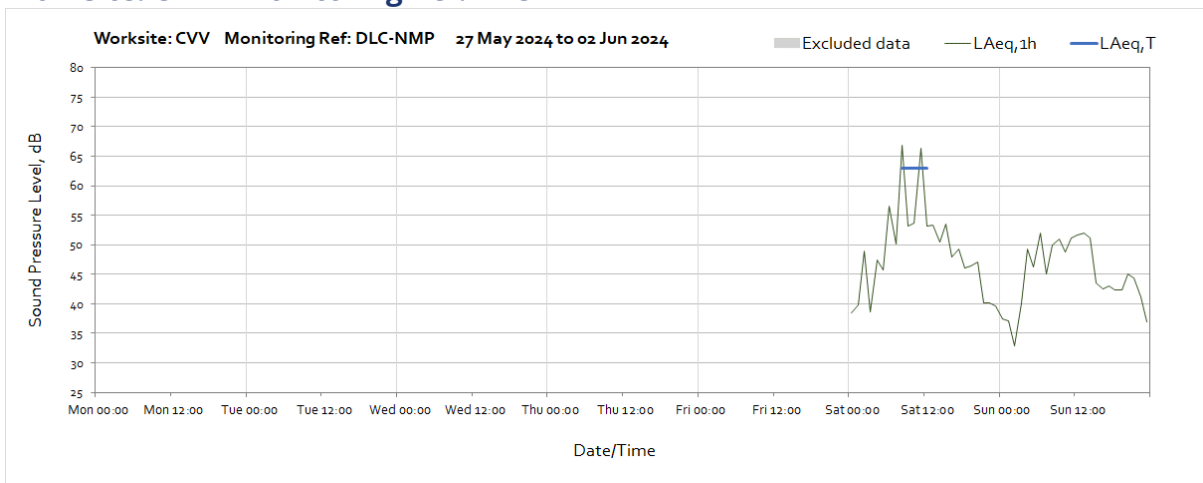
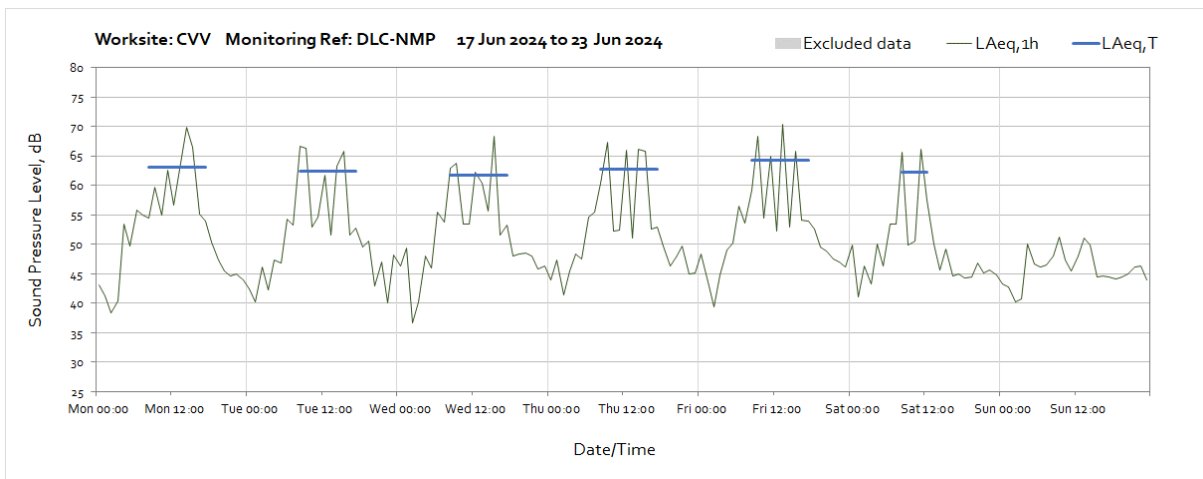
Worksite: CVV - Monitoring Ref: DLC-NMP

Note: Missing data between 10:00 and 11:00 on Tuesday 11th June and 09:00 and 10:00 on Wednesday 12th June was due to configuration changes in the monitor. Missing data between 16:00 and 17:00 on Thursday 13th June was due to a communication error.

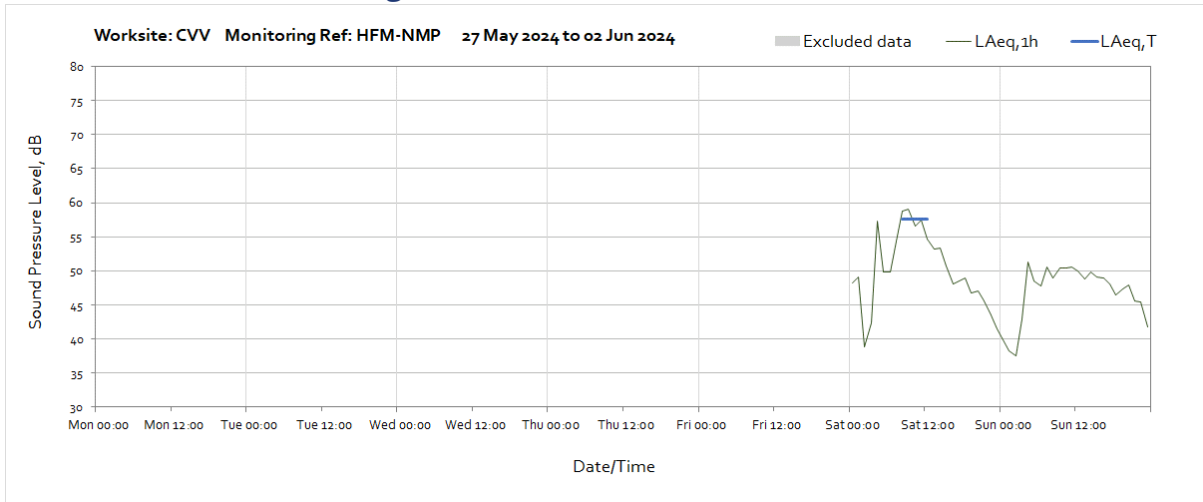
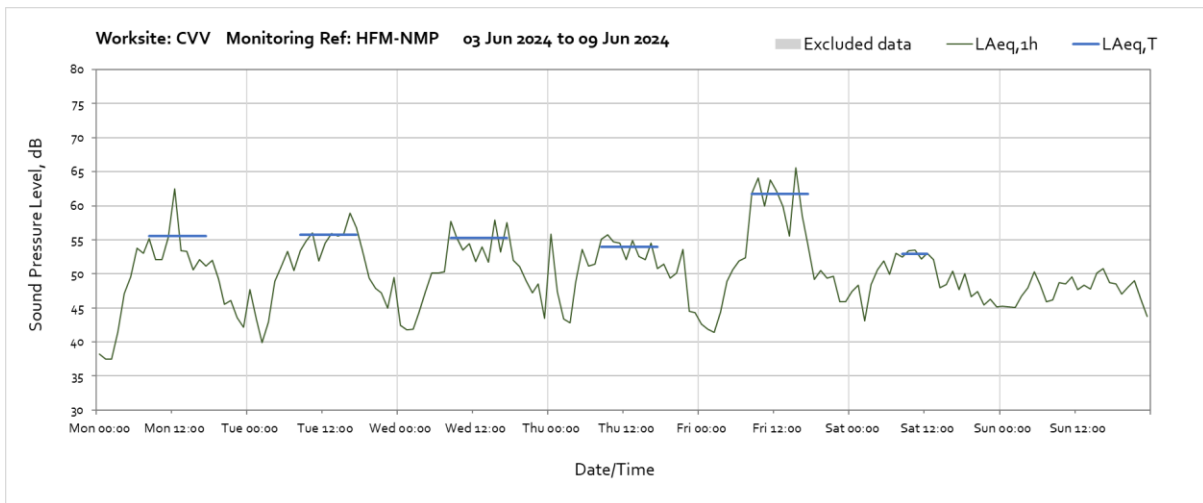
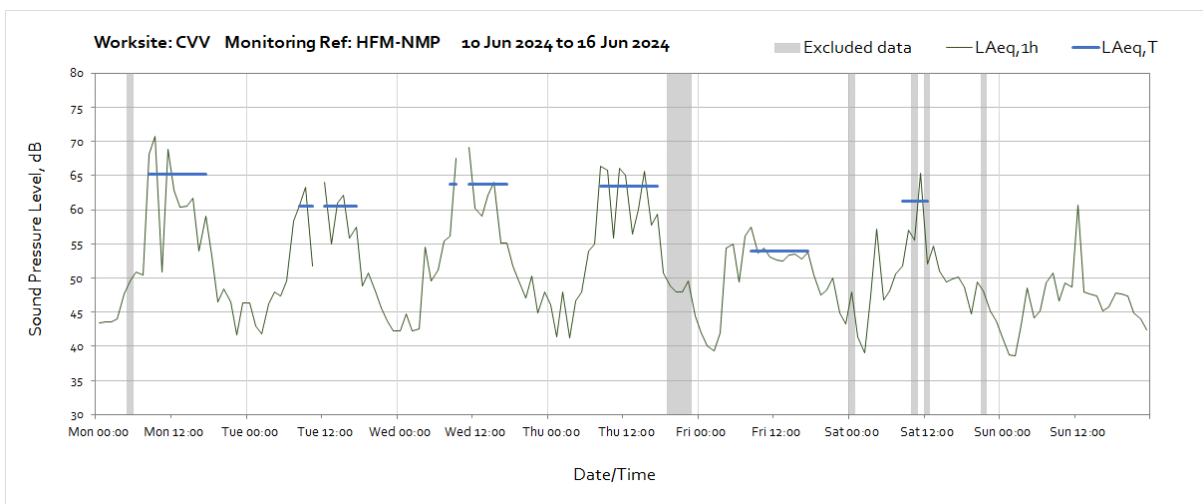
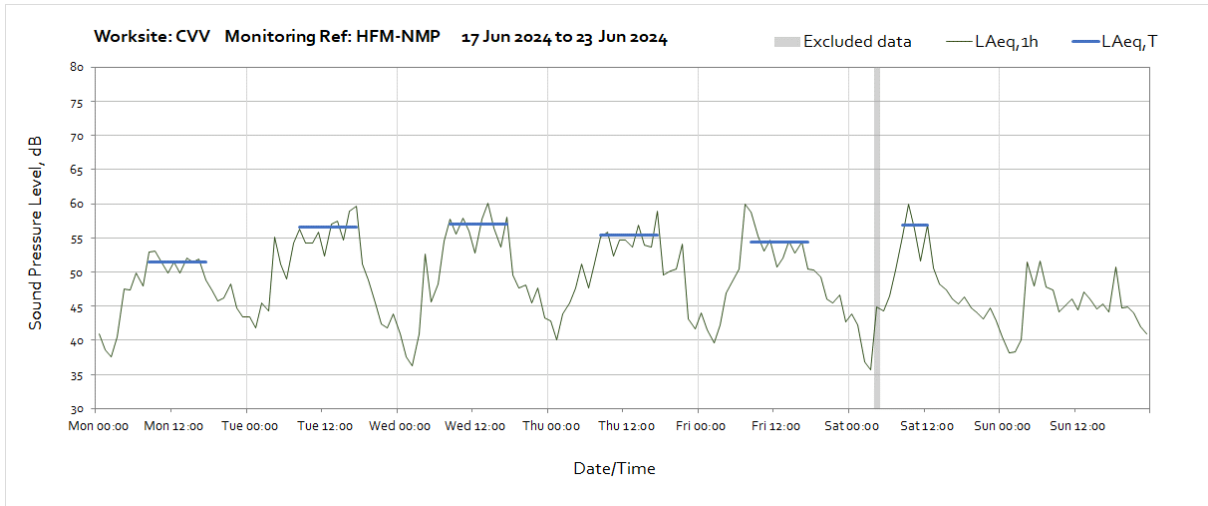
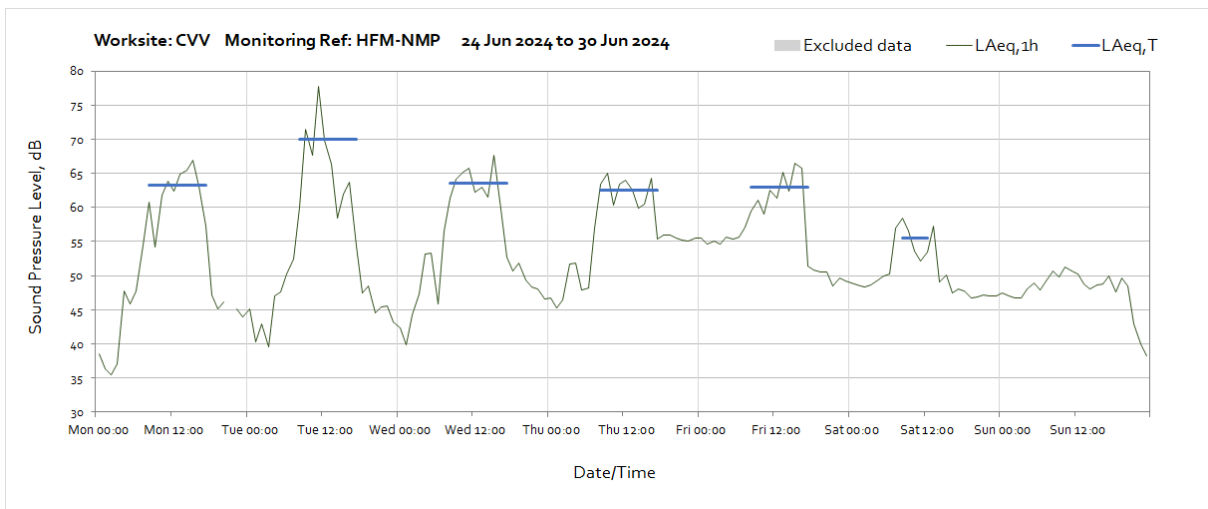
Worksite: CVV – Monitoring Ref: HFM-NMP

2.2.8 Two (2) SOAEL exceedances were recorded due to HS2 construction works during June 2024. The exceedance occurred at HFM-NMP during weekday night-time period.

Note: Missing data between 11:00 and 12:00 on Tuesday 11th June and 10:00 and 11:00 on Wednesday 12th June was due to configuration changes in the monitor.

Note: Missing data between 21:00 and 22:00 on Monday 24th June was due to a communication error.

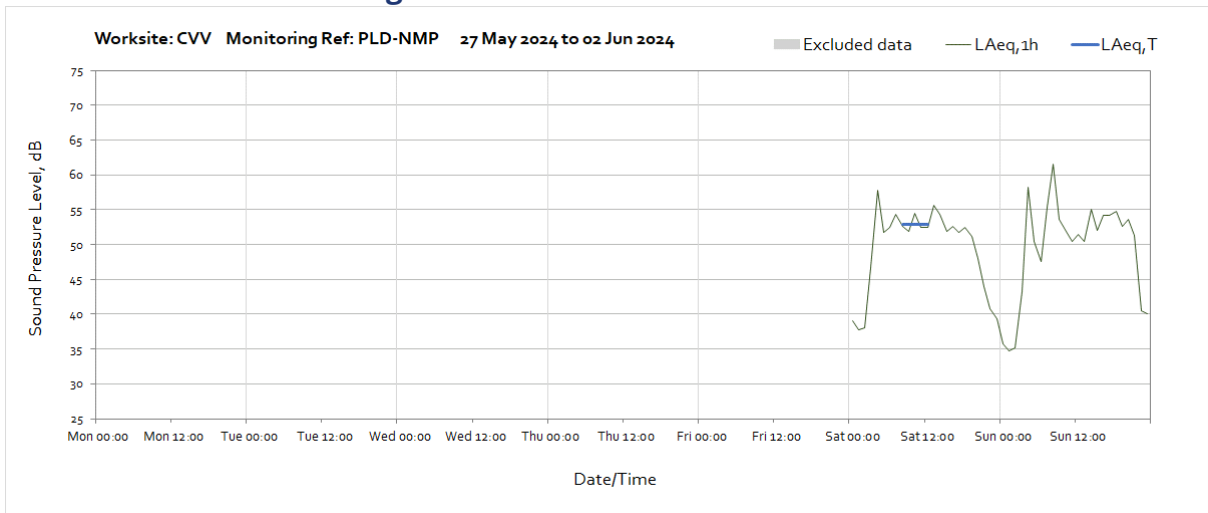
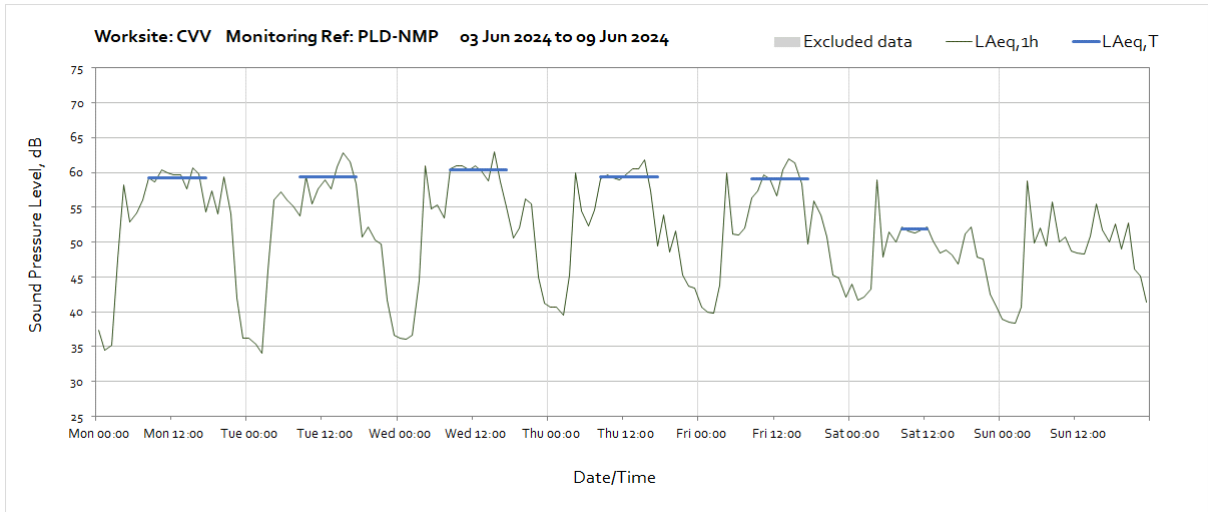
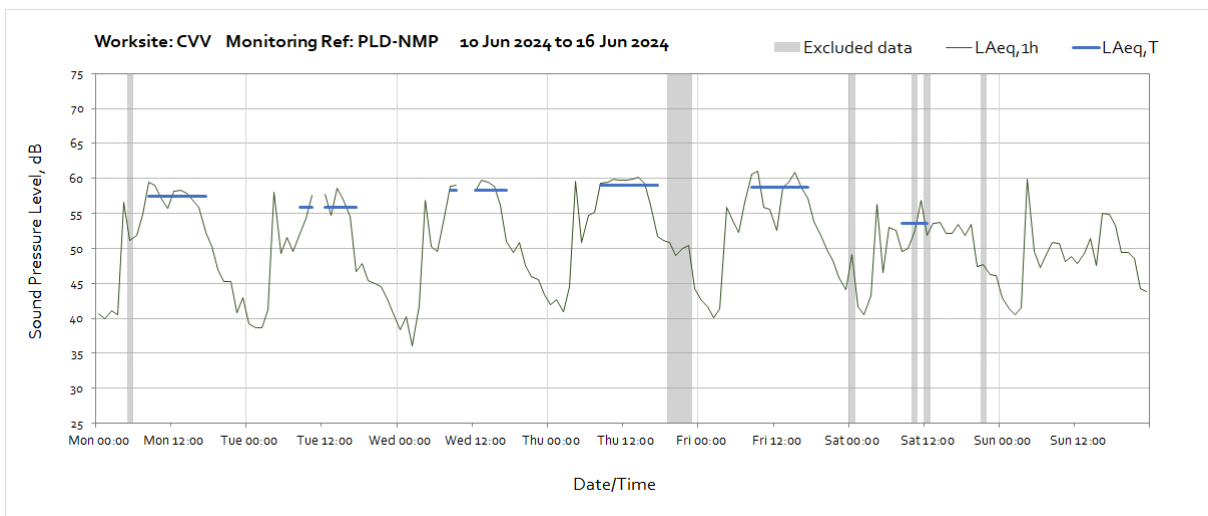
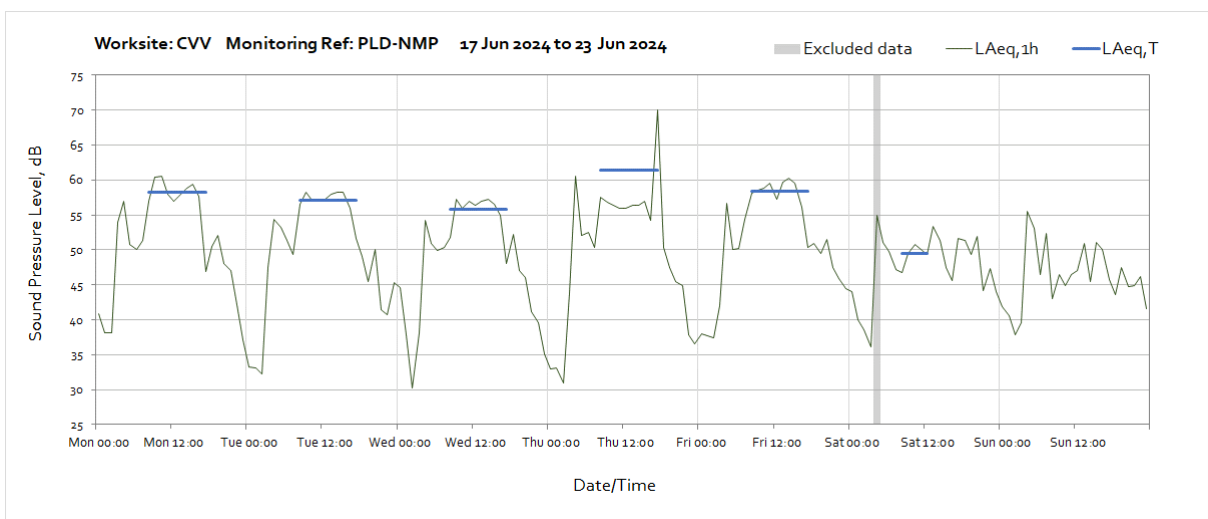
Worksite: CVV – Monitoring Ref: PLD-NMP

Note: Missing data between 11:00 and 12:00 on Tuesday 11th June and 10:00 and 12:00 on Wednesday 12th June was due to configuration changes in the monitor.

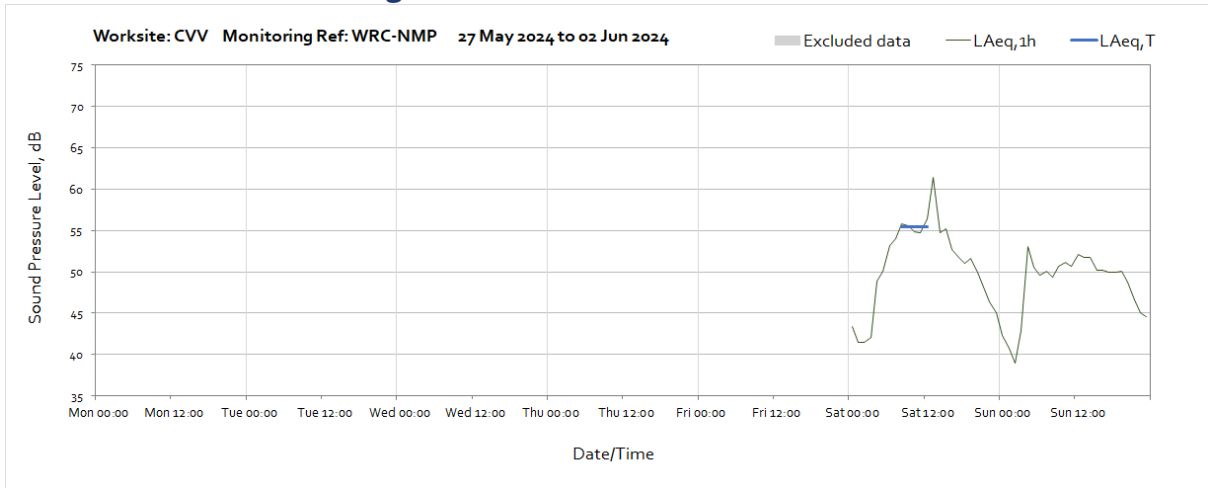
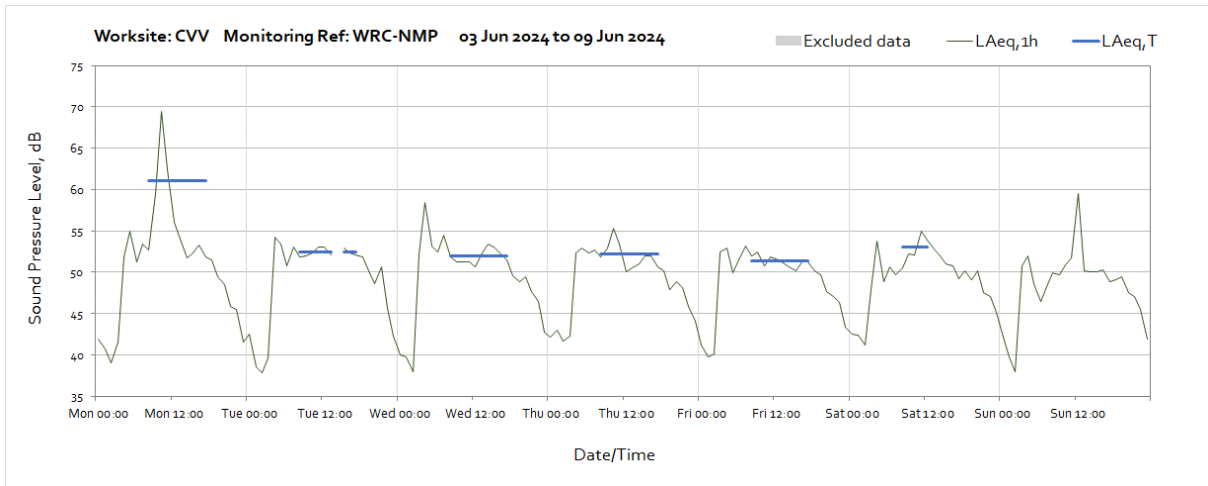
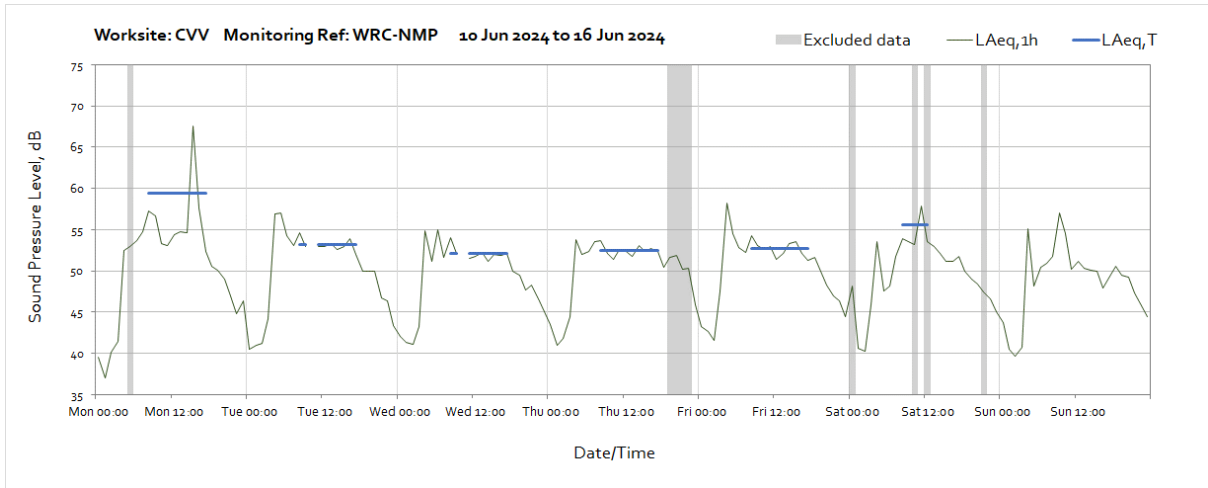
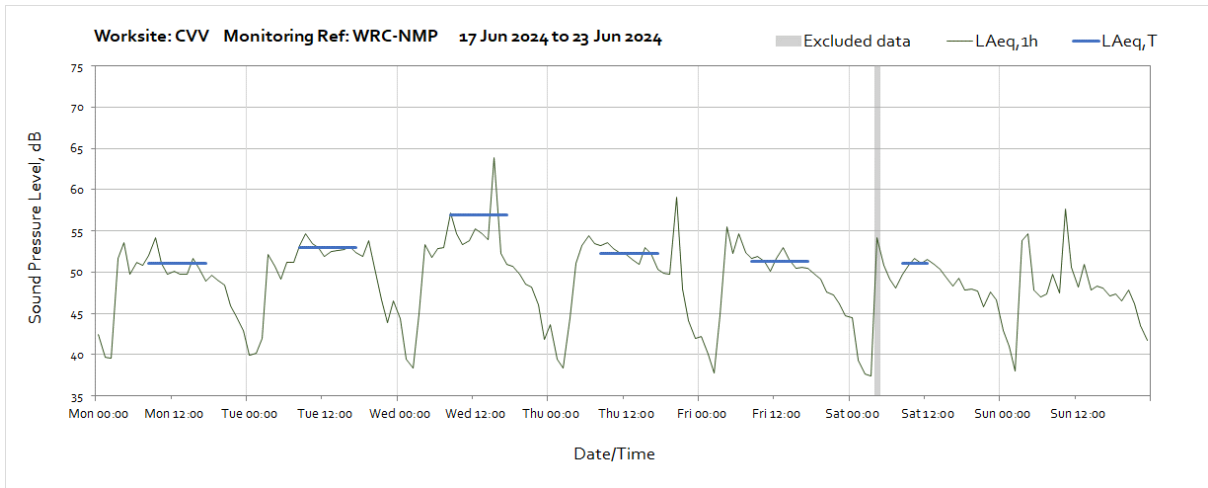
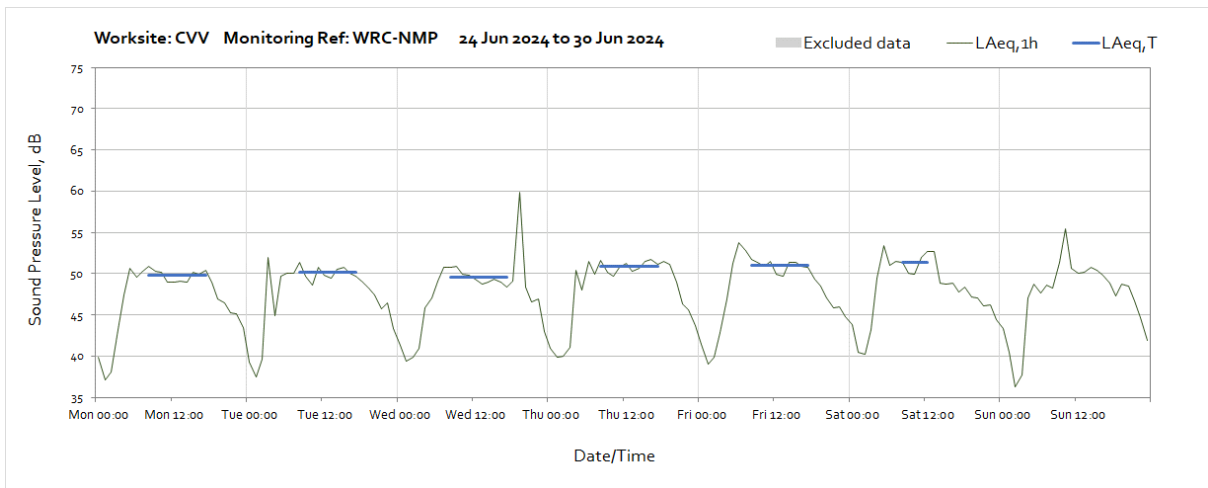
Worksite: CVV – Monitoring Ref: WRC-NMP

Note: Missing data between 14:00 and 15:00 on Tuesday 4th June was due to field calibration.

Note: Missing data between 10:00 and 11:00 on Tuesday 11th June and 10:00 and 11:00 on Wednesday 12th June was due to configuration changes in the monitor.

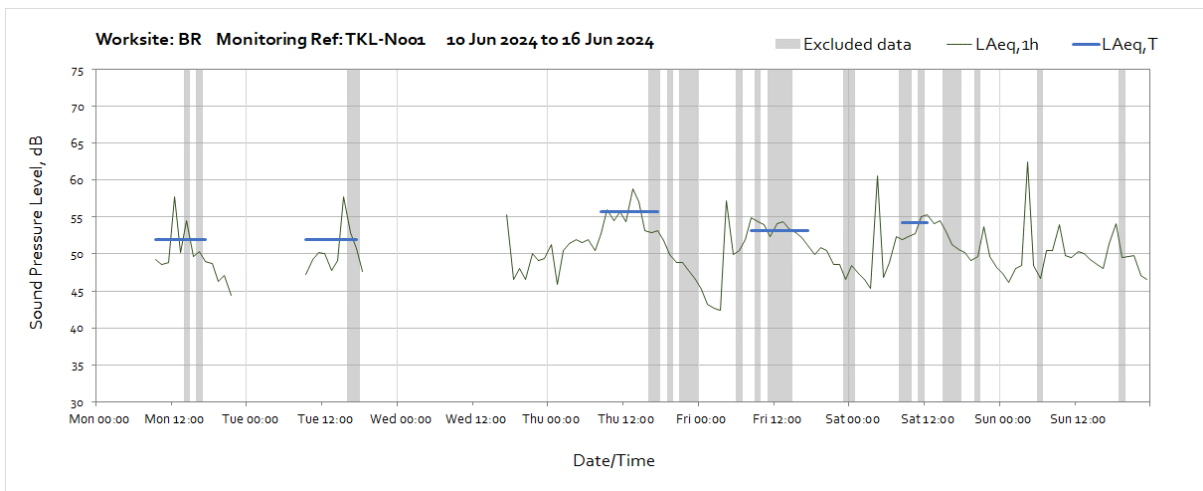
Worksite: BR – Monitoring Ref: TKL-N001

Note: Missing data between 02:00 on Wednesday 5th June and 09:00 on Monday 10th June was due to a communication issue with the monitor.

Note: Missing data between 22:00 on Monday 10th June and 09:00 on Tuesday 11th June, and between 19:00 on Tuesday 11th June and 17:00 on Wednesday 12th June was due to a communication issue with the monitor.
