Construction Noise and Vibration Monthly Report – June 2024

North Warwickshire Borough Council

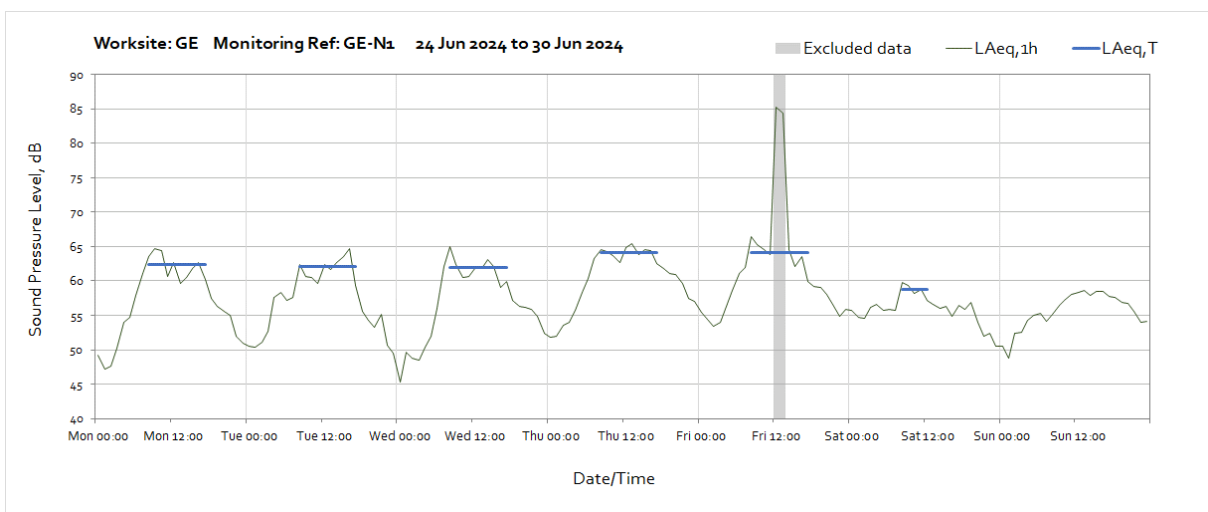
Worksite: GE - Monitoring Ref: GE-N1

Note: Missing data between 03:00 on Wednesday 12th and 16:00 on Monday 17th of June was due to a loss of mains power to the monitoring station.
