HS2

August 2024

Construction Noise and Vibration Monthly Report – June 2024

Solihull Metropolitan Borough Council

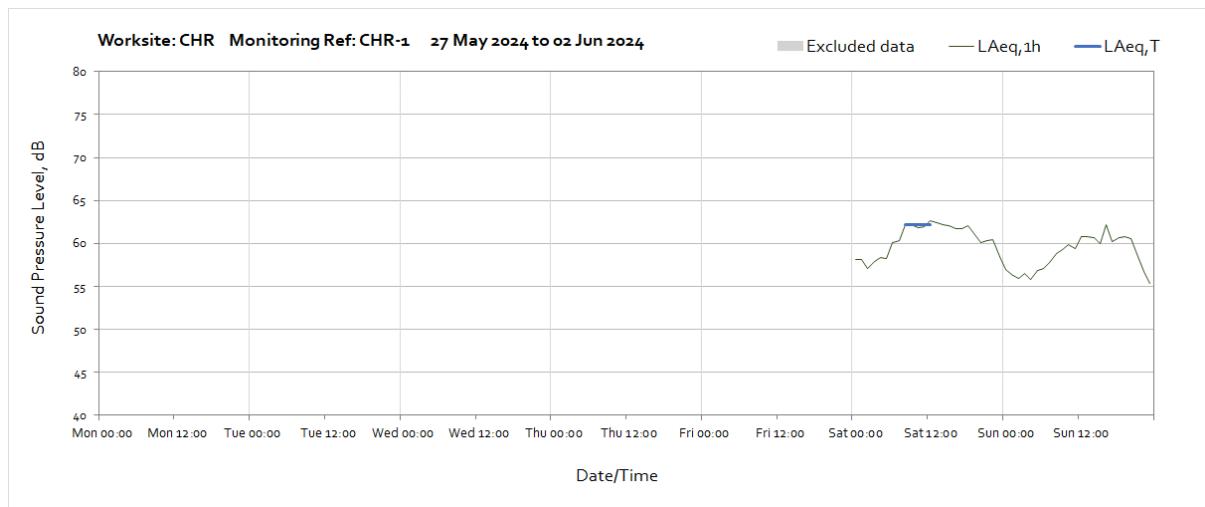
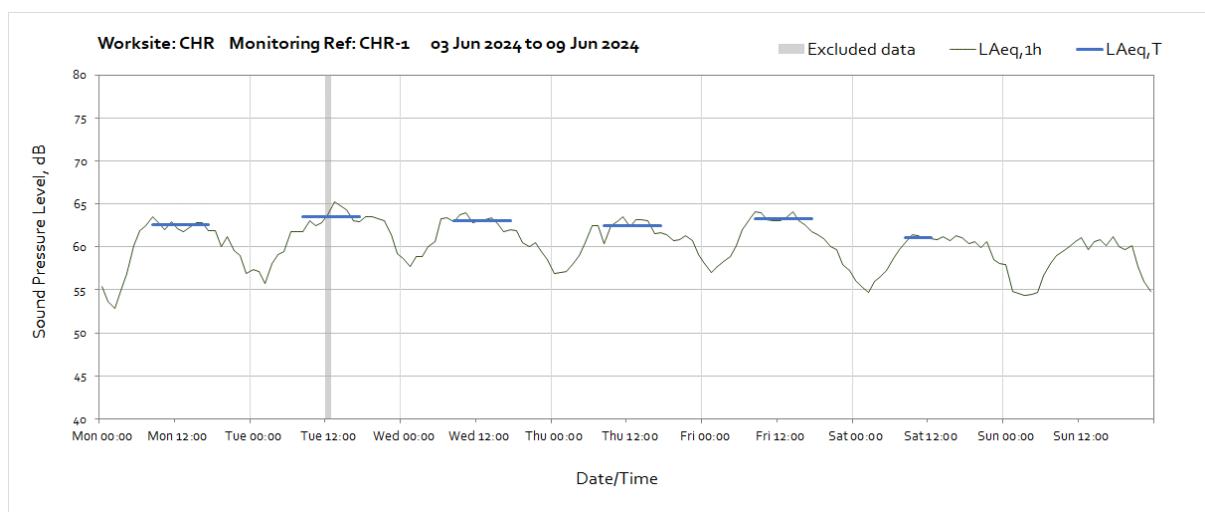
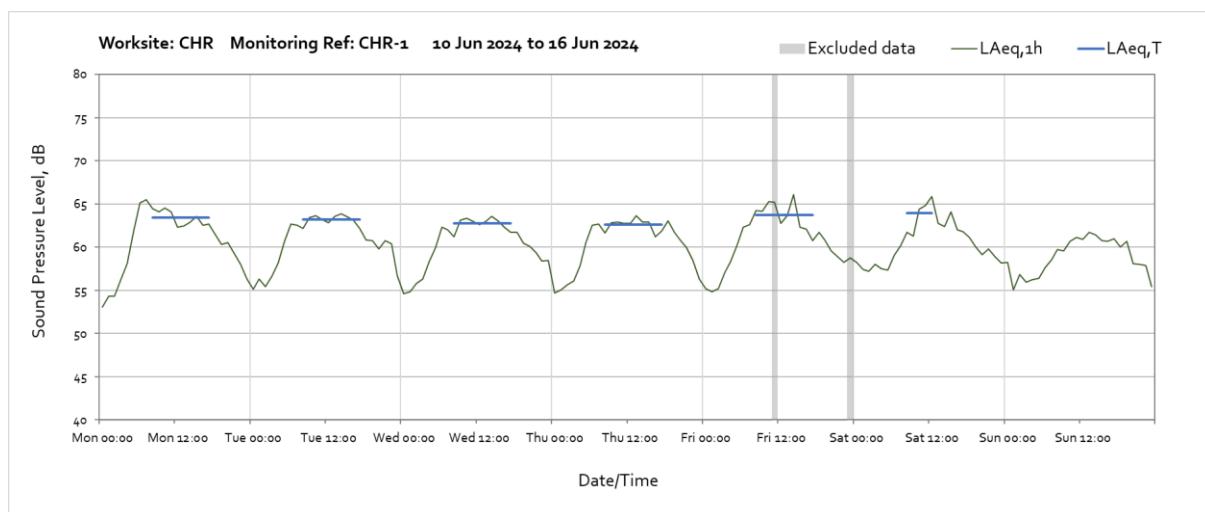
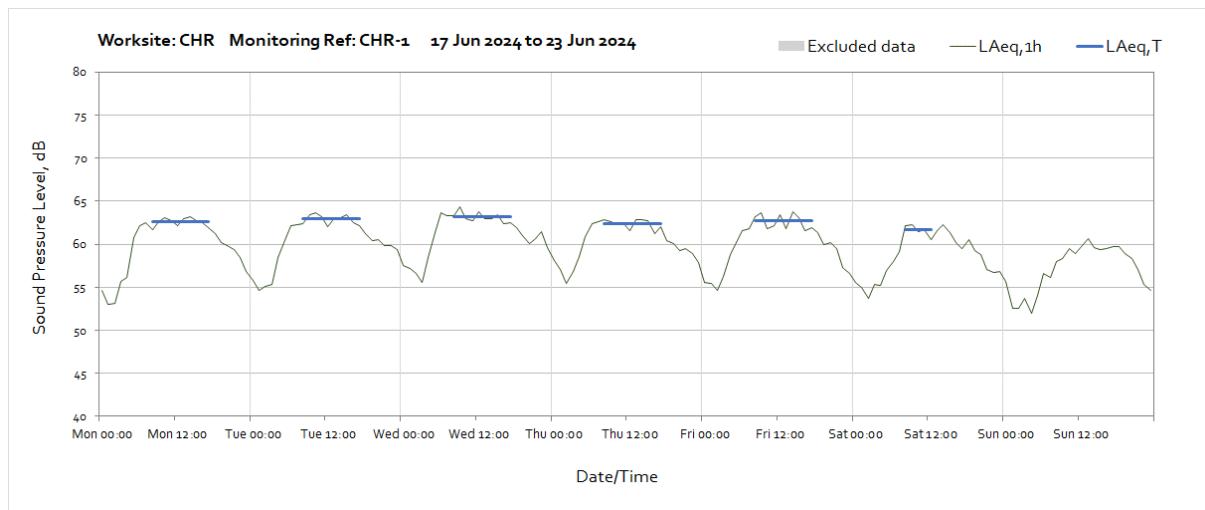
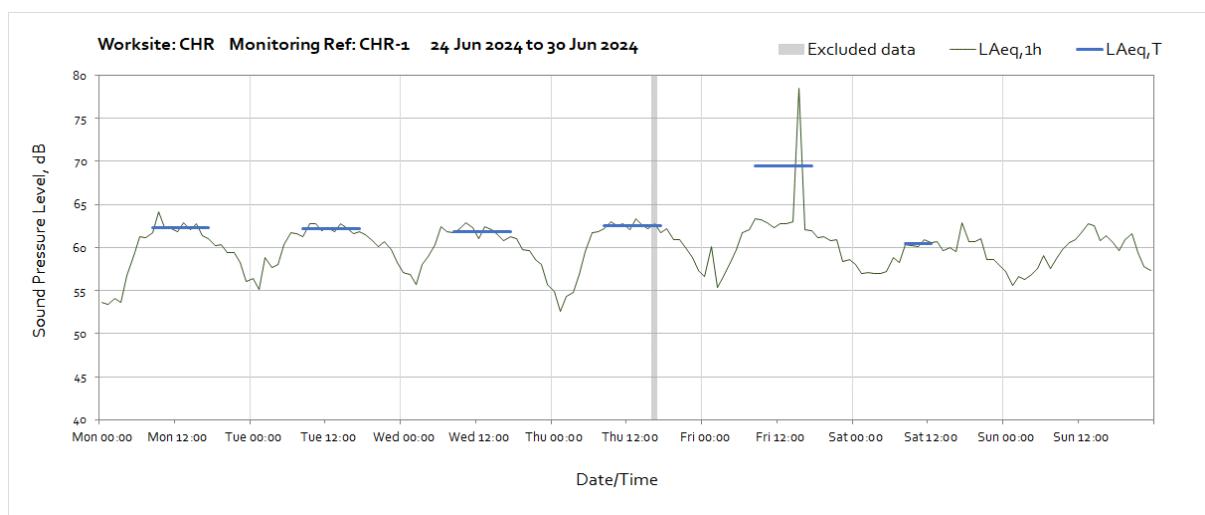
Worksite: CHR - Monitoring Ref: CHR-1

The following graphs show the hourly measured ambient noise level $L_{Aeq,1h}$ and, where relevant, the averaged noise level $L_{Aeq,T}$ values, where the time period T is as specified in Table 1 of HS2 Information Paper E23. Periods where noise levels are adversely affected by weather or only measured for part of the period, which are not representative of HS2 construction works, have been greyed out and excluded from the calculation of the $L_{Aeq,T}$ values in of the main report.

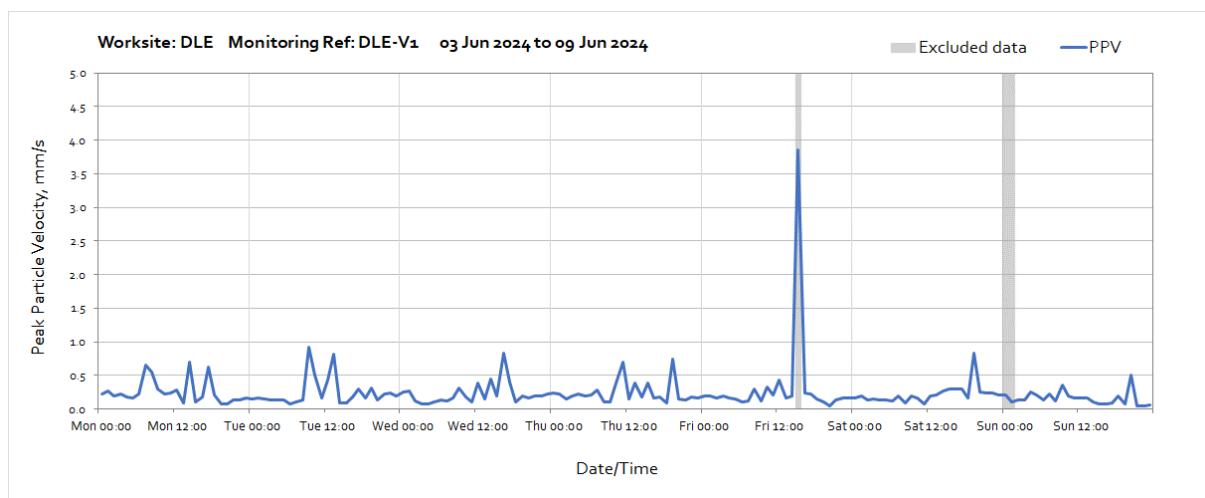
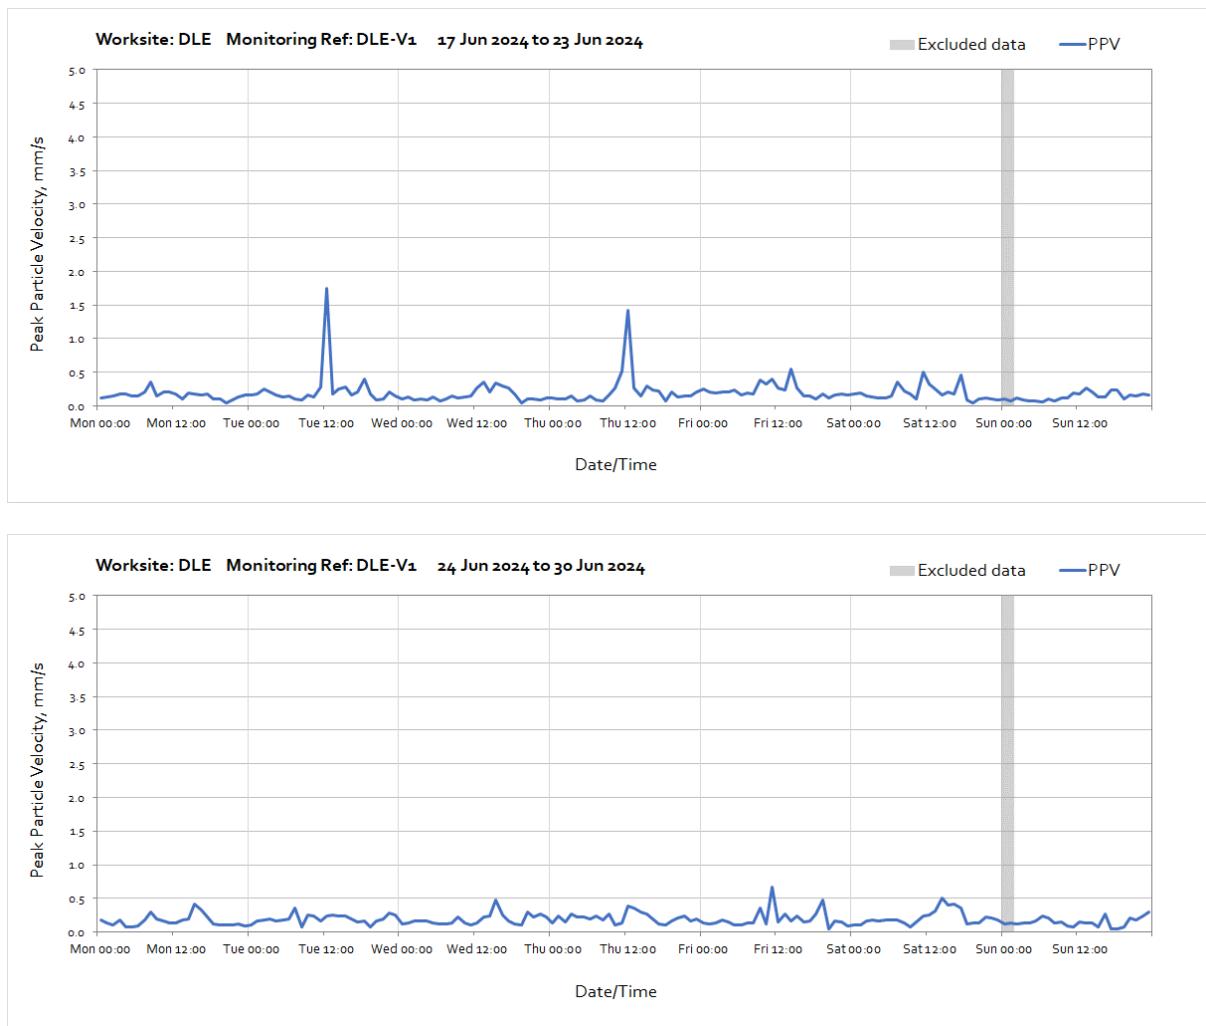
Worksite: DLE – Monitoring Ref: DLE-V1

The following graphs show the hourly measured peak particle velocity PPV recorded during the monitoring period. The graphs show the highest PPV of the three orthogonal axes x, y and z. Periods where PPV values have been affected by local interference with the vibration monitor or only measured for part of the period, which are not representative of HS2 construction works, have been greyed out and excluded when calculating values in of the main report.

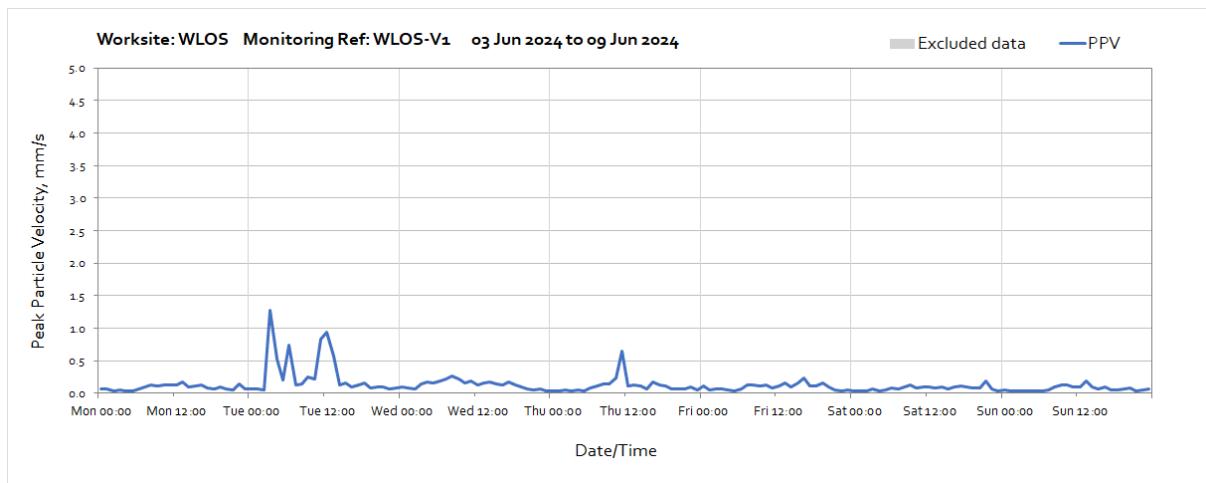
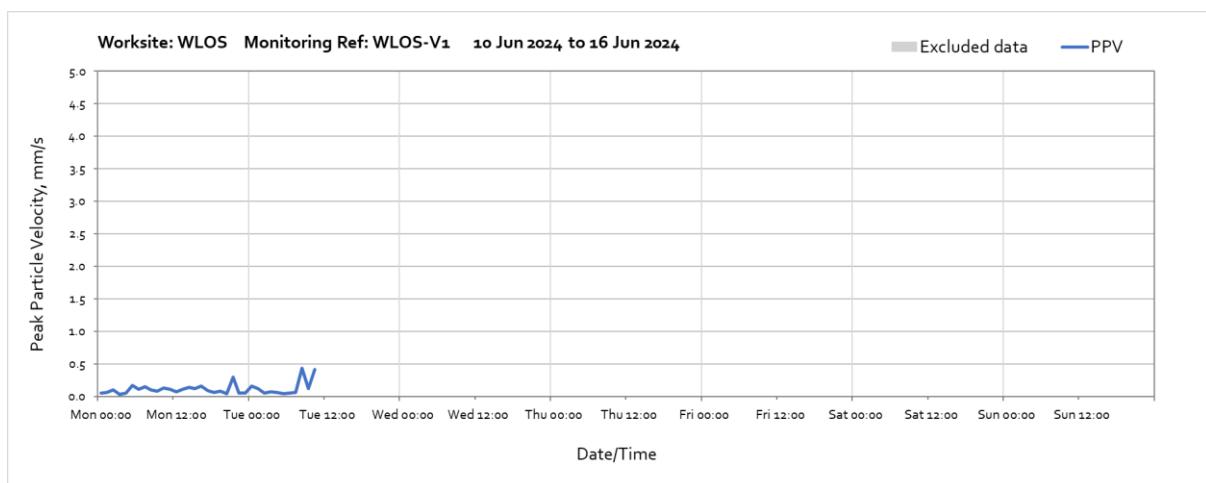
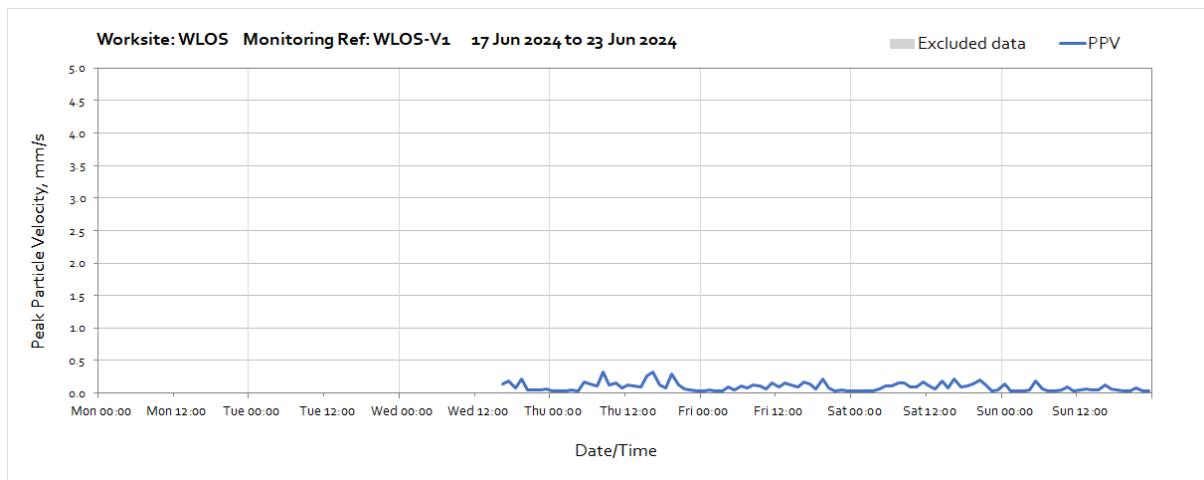
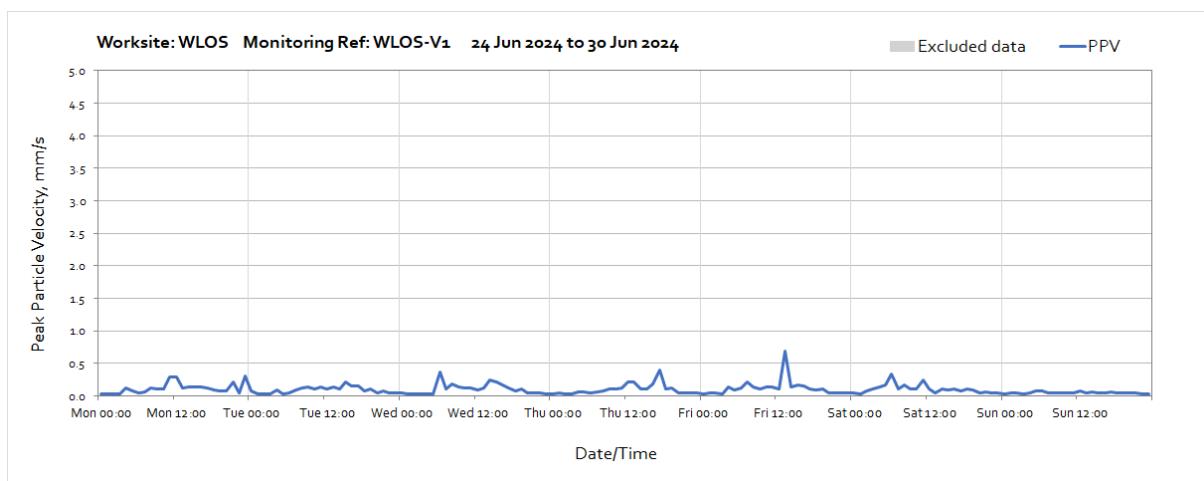
Worksite: WLOS – Monitoring Ref: WLOS-V1

Note: Missing data between 11:00 on Tuesday 11th until 16:00 on Wednesday 19th July is due to a monitor fault requiring replacement of the monitoring station.
